0129\_00\_904a BEECH COTTAGE, GRANGE LANE, DIDSBURY, MANCHESTER, M20 6RW

+ **method statement**

06 CONSERVATION-LED METHOD STATEMENT

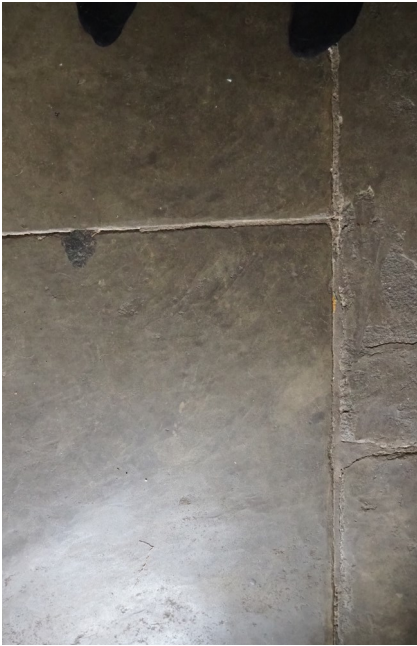
1. Existing York Stone flooring in Kitchen

1. Existing York Stone flooring to be carefully lifted and re-laid as existing in sections to install pipework for services providing hot and cold water supply to kitchen sink. All tools to be hand tools to ensure controllable working methods and reduce the risk of damage to existing fabric. Pointing and mortar to

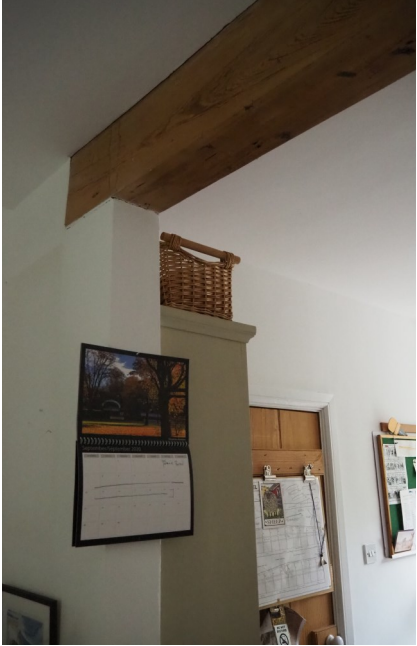
3. Existing opening between Kitchen and Office

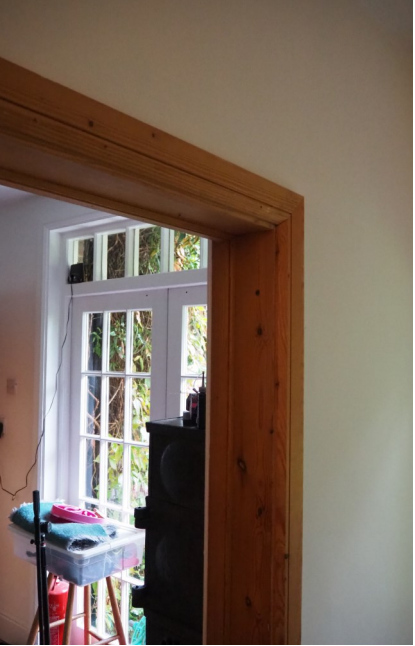
5. Existing opening between Kitchen and Hallway (non original)

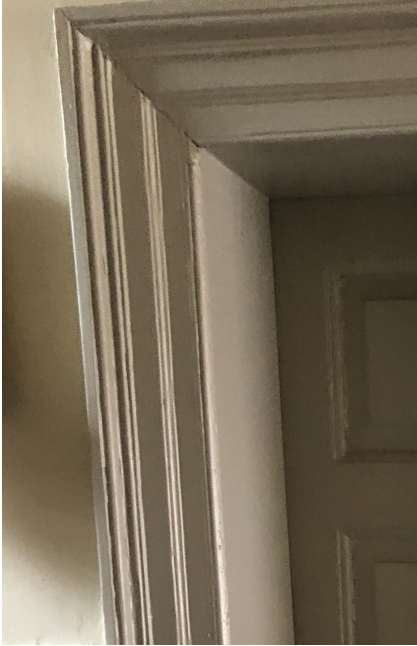
8. Existing architrave detailing in Moor Cottage

7. Mirrored panels to be fixed back to existing masonry walls with minimal screw fixings and demountable bracket mounts.
8. Architraves and skirtings throughout to be replaced with simple ogee-shaped mouldings with top-edge beading (to match existing skirtings in Moor Cottage). Doors to be replaced throughout to match existing examples in Moor Cottage.

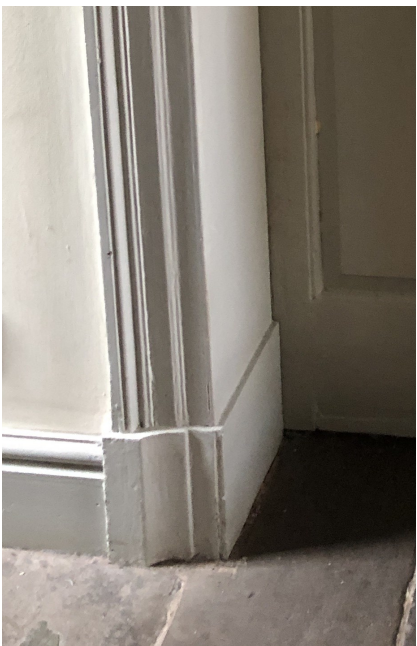
8. Existing architrave detailing in Moor Cottage

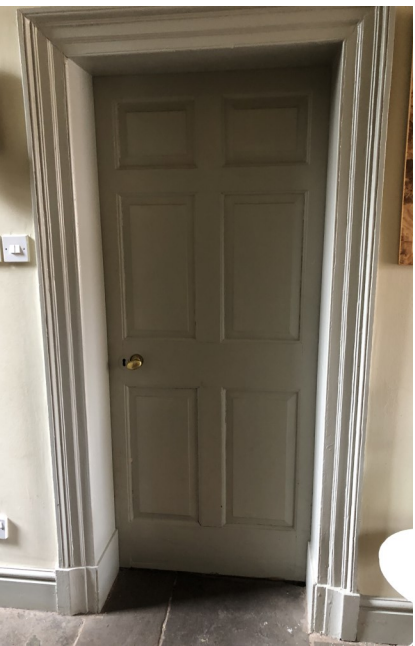
8. Existing door panels in Moor Cottage

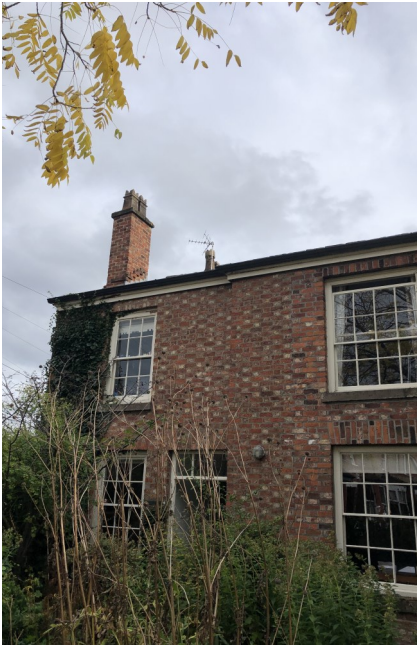
9. Areas of existing fascias/ gutters to be repaired like for like

9. Repairs to existing fascias – areas of existing rotten timber to be removed and replaced (like for like) as required and painted to match existing adjacent fascia panels.

10. Repairs to existing gutters – as above.
11. Upgrade of existing glazing – existing glazing to be carefully removed from frames and replaced with double glazed/ argon filled panes with ‘wibble’ roll effect to glass. Sash weights, ropes and pulleys to be carefully removed and replaced/ refurbished as necessary. All replacement fittings/ fixtures to match existing. All timberwork to be repainted to match existing colour as required. Areas of interior restoration around windows to be made good with lime-based plaster.

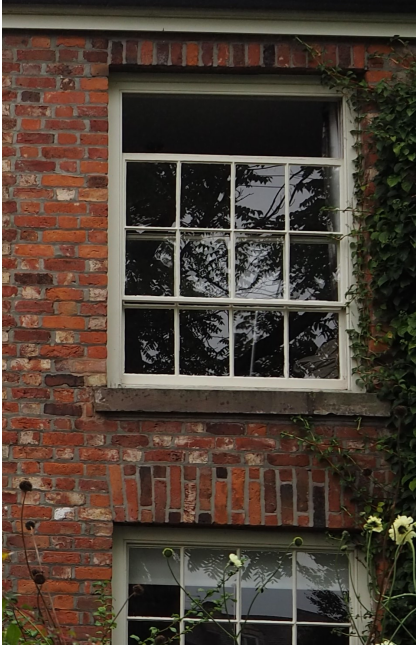
11. Existing glazing to be upgraded in existing frames

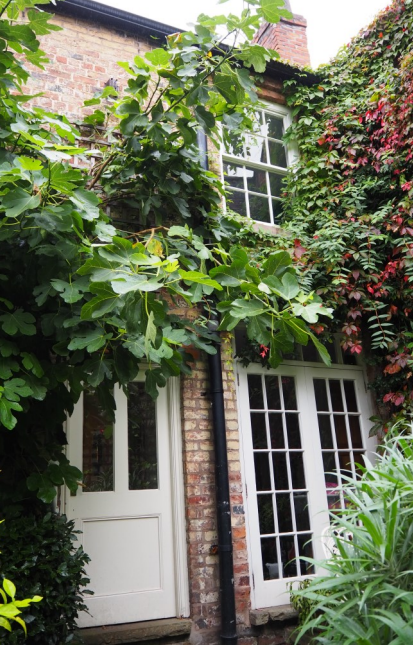
12. Existing non-original external doors to be removed

12. Existing non-original single timber door and frame in rear elevation to be carefully removed and replaced with aluminium framed panel-effect glazed door as approved elevations. Proposed fire rated aluminium door and frame to be installed in existing non-original door opening between Hallway and Extension. Area around installation to be made good and patched in with lime-based plaster.

13. Existing non-original timber French doors to be carefully removed and taken off site. Interior surfaces to be patch repaired/ made good as necessary using lime-based plaster. All surrounding exterior faces to be repaired/ repointed as above as necessary to match existing brickwork and mortar.

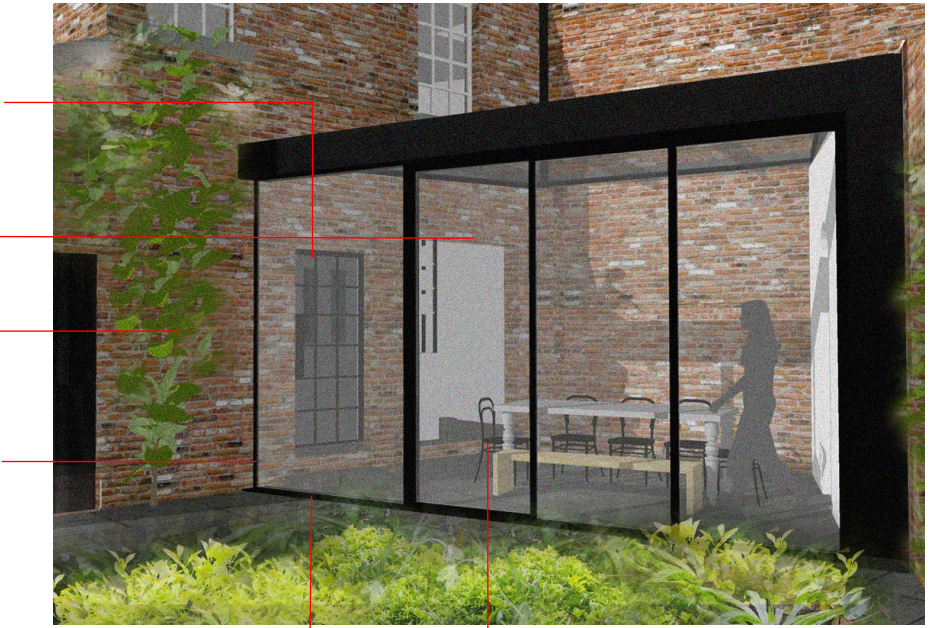
12. Existing non-original timber door to be removed and replaced in aluminium

13. Existing non-original timber doors to be removed

14. All existing vegetation in area of extension to be carefully removed and re-potted/ relocated

15. Perimeter wall frame to be fixed to existing walls with a perimeter upstand soaker in powder coated aluminium

18. Courtyard-facing glazing to be set on structural sub sill with concealed drainage channel

16. Any areas of damaged brickwork/ pointing to be carefully repaired as necessary as notes

- to be carefully repaired/ replaced as above.
- PROPOSED GLASS BOX CONNECTIONS TO EXISTING MASONRY WALLS**
15. Perimeter glazing wall frame to be fixed to the existing walls with a perimeter upstand soaker in powder coated aluminium. To be chased in with lead flashing and cavity tray and dressed down following soaker installation.

16. Any areas of damaged brickwork to be carefully repaired as necessary and re-pointed using a lime-based mortar with pointing style and colour matched to existing.

- PROPOSED GLASS BOX CONNECTIONS TO COURTYARD SURFACE**
18. Courtyard-facing glazed extension wall/ doors (with flush threshold) to be set on structural sub sill between York stone flags. Slot EDPM drainage channel to be installed below courtyard surface level between courtyard and extension to allow for weatherproofed flush threshold.
