## REMEDIATION METHOD STATEMENT

### LAND AT ILK STREET AND ALPINE STREET, CLAYTON

Report Ref: BEK-19661-1 (Rev D)

December 2019

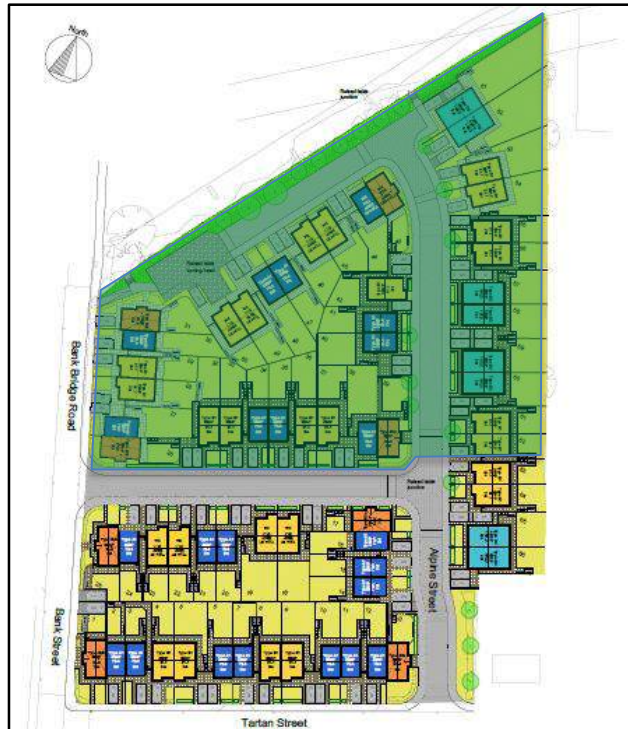
- 2.1.14 Due to the potential from contamination, Terra Consult recommend that clean cover in garden areas is required in the northern zone of the site. No remediation is required for the southern zone of the site. The Plots that need garden capping are highlighted green in Figure 2 below and listed in the adjacent table.

**Figure 2:** Plots Where Garden Capping is Required (highlighted Green)

- 2.2.4 The primary remediation solution recommended by Terra Consult is associated with the placement of a capping system in the gardens of all buildings in the northern zone of the site (minimum 600 mm of clean suitable soils) and this is considered appropriate to mitigate any potential risks to future site issuers. The plots which require garden capping are Plots 23 to 65.

- 3.1.1 The gardens within Plots 26 to 62 (of the current development layout plan – see Figure 2) will need to be capped with a minimum of 600 mm of clean suitable soils (minimum 450 mm topsoil overlying 150 mm subsoil).
- 3.1.2 Any soft landscaped areas in the vicinity of Plots 26 to 62 will need to be capped with a minimum of 450 mm of clean suitable soils.
- 3.1.3 Soils used in the capping system will need to be tested and assessed and ensure suitability for use. The soils will be placed on a geo-membrane to act as a marker layer and prevent mixing. All soil used in the capping system will need to be imported. Final capping thickness will also need to be validated.
- 3.1.4 The topsoil must be a minimum of 150 mm and be a suitable growing medium to assist future planting (predominantly grass and shrubs).

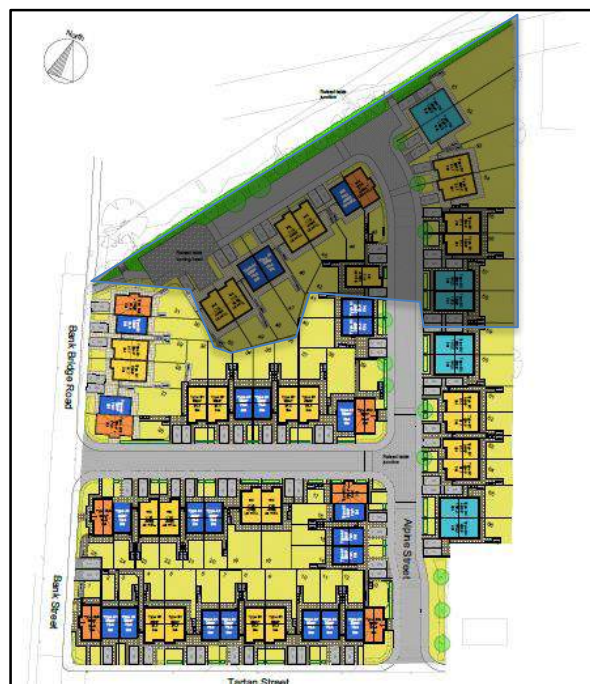
- 2.1.15 With respect to risks from ground gas at the site, Terra Consult identified Characteristic Situation 2 (CS2) ground gas conditions have been identified in the northern zone of the site and mitigation measures need to be incorporated into these buildings. The affected plots are highlighted in blue in Figure 3 below and listed in the adjacent Table.

**Figure 3:** Plots That Require Gas Mitigation Measures (highlighted blue)
