GTech Surveys Limited

Planning Condition 16
Television Signal Reception Assessment

1 NQ

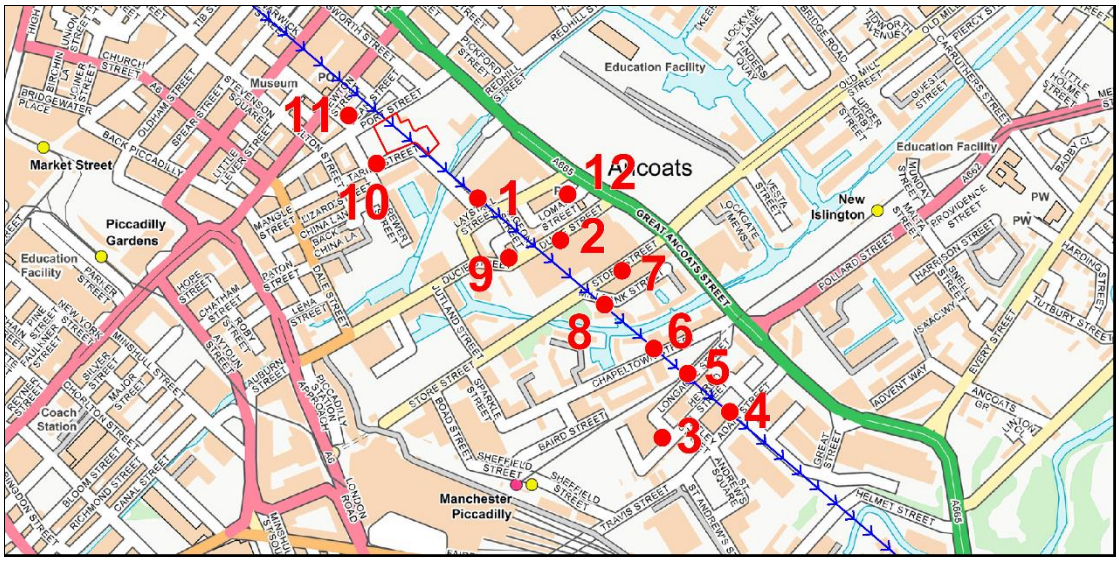
Figure 2 - Surveyed Locations. The Site is delineated in red. The blue arrow indicates the direction of the incoming DTT signals from Winter Hill transmitter in the study area

DTT services were available at all surveyed locations from the Winter Hill transmitter. At all locations, received signal levels were in excess of recommended minimum amounts and the technical quality of received signals was found to be good[1]. DTT services provided good coverage and service throughout the study area.

DTT services were available at all surveyed locations from the Winter Hill DTT transmitter. At all locations, received signal levels were well in excess of recommended minimum amounts and the technical quality of received signals was found to be good[2]. DTT services provide good coverage and service throughout the study area even though a number of new buildings and developments have been constructed in the wider area.
