# VITA T2, St Johns

## Piling Risk Assessment

Curtins Ref: T2-CUR-JC10-TS-XX-002

Piled foundations are proposed for the development at the VITA T2 site located off Water Street, Manchester, M3 4JQ.

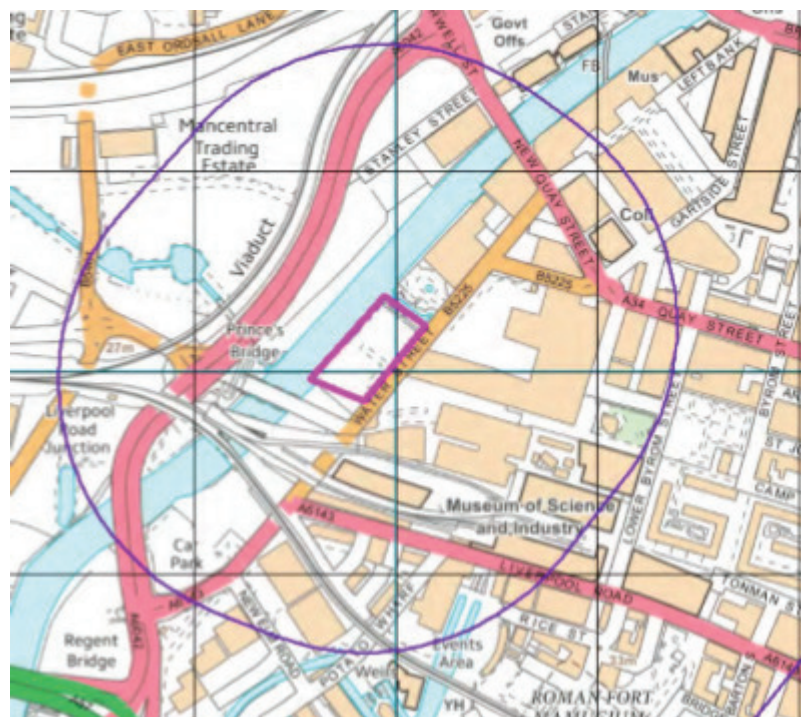
**Figure 2.1 – Site Location Plan (site boundary shown in pink. 250m buffer in purple).**  
Crown Copyright. License Number 100022432.

The site location and boundary are illustrated in *Figure 2.1*.
