TV RECEPTION SURVEY REPORT

DATE OF SURVEY: 16th January 2026
Tower A and midrise A (section 2).

VICTORIA RIVERSIDE, Towers A, and midrise A (section 2)
DANTZIC STREET
MANCHESTER

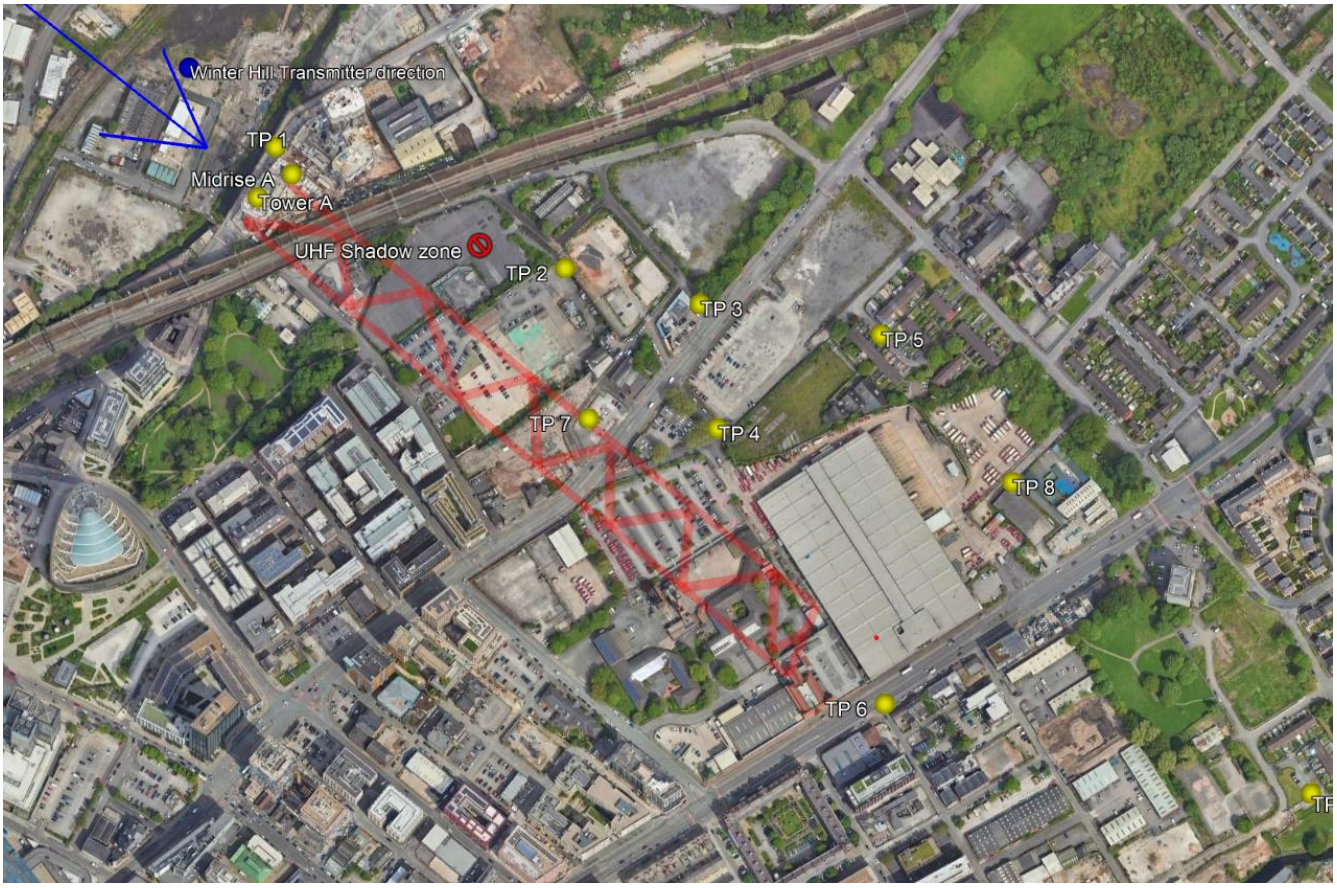
POTENTIAL IMPACT ZONE – MAP 1

There has been a slight reduction in aerial signal to the southeast of the proposed development covering test points 2 and 4. This is as largely as predicted in the initial pre-construction report, however as this area has predominantly car park areas and only a small amount of commercial properties we expect minor impact.
