| TITLE<br>EXISTING ELEVATION AND<br>PROPOSED REPAIR WORKS -<br>ELEVATION 1 - GOULDEN STREET<br>Perimeter walls | | | |

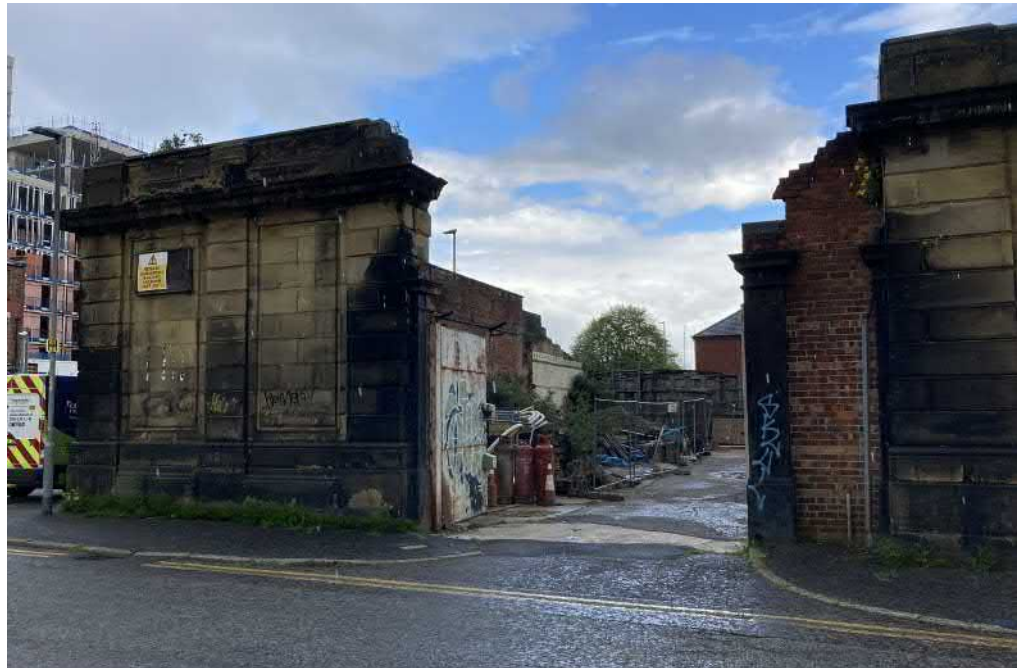
**OUTSIDE ELEVATION - WEST END**  
Wall to be partly demolished. East wall corner to be retained and restored.

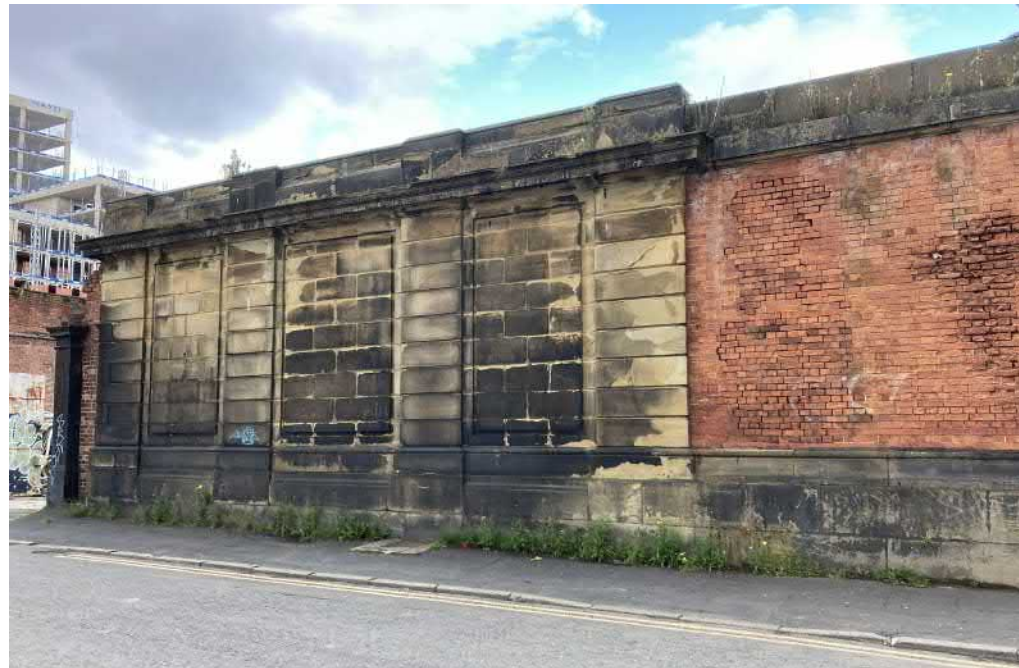
**OUTSIDE ELEVATION - MIDDLE PART**  
Wall to be partly demolished and partly restored.

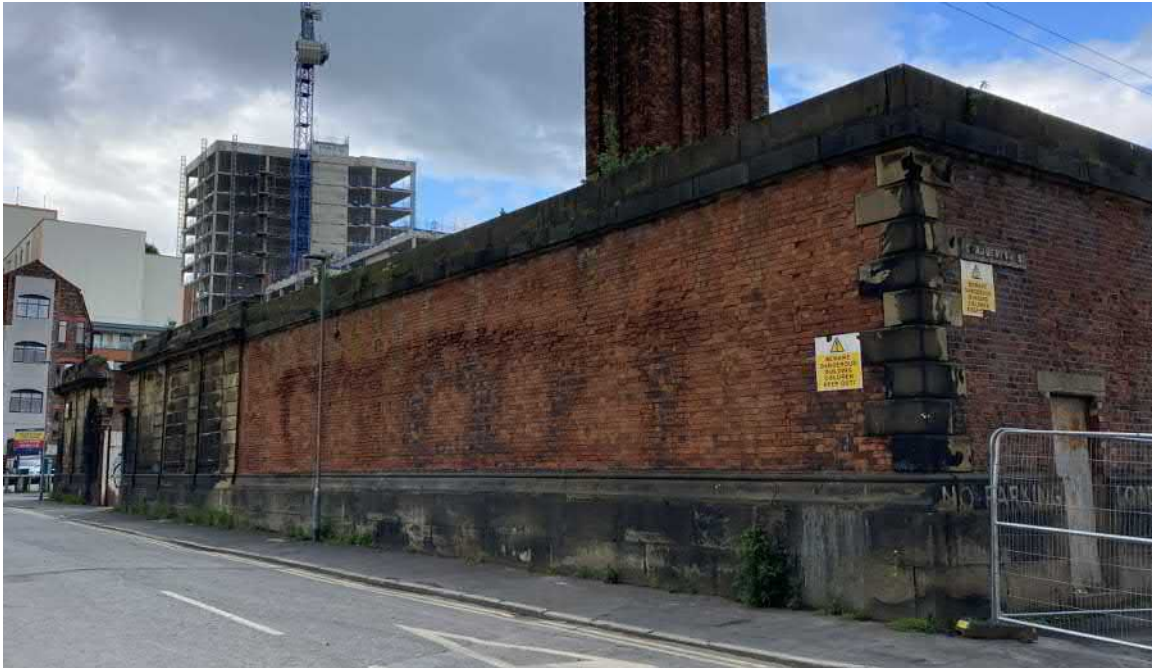
**OUTSIDE ELEVATION - EAST END**  
Wall to be partly demolished. East wall corner to be retained and restored.

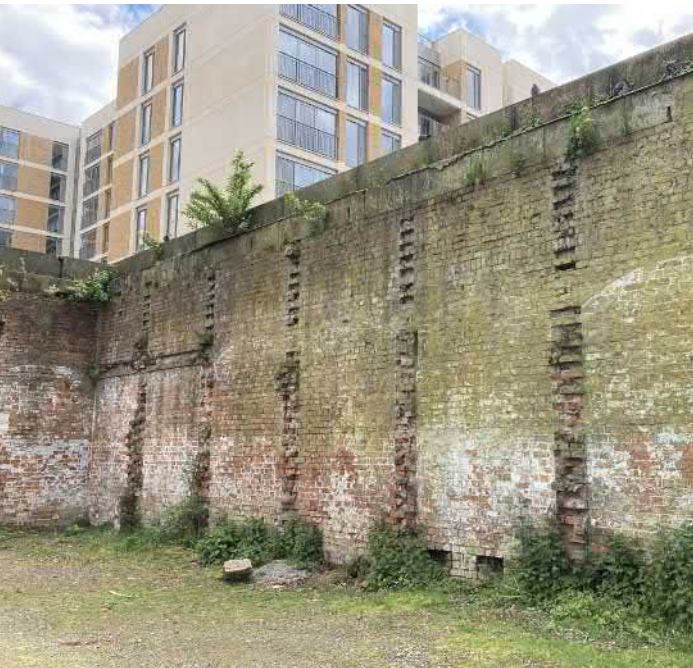
**INSIDE ELEVATION - EAST END**  
Wall to be partly demolished. East wall corner to be retained and restored.

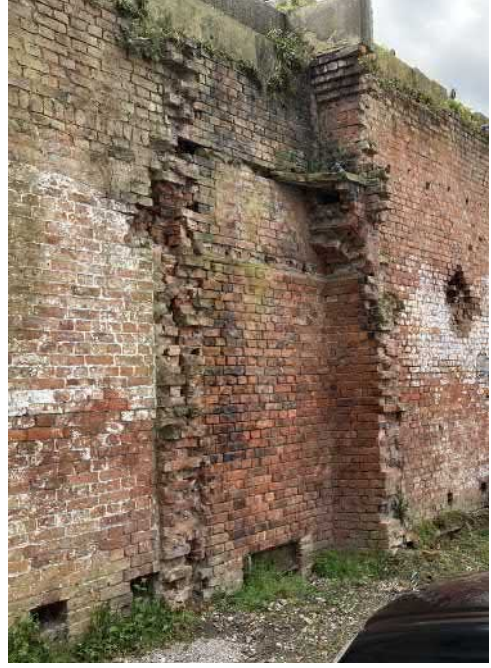
**INSIDE ELEVATION - MIDDLE PART**  
Wall to be partly demolished and partly restored.

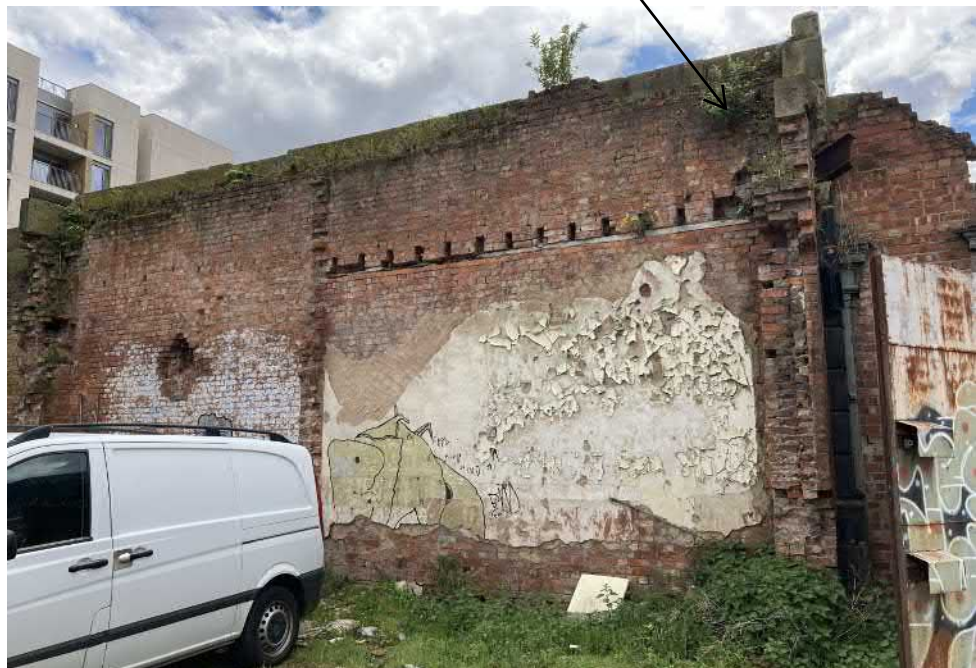
**INSIDE ELEVATION - MIDDLE PART**  
Wall to be partly demolished and partly restored.

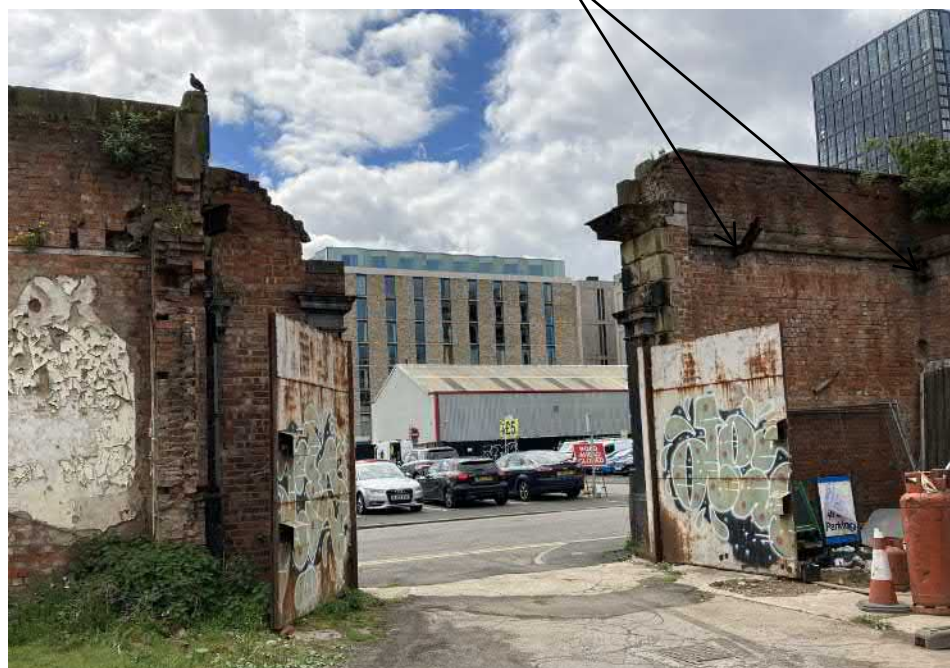
**INSIDE ELEVATION - WEST END**  
Existing metal gate to be removed.
