TIM GROOM ARCHITECTS  
GOULDEN STREET EXISTING EXTERNAL MATERIAL SAMPLE TRACKER

0321-TGA-PM\_40\_50\_56-Existing Sample Tracker

Goulden Street  
DRAFT FOR DISCUSSION

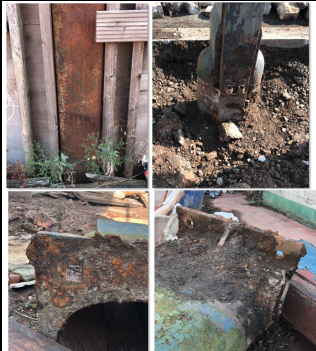
| Description | Method Statement | Range/Colour | Image | Sample - Initial repair sample | AGREED APPROACH | Approval / Date | | | | Notes |
|---|---|---|---|---|---|---|---|---|---|---|
| 3.1 - Cast Iron Column | Refer to Henley Stone Restoration and Remedials Method Statement | Demolition team are to remove the columns from there current fixed position and remove excess concrete/fixing material from them, place on pallets and shrink wrap ready for collection and store in a safe and accessible area of site. Site visit by Henley Stone Restoration & Remedials management whilst the above is in progress to ensure each column is clearly marked up and identified. HSRR to collect from site and remove to premises where recondition works can be undertaken, using the Thermatec abrasive attachment to remove surface dust & defective paint. Recoat with specified colour primer/treatment (TBC). Return to site at agreed date/time for reinstallation. Installation process to TBC with Mulbury & Henley Stone Restoration & Remedials. | | On site there is a historically cracked column, that had to be removed for safety reasons. Photograph of this show that see the base for this one has been removed intact and undamaged also. Methodology of the cast iron column removal to be agreed by LPA. | A sample column clean and repaint is to be provided prior to all the columns being treated. Estimated date of initial column sample XXXX 2021. | | | | | |
