## **39 Deansgate, Manchester**

# **Flood Risk Assessment & Drainage Strategy Report**

For: Kames Property Income Fund

Ref: 3174-03

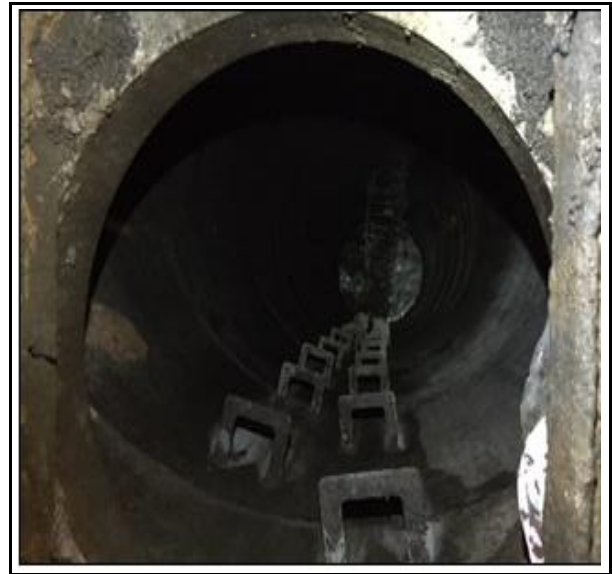
INTERNAL PHOTO

RECOMMEND TO REMOVE LADDERS FROM WITHIN MH CHAMBER
