W13-LG

**OSBORNES**CHARTEREDARCHITECTS  
The Balconies • Hanley Swan • Malvern • Worcestershire • WR8 0DN  
T: 01684 311303 E: architecture@osbornesarchitects.com F: 01684311255 W: osbornesarchitects.com  
CLIENT AMBASSADOR THEATRE GROUP  
PROJECT MANCHESTER OPERA HOUSE  
TITLE WINDOW REPAIR - W13-LG  
SCALE 1:5; NTS @ A1  
DATE MAR 2020  
DRAWN AML DRAWING NUMBER 19-143- WR13

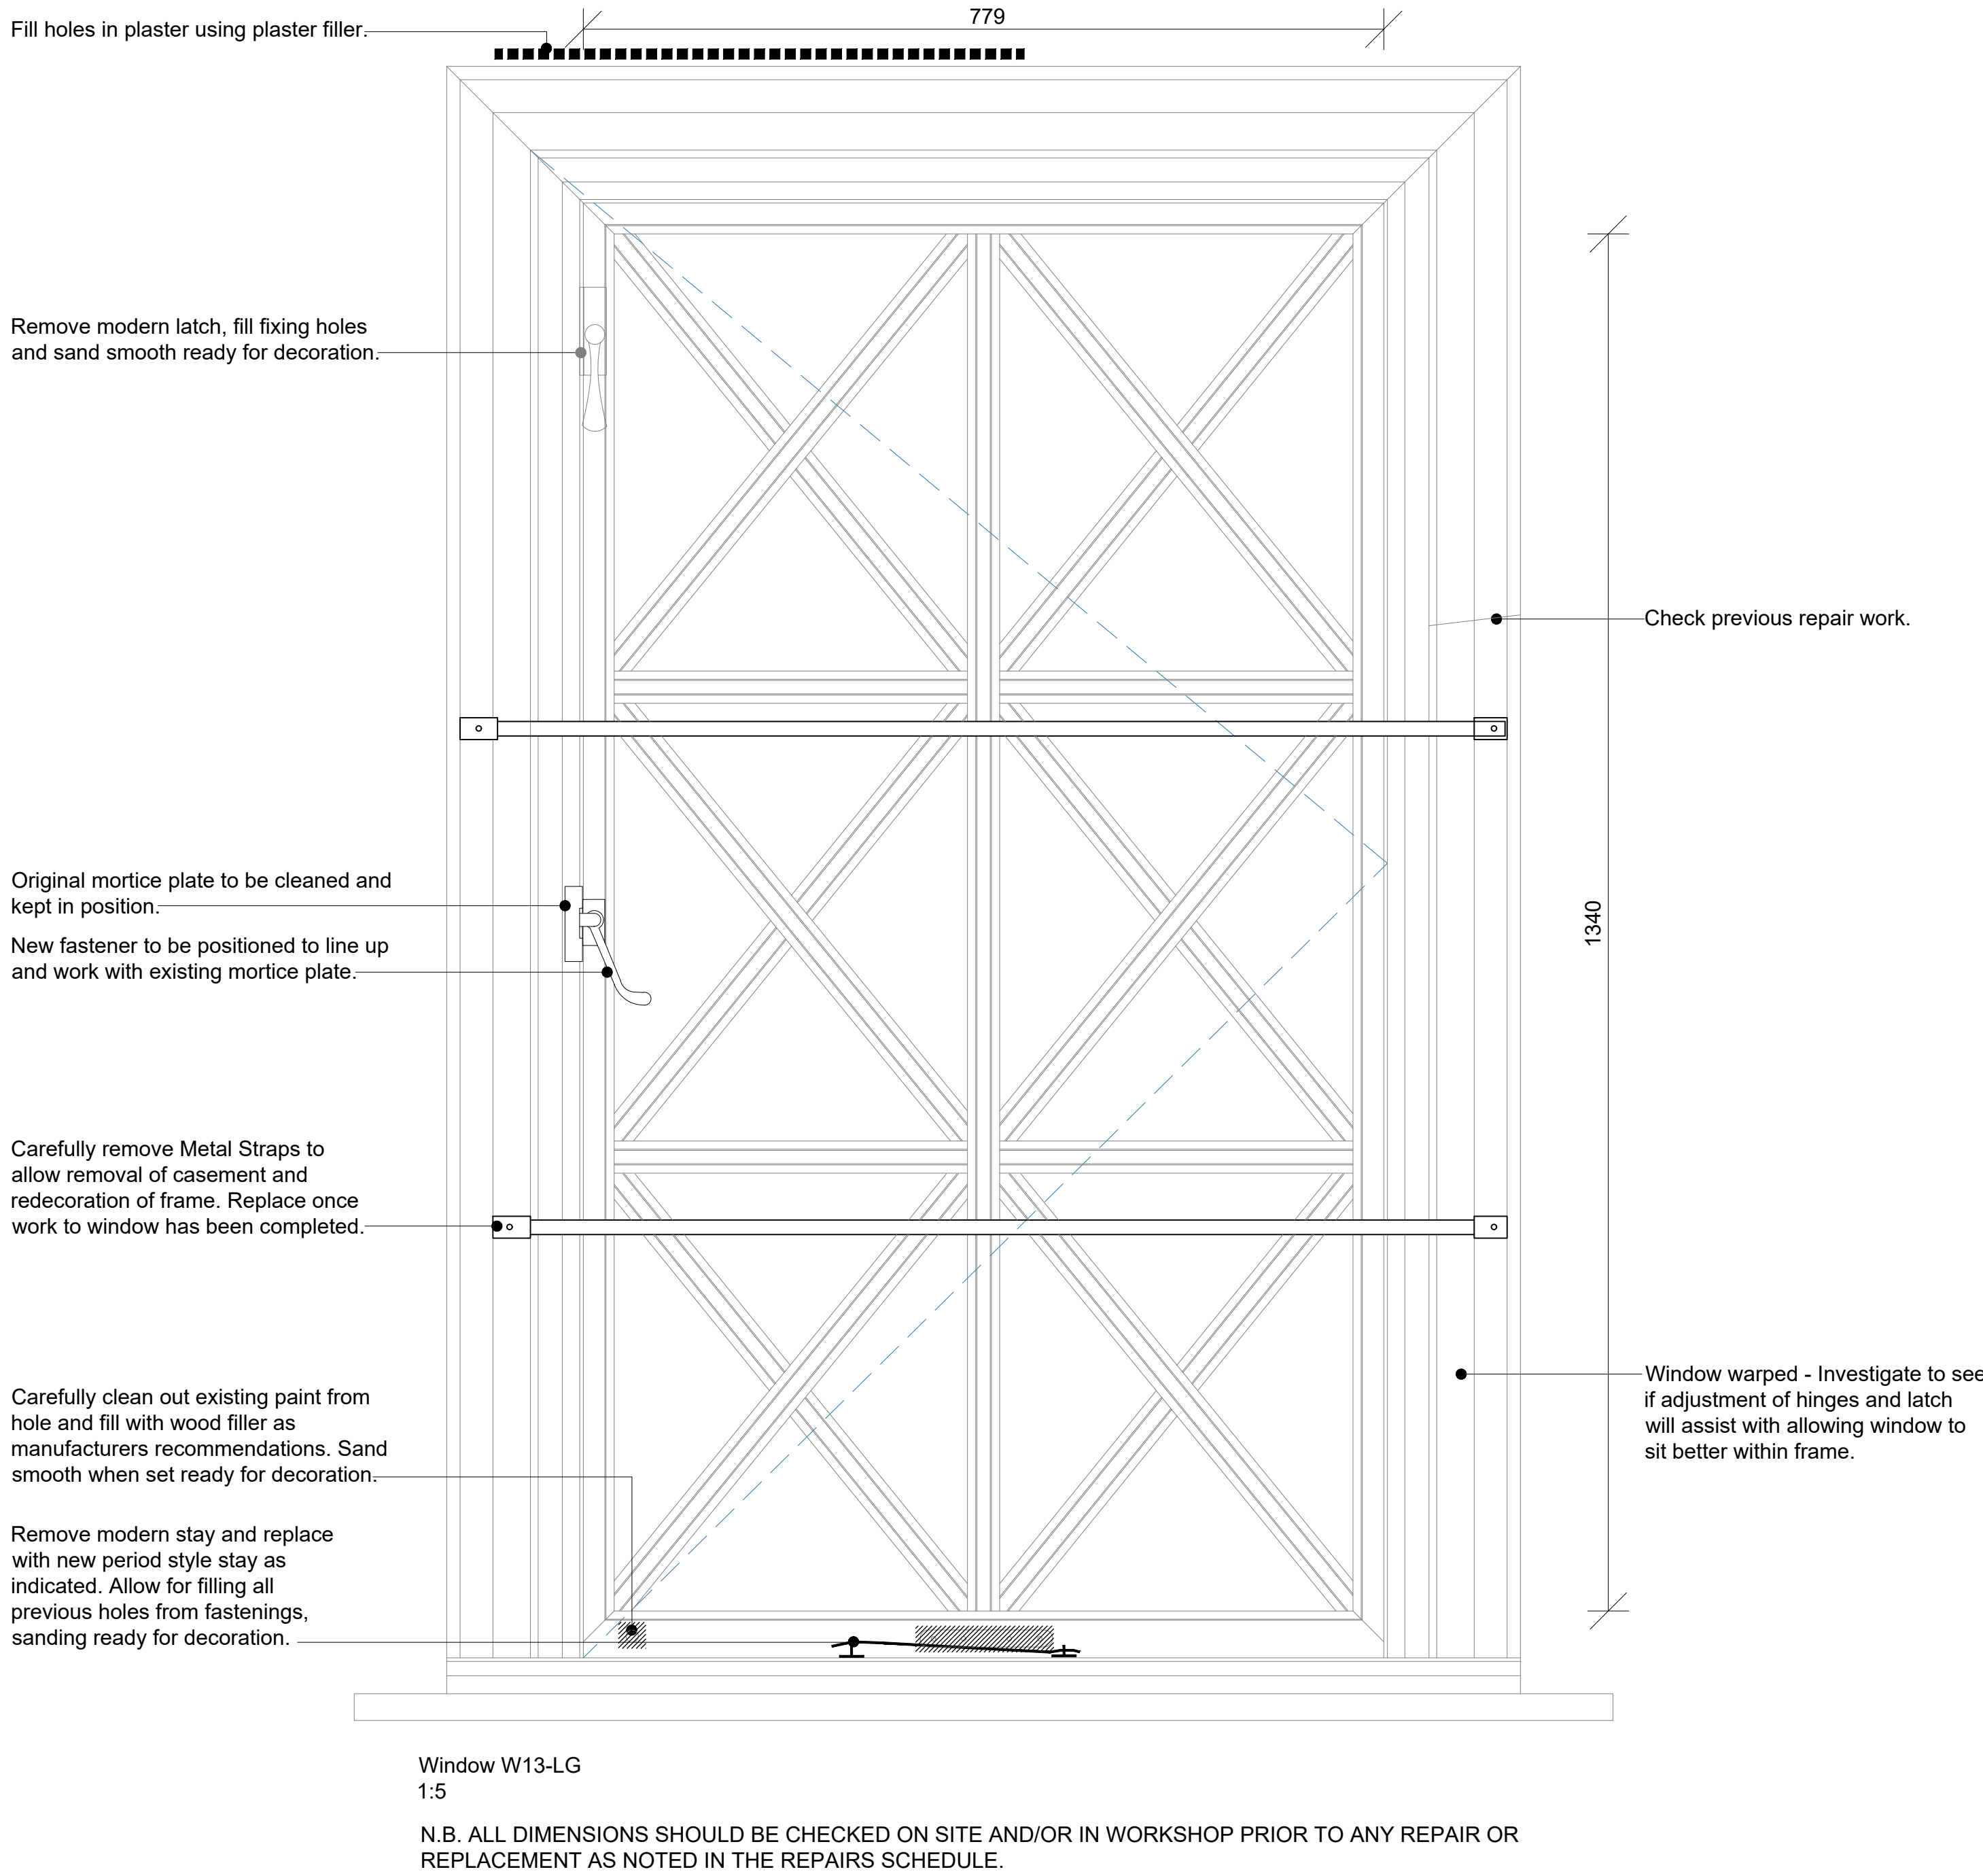
INTERNAL ELEVATION

Window W13-LG Kitchen

Once all repairs have been carried out.

**Decoration**  
Clean down and remove any loose paint. Prepare surface to receive new painted finish, preferably using specialized scrapers or heat guns where appropriate. Avoid using an alkaline based paint stripper as the surface needs to be ph.neutral.  
Repaint with linseed oil based paint to give long lasting preservation of the timber and breathability. Apply in 2-3no thin coats with 24hr drying time between coats as manufacturers recommendations.

**Glass**  
Carefully clean glass and check for damage. If any glass needs to be removed during the course of the repair it must be labeled and re-used in its original location and orientation. Ensure rebates are clean, dusted given a thin coat of paint before linseed-oil bedding putty is applied. Once bead is re-fixed use more putty to seal between glass and frame joint.

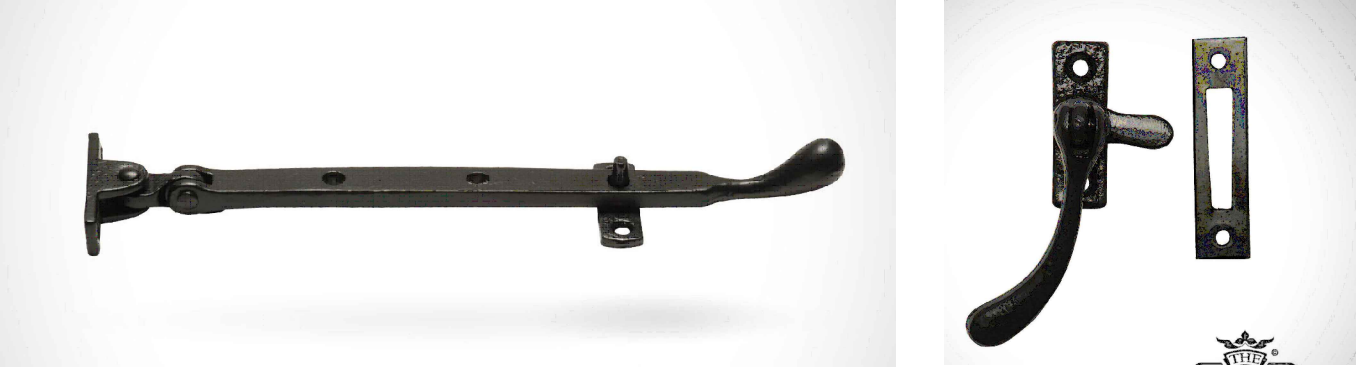
**Ironmongery**  
Check all ironmongery is in sound working order. Ease any moving parts with lubricant if required. Ensure all hinges are sound, if not replace with like for like hinges using stainless steel fastenings.  
If replacement ironmongery is required source to closely match original black iron window fasteners and stays as indicated below.

For reference these are available from 'The Victorian Emporium' - N.B ensure size is suitable to coordinate with existing ironmongery that is being retained.

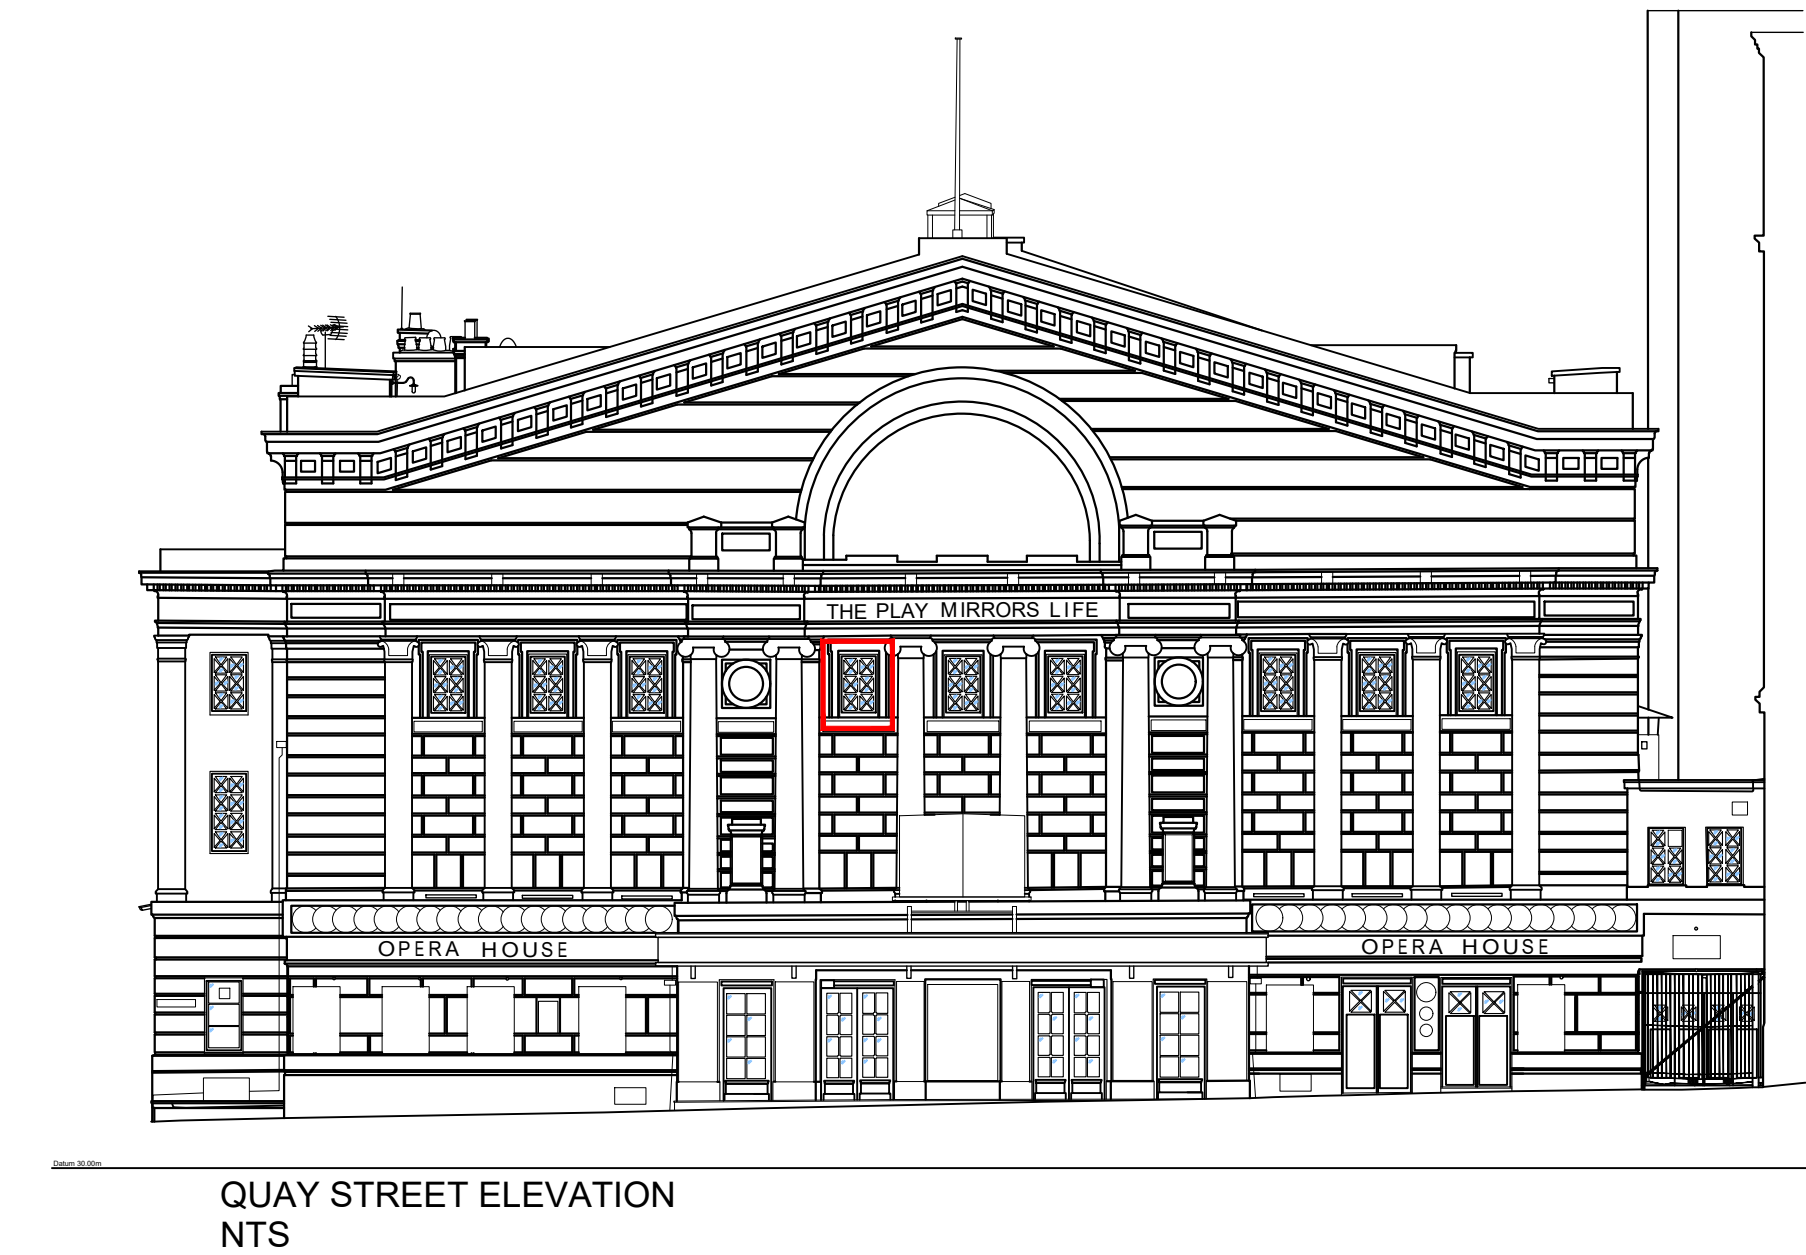
EXTERNAL ELEVATION

Window W13-LG

Once casement has been removed and the existing frame has been left in-situ, check frame and cill for and damage or rot. Record areas and inform CA.

Where external cills are to be replaced - replicate the profile of the existing cill in a durable hardwood such as oak incorporating a drip detail to the underside. Any new cill parts should be butt jointed below the casement frame. Finish using linseed oil based paint as described above in the colour to match the existing colour.
