**HERITAGE STATEMENT AND JUSTIFICATION FOR THE WORKS UNDER THE NATIONAL PLANNING POLICY FRAMEWORK**

Revision A 14.07.21.

PROJECT; REFURBISHMENT 4th FLOOR 18 HILTON STREET, MANCHESTER

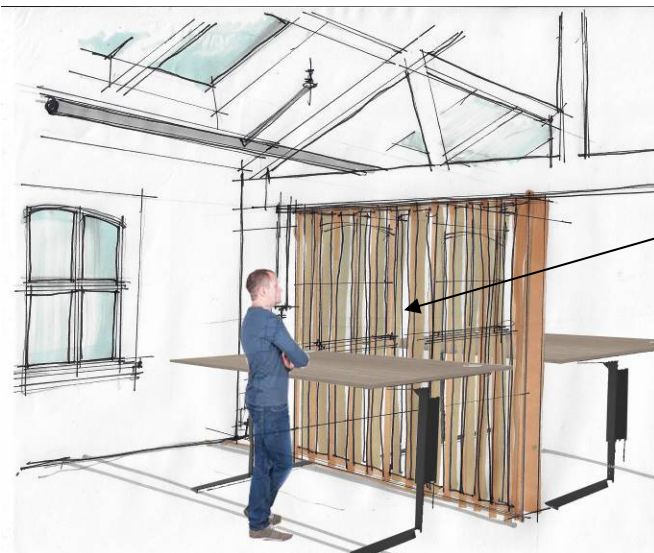
### TIMBER SCREEN TO STAND DESKS

Sanded rough sawn stained timber palisade screen

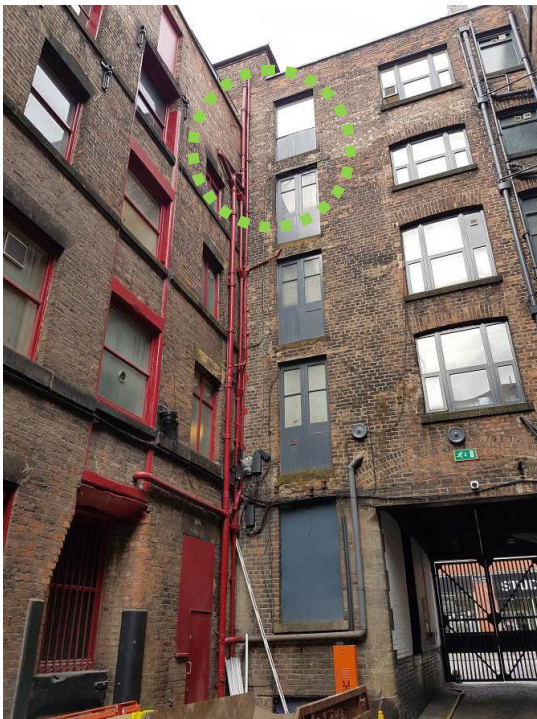
EXISTING

Core drill 110mm hole through existing external wall as close to the corner as possible and connect the internal new soil vent pipe ( stub stack- no roof penetration) to new cast iron branch discharge pipe connected to existing cast iron SVP and painted in heritage Pugin red to match existing.

Consideration has been given to existing similar drainage in the building and the nearest, least intrusive solution. Fortunately, an existing original vertical soil stack is already in the corner of the yard at high level next to where the connection is required. There is precedent for a similar branch connection one floor down as shown on the photograph. Therefore a simple branch connection in a matching profile cast iron is proposed, painted in the same Pugin Heritage red colour

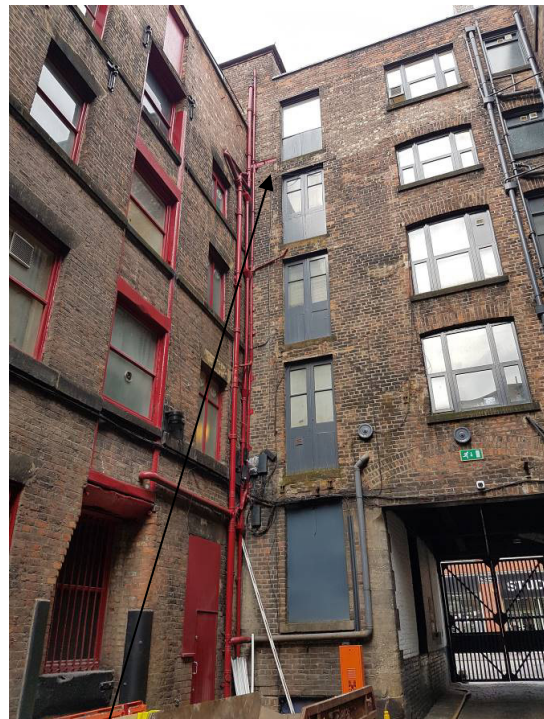
PROPOSED

New cast iron branch discharge pipe  
connected to existing vertical cast  
iron SVP
