# W15-LG

TITLE WINDOW REPAIR - W15-LG

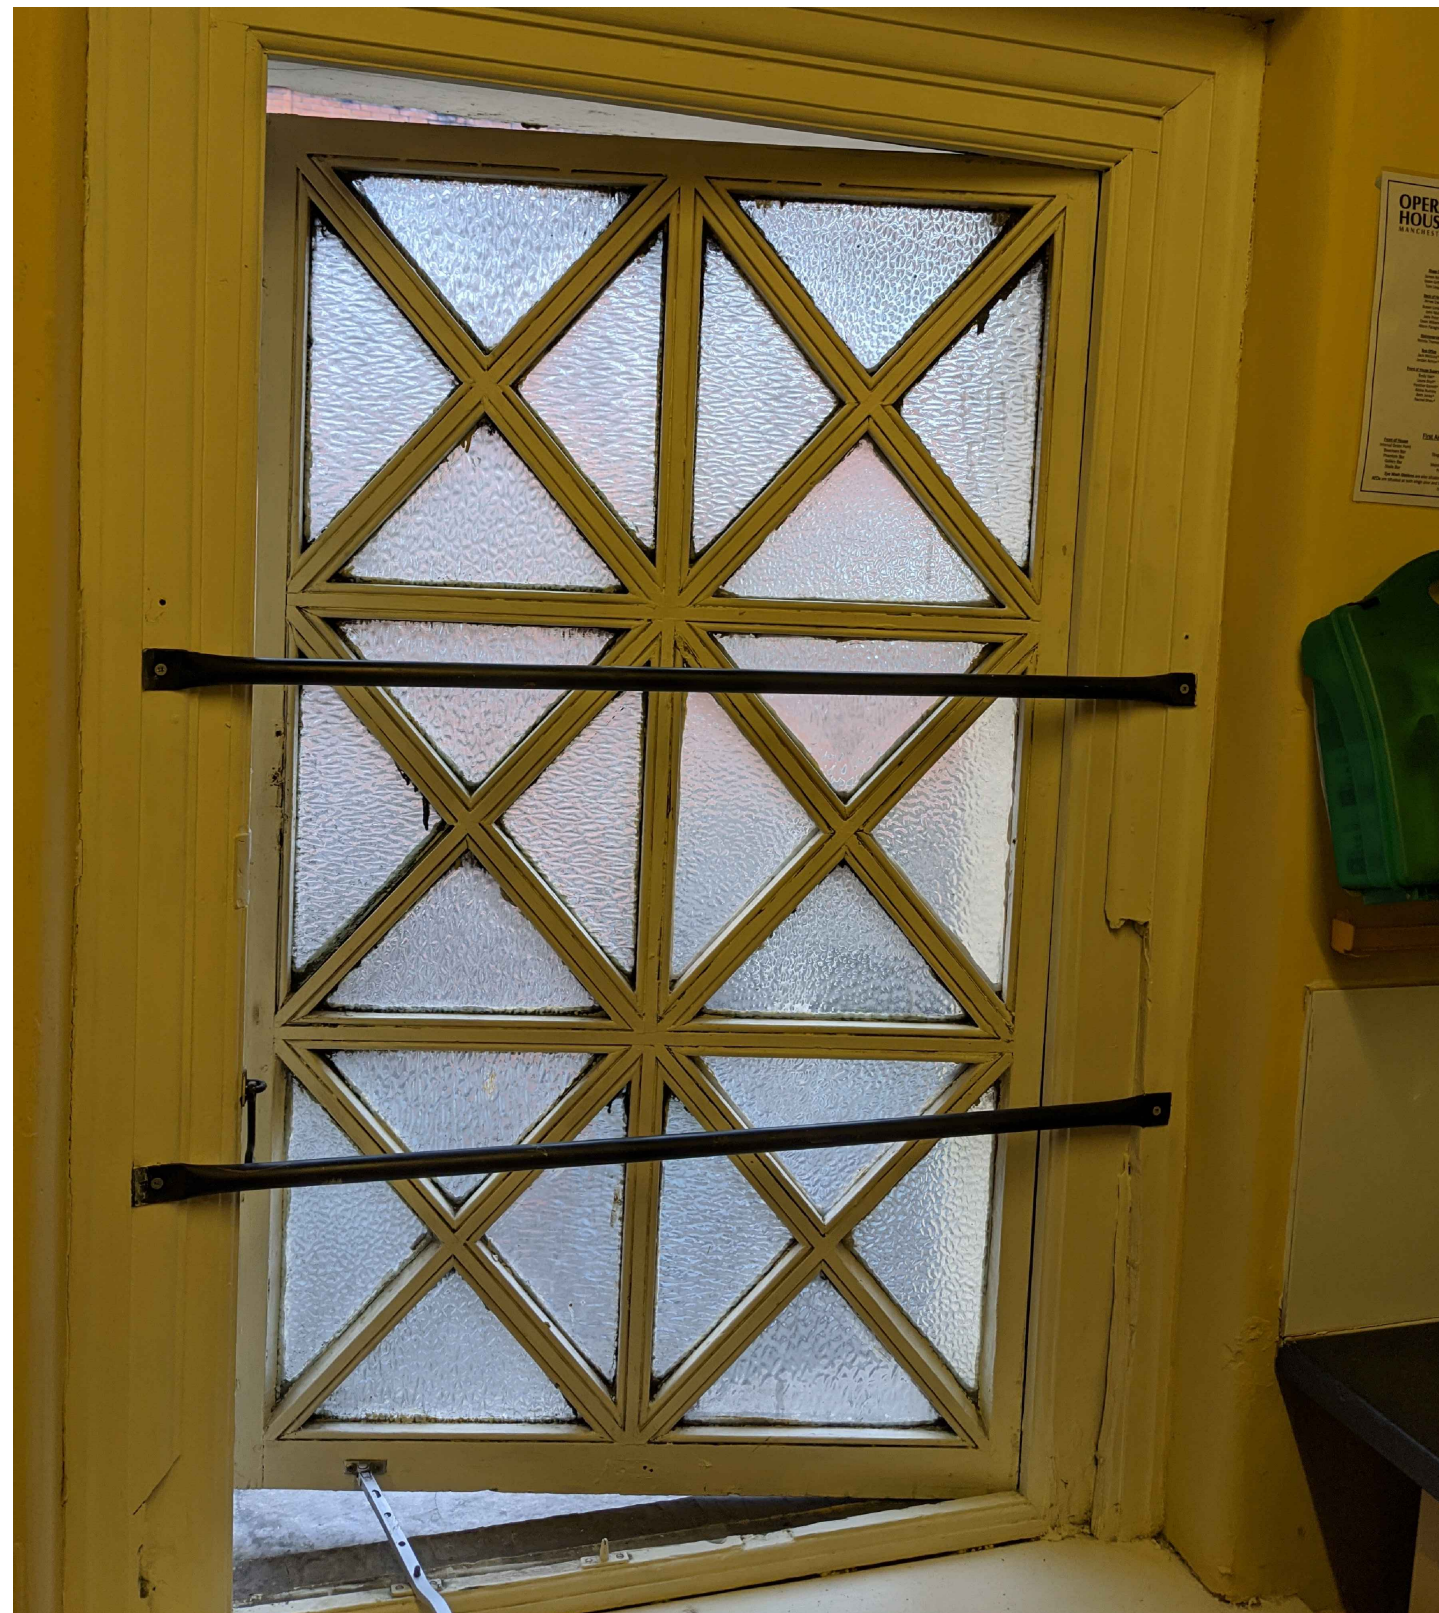
#### INTERNAL ELEVATION

Window W15-LG Kitchen

Once all repairs have been carried out.

Clean down and remove any loose paint. Prepare surface to receive new painted finish, preferably using specialized scrapers or heat guns where appropriate. Avoid using an alkaline based paint stripper as the surface needs to be ph.neutral.  
Repaint with linseed oil based paint to give long lasting preservation of the timber and breathability. Apply in 2-3no thin coats with 24hr drying time between coats as manufacturers recommendations.

Carefully clean glass and check for damage. If any glass needs to be removed during the course of the repair it must be labeled and re-used in its original location and orientation. Ensure rebates are clean, dusted given a thin coat of paint before linseed-oil bedding putty is applied. Once bead is re-fixed use more putty to seal between glass and frame joint.

Check all ironmongery is in sound working order. Ease any moving parts with lubricant if required. Ensure all hinges are sound, if not replace with like for like hinges using stainless steel fastenings. If replacement ironmongery is required source to closely match original black iron window fasteners and stays as indicated below.

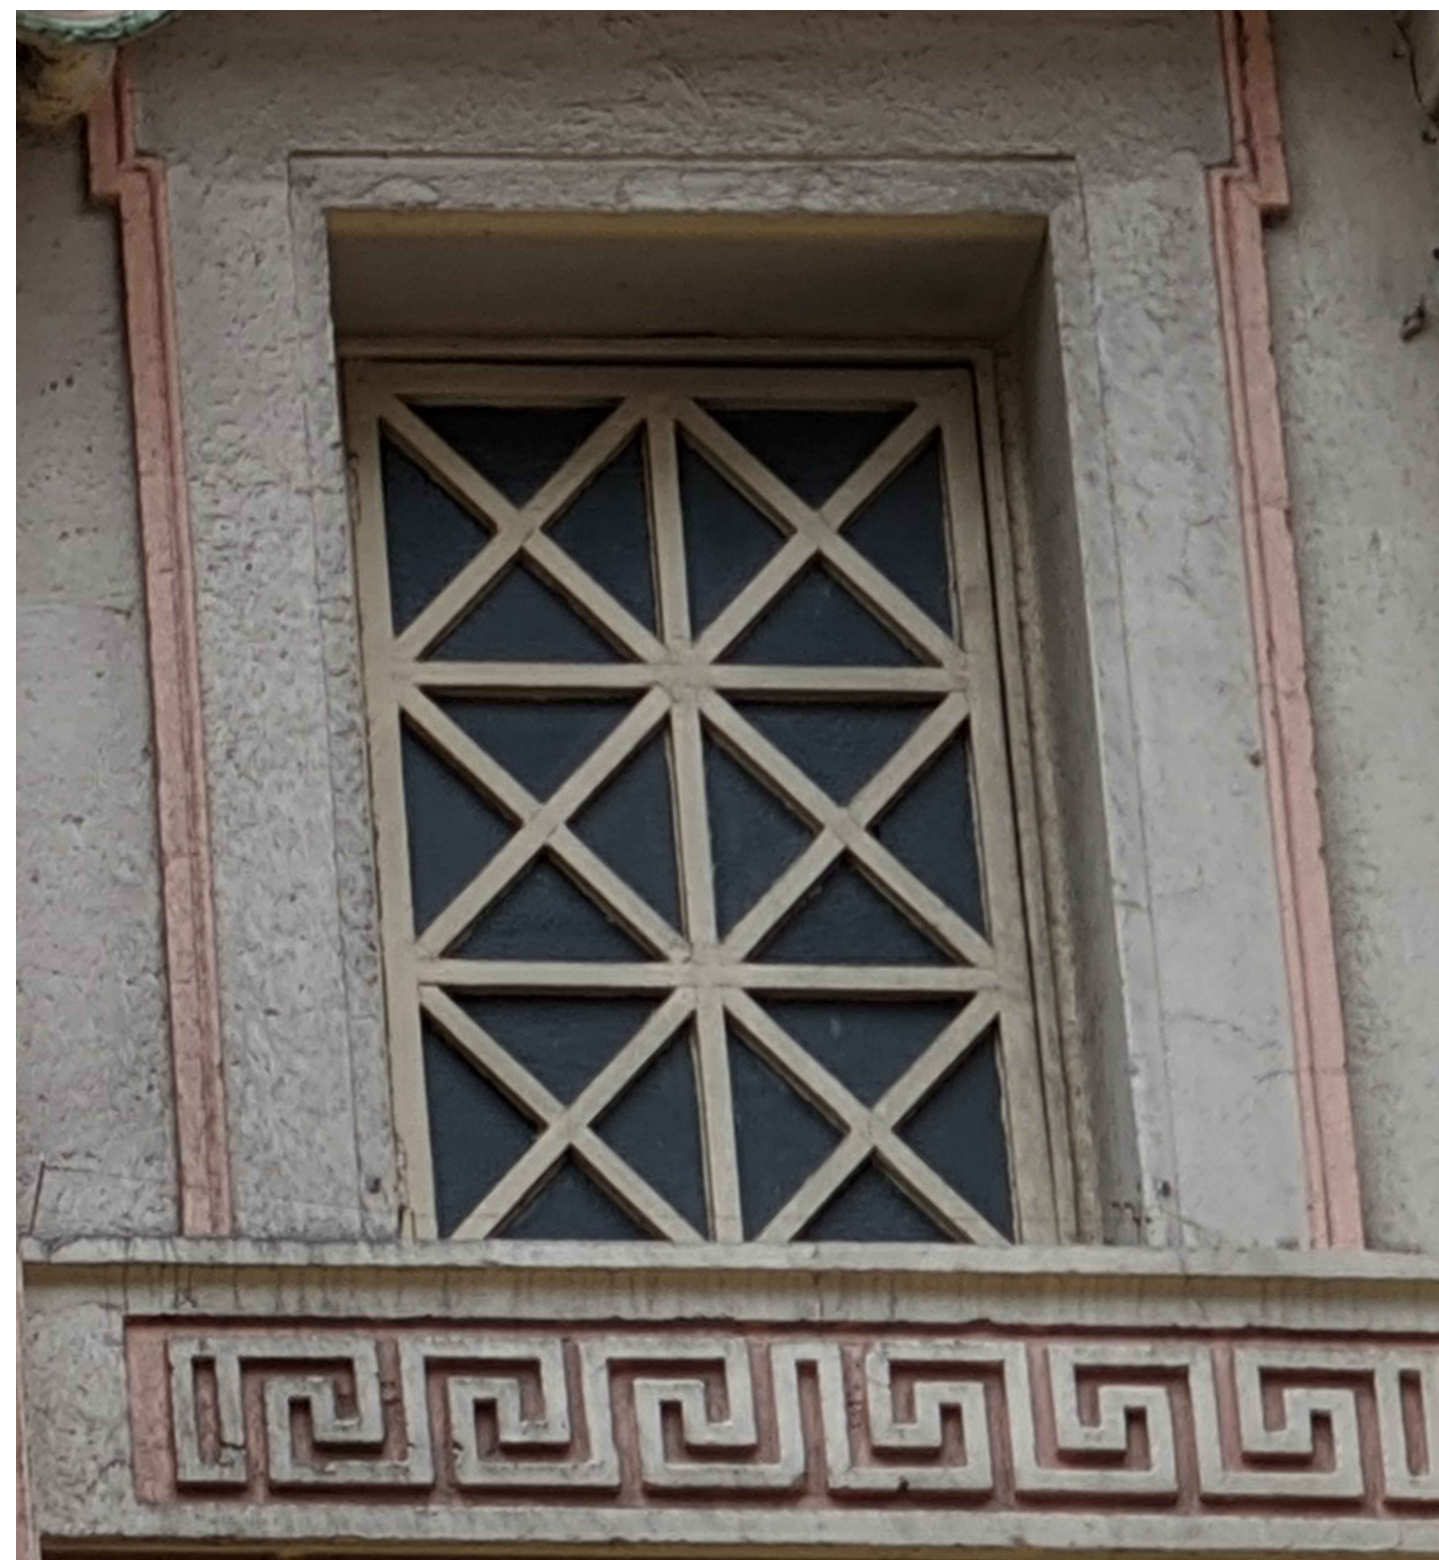
#### EXTERNAL ELEVATION

Window W15-LG Kitchen

Once casement has been removed and the existing frame has been left in-situ, check frame and cill for and damage or rot. Record areas

Where external cills are to be replaced - replicate the profile of the existing cill in a durable hardwood such as oak incorporating a drip detail to the underside. Any new cill parts should be butt jointed below the casement frame. Finish using linseed oil based paint as described above in the colour to match the existing colour.

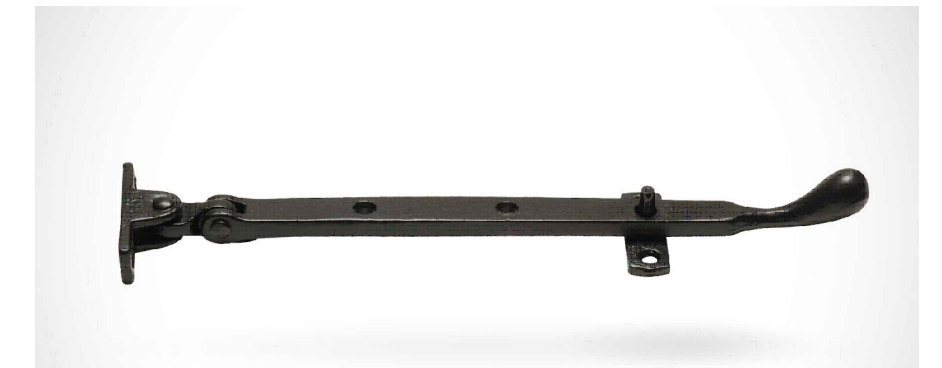
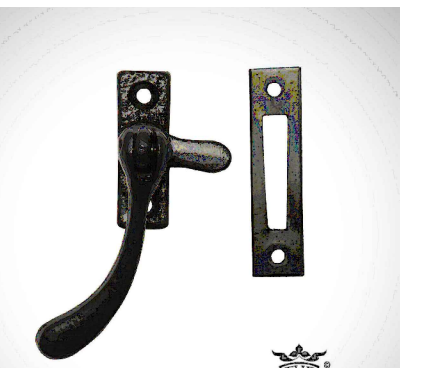
For reference these are available from 'The Victorian Emporium' - N.B ensure size is suitable to coordinate with existing ironmongery that is being retained.
