Land bound by John Dalton  
Street, Ridgefield, Bow Street  
and South King Street,  
Manchester

## Phase 1 Preliminary Risk Assessment

Curtins Ref: 070298-CUR-00-XX-RP-GE-001

Client Name: Island Site (General Partner) Ltd

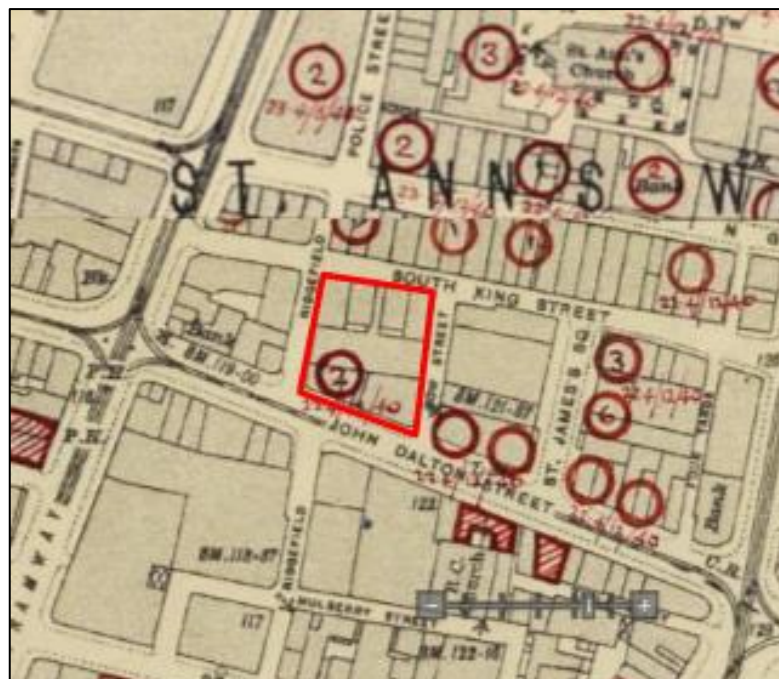
**Figure 6.1:** Site boundary shown in red. Fire bombs red circles, damaged building in red hatching

Risk Mapping for UXO's (6) has placed the site in a Moderate Risk area. Moderate risk areas are those that show a bomb density of 11-50 bombs per 1000 acres and may contain WWII targets. Two Luftwaffe targets are located within 1km of the site; approximately 350m south and 750m north, and one post-war UXO find approximately 50m north of the site.

Analysis of historical bomb mapping from the University of Manchester (7) shows the site was hit by a fire bomb in 1940, with the surrounding area to the east and sustaining fire bombs spanning 1940-1941. During this period, buildings were damaged (red hatching) 50m south east and 110m south west.
