Back Piccadilly elevation

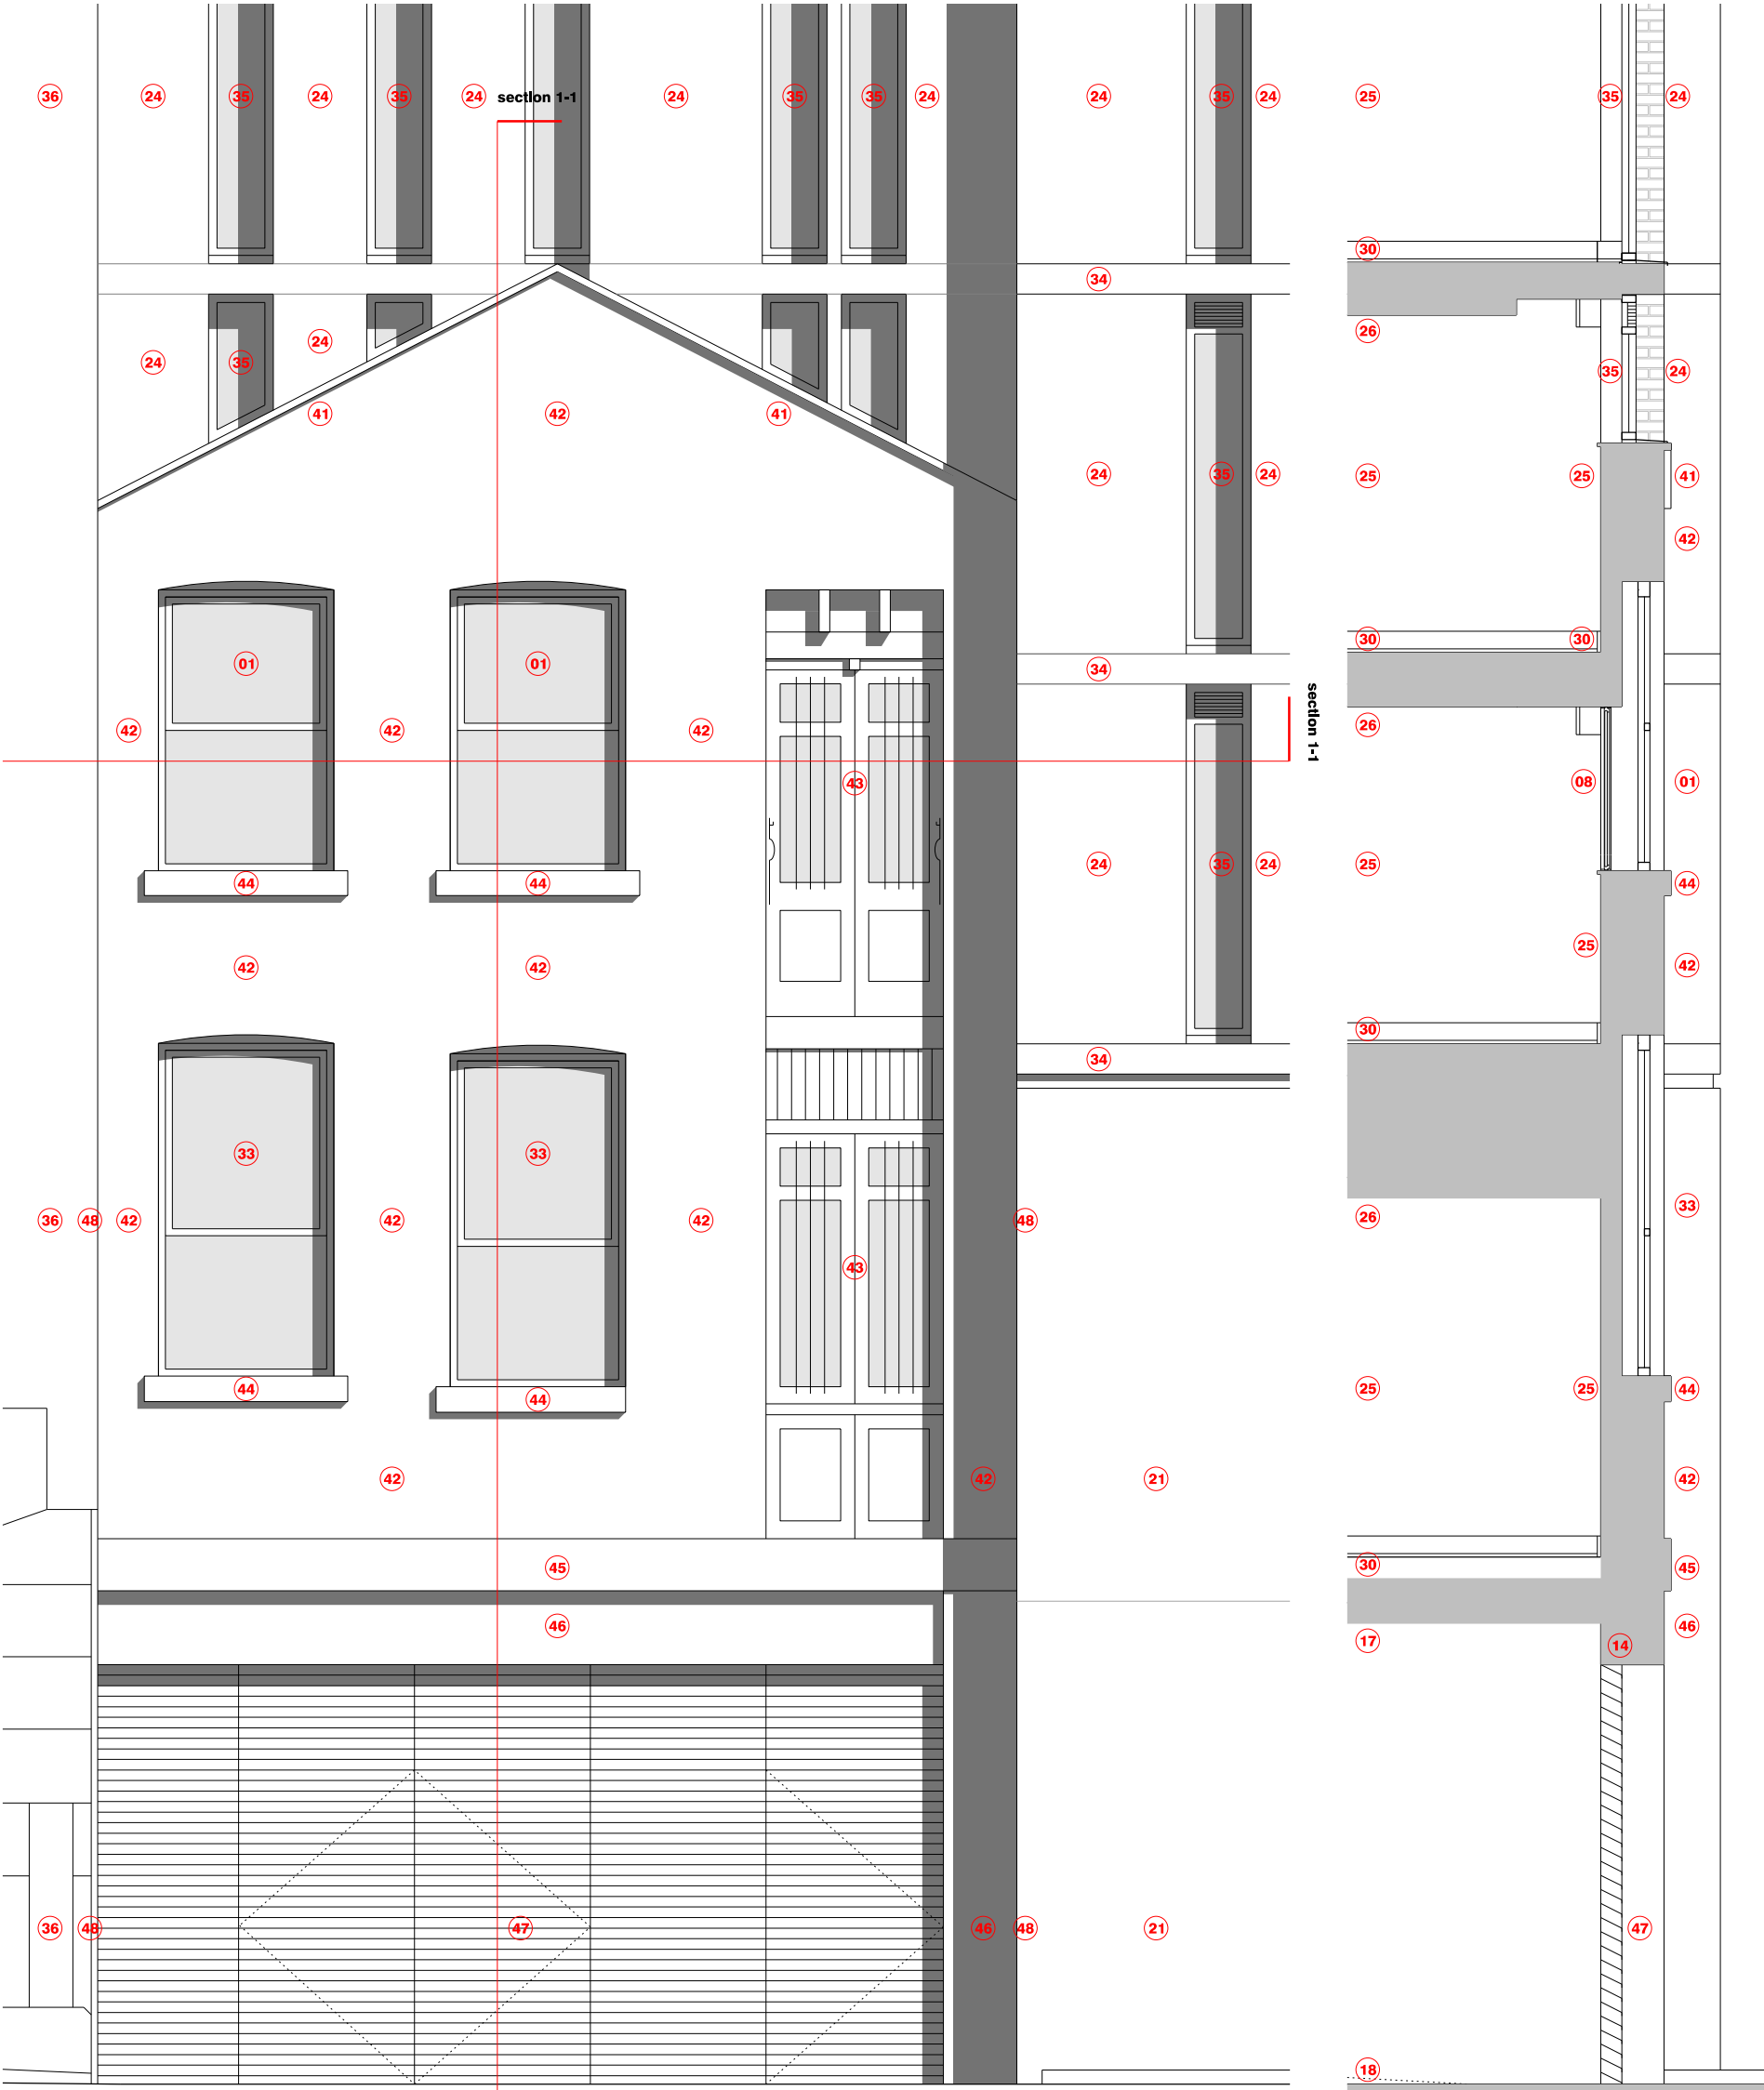
- 01 existing timber window, internal architraves, and cill repaired and painted
- 02 existing dado rail repaired as required and painted
- 03 existing skirting repaired as required and painted

- 04 existing painted plaster wall repaired as required and painted
- 05 existing painted plaster ceiling repaired as required and painted
- 06 new plasterboard ceiling concealing existing ceiling with possible cornice above

- 07 existing chipboard raised floor removed to reveal existing floorboards with new carpet and underlay
- 08 new p.p.c clear double glazed secondary glazing unit

- 09 existing skirtings re-located following removal of chipboard raised floor
- 10 all existing cornices to be retained, repaired and painted
- 11 new independent waterproof and insulated wall with painted plasterboard lining

- 12 existing stone slab retained and over-boarded with plywood
- 13 new painted skirtings to match existing
- 14 new beam required for structural integrity

- 15 insulation with painted plaster finish fixed to existing timber ceiling
- 16 new concrete steps and floor slab
- 17 exposed concrete ceiling to underside of new floor

- 18 new exposed screed floor finish to retail unit
- 19 existing floor tiles and skirtings retained and repaired as necessary
- 20 new p.p.c doors and associated glazing with louvred over-panel

- 21 new grc wall cladding and soffit
- 22 existing slate roof repaired as required
- 23 new lead flashing between existing slate roof and new facade
- 24 new brickwork facade in stretcher bond with flush pointing

- 25 new painted plasterboard wall lining
- 26 new painted plasterboard ceiling
- 27 existing timber door painted and clad externally with grc panel
- 28 existing retained facade restored, made good and painted

- 33 existing timber window repaired and painted, opalescent vinyl added to internal glass face
- 34 new grc cornice
- 35 new ppc windows with clear glass and micro-louvre at head

- 36 existing gable to 49 Piccadilly
- 37 existing door and architraves repaired and painted to corridor side but dry-lining added to internal room
- 38 existing timber stair, handrail, balustrades retained, repaired and painted

- 43 existing timber doors retained, repaired and painted
- 44 existing stone cill retained, cleaned, and re-pointed
- 45 new brickwork soldier course with flush pointing
