section B-B

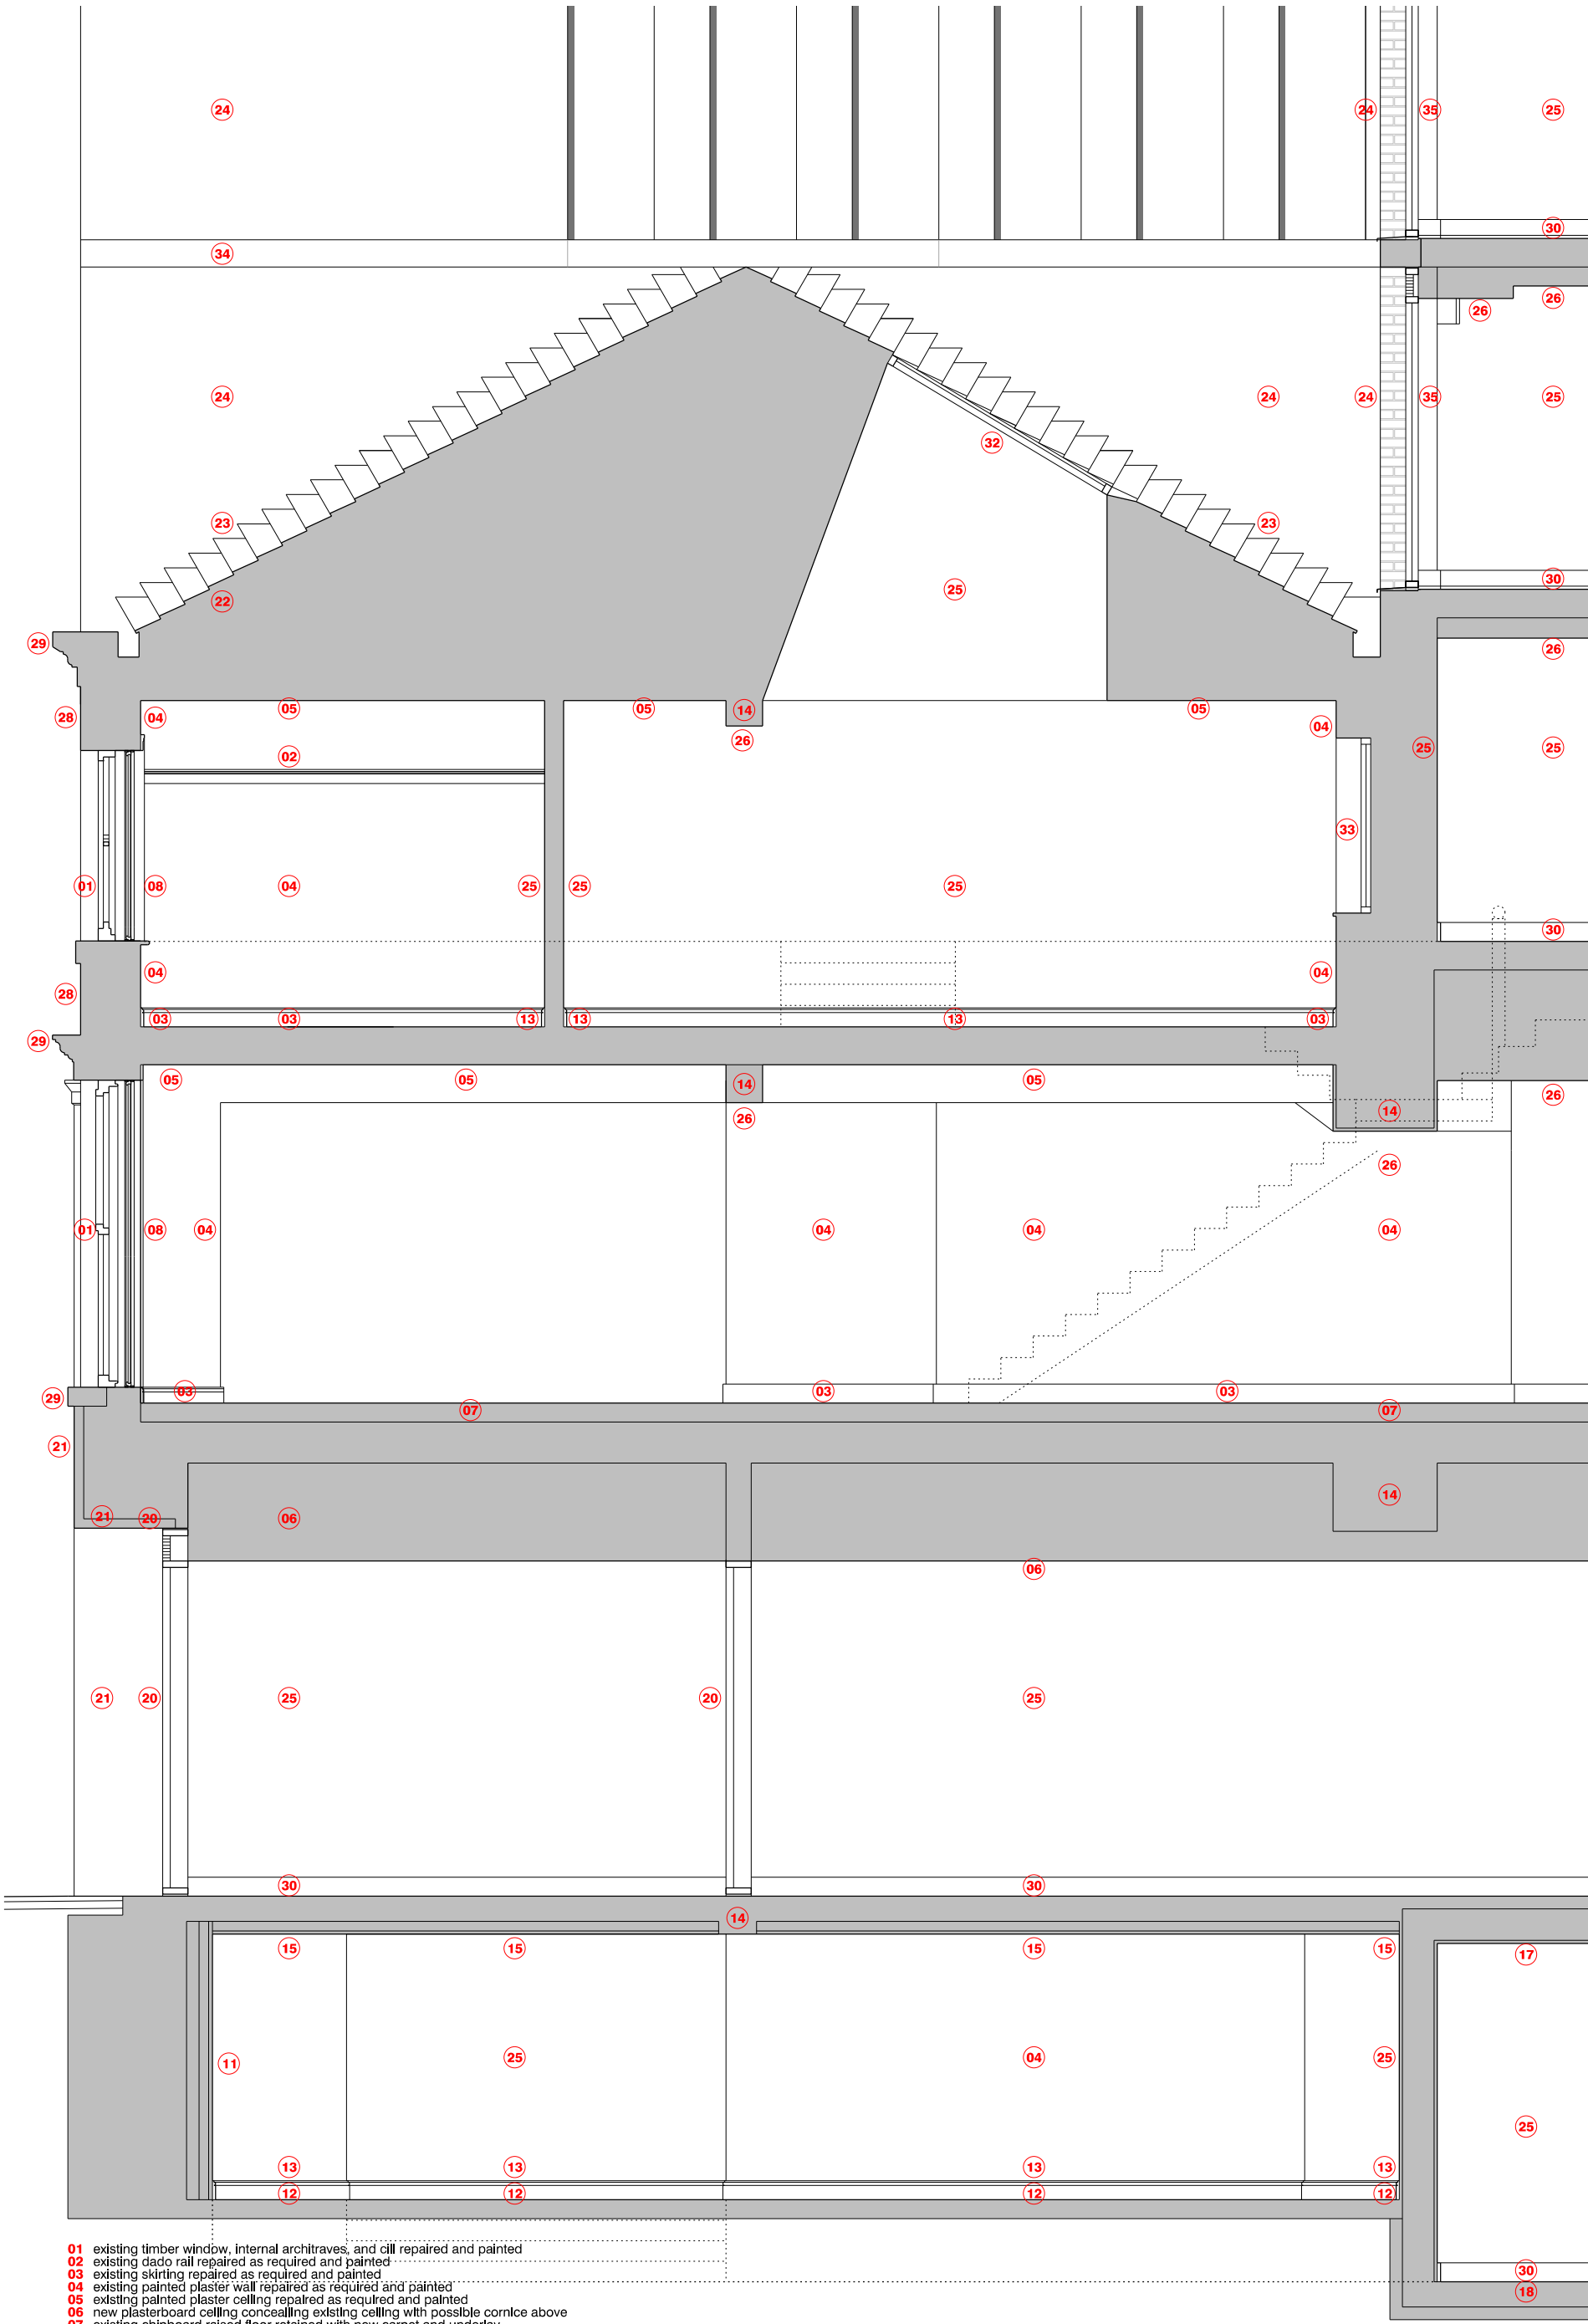
- 01 existing timber window, internal architraves, and cill repaired and painted  
02 existing dado rail repaired as required and painted  
03 existing skirting repaired as required and painted  
04 existing painted plaster wall repaired as required and painted  
05 existing painted plaster ceiling repaired as required and painted  
06 new plasterboard ceiling concealing existing ceiling with possible cornice above  
07 existing chipboard raised floor retained with new carpet and underlay  
08 new p.p.c clear double glazed secondary glazing unit  
09 existing skirtings re-located following removal of chipboard raised floor  
10 all existing cornices to be retained, repaired and painted  
11 new independent waterproof and insulated wall with painted plasterboard lining  
12 existing stone slab retained and over-boarded with plywood  
13 new painted skirtings to match existing  
14 new beam required for structural integrity

15 insulation with painted plaster finish fixed to existing timber ceiling  
16 new concrete steps and floor slab  
17 exposed concrete ceiling to underside of new floor  
18 new exposed screed floor finish to retail unit  
19 existing floor tiles and skirtings retained and repaired as necessary  
20 new p.p.c doors and associated glazing with louvred over-panel  
21 new grc wall cladding and soffit  
22 existing slate roof repaired as required  
23 new lead flashing between existing slate roof and new facade

- 24 new brickwork facade in stretcher bond with flush pointing  
25 new painted plasterboard wall lining  
26 new painted plasterboard ceiling  
27 existing timber door painted and clad externally with grc panel  
28 existing retained facade restored, made good and painted  
29 existing cornice restored, made good and painted  
30 new painted skirting  
31 new carpet or vinyl floor covering over existing  
32 new double glazed conservation skylight  
33 existing timber window, internal architraves, and cill repaired and painted, opalescent vinyl added to glass  
34 new grc cornice  
35 new ppc windows with clear glass and micro-louvre at head
