section D-D

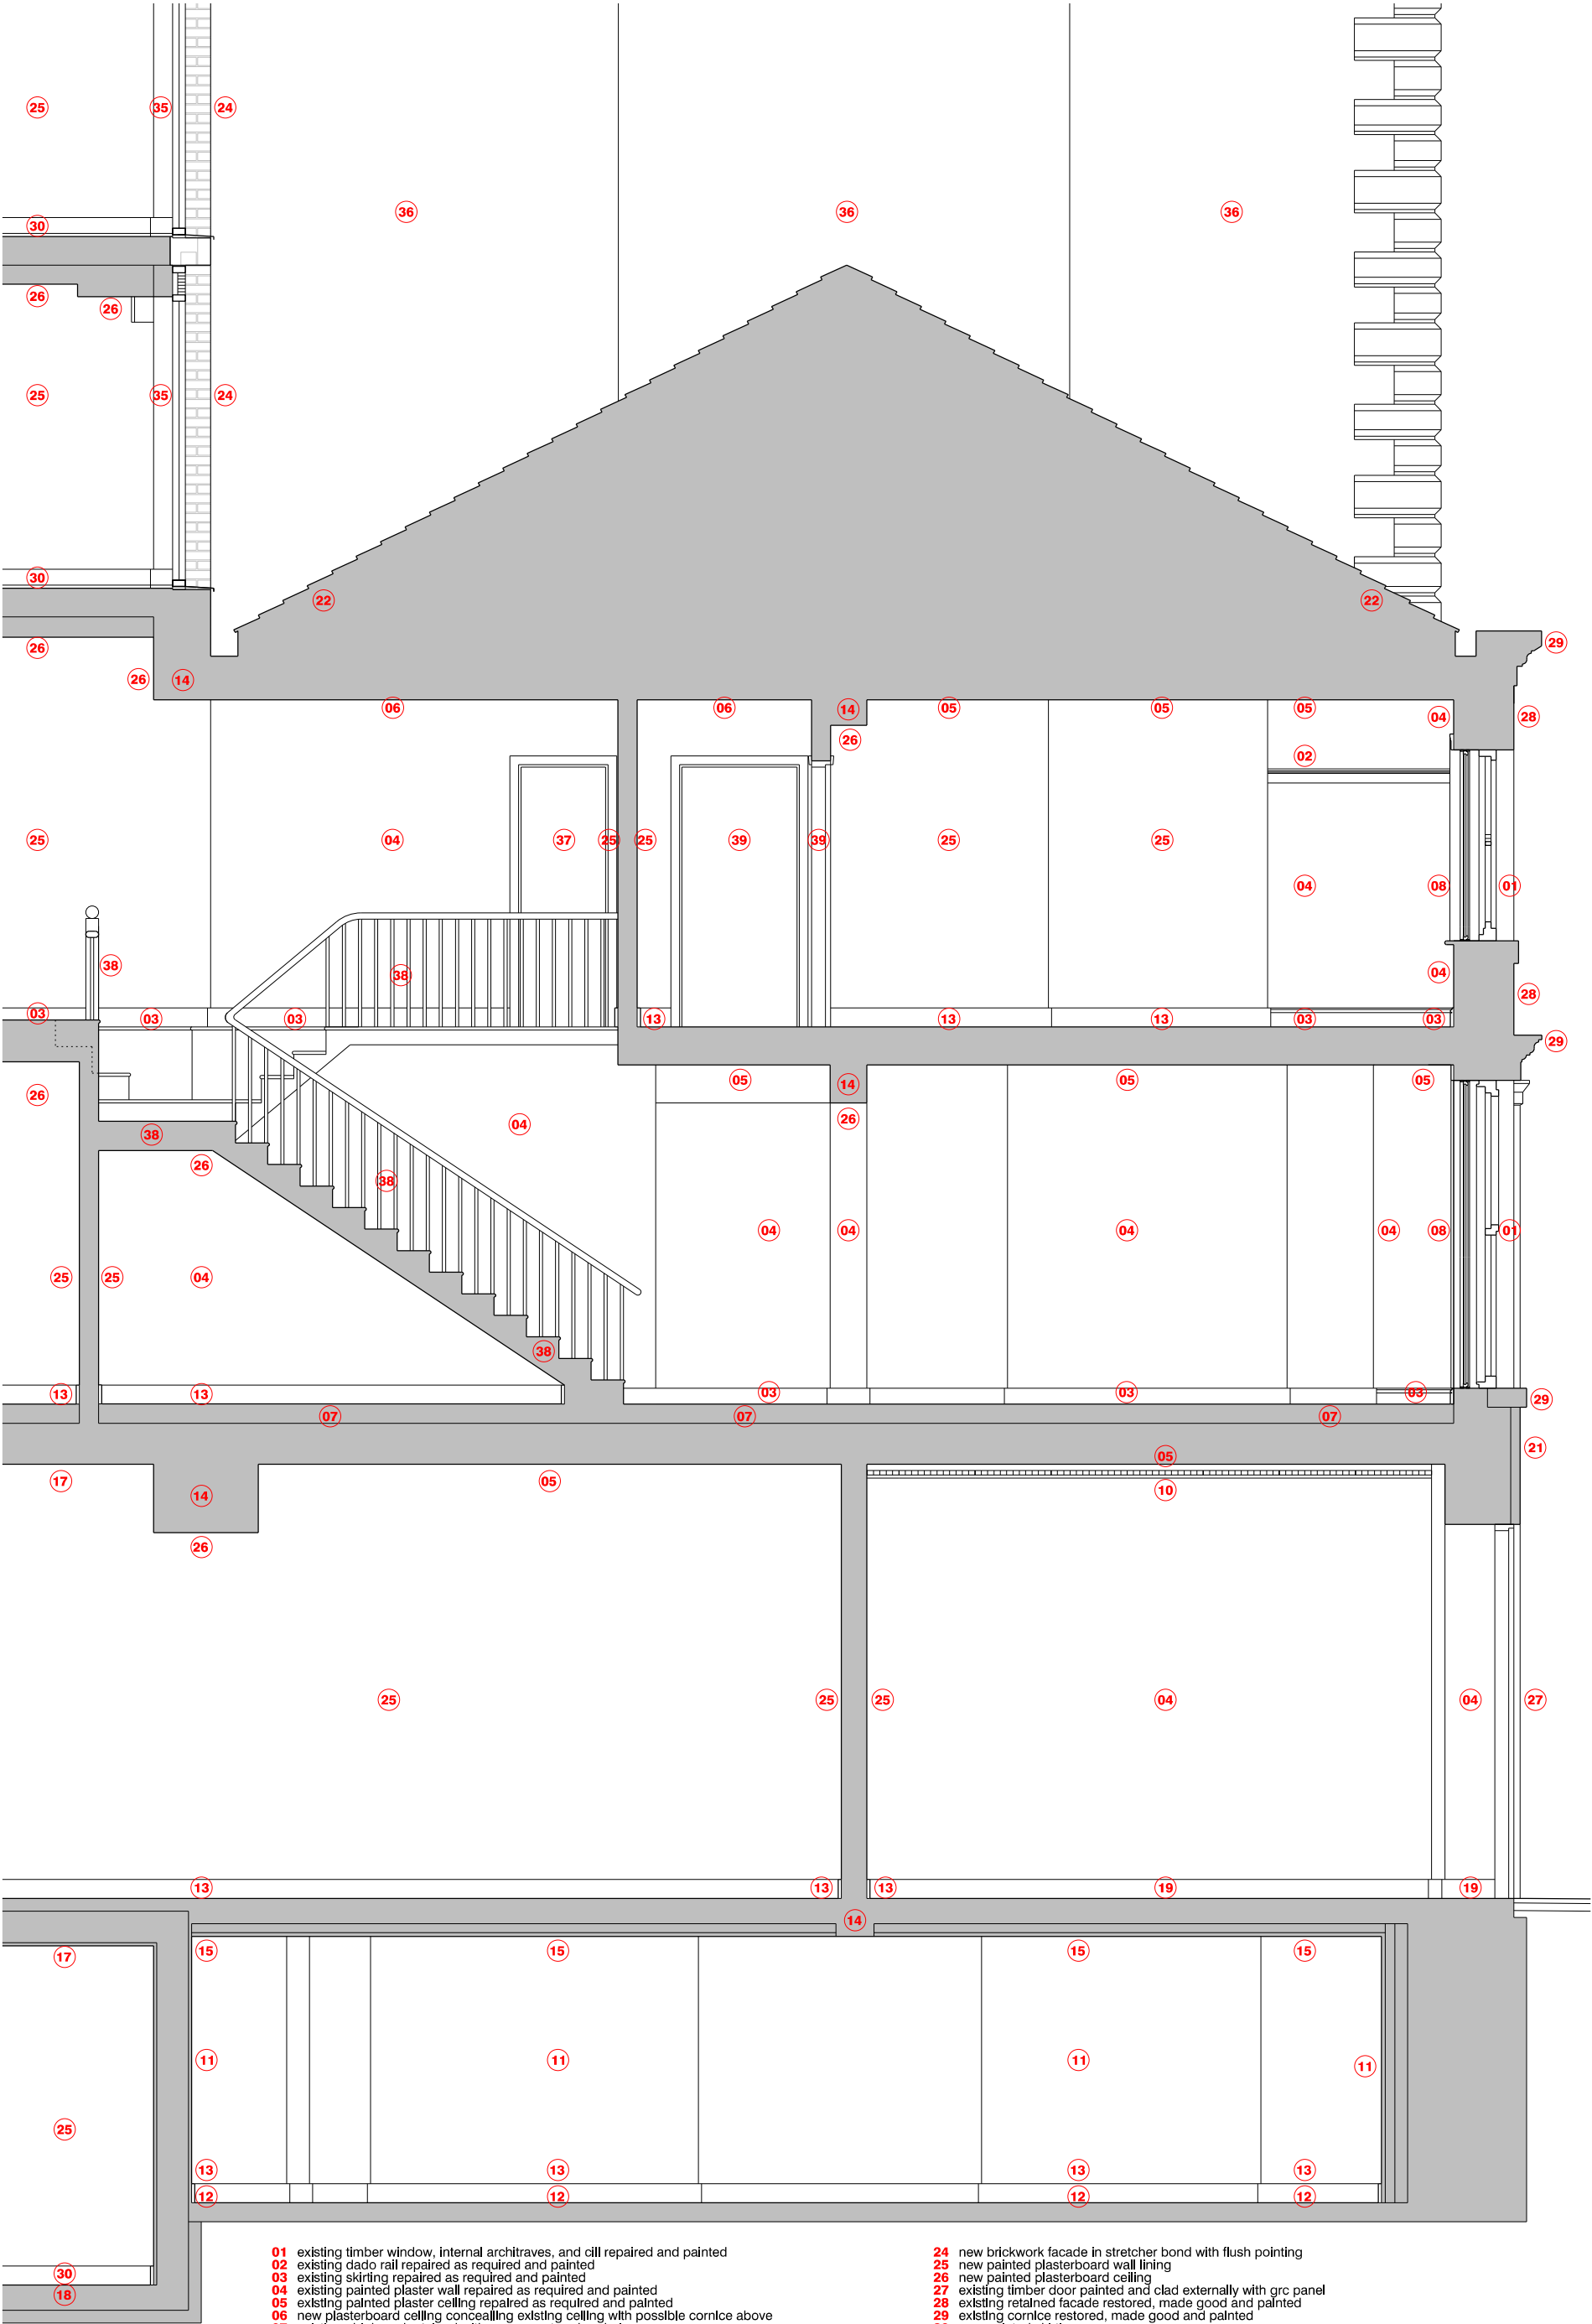
- 01 existing timber window, internal architraves, and cill repaired and painted

02 existing dado rail repaired as required and painted

03 existing skirting repaired as required and painted

04 existing painted plaster wall repaired as required and painted

05 existing painted plaster ceiling repaired as required and painted

06 new plasterboard ceiling concealling existing ceiling with possible cornice above

07 existing chipboard retained with new carpet and underlay

08 new p.p.c clear double glazed secondary glazing unit

09 existing skirtings re-located following removal of chipboard raised floor

10 all existing cornices to be retained, repaired and painted

11 new independent waterproof and insulated wall with painted plasterboard lining

12 existing stone slab retained and over-boarded with plywood

13 new painted skirtings to match existing

14 new beam required for structural integrity

15 insulation with painted plaster finish fixed to existing timber ceiling

16 new concrete steps and floor slab

17 exposed concrete ceiling to underside of new floor

18 new exposed screed floor finish to retail unit

19 exsting floor tiles and skirtings retained and repaired as nessessary

20 new p.p.c doors and associated glazing with louvred over-panel

21 new grc wall cladding and soffit

22 existing slate roof repaired as required

25 new painted plasterboard wall lining

26 new painted plasterboard ceiling

33 existing timber window, internal architraves, and cill repaired and painted, opalescent vinyl added to glass

38 existing timber stair, handrail, ballustrades retained, repaired and painted
