Note: Drawing to be read in conjunction with 1665 C(423), 1665 C(802) NBS the External works repair schedule and the window repair schedule.

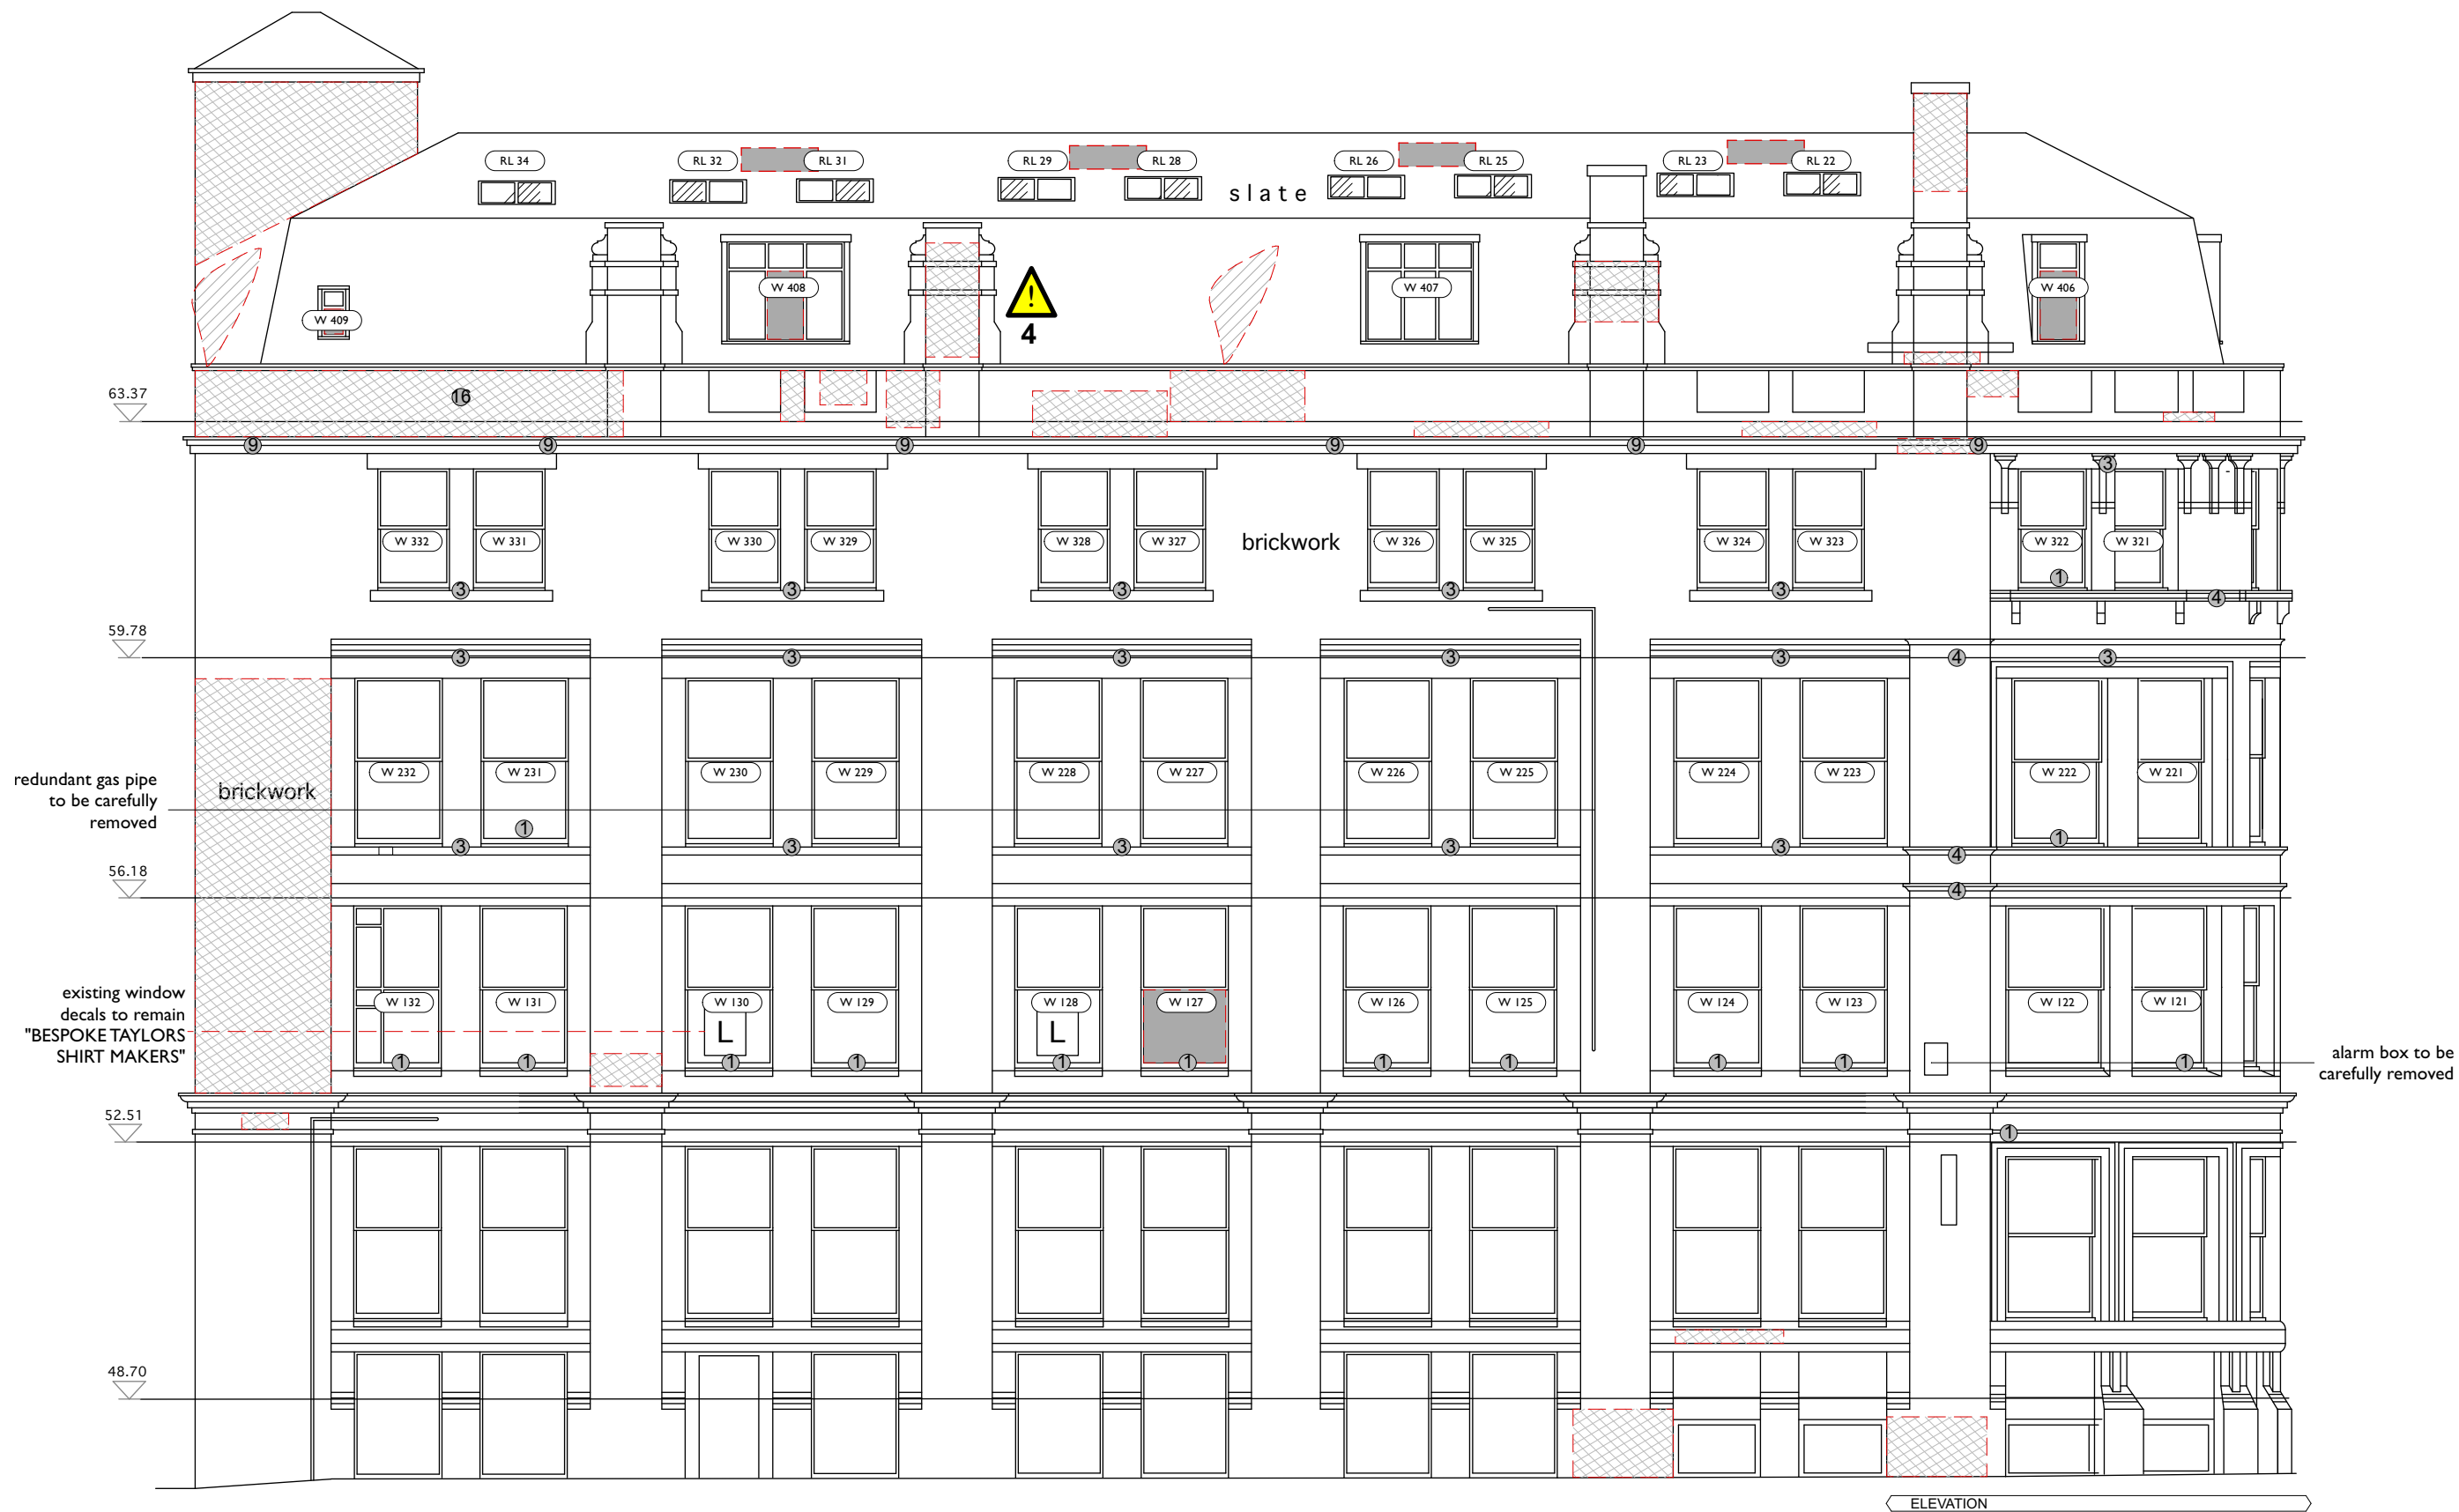
**Existing windows with timber boarding** - boarding to be carefully removed and window to be repaired in accordance with **item 11** in the external repair schedule.

**Areas of vegetation growth on elevation**- existing vegetation to be carefully removed and hacked out from joints with hand tools only. localised area to be sprayed with weedkiller. Jointing to be repointed in accordance with **item 3** in the external repair schedule.

**Areas of repointing**  
Mortar to be carefully hacked out and replaced where missing as per NBS C41/810-860 and **item 3** in the external repair schedule  
**L** Indicates window decals to be retained.

**Generally**  
non-original and redundant fittings to be carefully removed by hand

Stone and brick to be cleaned with the Doff system in accordance with **items 12 and 13** of the external repairs schedule (NBS clause M40)

① numbers on elevations refer to works on the external repairs schedule
