# John Wood Architect

project 1661 project title 33 Thomas Street  
drawing 3117 - issue 02 External Opening OE.02.02  
issue date 18/06/2025 scales shown @ A3

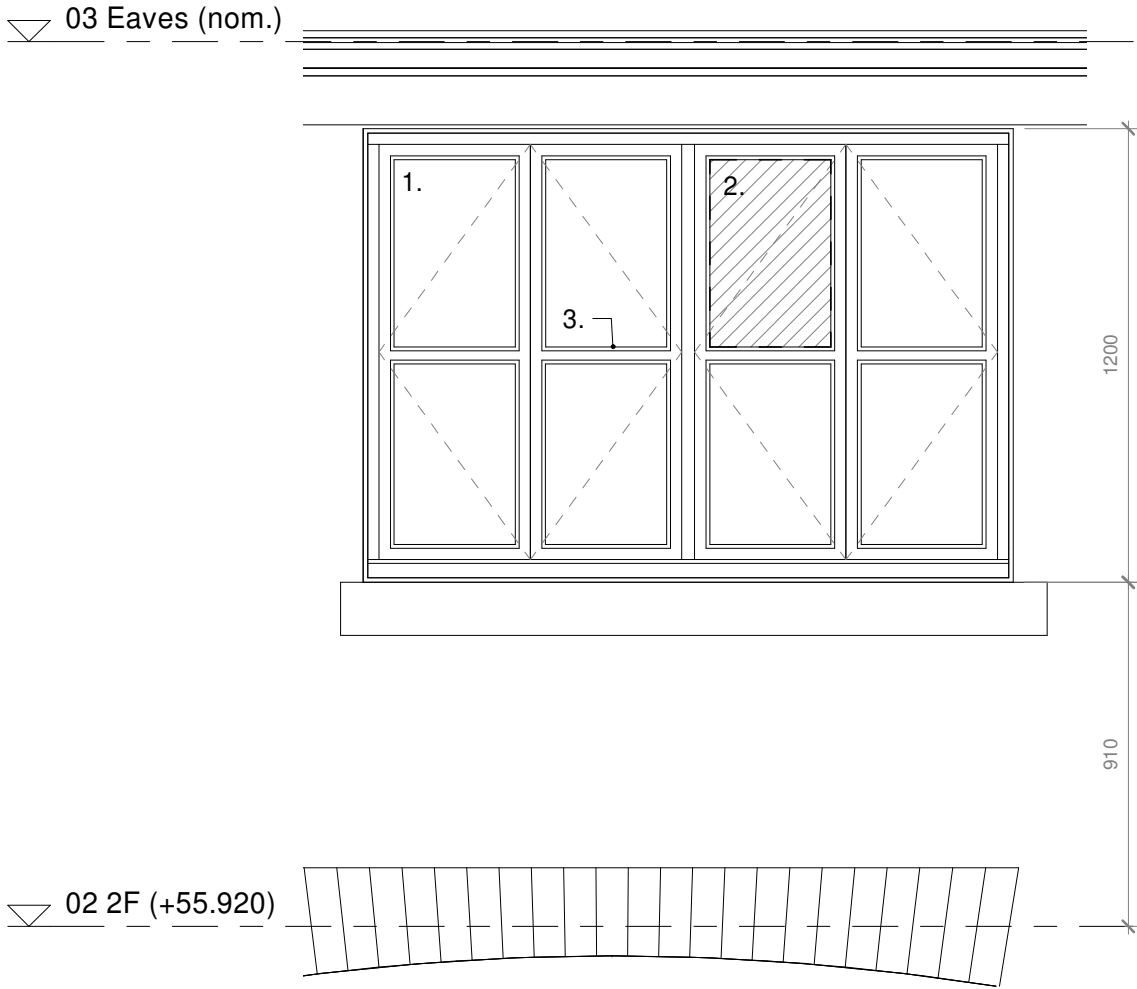
OE.02.02-Elevation  
scale 1 : 20

- Legend.
1. Existing window, loose paint carefully removed and repainted using linseed oil paint, Colour: 'blackout' by Brouns.
  2. Broken glass panes removed and replaced with laminated replica single glazing, L10/124.
  3. New glass secured in place with putty / existing loose putty removed and replaced as necessary.
  4. Secondary glazing to be installed inside existing windows, L10/131.
  5. Wall and roof build-up shown indicatively - tbc on site and refer to typical details.
  6. Window lintels repaired or replaced in accordance with structural engineer's specification.

For cross-section as OE.02.01, ref. '1661-3115 External Opening OE.02.01'.
