## Heritage Design & Access – William Kay House

September 2025

| Report Title | William Kay Heritage Design & Access |
| Document No. | 5807-HMA-WK-ZZ-RP-A-0102 |

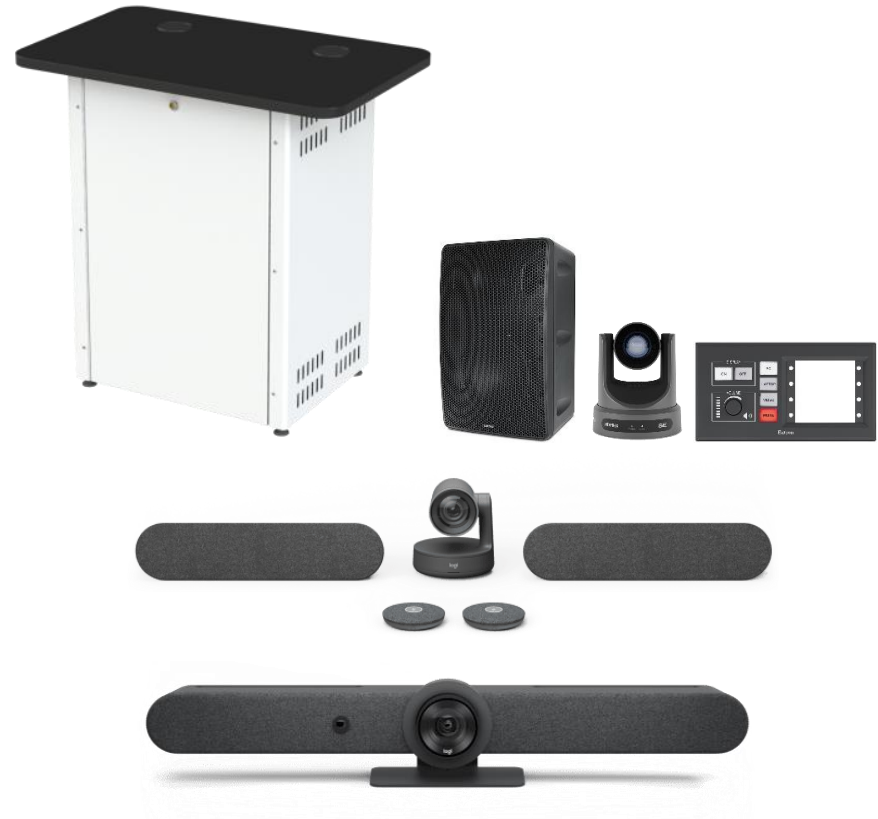
### 1.013 – Small Video Conference Room

Huddle space hybrid meeting room with large format display, all in one video conferencing huddle bar with button panel control and laptop connectivity for hybrid meetings on Zoom or MS Teams.

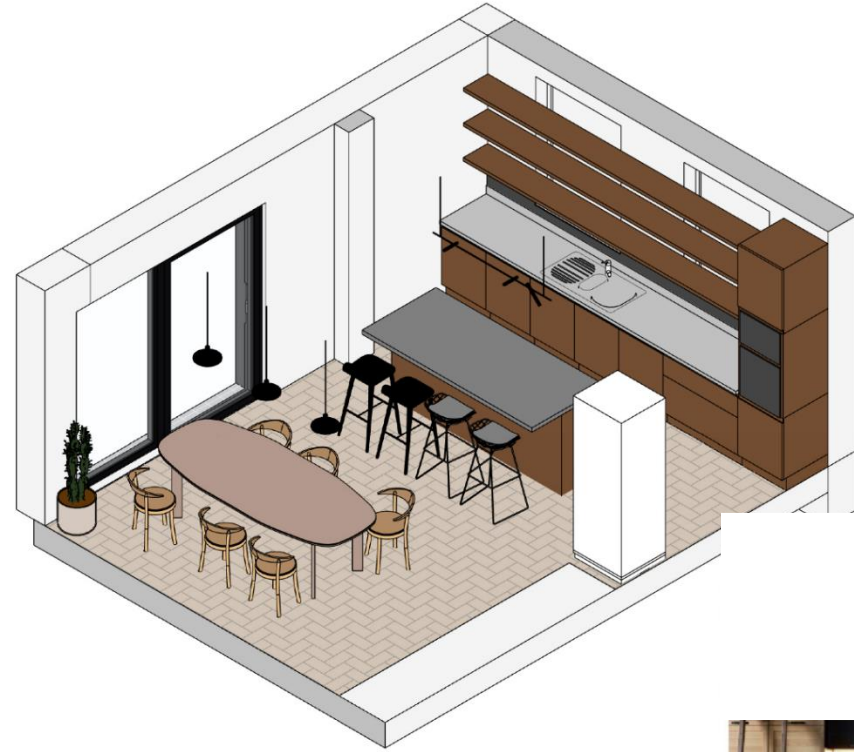
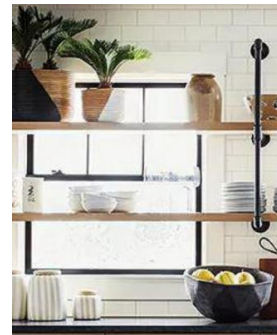
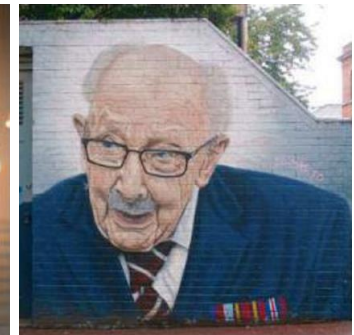
## Kitchen Refurbishment

The brief was to provide space for a large dining table that people could commune around and share ideas and hold informal meetings. It would act as a centre point for staff using the building. This part of the building is in a later extension to the original building. Therefore, adaptations are more acceptable to the heritage officer. New barrier matting will be provided to the rear access door to ensure wet and dirt is not tracked into the space. New pendant lighting sits above the table to zone the area.

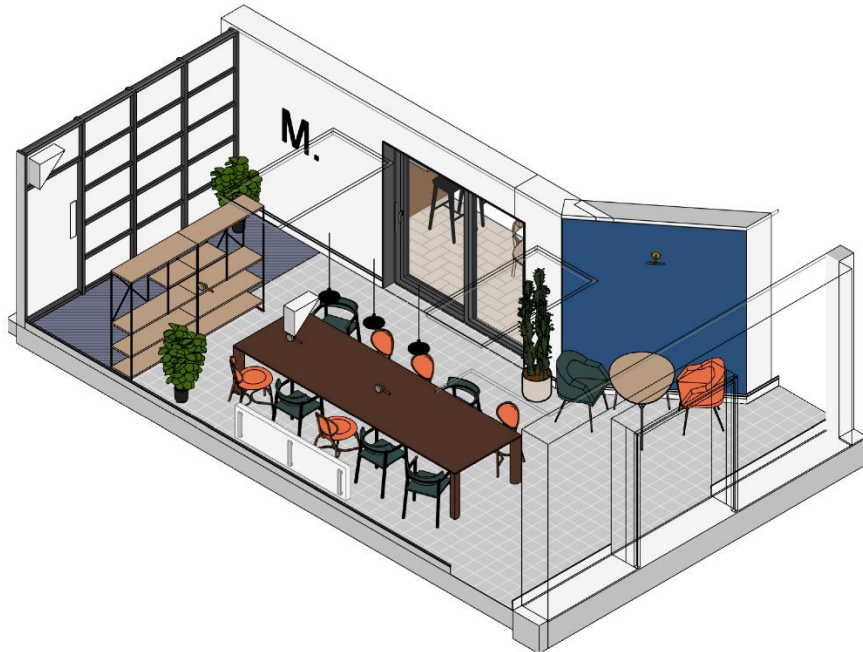
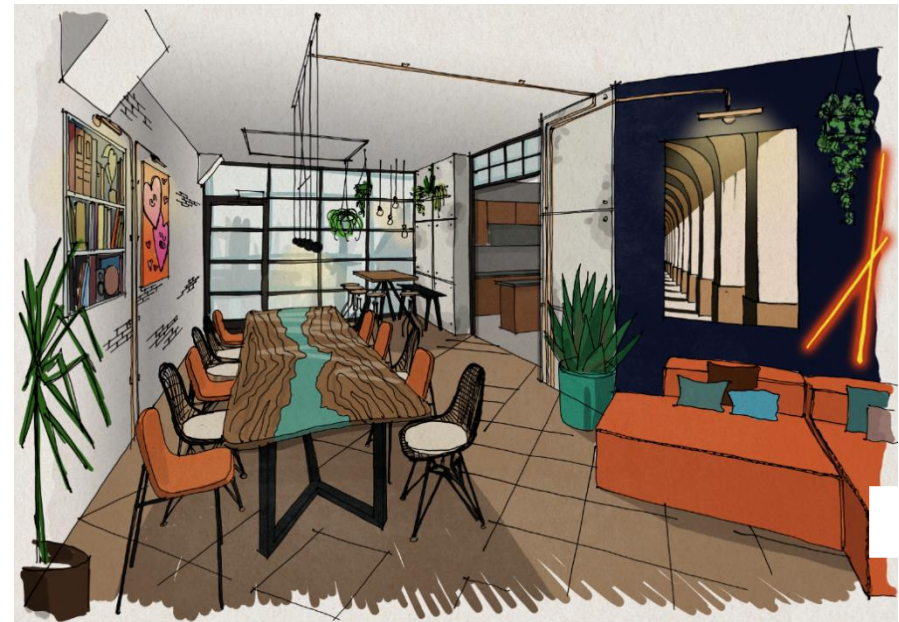
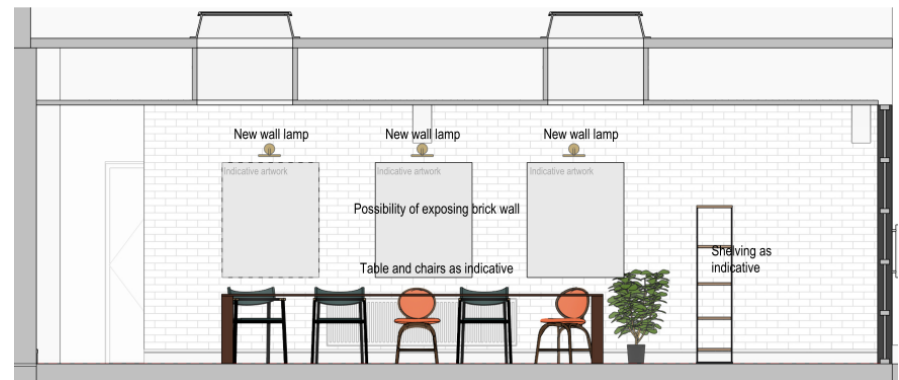
## Dining Area Refurbishment

The brief was to provide space for a large dining table that people could commune around and share ideas and hold informal meetings. It would act as a centre point for staff using the building. This part of the building is in a later extension to the original building. Therefore, adaptations are more acceptable to the heritage officer. New barrier matting will be provided to the rear access door to ensure wet and dirt is not tracked into the space. New pendant lighting sits above the table to zone the area.

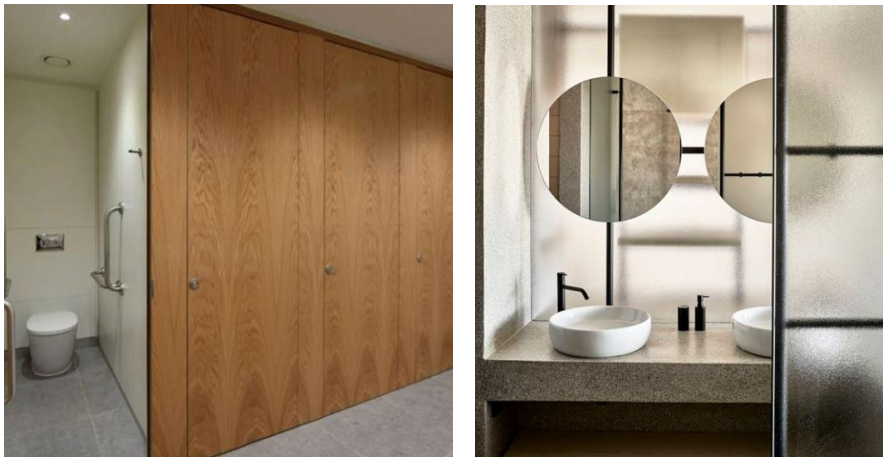
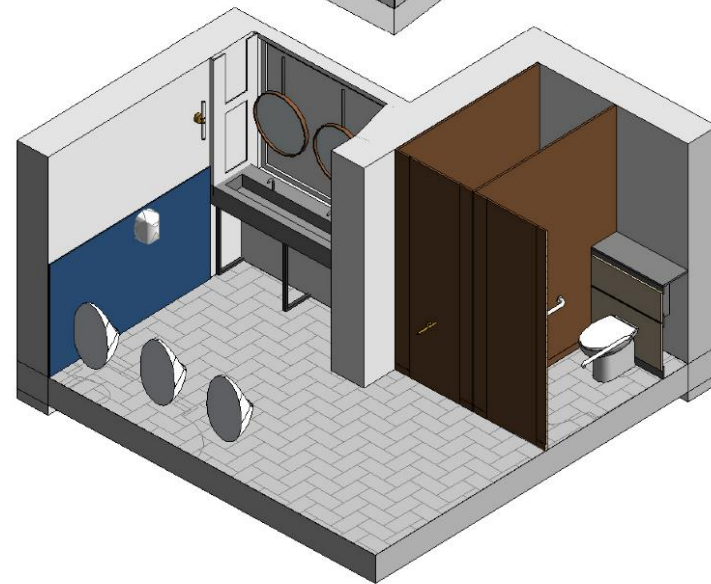
## WC Refurbishment

As these newly refurbished spaces will provide a convening point for some of the core university business engagement and innovation functions the toilet facilities require refurbishment also. Full refurbishment of toilets including cubicles, sinks, toilets, floors, ceilings and decoration.

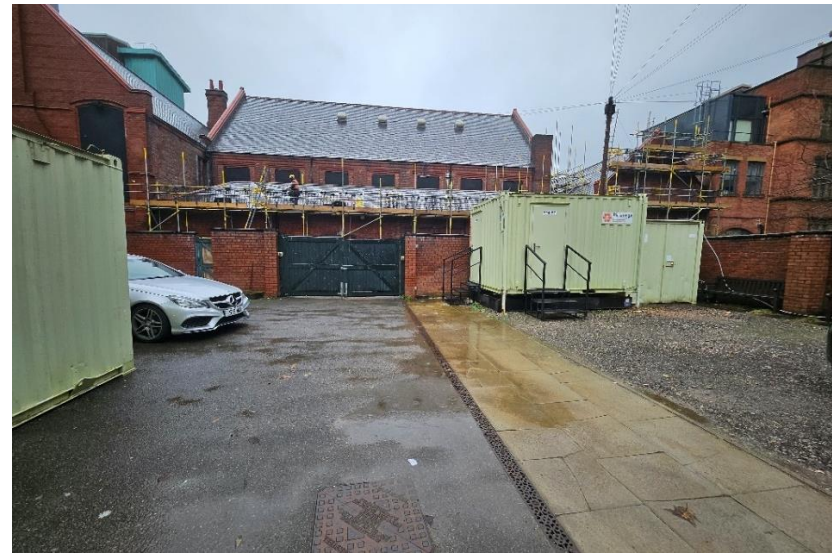
It has been confirmed that the rear ramp is not compliant for wheelchair users.

*Rear access of the site*

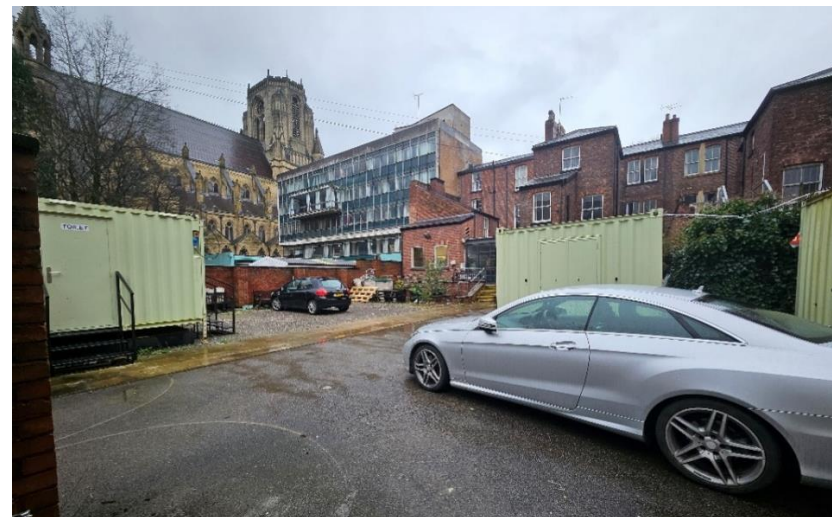
*Rear of the building*

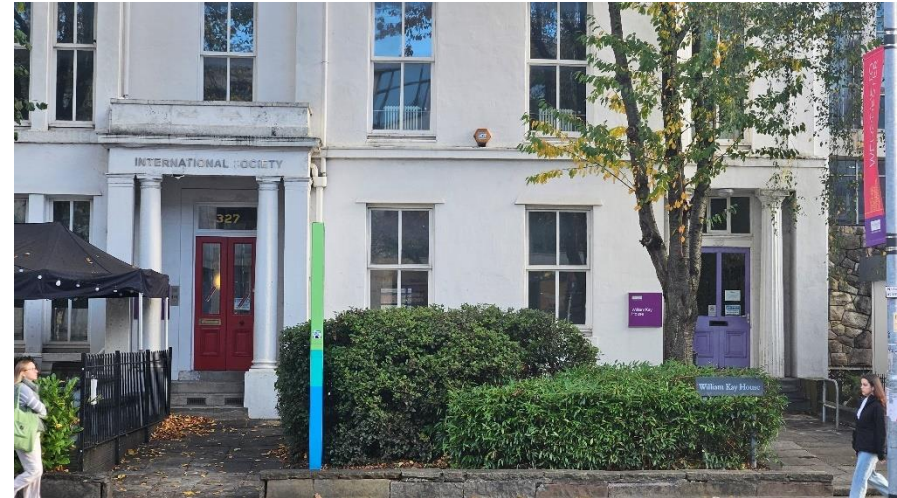
Timber fascia and soffit boards have been identified for replacement and painting.

Surveys to the render and roof are to be carried out once scaffold is erected for the painting of the building. Provisionally this may lead to repairs and new flashing to the gable elevation.

Front of the building

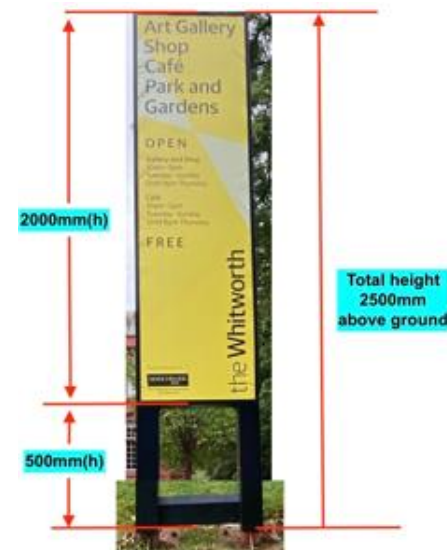
The existing plinth signage to the front of the site is to be removed and replaced with a new design, in line with UoM's signage design for the Whitworth Gallery. Heritage and Planning accepted the new monolith as it is more slim line. Please see image right.

Signage Precedent

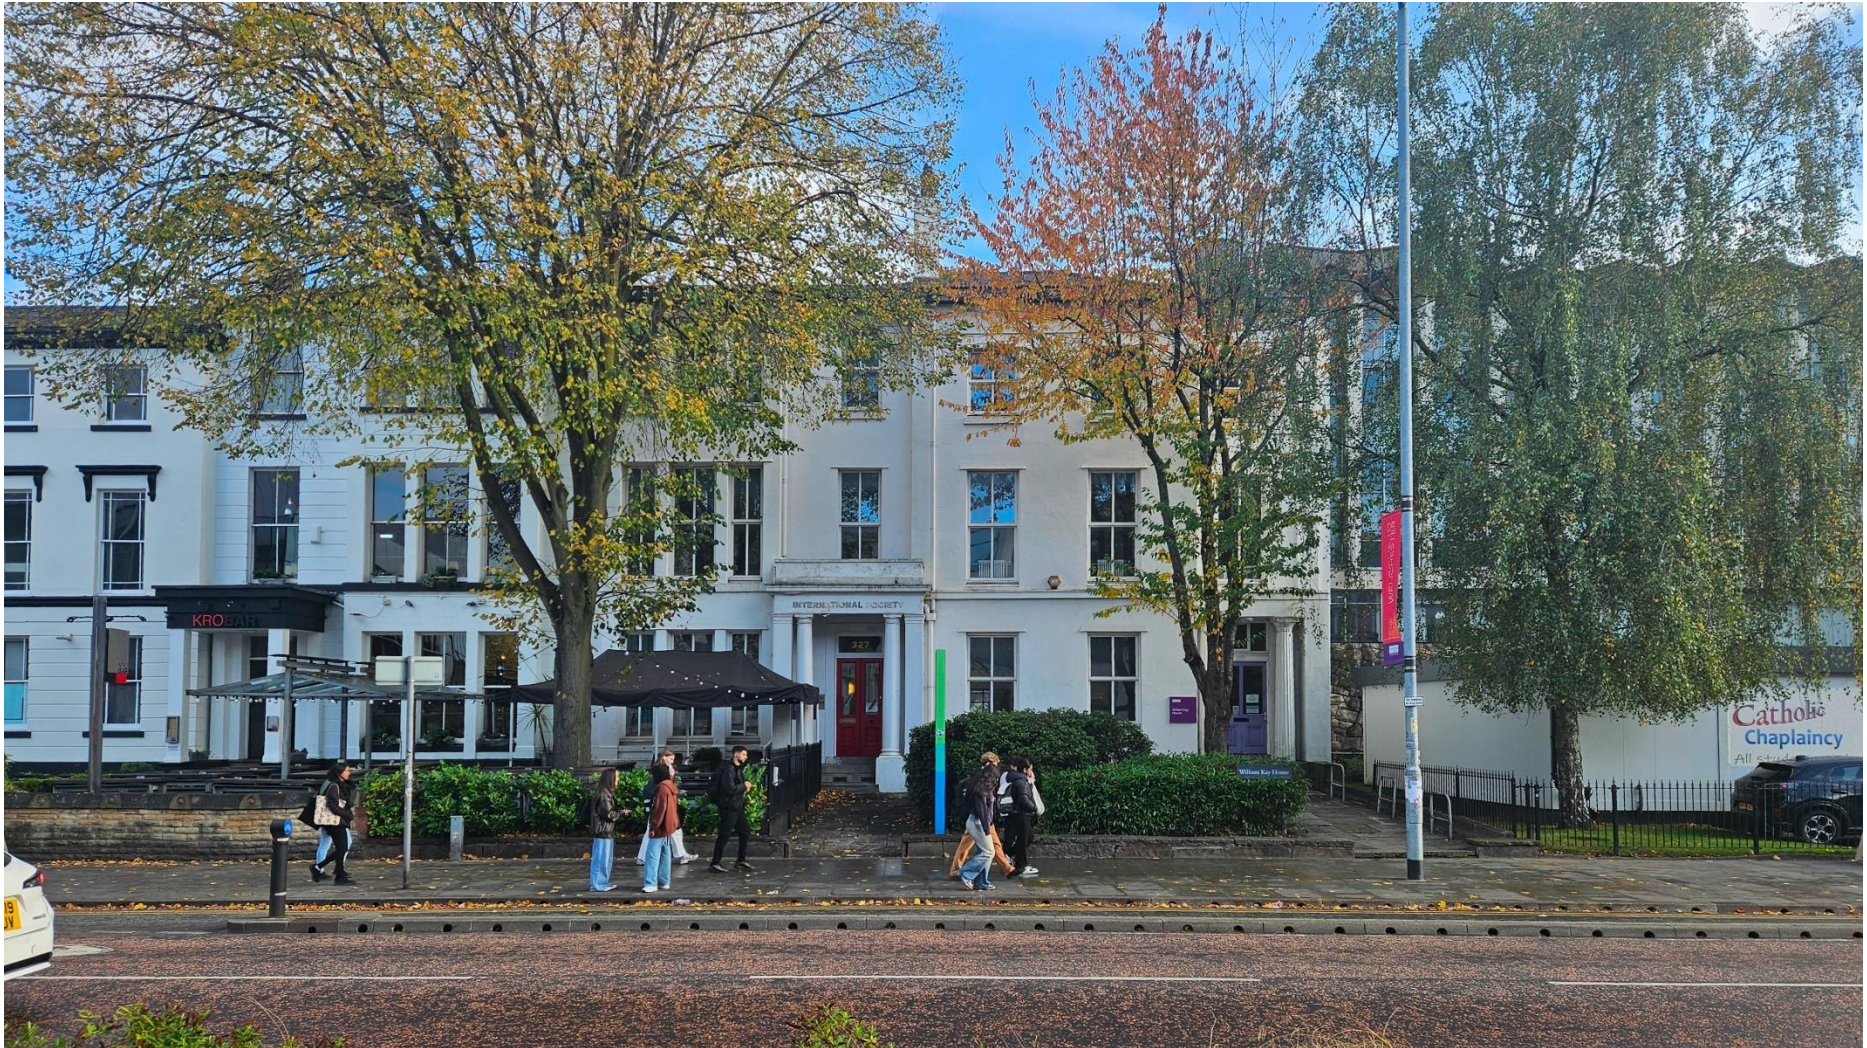
Elevation paint as Existing

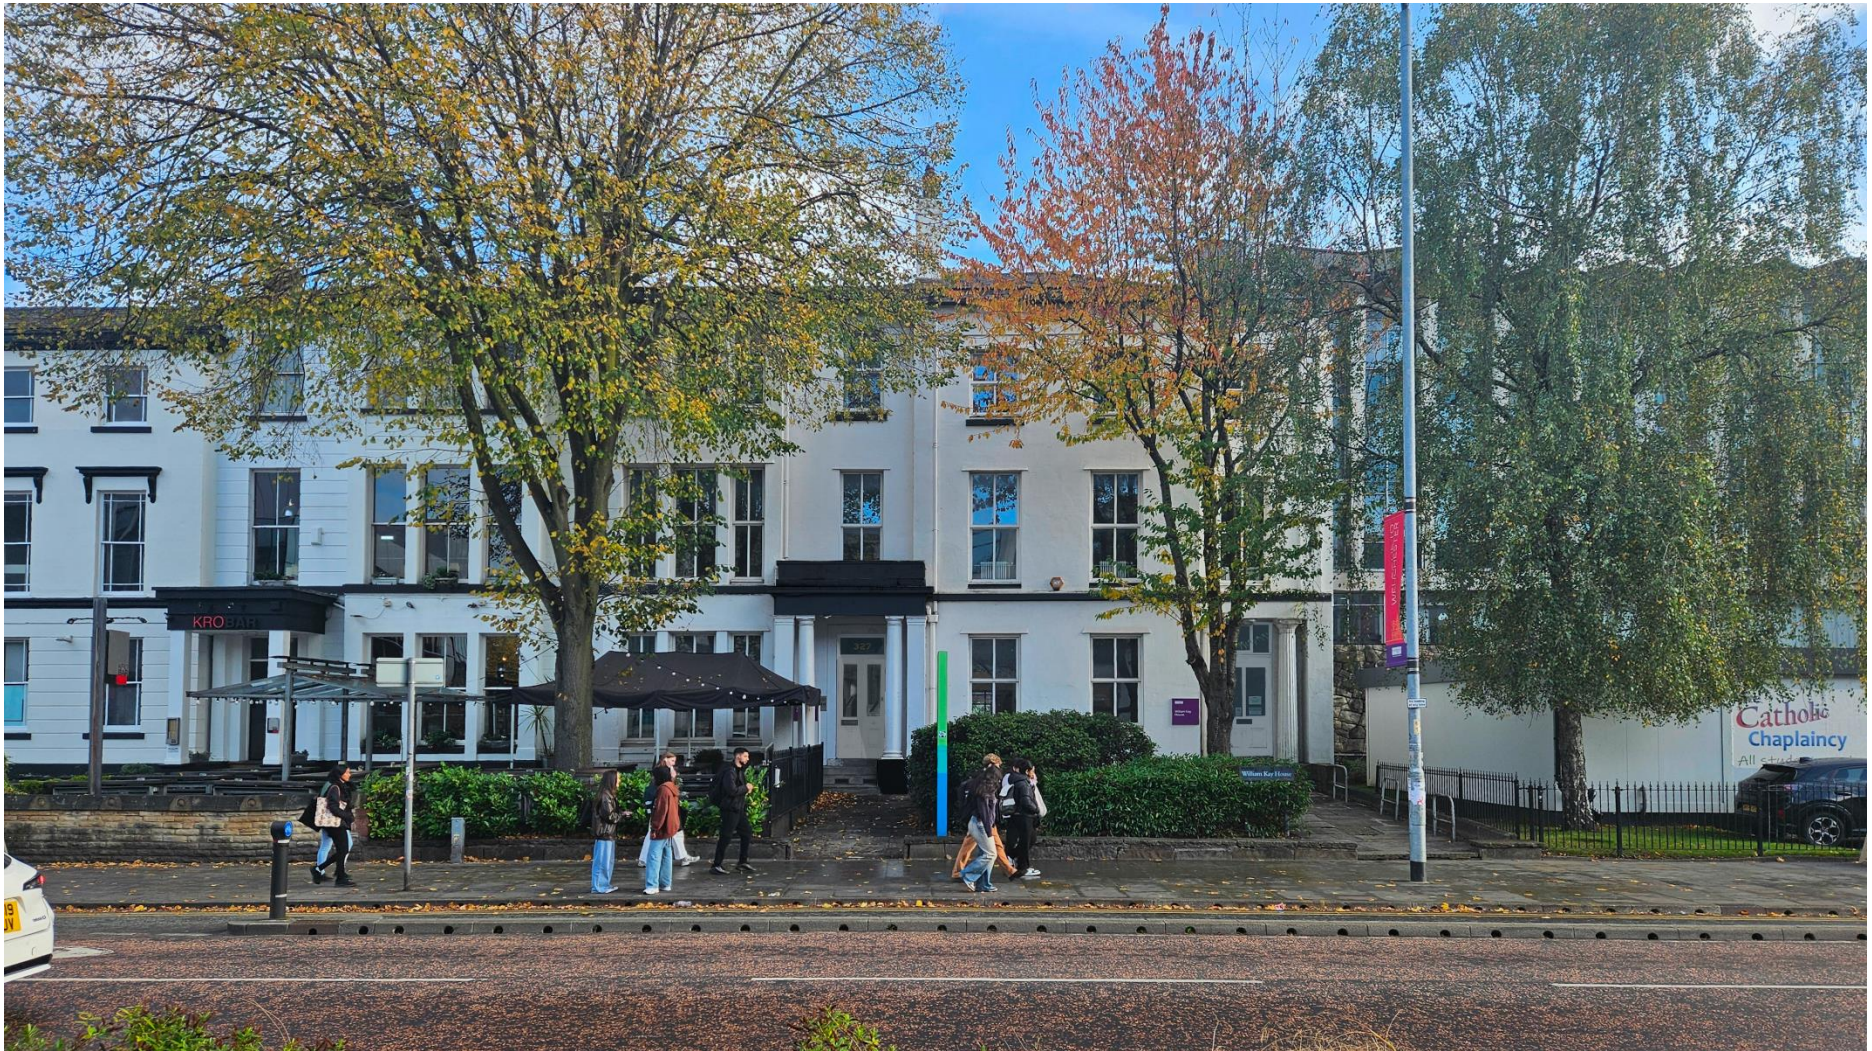
Elevation paint as Proposed

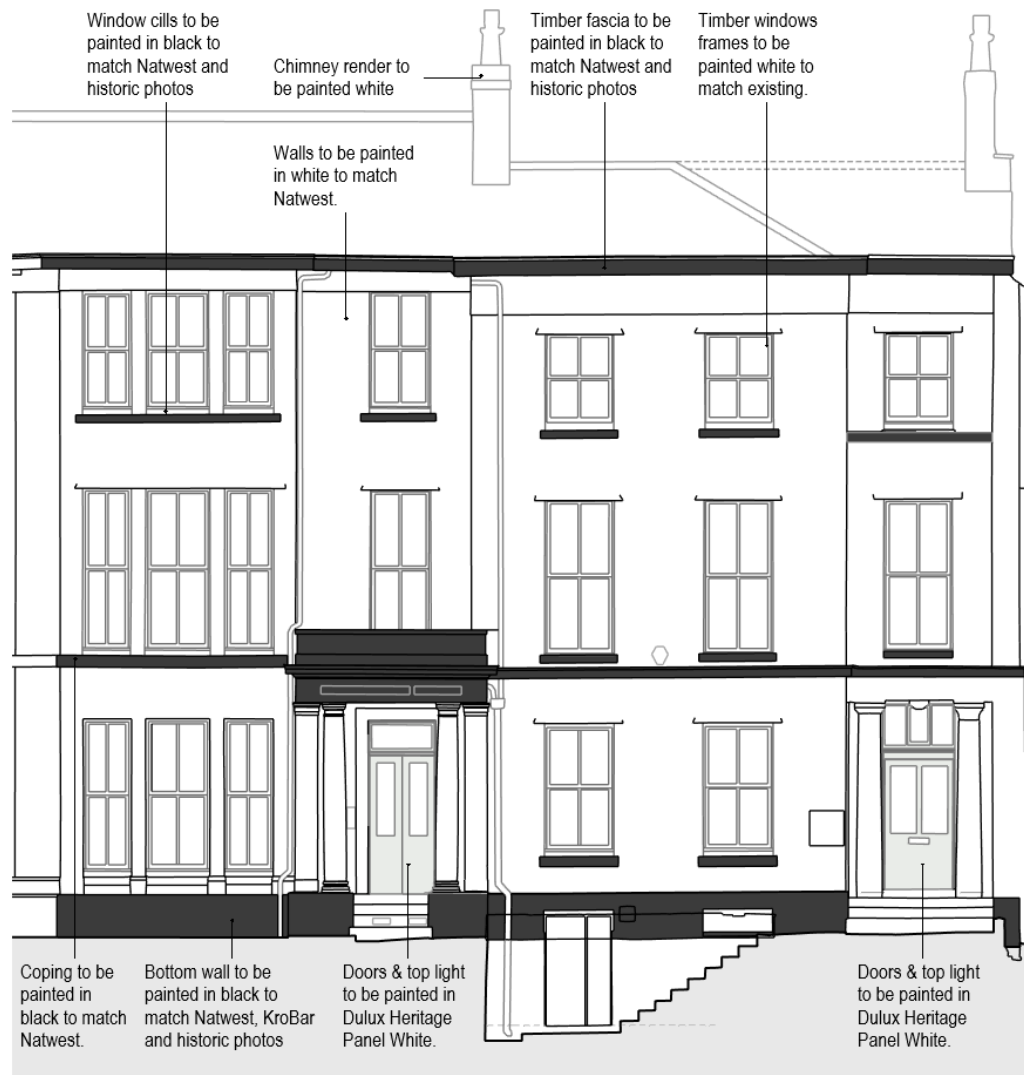
William Kay South West Elevation as Proposed

1:50 @ A1

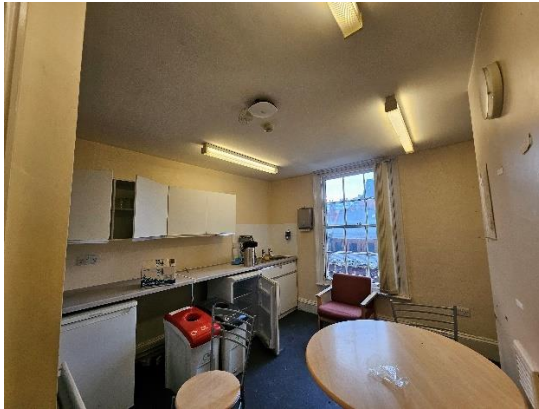
Figure 30: Existing Kitchenette on Level 2

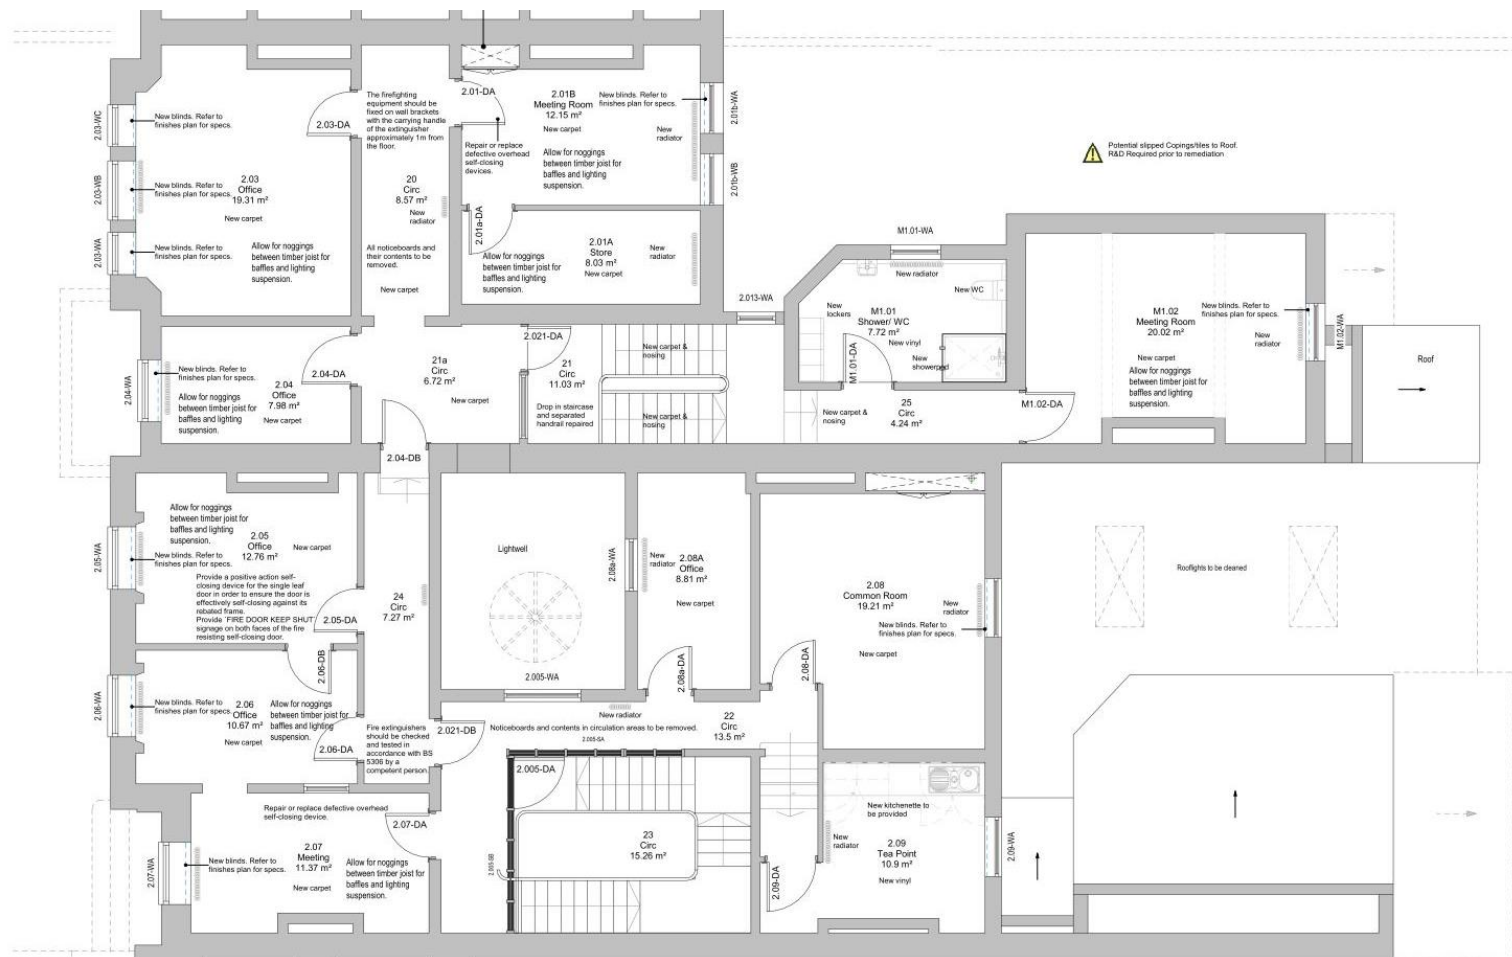
## Level 2 (Second Floor) Works

The second floor is for office staff. Rooms will receive new decoration, lighting, radiators and floor finishes. The end users have specified which rooms they would like as meeting rooms. As part of the works to this floor it is proposed to refurbish the existing Shower Room and Kitchenette.

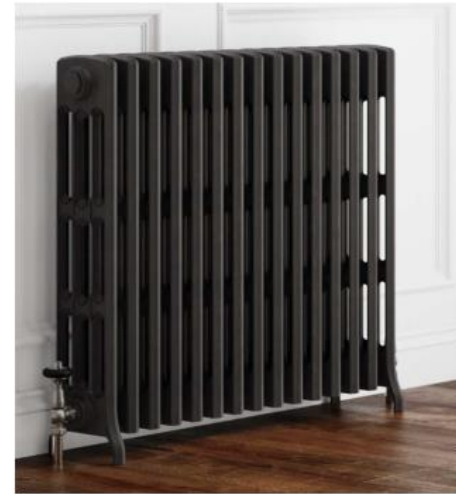
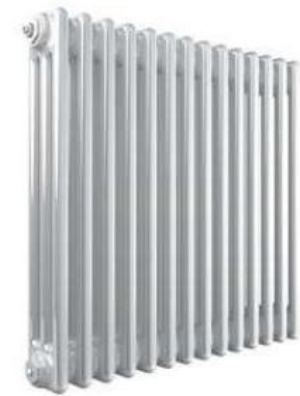
It is proposed that the existing radiators within the demise of the project are replaced with new on a point-for-point basis. A number of existing radiators are floor mounted cast iron column radiators. It is proposed that these are replaced with new similar cast iron radiators as Stelrad Cast Iron Radiators. The existing wall mounted panel radiators are to be replaced with wall mounted column radiates as Stelrad Classic Column Radiators or equal and approved.

*Stelrad cast-iron-radiator with integral feet (left). Stelrad classic column radiator (right)*
