## GAS MEMBRANE VALIDATION – BENNETT STREET

| <b>Project Name:</b> | Bennett Street |
| <b>Project Number:</b> | 15-974 |
| <b>Plot:</b> | 71-76 |

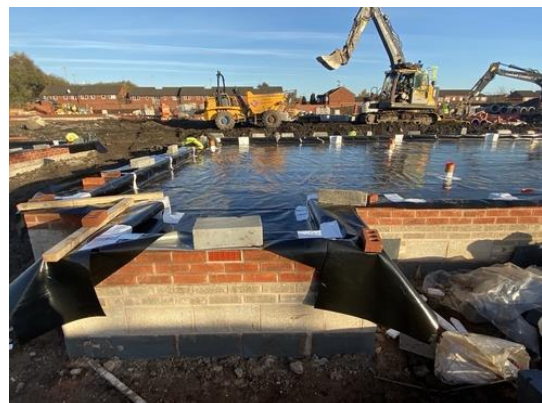
**Condition of sub-grade and underside of gas membrane: Check that the subgrade does not contain rough/uneven surfaces, is appropriately clean and that there are no hard/sharp objects. That protective sand blinding or geotextile (if specified) is present and meets the design criteria. ( Lift back the membrane and photo the subfloor)**

Photo 125

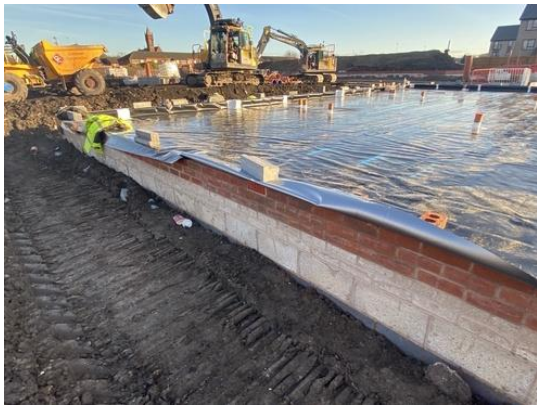
**Slab / membrane condition (is membrane clear of snow, standing water, debris or insulation): Can membrane be fully seen and photographed – ask contractor to remove an debris so membrane can be fully seen an inspected – this is a requirement of NHBC and local authorities.**

Photo 126

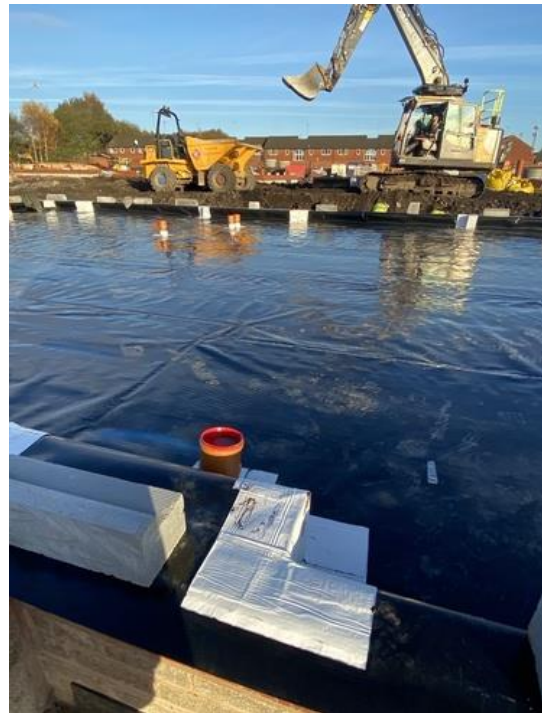
Photo 131

| <b>Gas Membrane Condition: Open punctures, tears, rips, stretching, Presence of debris, Repairs, Signs of weakness such as raised or sunken indentations, Protection plan in place to restrict access to lain gas membrane? IF FAIL DESCRIPTION IN ACTIONS AND PHOTOS REQUIRED</b> | | Pass |

| <p>Photo 131</p> <p>Photo 132</p> <p>Photo 133</p> <p>Photo 134</p> | | |

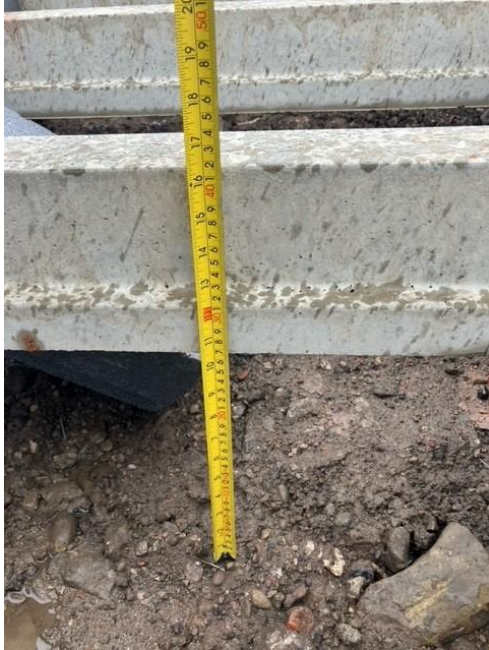
Plot 83

## SUB-FLOOR VOID PHOTOS
