Date: 6<sup>th</sup> August 2024  
Reference: 15-974 V9

## GAS MEMBRANE VALIDATION – BENNETT STREET

| <b>Project Name:</b> | Bennett Street |
| <b>Project Number:</b> | 15-974 |

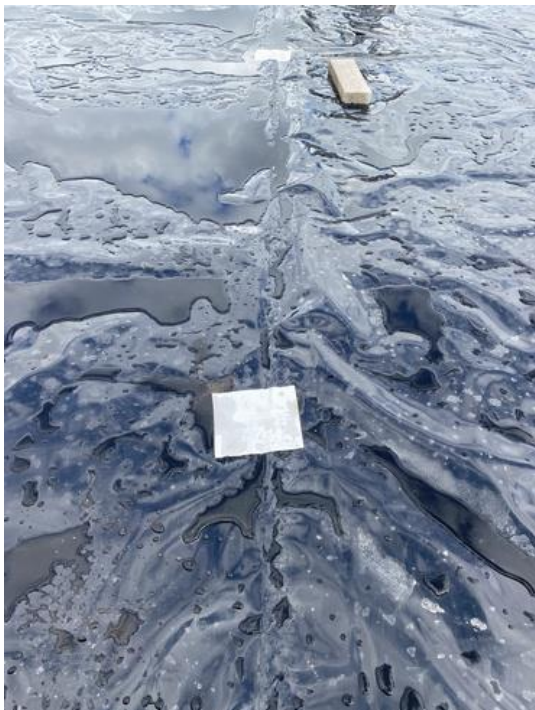
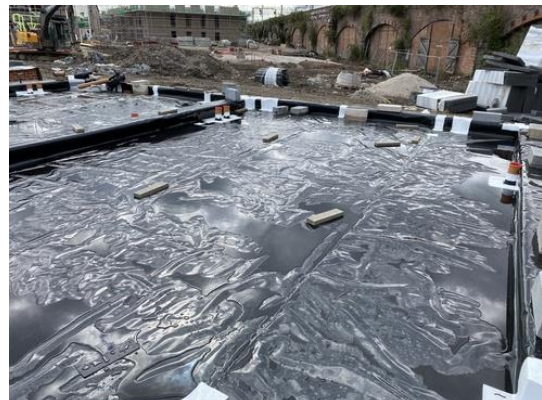
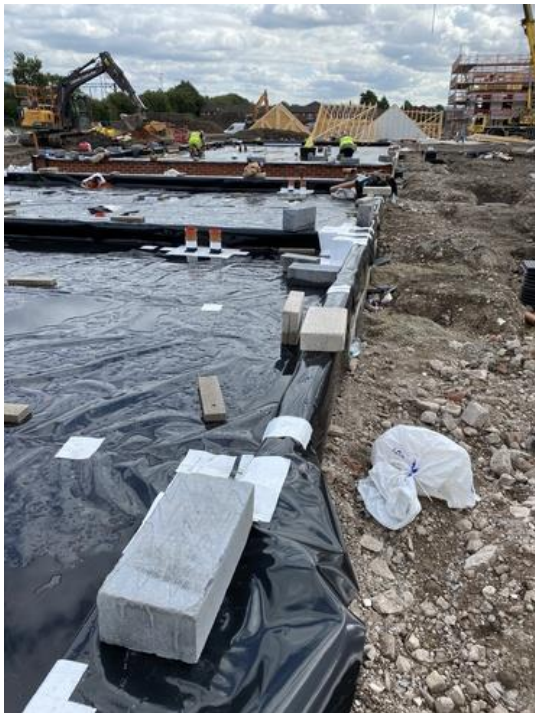
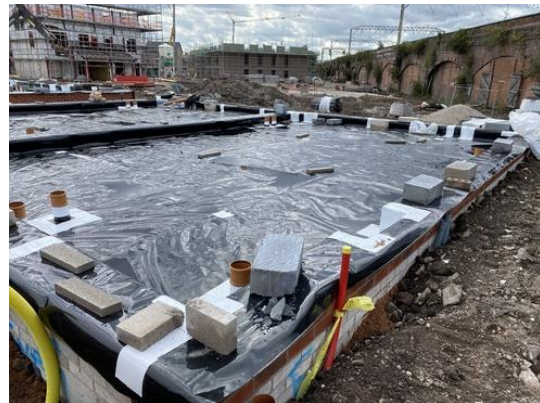
| <b>Gas Membrane Condition: Open punctures, tears, rips, stretching, Presence of debris, Repairs, Signs of weakness such as raised or sunken indentations, Protection plan in place to restrict access to laid gas membrane? IF FAIL DESCRIPTION IN ACTIONS AND PHOTOS REQUIRED</b> | Pass |

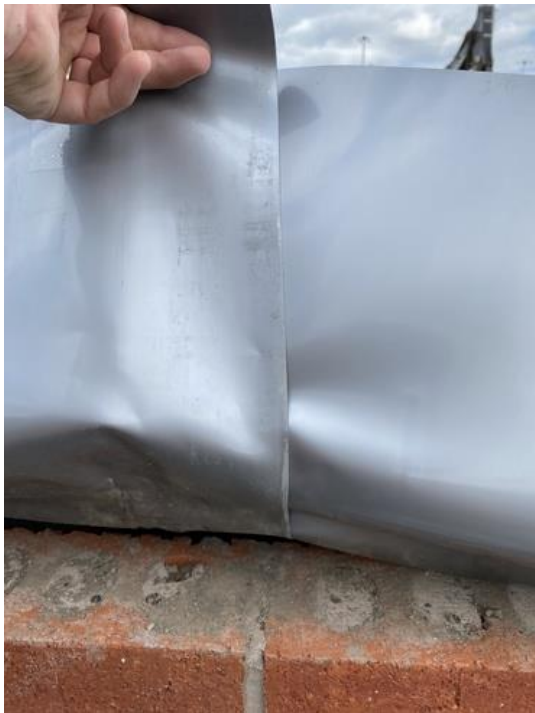
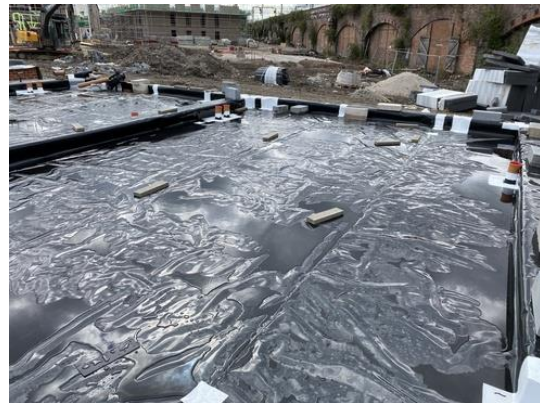
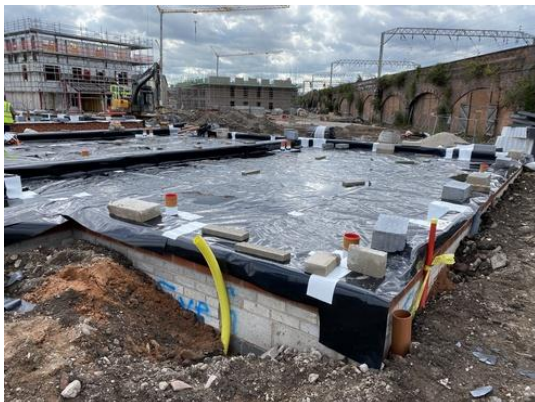
**Condition of sub-grade and underside of gas membrane: Check that the subgrade does not contain rough/uneven surfaces, is appropriately clean and that there are no hard/sharp objects. That protective sand blinding or geotextile (if specified) is present and meets the design criteria. ( Lift back the membrane and photo the subfloor)**

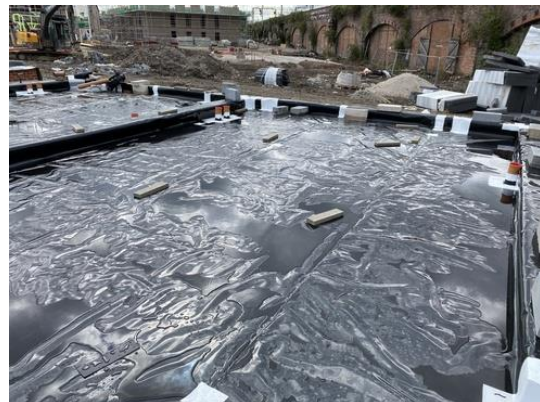
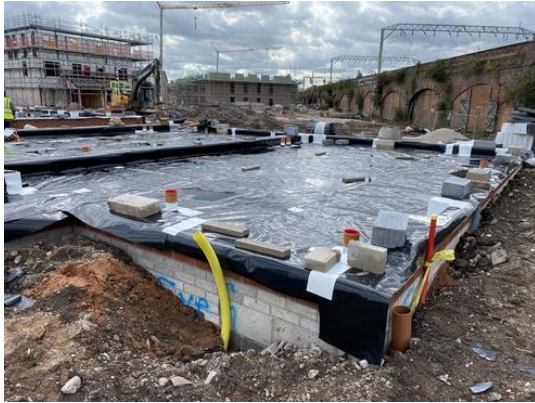
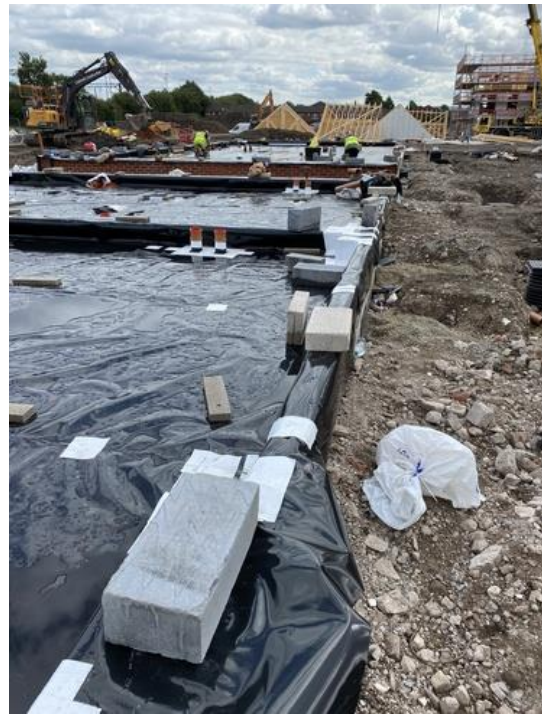
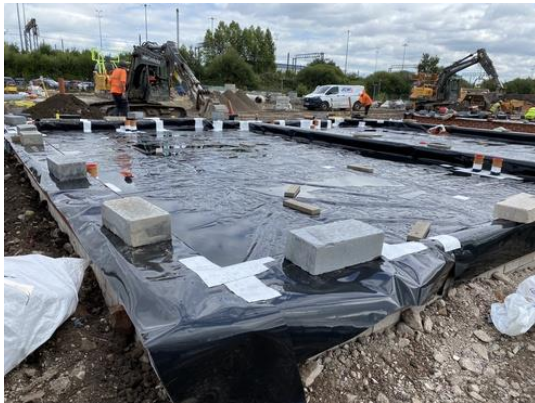
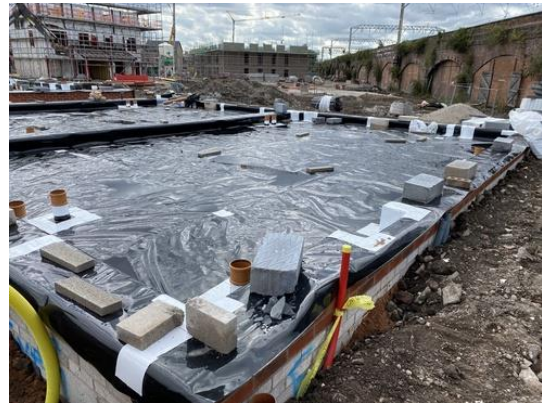
**Slab / membrane condition (is membrane clear of snow, standing water, debris or insulation): Can membrane be fully seen and photographed – ask contractor to remove an debris so membrane can be fully seen an inspected – this is a requirement of NHBC and local authorities.**
