Date: 24th September 2024  
Reference: 15-974 V14

## GAS MEMBRANE VALIDATION – BENNETT STREET

| <b>Project Name:</b> | Bennett Street |
| <b>Project Number:</b> | 15-974 |

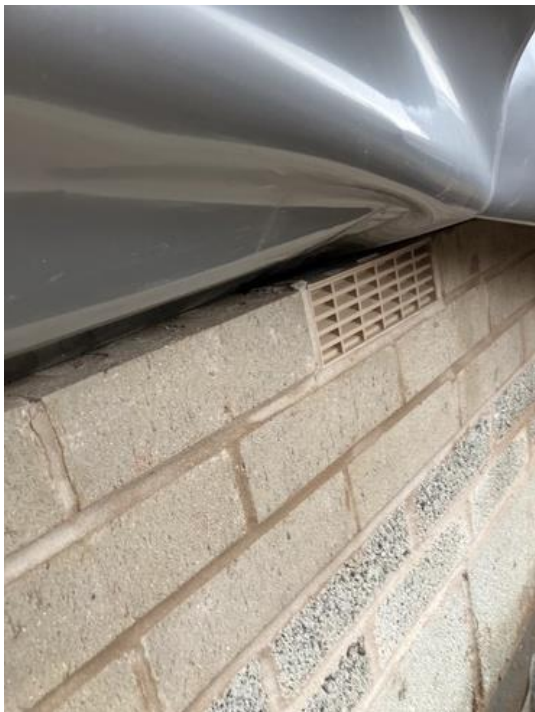
Photo 170

Condition of sub-grade and underside of gas membrane: Check that the subgrade does not contain rough/uneven surfaces, is appropriately clean and that there are no hard/sharp objects. That protective sand blinding or geotextile (if specified) is present and meets the design criteria. ( Lift back the membrane and photo the subfloor)

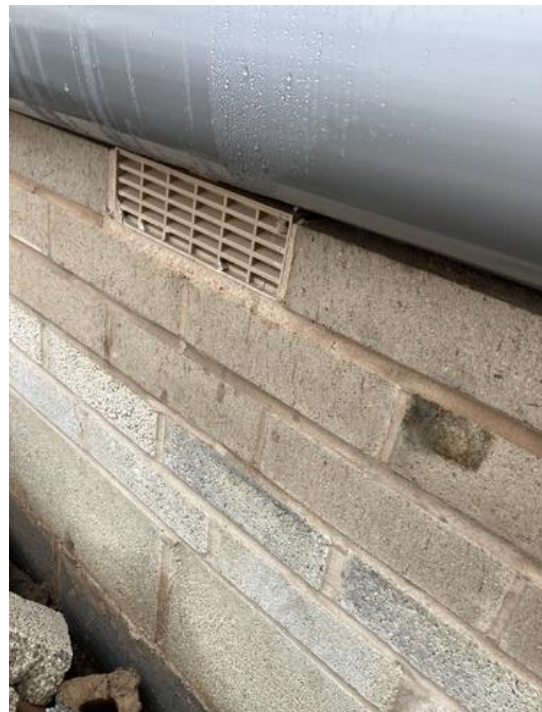
Photo 171

Slab / membrane condition (is membrane clear of snow, standing water, debris or insulation): Can membrane be fully seen and photographed – ask contractor to remove an debris so membrane can be fully seen an inspected – this is a requirement of NHBC and local authorities.

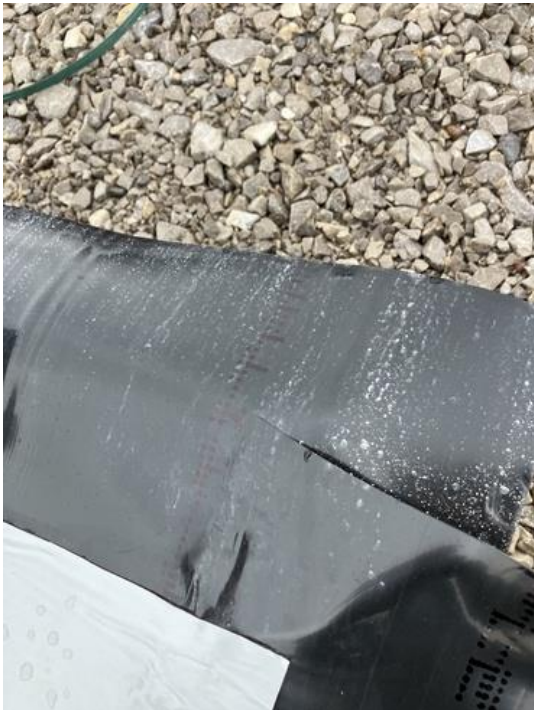
Photo 178

Gas Membrane Condition: Open punctures, tears, rips, stretching, Presence of debris, Repairs, Signs of weakness such as raised or sunken indentations, Protection plan in place to restrict access to lain gas membrane? IF FAIL DESCRIPTION IN ACTIONS AND PHOTOS REQUIRED

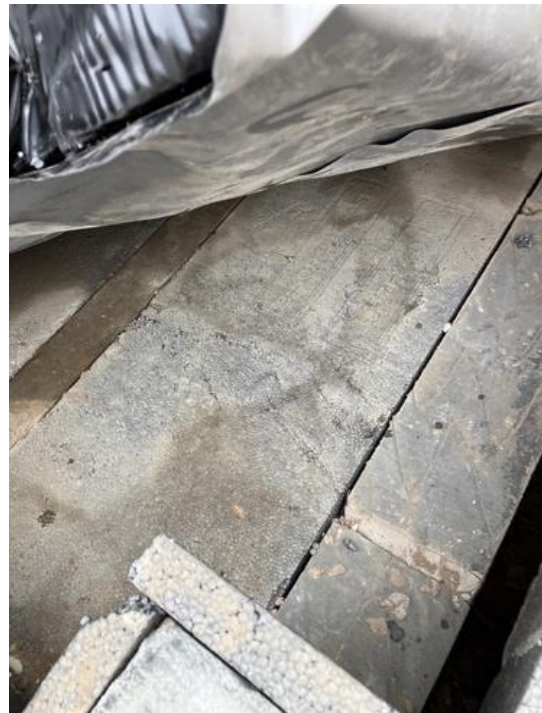
Photo 201

Condition of sub-grade and underside of gas membrane: Check that the subgrade does not contain rough/uneven surfaces, is appropriately clean and that there are no hard/sharp objects. That protective sand blinding or geotextile (if specified) is present and meets the design criteria. ( Lift back the membrane and photo the subfloor)

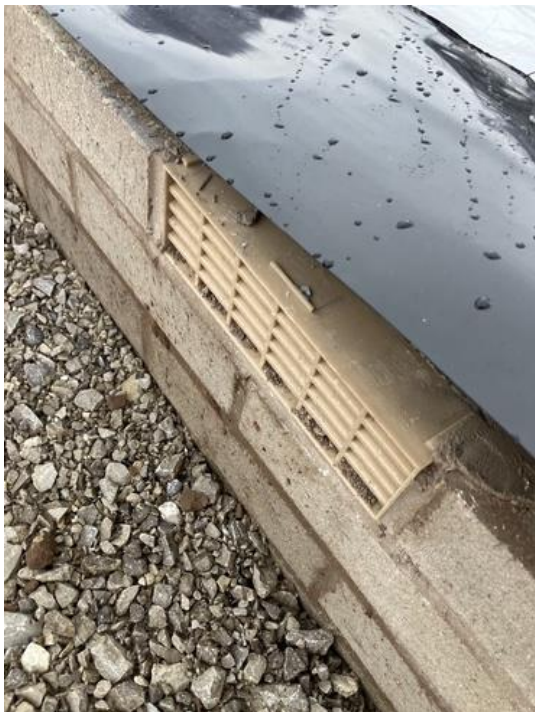
Photo 202

Slab / membrane condition (is membrane clear of snow, standing water, debris or insulation): Can membrane be fully seen and photographed – ask contractor to remove an debris so membrane can be fully seen an inspected – this is a requirement of NHBC and local authorities.

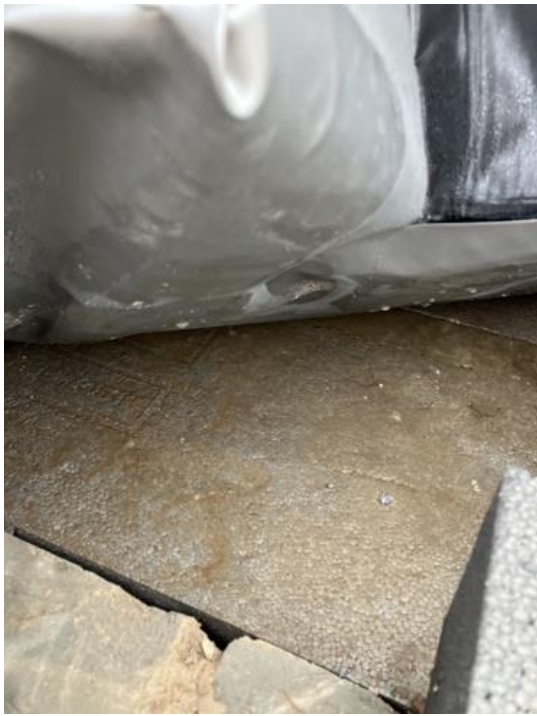
Photo 232

Condition of sub-grade and underside of gas membrane: Check that the subgrade does not contain rough/uneven surfaces, is appropriately clean and that there are no hard/sharp objects. That protective sand blinding or geotextile (if specified) is present and meets the design criteria. ( Lift back the membrane and photo the subfloor)

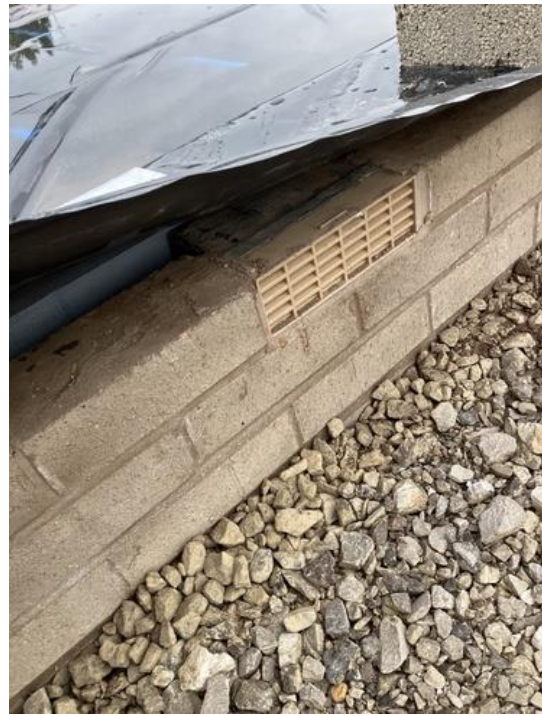
Photo 233

Slab / membrane condition (is membrane clear of snow, standing water, debris or insulation): Can membrane be fully seen and photographed – ask contractor to remove an debris so membrane can be fully seen an inspected – this is a requirement of NHBC and local authorities.
