Date: 24th September 2024  
Reference: 15-974 V14

## GAS MEMBRANE VALIDATION – BENNETT STREET

| <b>Project Name:</b> | Bennett Street |
| <b>Project Number:</b> | 15-974 |

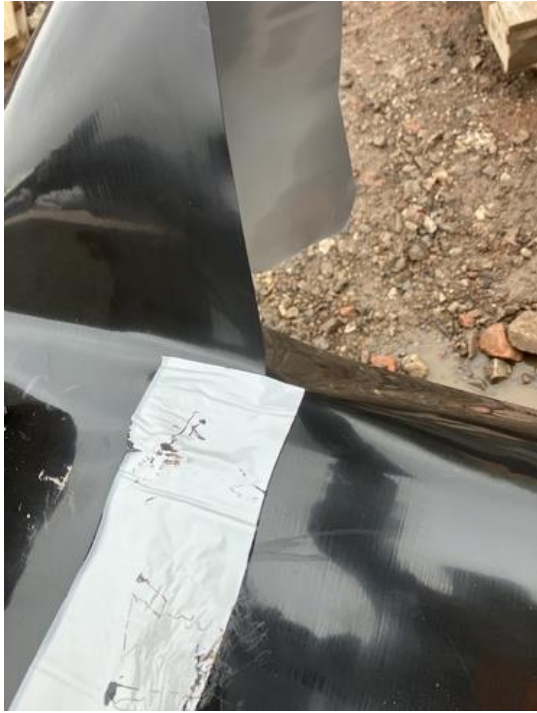
Photo 1

| Gas Membrane Condition: Open punctures, tears, rips, stretching, Presence of debris, Repairs, Signs of weakness such as raised or sunken indentations, Protection plan in place to restrict access to laid gas membrane? IF FAIL DESCRIPTION IN ACTIONS AND PHOTOS REQUIRED | Pass |

| <p>Photo 1      Photo 2</p> | |

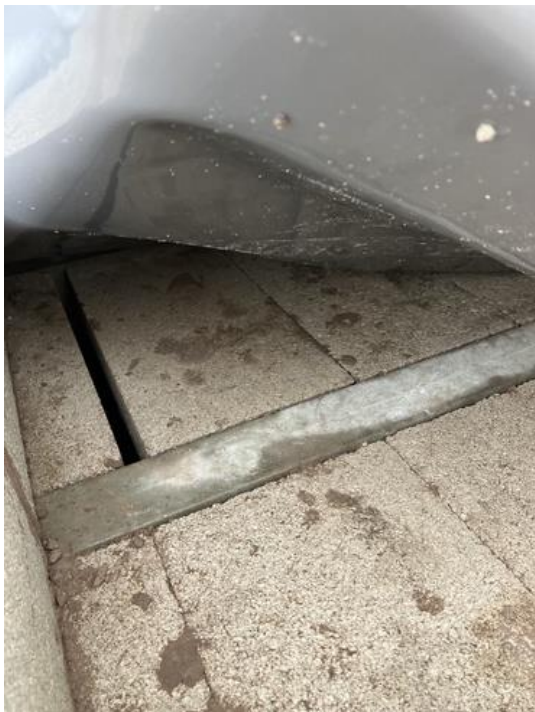
Condition of sub-grade and underside of gas membrane: Check that the subgrade does not contain rough/uneven surfaces, is appropriately clean and that there are no hard/sharp objects. That protective sand blinding or geotextile (if specified) is present and meets the design criteria. ( Lift back the membrane and photo the subfloor)

Photo 23

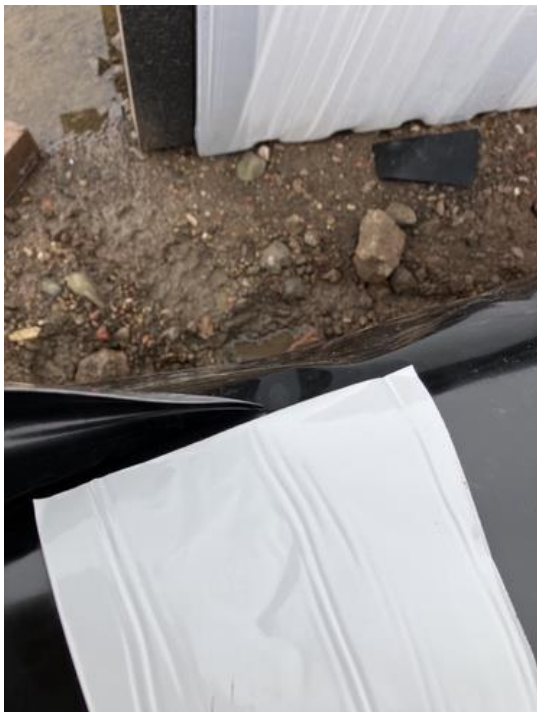
Photo 31

| Gas Membrane Condition: Open punctures, tears, rips, stretching, Presence of debris, Repairs, Signs of weakness such as raised or sunken indentations, Protection plan in place to restrict access to laid gas membrane? IF FAIL DESCRIPTION IN ACTIONS AND PHOTOS REQUIRED | | Pass |

| <div style="display: flex; justify-content: space-around;"> </div> <div style="display: flex; justify-content: space-around;"> <p>Photo 31</p> <p>Photo 32</p> </div> | | |

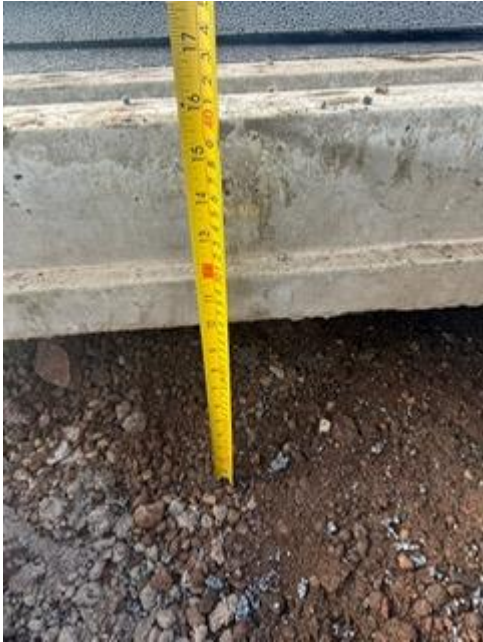
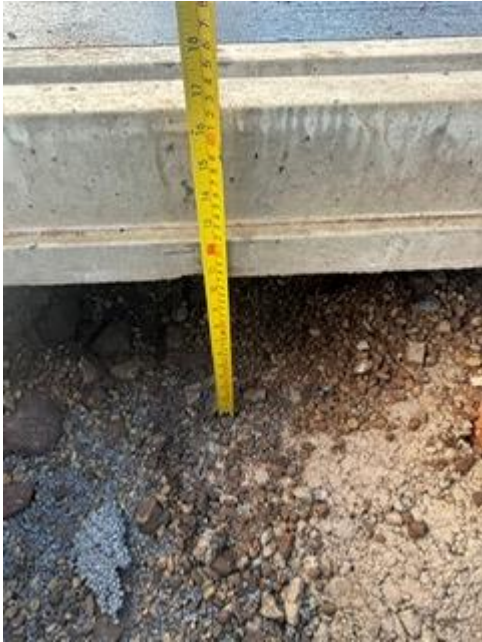
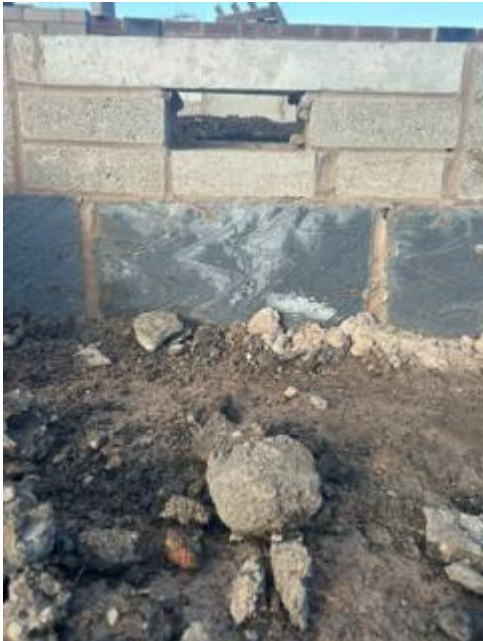
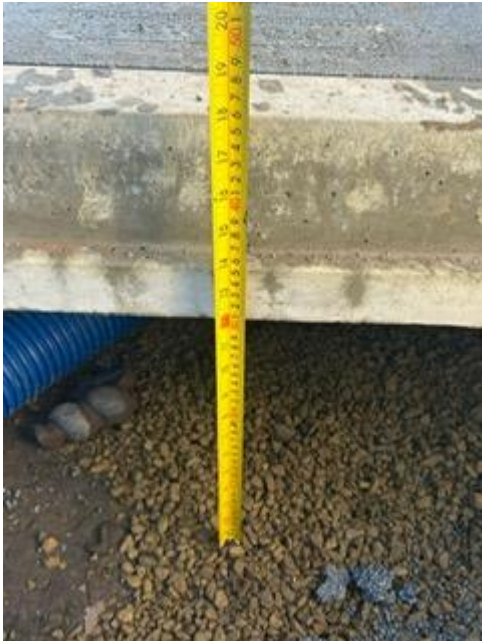
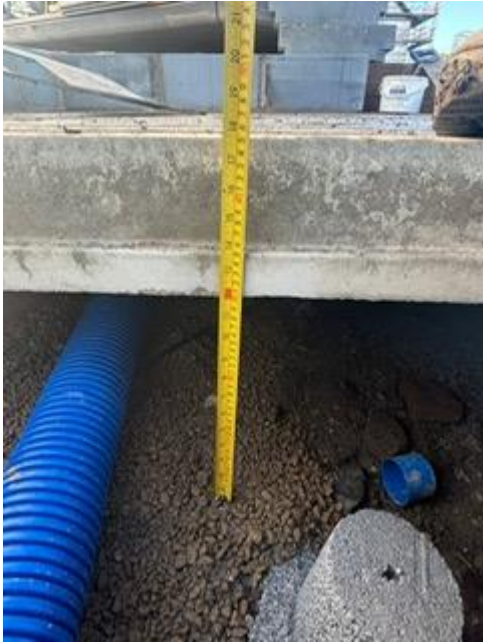
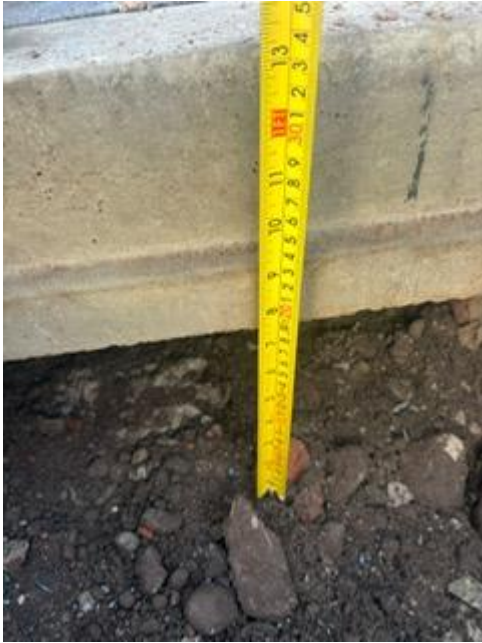
## SUBFLOOR VOID PHOTOS

| Plot 101 | Plot 102 |
| Plot 101/102 | Plot 103 |

| Plot 104 | Plot 128 |
