Proposed Facade Restorations - North West Elevation

Proposed Facade Restorations - North East Elevation

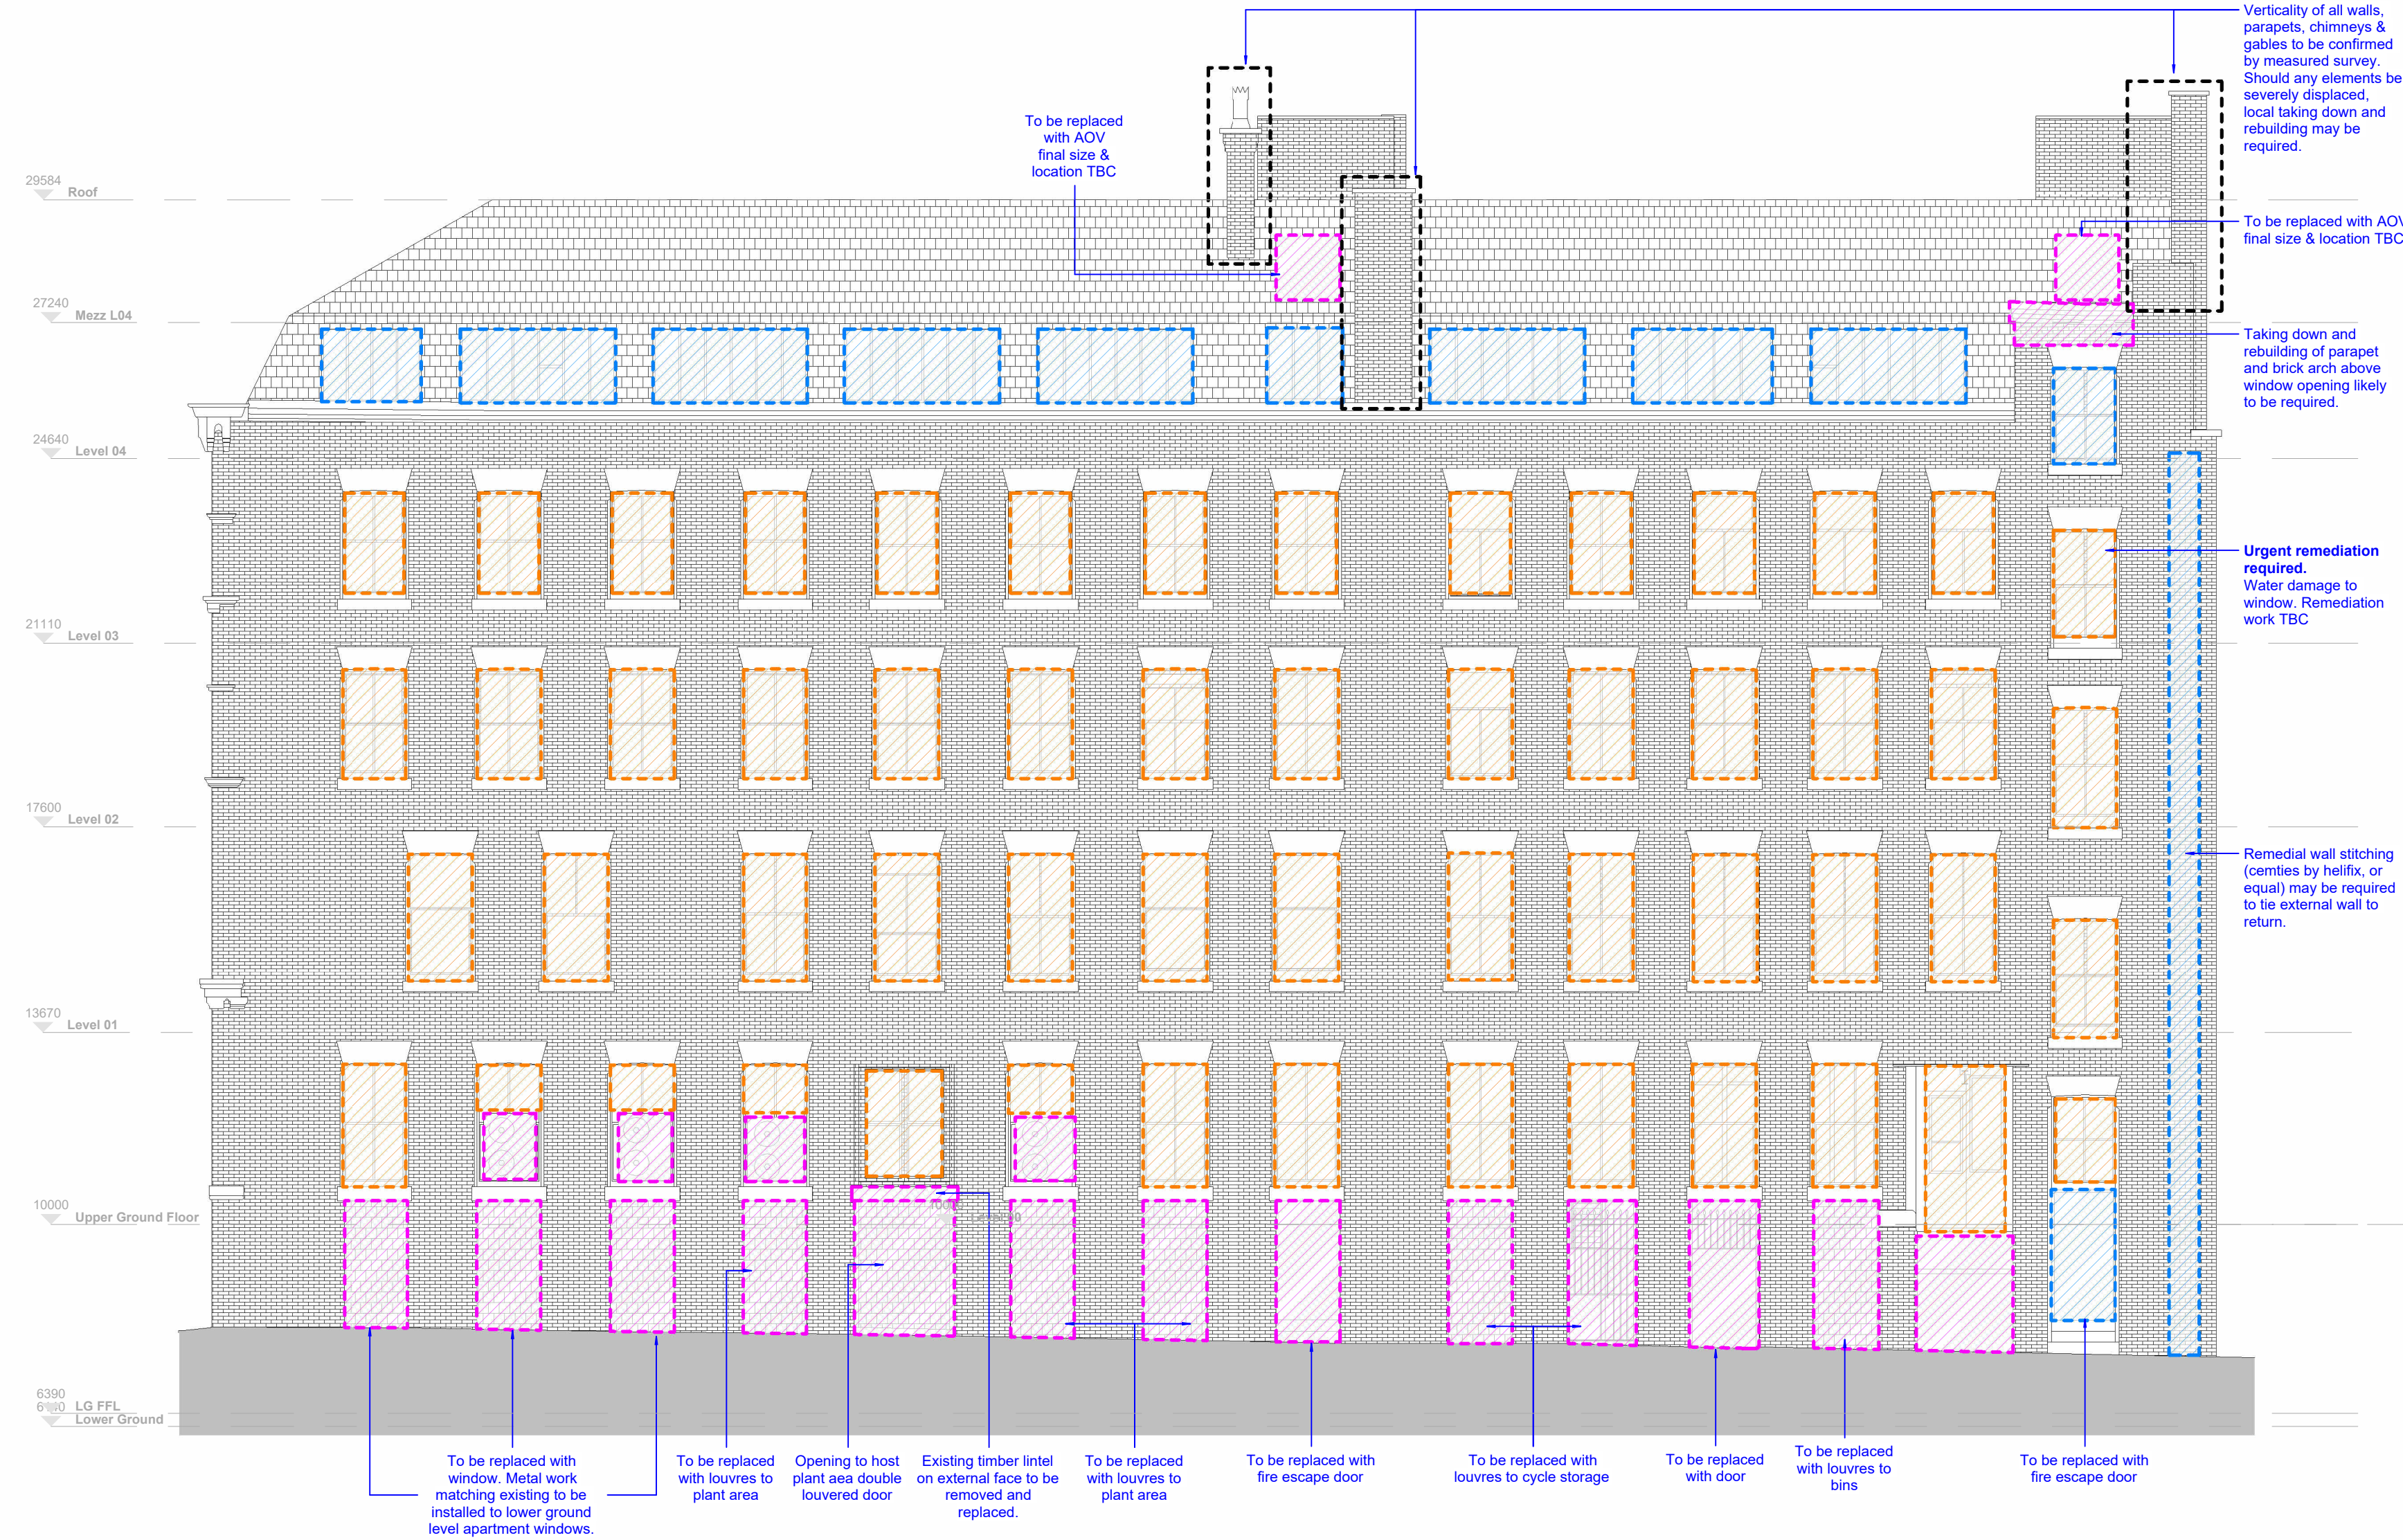
**Note**  
Condition of all facades and requirements for repairs / remedial works are to be confirmed following visual and tactile survey, once a suitable access scaffold is installed.

All stone indent repairs are to be specified by the conservation architect.

All cement-based mortar should be removed and replaced with a suitable lime-based mortar, to be specified by the conservation architect. Allowance should be made for full repointing of all walls.

Removal of vegetation and treatment of any remnant root systems is to be in accordance with the advice of a specialist.

Allowance should be made for the removal and replacement of any bricks where one-third (or more) of the depth has been lost, or the brick has become friable. Replacement bricks to be specified by the conservation architect.

For remedial crack stitching, allow for the following:  
- 6mm grade 304 helibars, 2m long, by helifix (or equal) installed at 300mm ctrs. Vertical on both faces of the wall.

Where stone or gauged brick arches above window openings have become displaced, allow for jacking, and packing of joints with slate and mortar.
