## **New Playzone Pitch Proctor Learning Centre Manchester**

### **Surface Water Strategy**

R - 00282 – 001 – SDS – 0  
June 2025

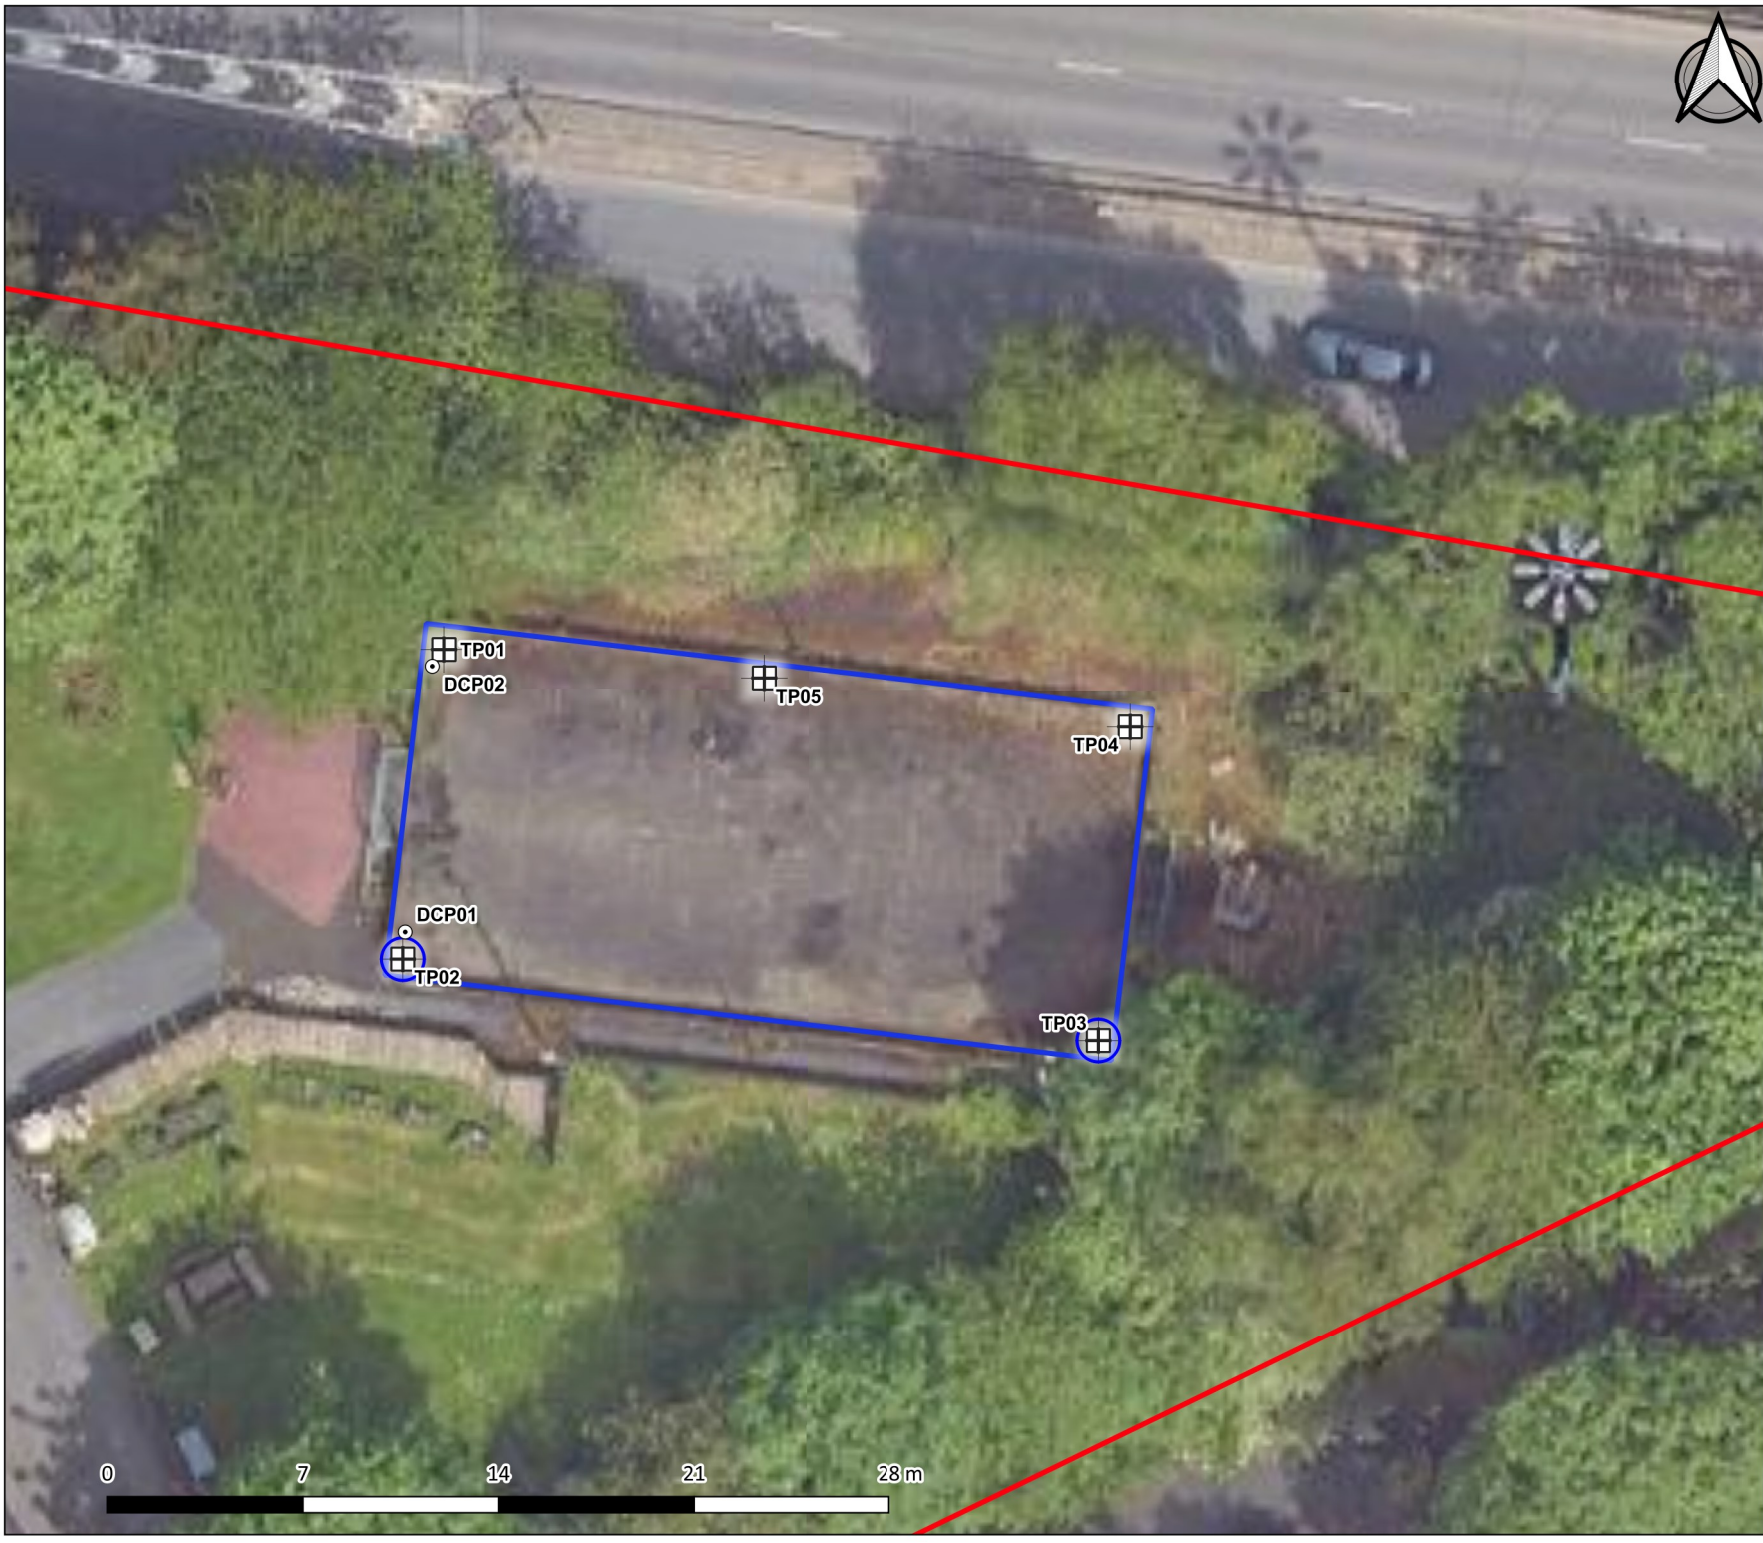
**Key:**  
**Exploratory Holes**

Infiltration Testing

- 7.4.1 Infiltration testing has been undertaken at the site following the principles of BRE 365: Soakaway Design (2016).
- 7.4.2 Subbase and underlying subgrade Made Ground were encountered as a granular material, with significant fines content. Indicative testing was undertaken within TP02 and TP03 for each strata respectively, however only one cycle could be undertaken in each due to the very slow dissipation of water added. Due to insufficient infiltration over a test period of 88-89 minutes, permeability could not be determined.

- 7.4.6 No existing soakaway features were observed on site during ground investigation works; however, a full drainage survey was not undertaken.
- 7.4.7 As an alternative, it is possible that the PlayZone drainage could key into the existing surface water drainage system currently used by the referral centre. If this is considered an option for the development a comprehensive drainage assessment will be required to determine the potential impact on the capacity of the existing systems, to identify the invert levels of existing features, and to confirm drainage gradients achievable across the proposed PlayZone area.
