EXISTING DRAWINGS NOTES & KEY

ALTERATIONS DRAWINGS NOTES & KEY

PROPOSED DRAWINGS NOTES & KEY

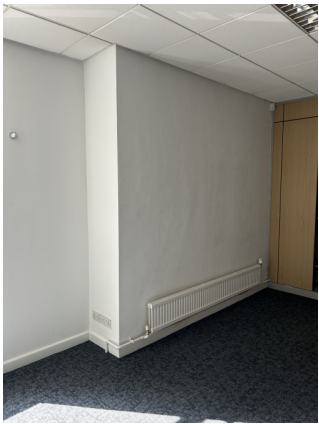
Existing view of internal elevation

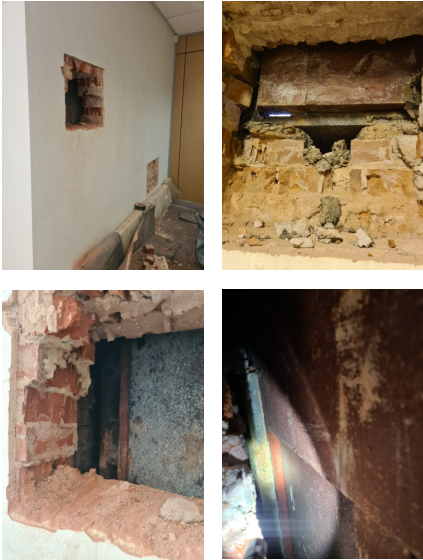
Photos of 1980s infill / investigation works with original late 19th century door behind:

Notes:  
-Based on latest available information. Subject to change following further site investigation.  
-Limited access currently available to inner leaf of door and door frame. Pending further site investigation and survey. Condition of interior of door to be assessed including any original ironmongery.  
-Heritage status and condition of step closest to timber door to be confirmed. Stone joint in the centre of the step and the difference in stone materiality and construction method compared to remaining two steps may indicate it is a later addition.  
-Photos below depict result of intrusive investigation on site. Due to limited visibility and extent of survey works all assumptions of existing condition are in abeyance

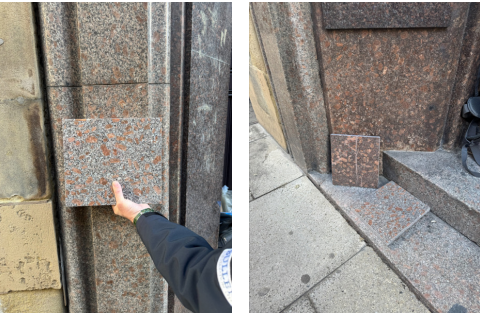
WIP Stone Samples:

Material Key:  
1. ALT-311 Original Granite stone surround, cleaned and repaired  
2. Infill of voids in stone surround resulting from the removal of existing stone step and the drop in level to create a level threshold. Material to match existing fabric. Existing damage and cracking of stonework to be repaired and infilled using method resulting in closest match to existing fabric (see below proposed stone samples to match existing stone)
