## Land off Kenyon Lane, Failsworth

### Remedial Strategy Report

For: John Southworth Builders Ltd.

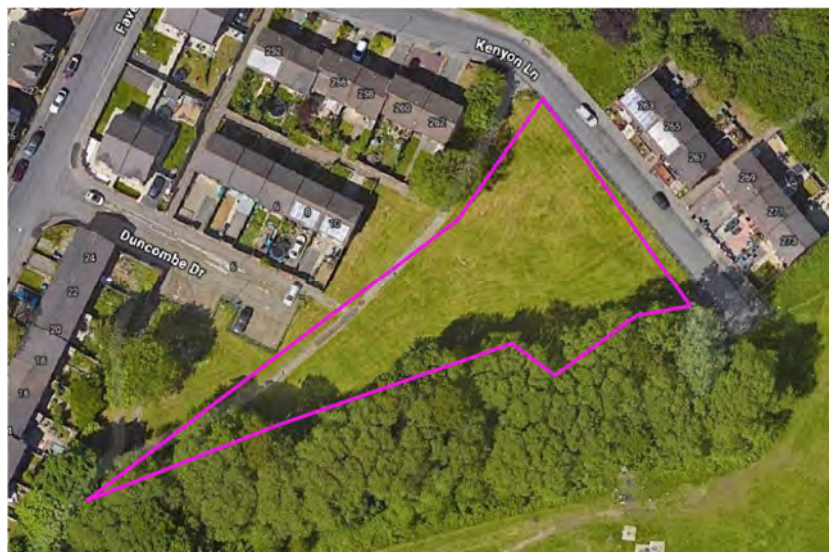
The site currently comprises a grassed vacant area of land with dense vegetation and established trees along the southern boundary. The site is accessed via Kenyon Lane off the eastern boundary. The site is bound by residential property to the north east and north west and open land to the south. An aerial photo of the site is below:

Figure 1: Aerial image of the site dated 2024

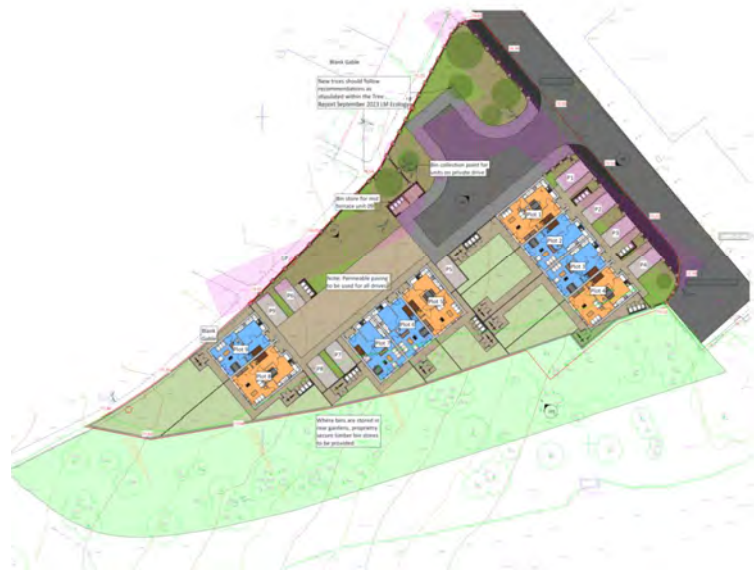
This Remedial Strategy Report has been undertaken to determine the remedial requirements of the site based upon the previous site investigation works. It is the client's intention to develop the site into a low-rise residential development comprising 9 No. low rise dwellings with associated private gardens, soft landscaping and access roads. The proposed development plan is contained in Appendix 2. An extract is shown below:

Figure 2: Extract of the proposed development plan

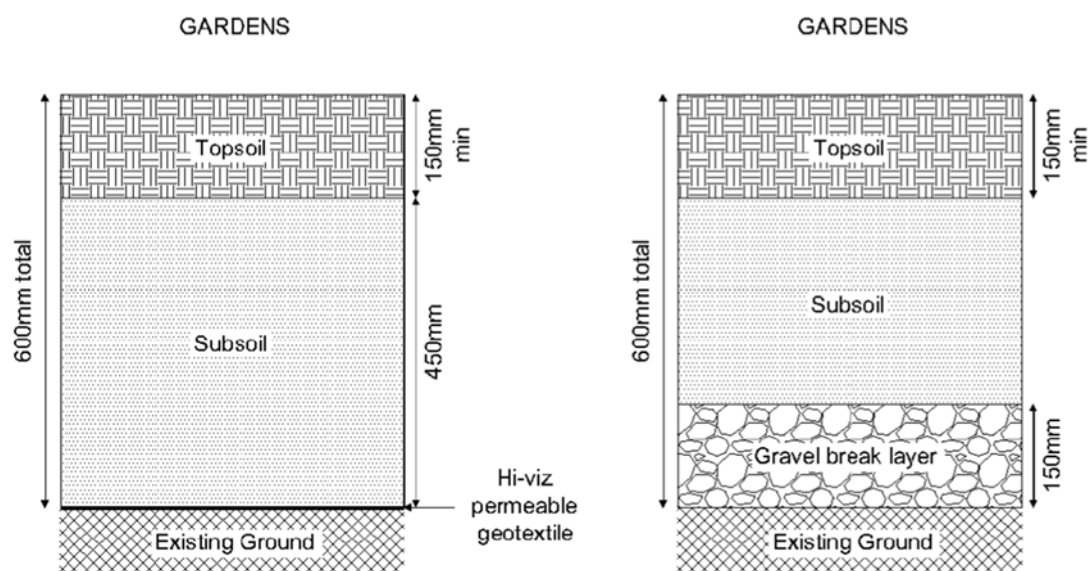
2. A 600mm clean cover system is recommended to be added to the proposed private gardens (450mm in soft landscaping areas). This is to consist of:

- No less than 150mm and no more than 300mm suitable topsoil, underlain by;
- Suitable subsoil to a total (topsoil + subsoil) depth of 600mm (450mm in areas of soft landscaping), underlain by;
- A high vis geotextile marker;
- Validate in line with the below strategy.

This is shown diagrammatically below:

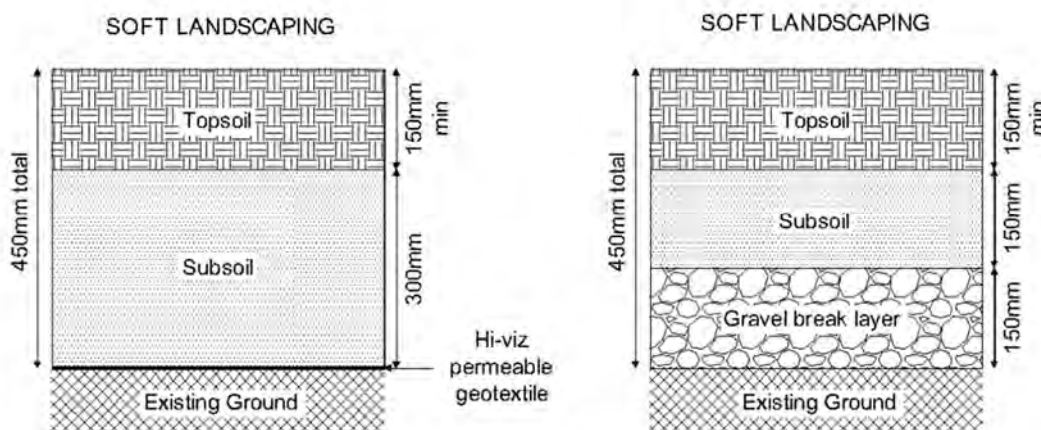
The cover system for the soft landscaping is to be 450mm thick, due to the presence of asbestos on site, and consist of:

- A minimum of 150mm suitable topsoil, underlain by;
- Suitable subsoil, to a total thickness of 450mm.

This is shown diagrammatically below:

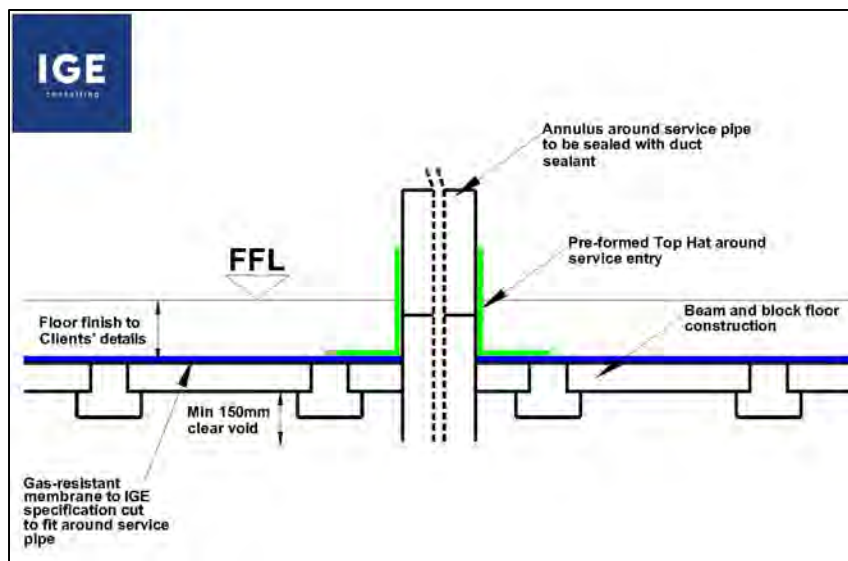
Beam and block suspended floor slabs (such as Litecast or Jetfloor) are to be utilised for this proposed residential development, as such construction is deemed adequate for the CS2 designation of the development. The below cross-section details the elements of construction required for the proposed floor slabs.

Figure 3 – Service entry detail including pre-formed top hat (green) and location of ground gas-resistant membrane (blue).

*This drawing is not to scale. Use detailed dimensions only.*

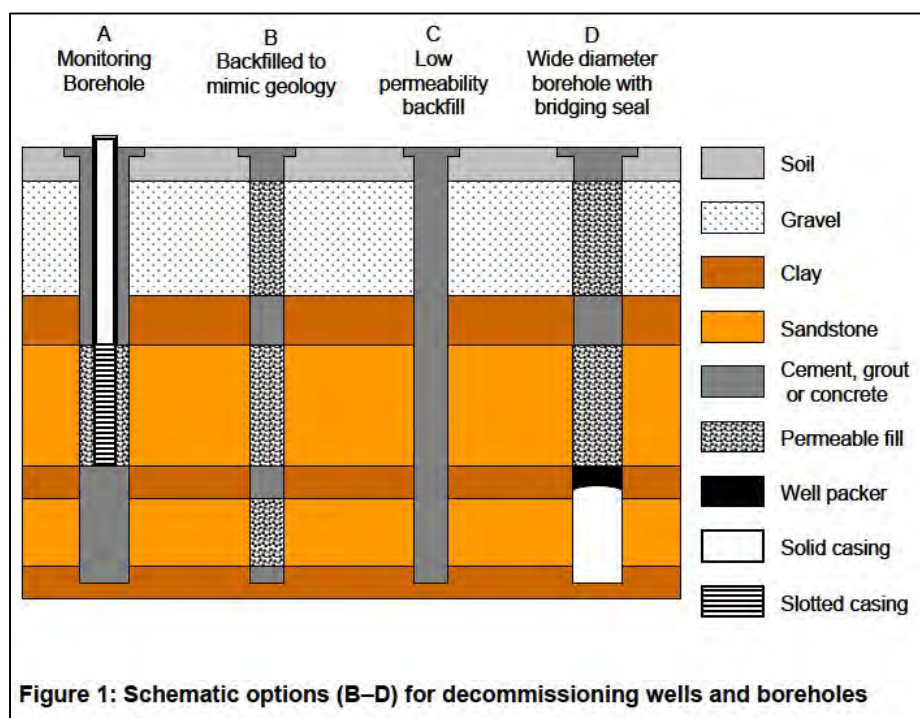
Utilising guidance provided in the Environment Agency's '*Good practice for decommissioning redundant boreholes and wells*' (October 2012), it is prudent to secure redundant boreholes to ensure that no groundwater pollution can occur. The Environment Agency (EA) offer advice on the methods of sealing wells to ensure that the preferential pathway is removed. The following diagram taken from the EA guidance shows a monitoring well (A) and 3 No. options for decommissioning (B, C and D):

It is considered prudent to utilise Option C – low permeability backfill, shown in the diagram above, to adequately seal the borehole. The guidance recommends that 'the backfill materials must be clean, inert and non-polluting', e.g. bentonite. It is recommended to remove the standpipe and seal with bentonite to ground level. This will be sufficient to prevent contaminant transport.

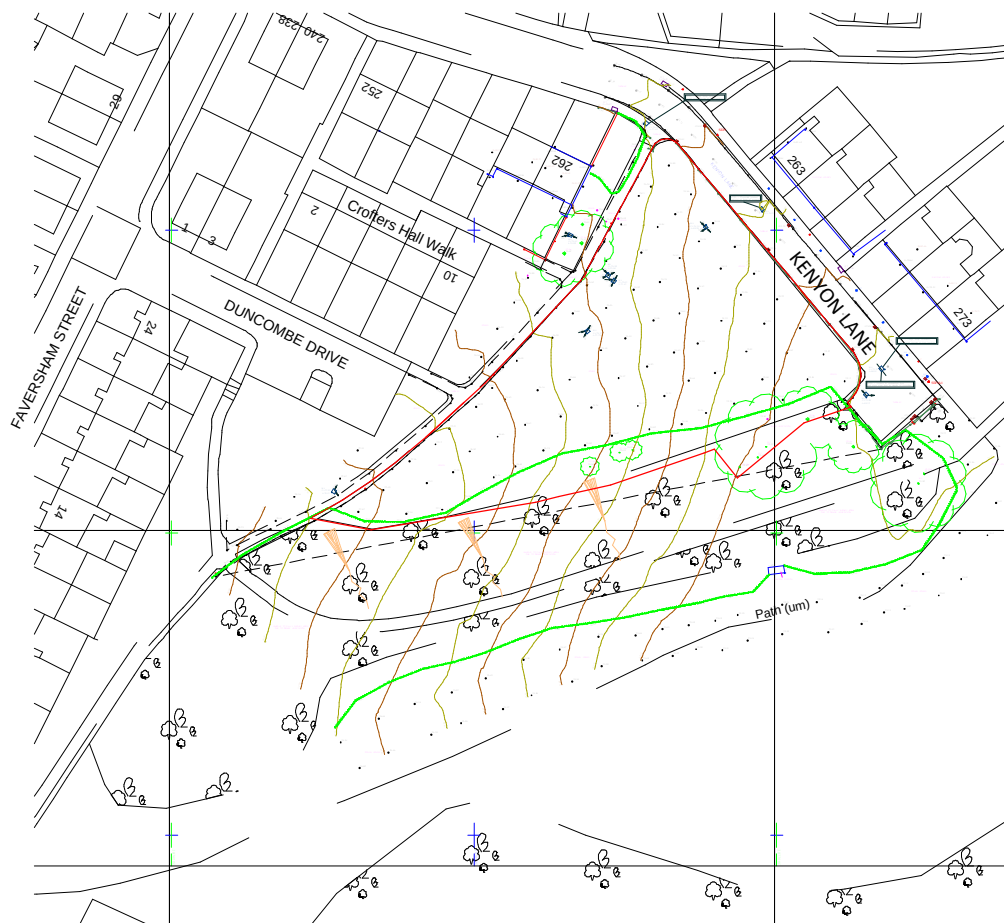
1 : 1250

# 1 Location Plan

This report pertains to a triangular shaped c. 0.38 Ha site located to the west of Kenyon Lane, Failsworth at the approximate post code M40 5FH. The National Ordnance Survey Grid Reference for the centre of the site is 387656E, 401212N. A site location plan is included in Appendix 2 (Drawing ref: SI-01).

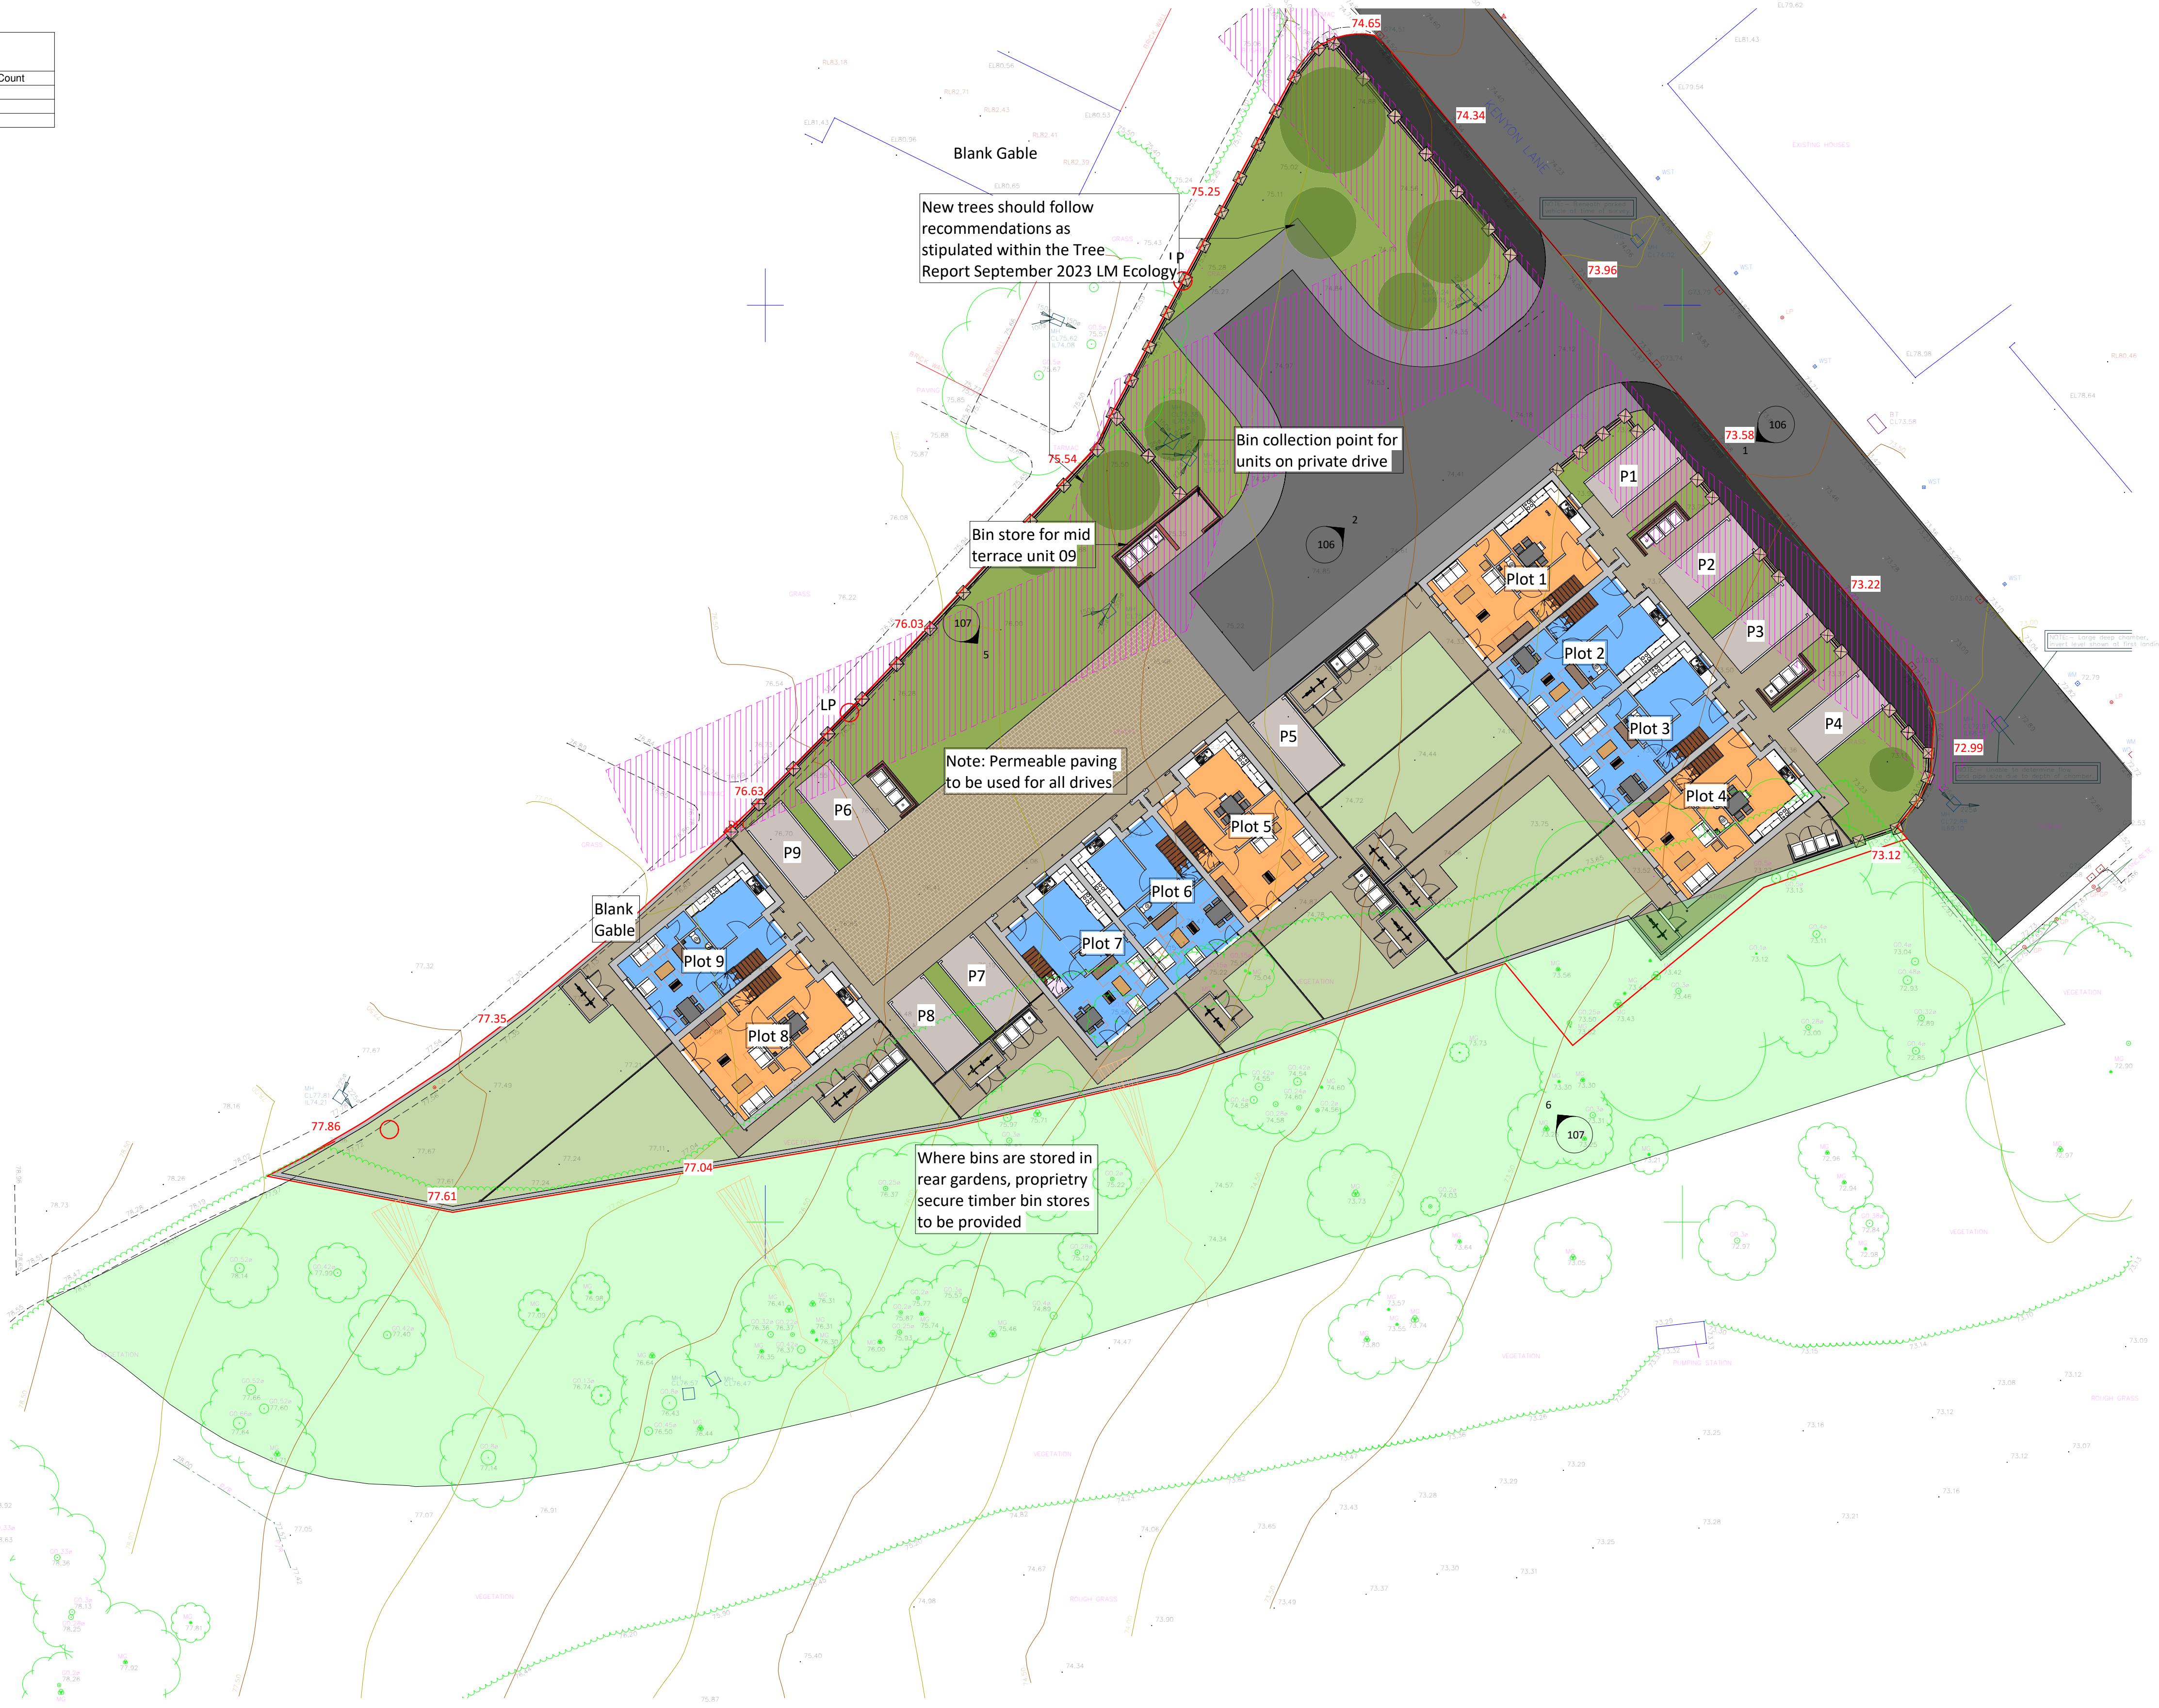
1 : 200

# 100 Proposed Site Plan
