## B.E.A.U WINDOWS

Flat 514 Victoria Mill 10 Lower Vickers street Manchester M40  
7LL

This proposal is to outline the details of the works that will be carried out during the replacement of 8 timber windows at the property mentioned above. This will include the design and specifications of the windows, additional items included on the windows as well as the specification of the glass units being installed.

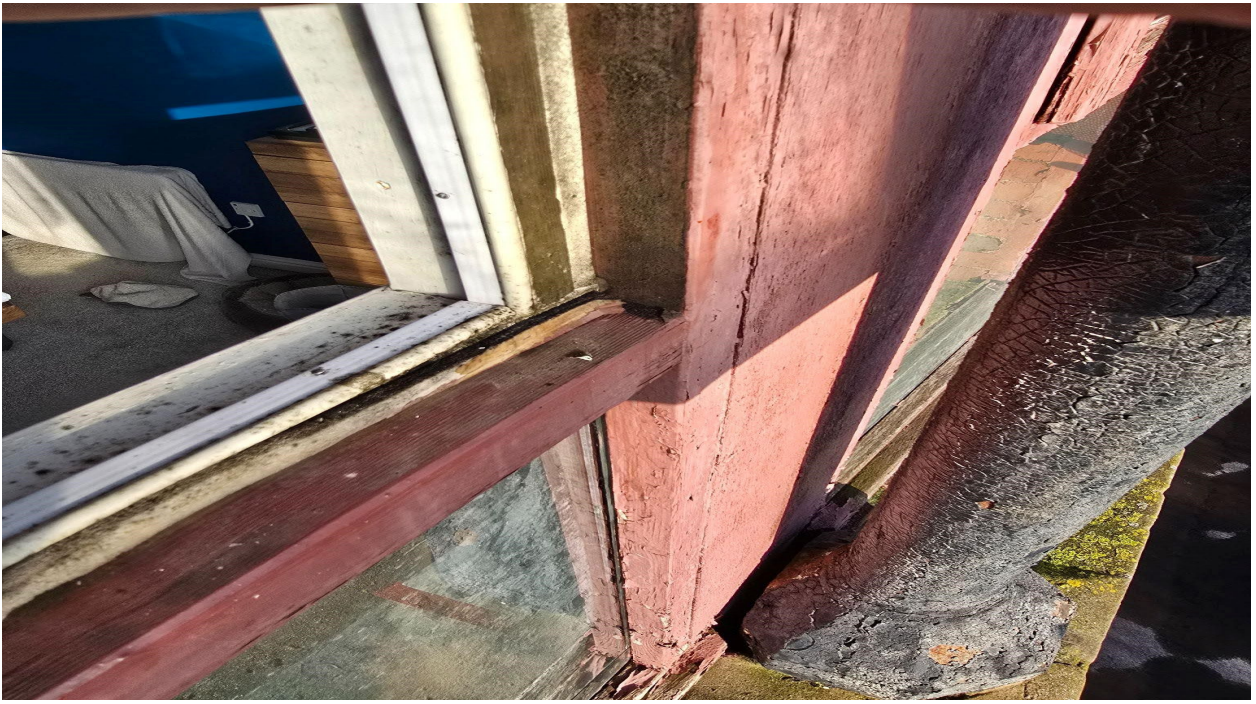
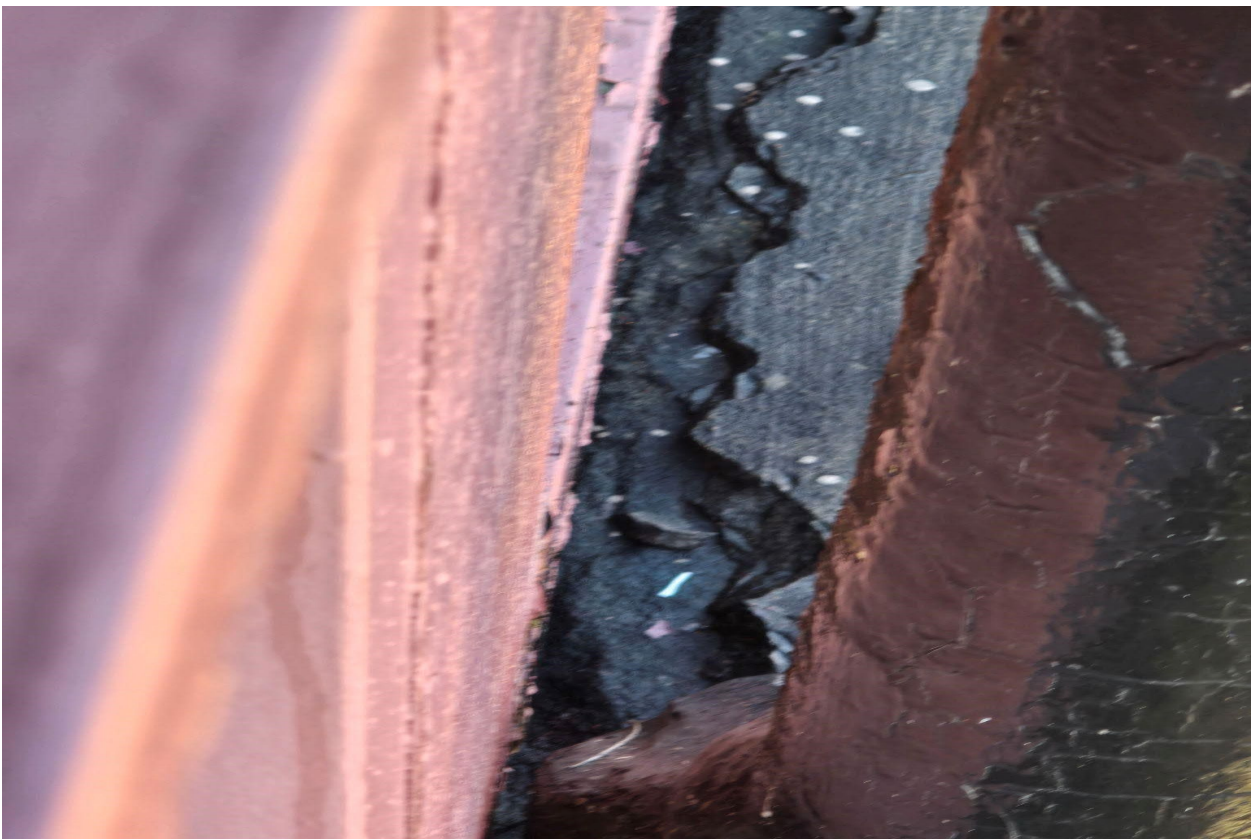
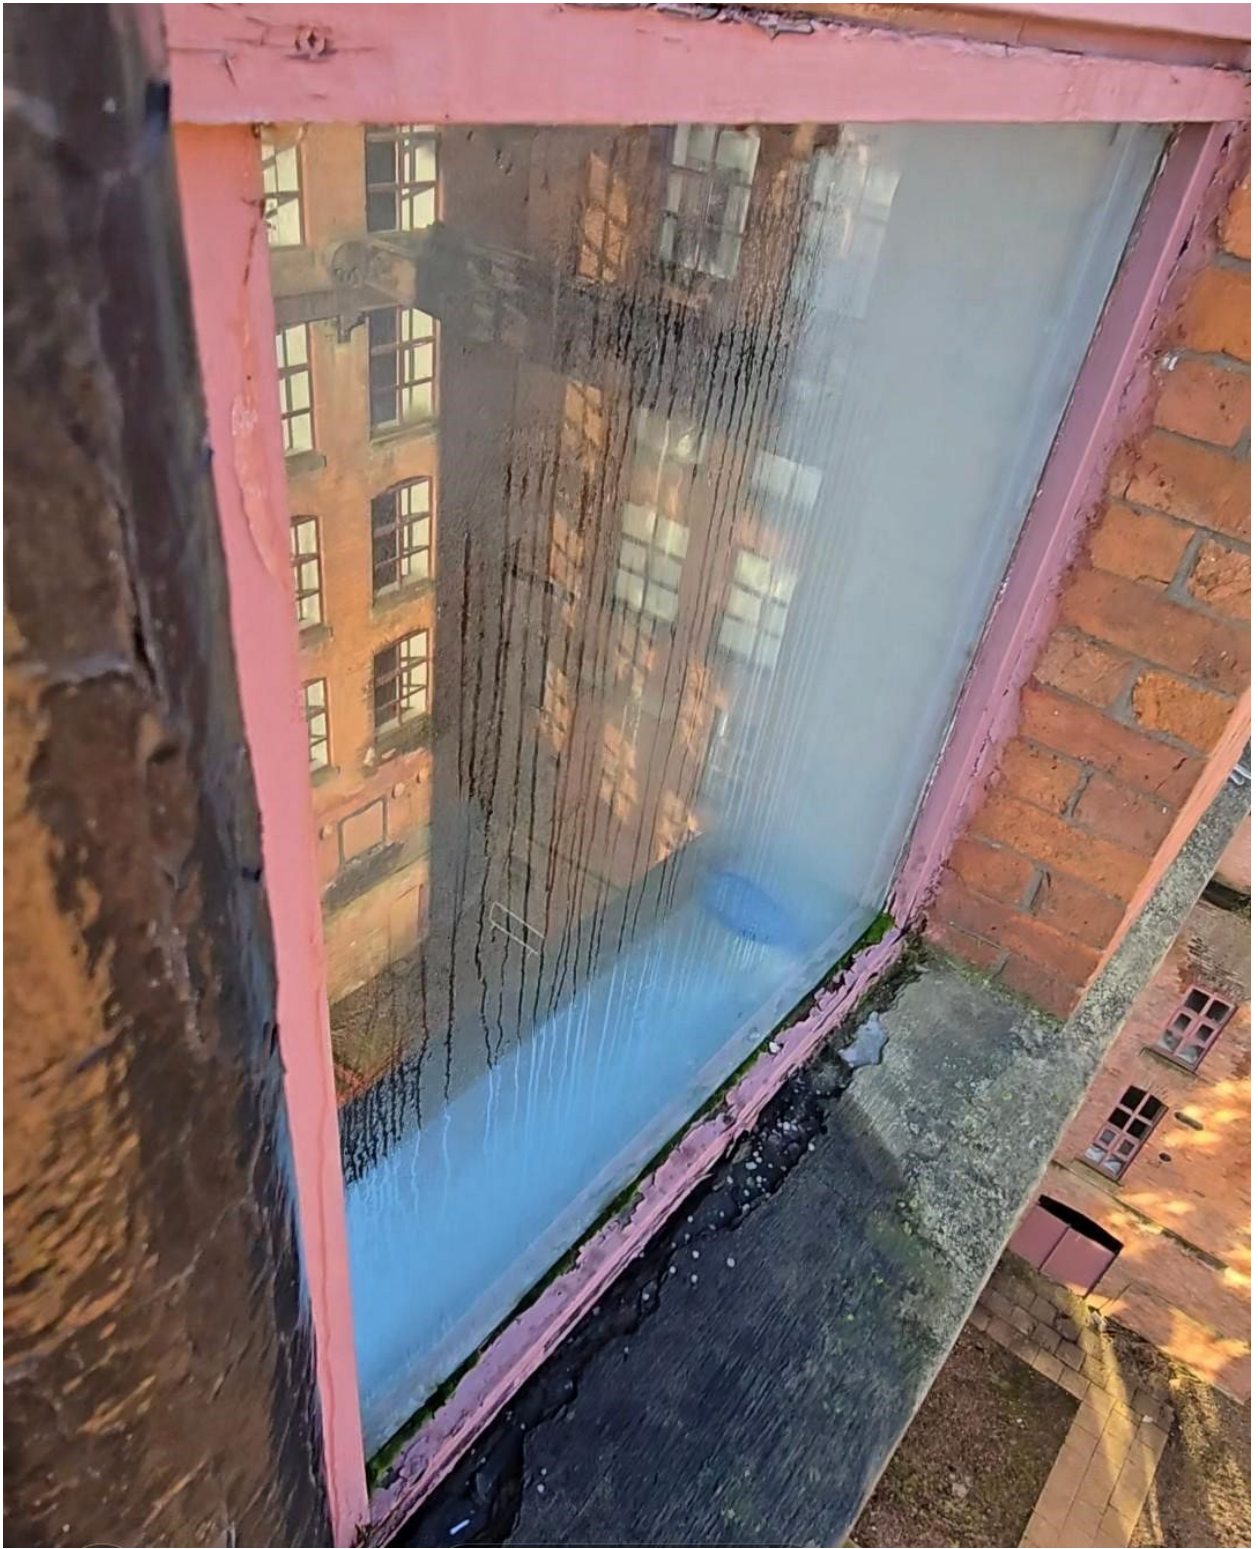
Stone Cills will be cleaned and repaired prior to installing the window frames, all damage and gaps will be filled using a limestone mortar to ensure adequate breathability and weather protection. Damage has already been identified and will be included in the onsite pictures below.
