**Manchester City Football  
Academy**

**Geotechnical Design Report**

REP/226518/G001

Issue 4 | 2 May 2013

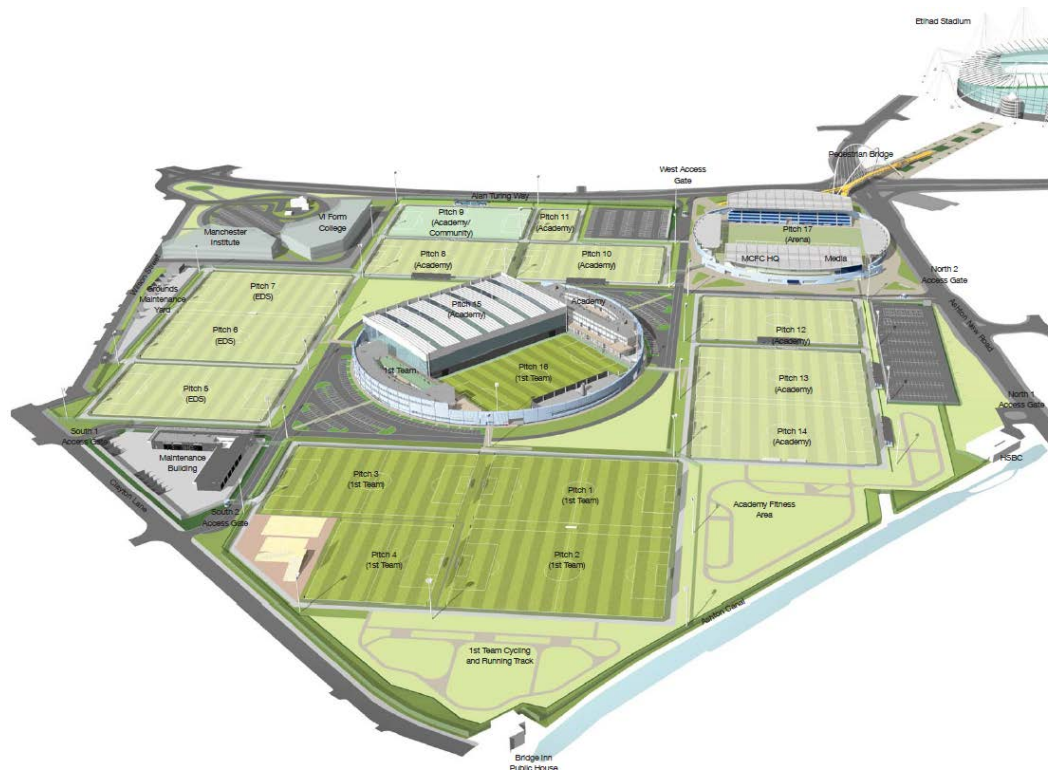
**Figure 1 Proposed Development**

The overall vision and proposed layout of the final development is as illustrated in **Figure 1** below:

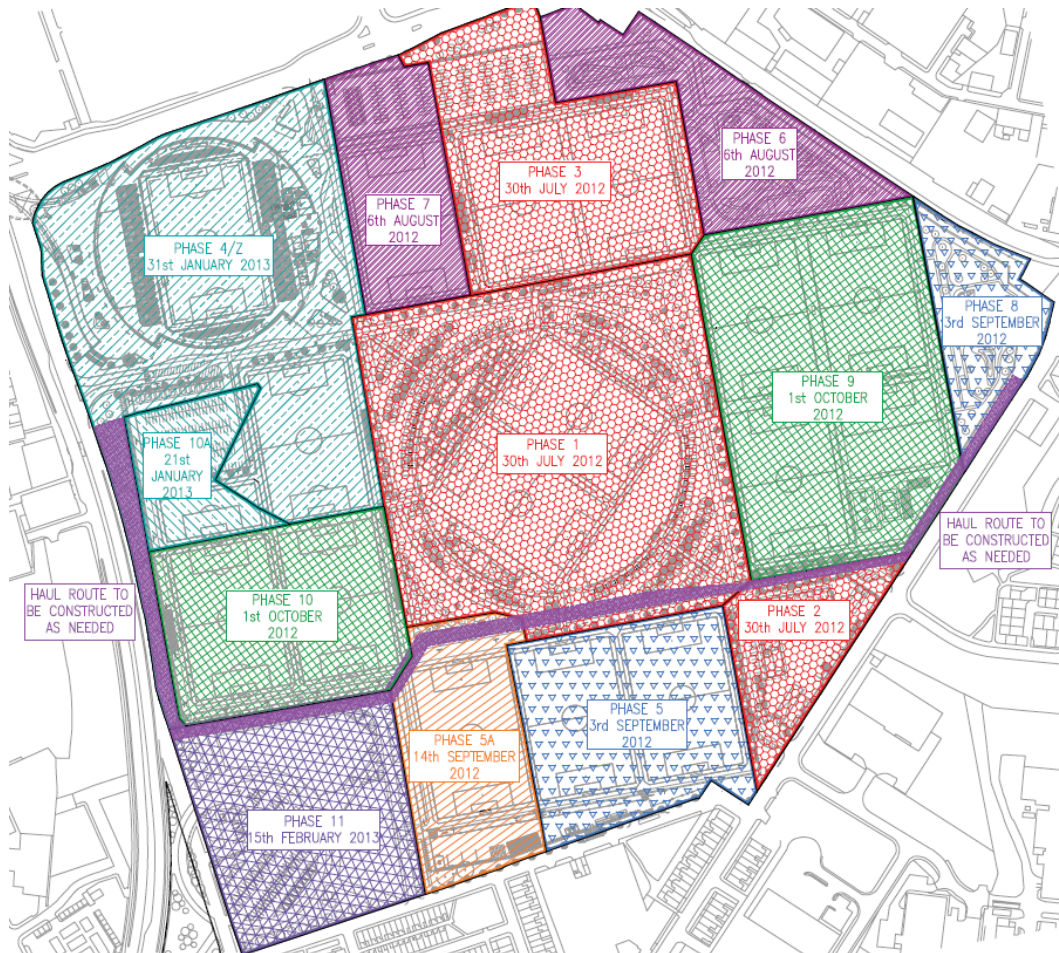
**Figure 2 Original Development Phasing**

The works are to be undertaken by BAM Construction, following a phased hand over from the Enabling Works/Constraints Removal Works contractor Buckingham Group Contracting Ltd (BGCL). The phased sequence of hand over is indicated in **Figure 2** below.

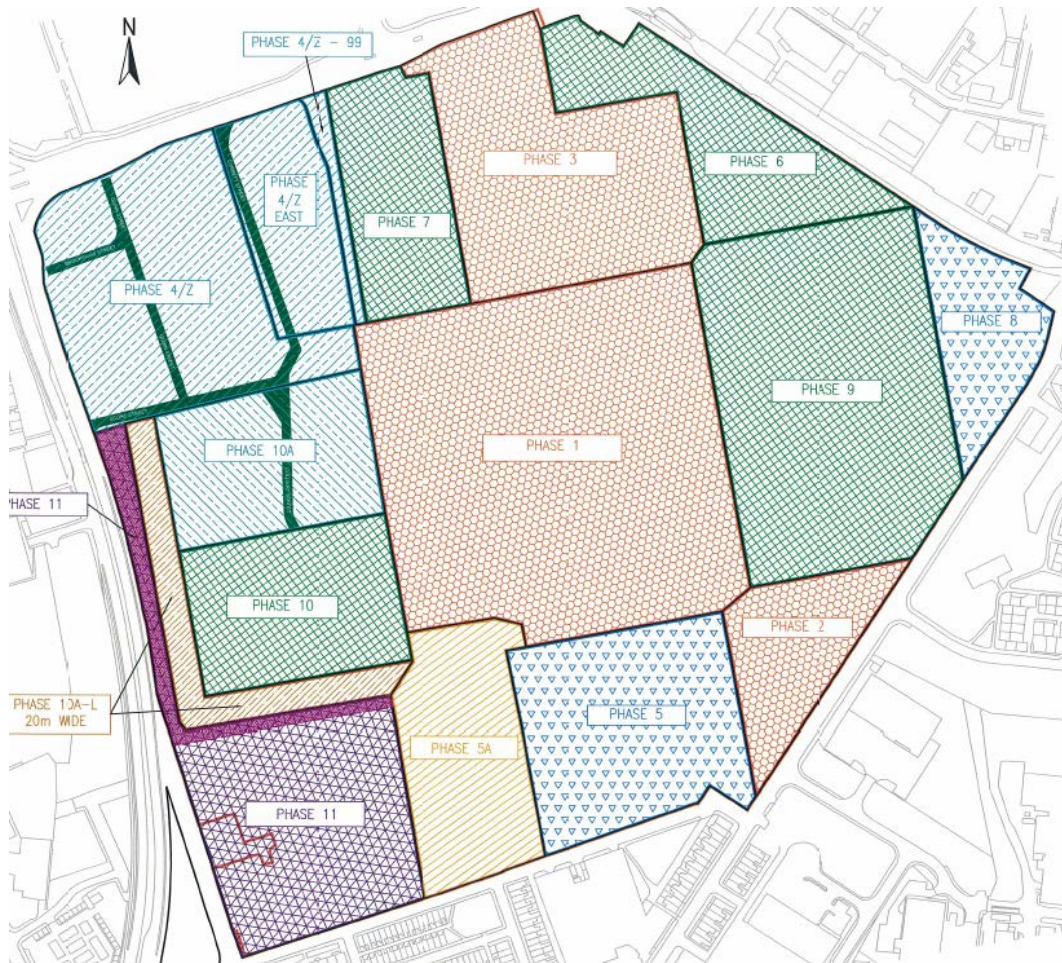
**Figure 3 Revised Development Phasing**

Due to delays in the execution of the CRW, the work phasing has now been further split, to allow early hand over of intermediate parts of some of the phases. The revised phasing is illustrated below.

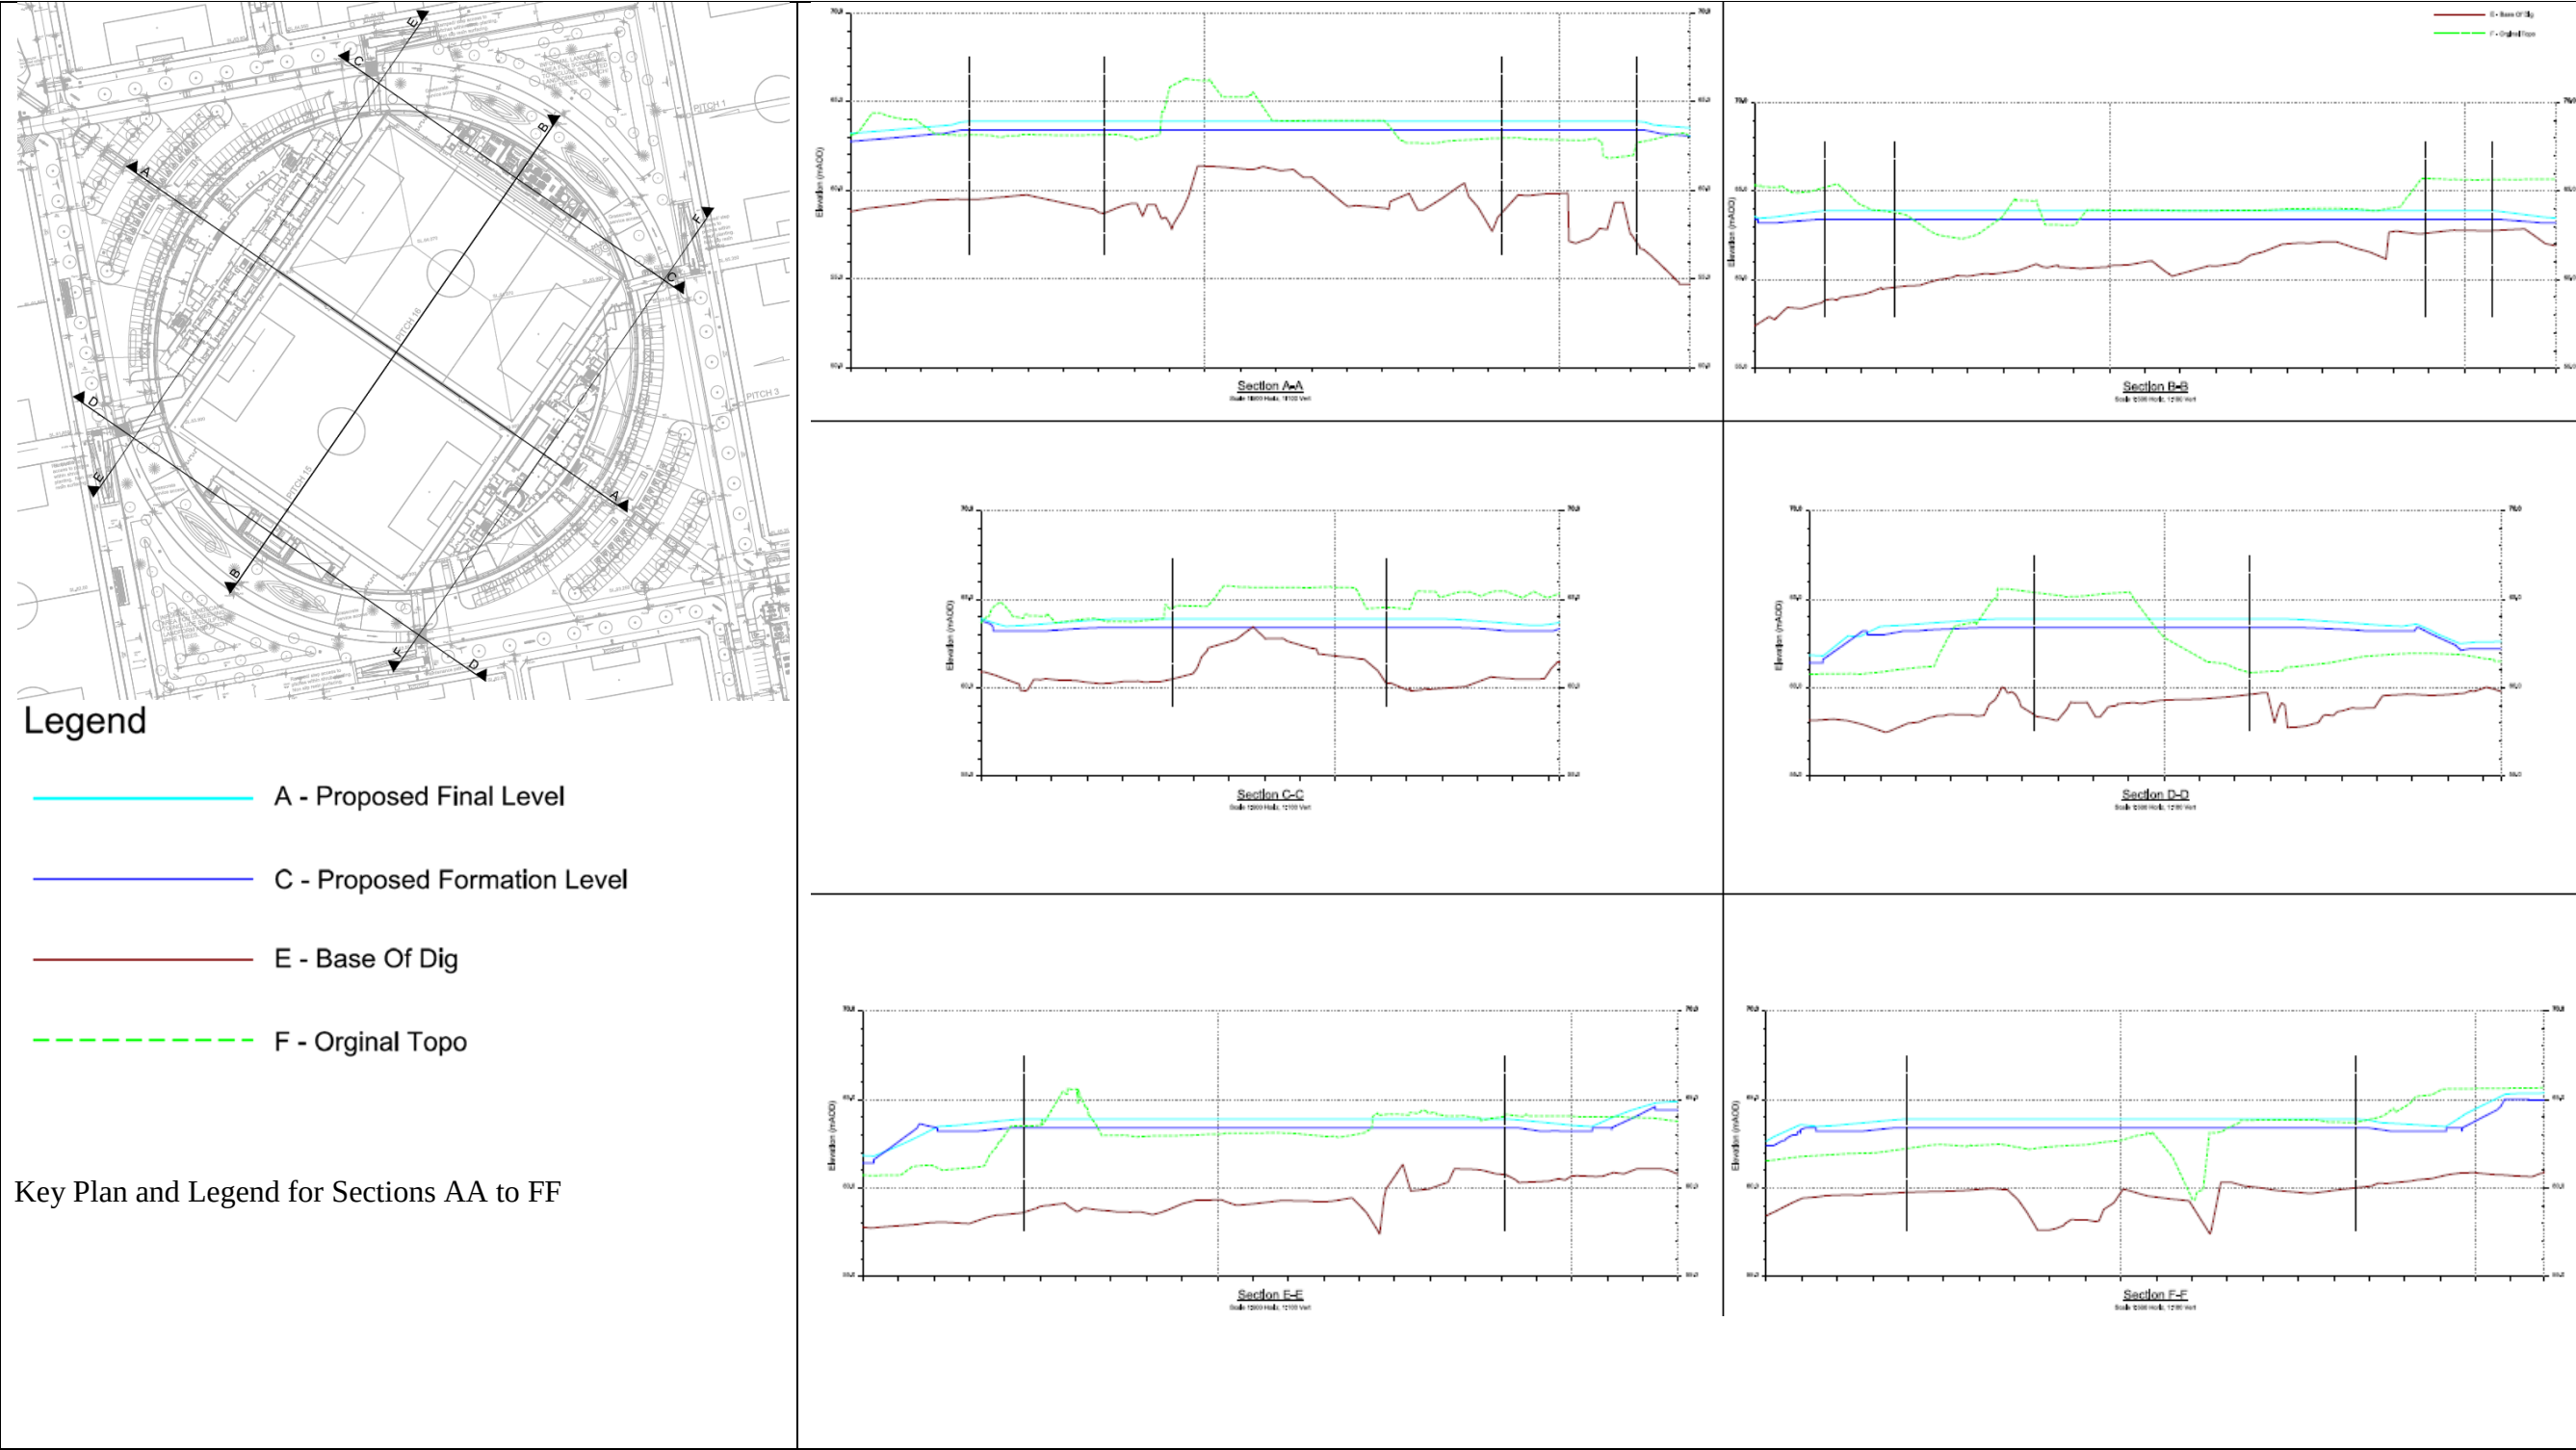
Figure 4 Earthworks Cross Sections for CTF Area (Sections AA to FF)

The base of excavation (Surface E) is available for the Phase 1 area and has been used to produce the following cross sections for the CTF area (**Figure 4**):

The data appears to suggest a thickness of engineered fill of varying thickness (typically 0.5m to 5m) and a thickness of 'enhanced' engineered fill typically between 3m and 5m.

It is also noted that the development platform is above the original pre CRW levels in some locations and below it in others, resulting in differences in the likely responses of the underlying soils, due to either reduction in stress, where levels have been reduced, or increase in surcharge stresses where levels increased.

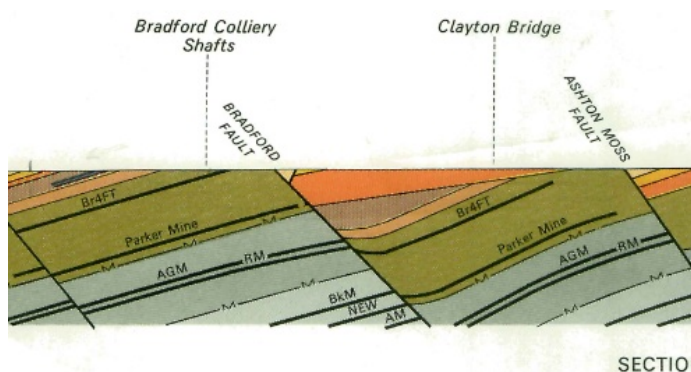
**Figure 5 Geological Map extract showing Bradford Fault (section of west to east orientation)**

A review of the geological map for the area shows the fault to be about 45 degrees to the horizontal as shown below (**Figure 5**). The fault down throw is to the east. The shallow named seams are likely to outcrop to the west of the fault and the Parker Mine seam appears to be deep (>500m below surface).

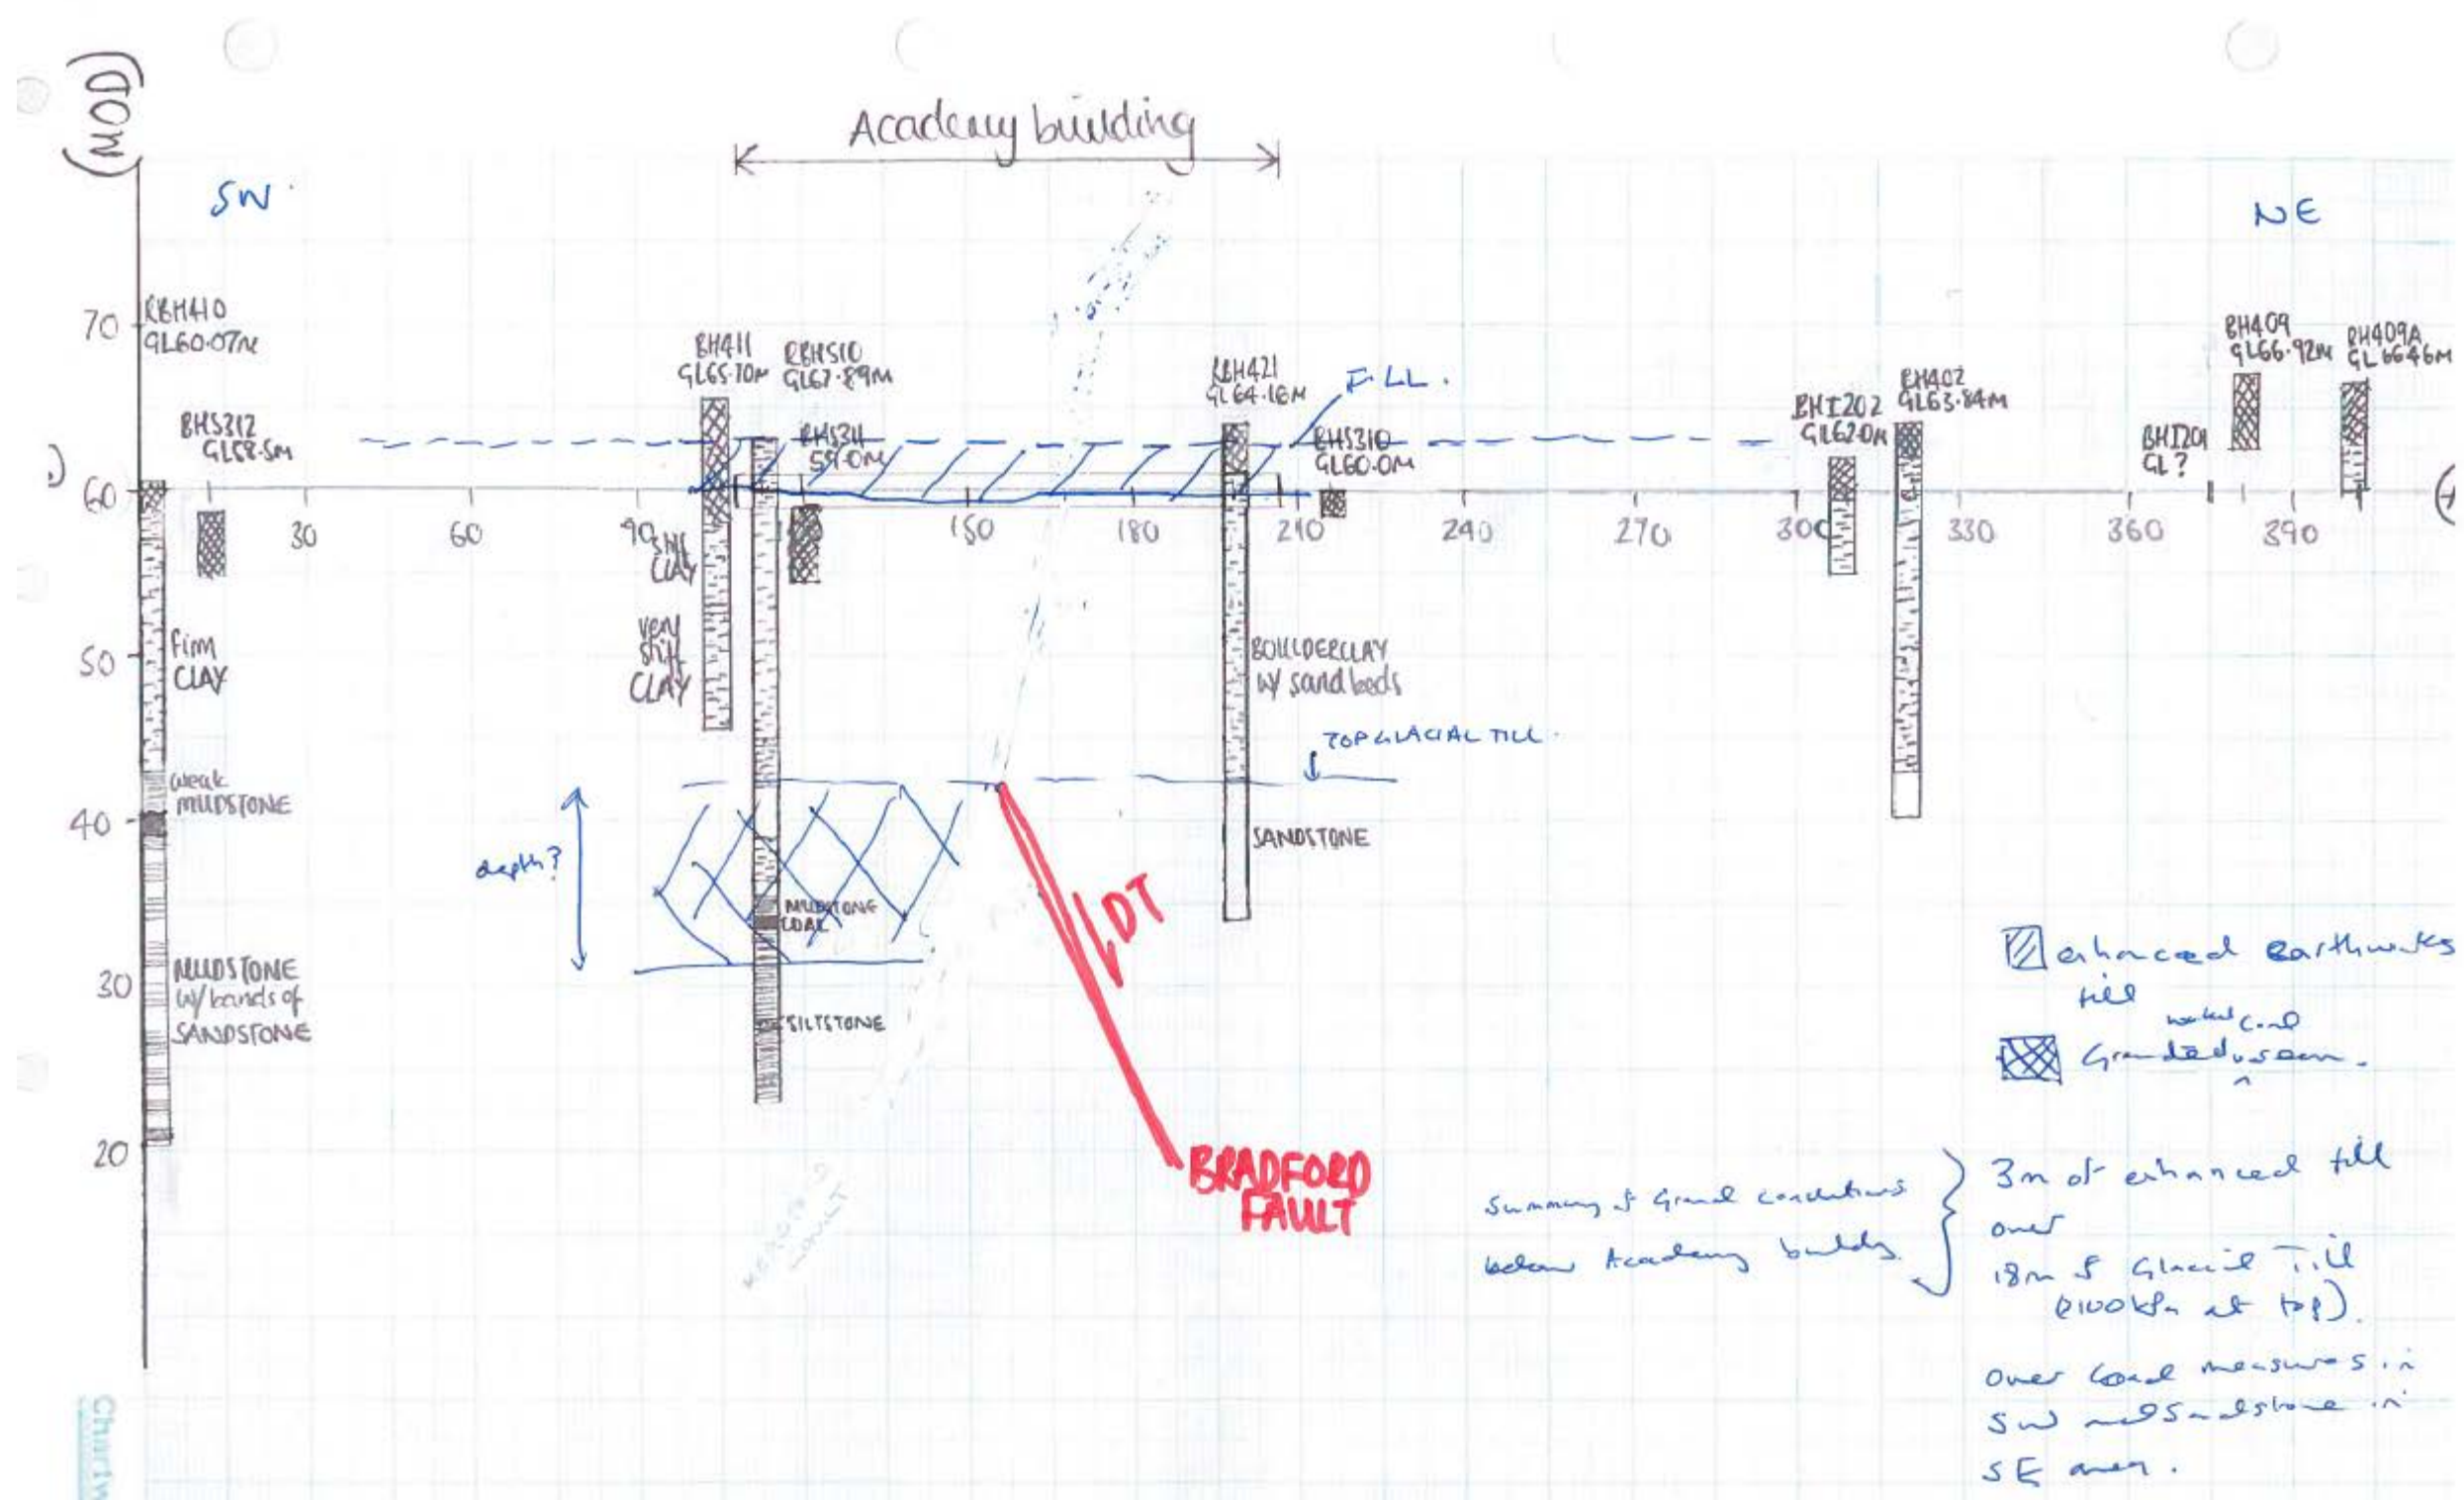
Figure 6 Indicative Geological Cross Section through Academy Building (Section looking to the North West i.e. Section line SW to NE)

Cross-sections under each building area are shown in **Figure 6-Figure 9** below, based on existing borehole data from within around 20m of the line bisecting the building. It should be noted that the proposed Laundry Centre in the south of the CTF (Figure 9) has now been relocated away from the CTF.

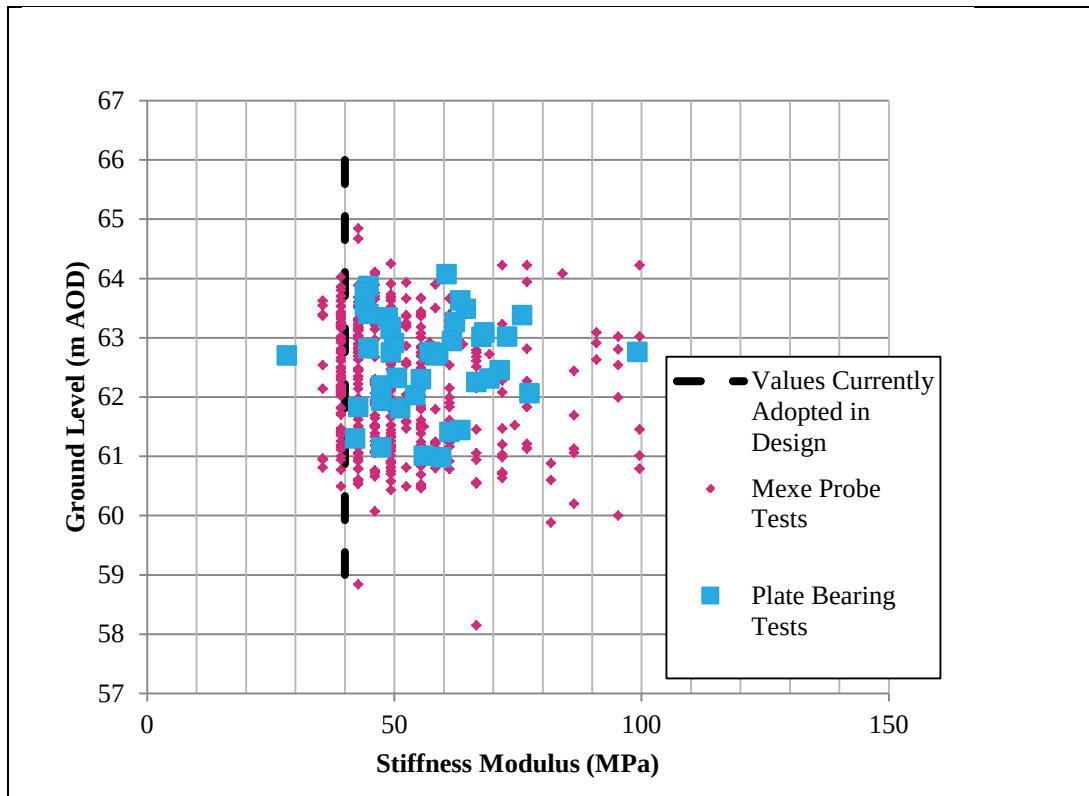
**Figure 10 Assessment of Stiffness Modulus  $E_u$  for General Engineered Fill below Energy Centre based on field tests.**

The results from the field tests have been used to assess values for Stiffness Modulus (ratio of applied stress to induced strain) based on correlations between E and CBR published in IAN 73/06, Rev 1 (Section 5.11 of Interim Advice Note 73/06, DfT Highways Agency, 2009) i.e.  $E = 17.6 (CBR)^{0.64}$  MPa. E is considered to be short term based on the tests used in its determination and the general cohesive nature of material encountered. Results are presented for the areas of general engineered fill tested beneath the Energy Centre and former Laundry Building locations/vicinity (based on panel ID locations) in **Figure 10** and **Figure 11**.

The results show results typically in a range for Eu of 40-60MPa for both locations.

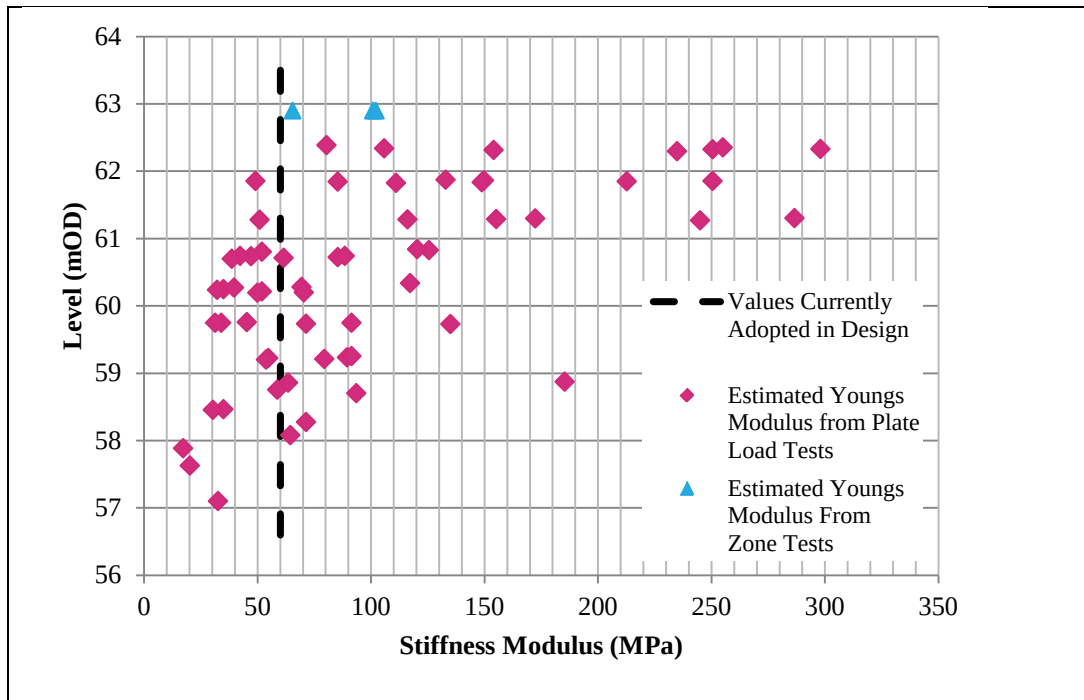
**Figure 12 Assessment of Stiffness Modulus E' for Enhanced Engineered Fill below Elite Building from field tests**

The results for interpretation of in situ testing are presented in **Figure 12** and **Figure 13**

Results show  $E'$  typically in a range of 50-100MPa for the ‘enhanced’ engineered fill with more reliable load testing at the Elite building showing  $E' > 75$ MPa. The lower values for  $E'$  may be influenced by the depth of testing as results at depths closer to top of base of ‘enhanced’ engineered fill appear to show lower stiffness than those closer to the final formation level. This should be considered further when considering formation level of foundations and slabs in design.

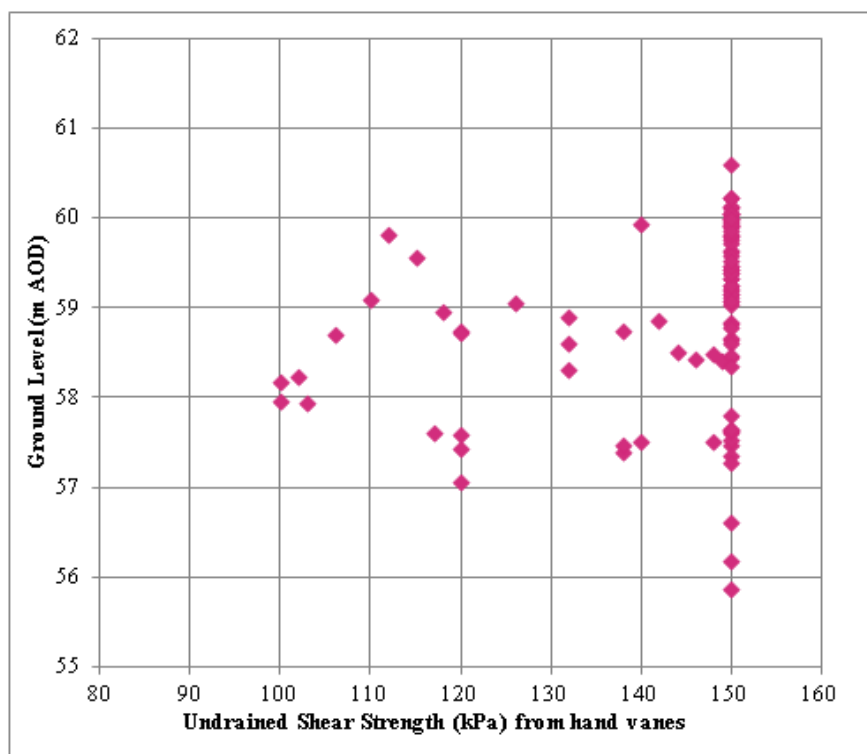
**Figure 14 Undrained Shear Strength ( $C_u$  in kPa) at top of Glacial Till (rolled base of excavation in enhanced earthworks area)**

Validation reports for the enhanced earthworks and a benching trial undertaken to inform the earthworks approach included strength testing in the top of formation of Till. The results of hand vane tests show an undrained shear strength in excess of 100kPa and frequently in excess of 150kPa (assumed to be the test limit of the apparatus) as shown in **Figure 14**.

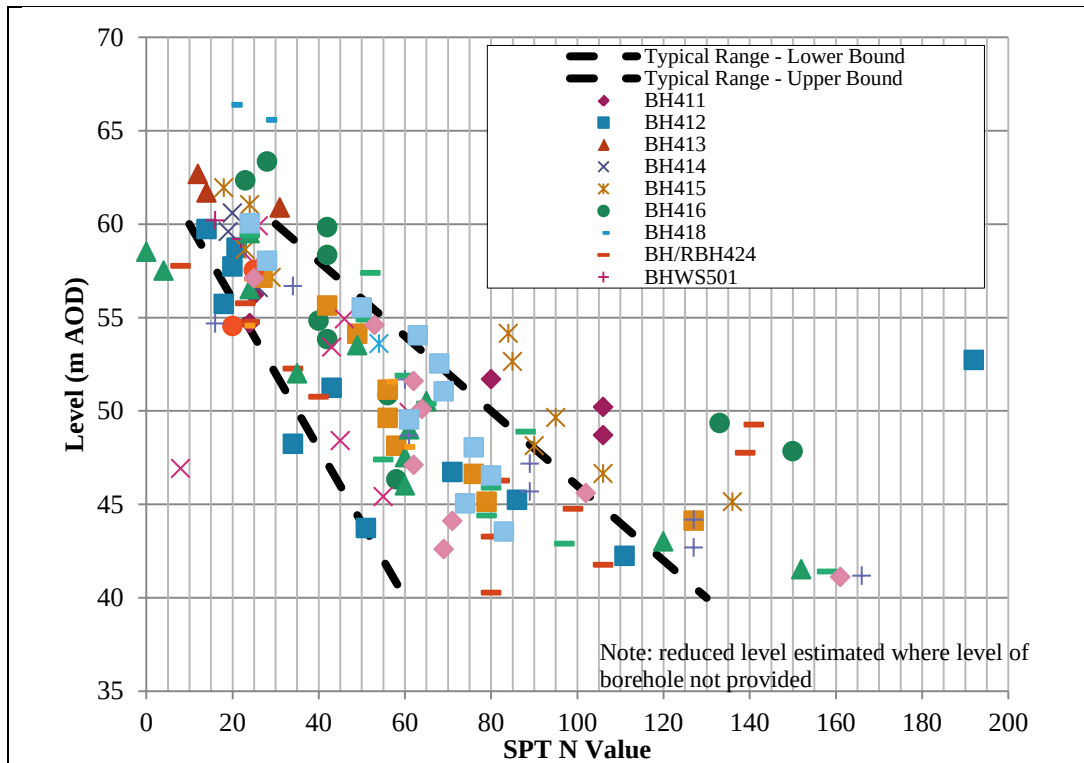
**Figure 15 Site wide SPT vs. Reduced Level Plot for Glacial Till**

In addition, an assessment has been made of the strength of the Glacial Till using the results of site wide Standard Penetration Tests (SPTs) from the WYG investigation and other historical ground investigations as shown in **Figure 15**.

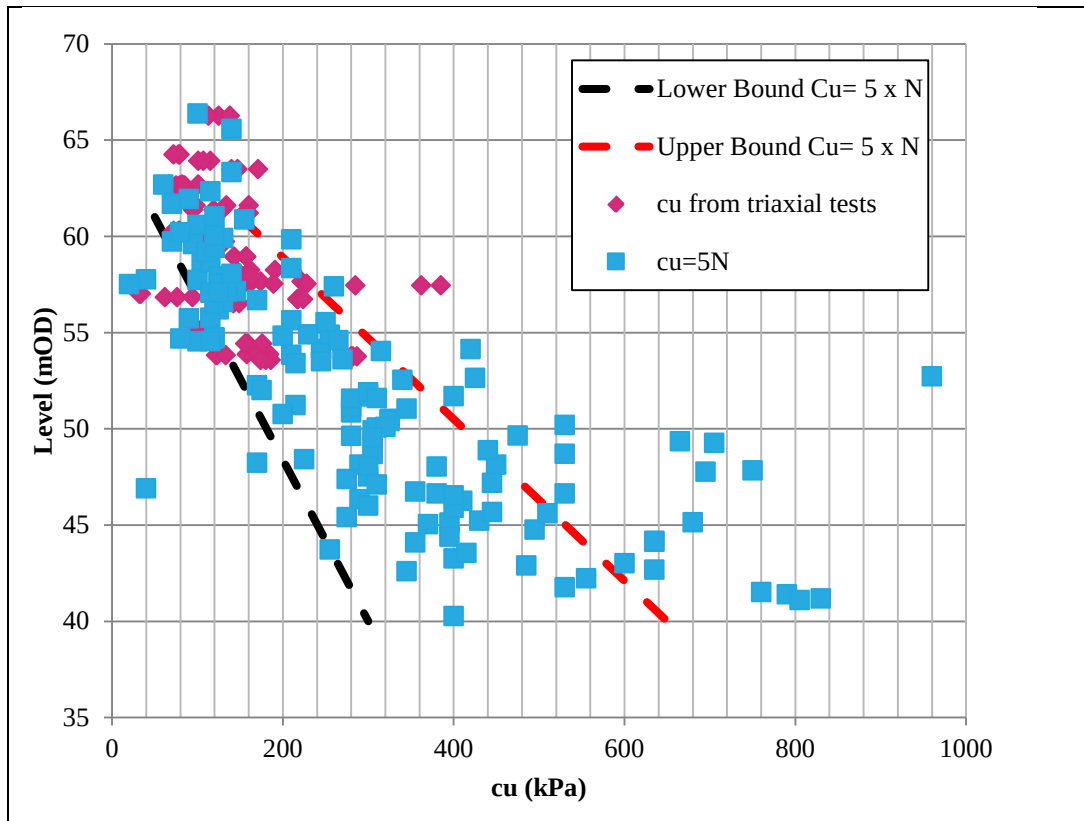
**Figure 16 Undrained shear strength,  $c_u$  vs. Reduced Level from site wide results**

A plot of the triaxial test results of  $c_u$ , along with  $c_u$  values derived from the relationship  $c_u = 5 \times \text{SPT 'N'}$  are shown in **Figure 16**.

The shear strength derived from SPT tests appears to be comparable with the triaxial results.

The shear strength of the Glacial Till increases significantly with depth. For the settlement prediction model a generally lower bound range of shear strengths has been considered, with strength of 100kPa at the base of the placed fill, increasing linearly with depth to 300kPa at rockhead.

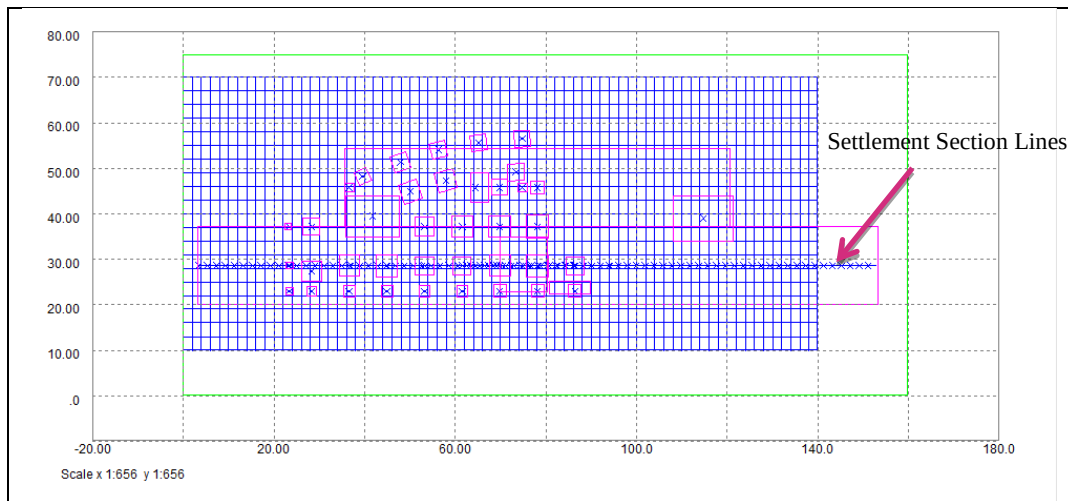
**Figure 18: Academy Building PDisp Model Layout (southern half pads considered only)**

The model plan layouts are shown in **Figure 18** and **Figure 24** for information and orientation for the results contour plans shown in **Figure 19** to **Figure 23** and **Figure 25** to **Figure 29**.

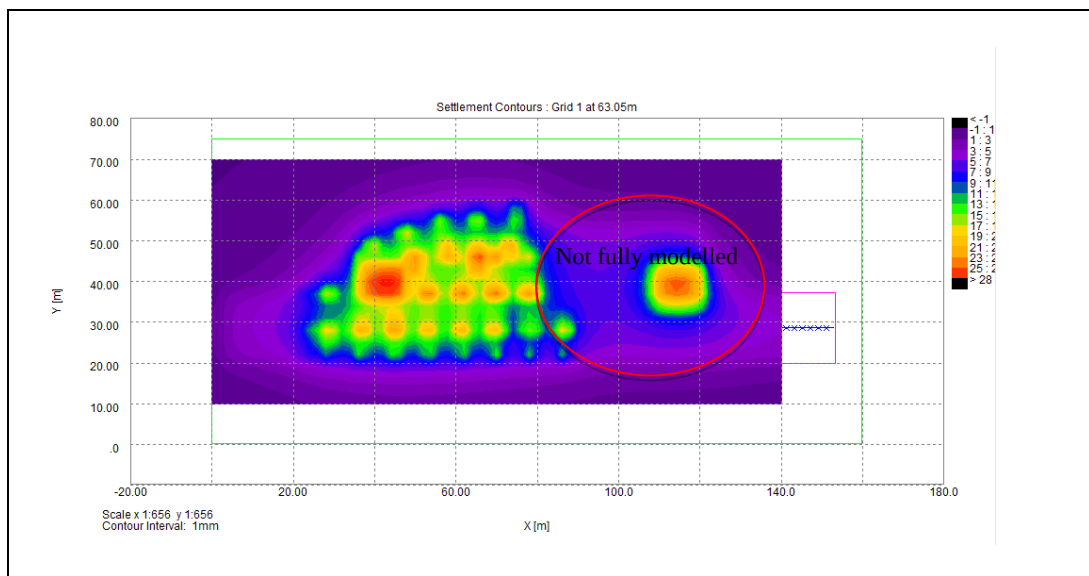
**Figure 19 Run 1 Academy Building Settlement Contours at 63.05mOD  
Ground Floor Slab Formation –case: pool empty, DL + ave. LL for core pads**

**Note: Southern half representative ONLY, based on lower bound E' values**

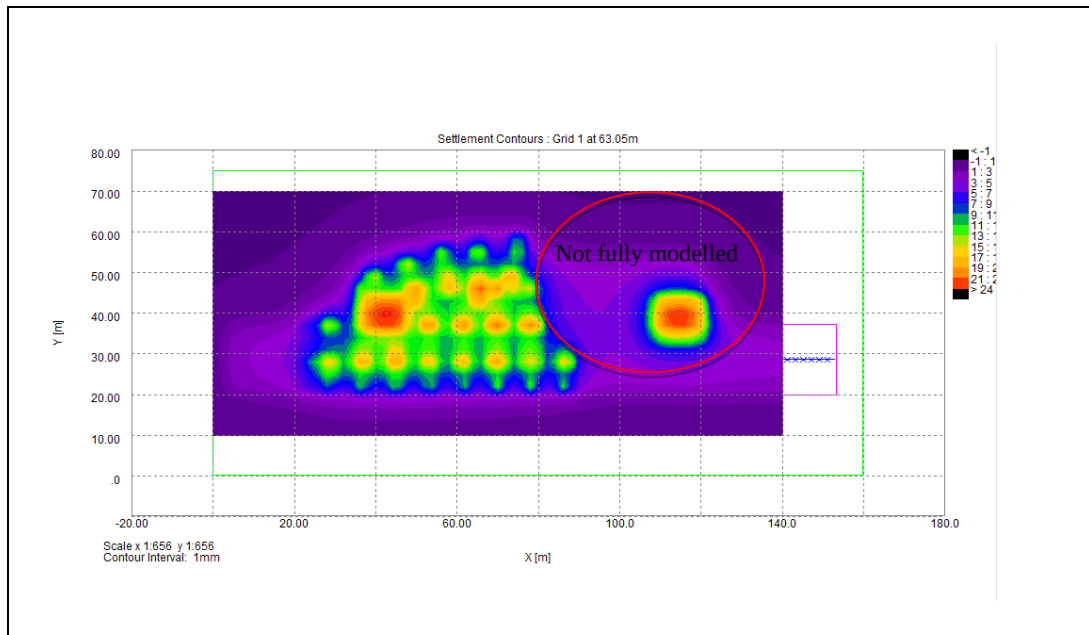
**Figure 21 Run 2 Academy Building Settlement Contours at 63.05mOD  
Ground Floor Slab Formation –case: pool full, DL + ave. LL for core pads**

**Note: Southern half representative ONLY, based on lower bound E' values**

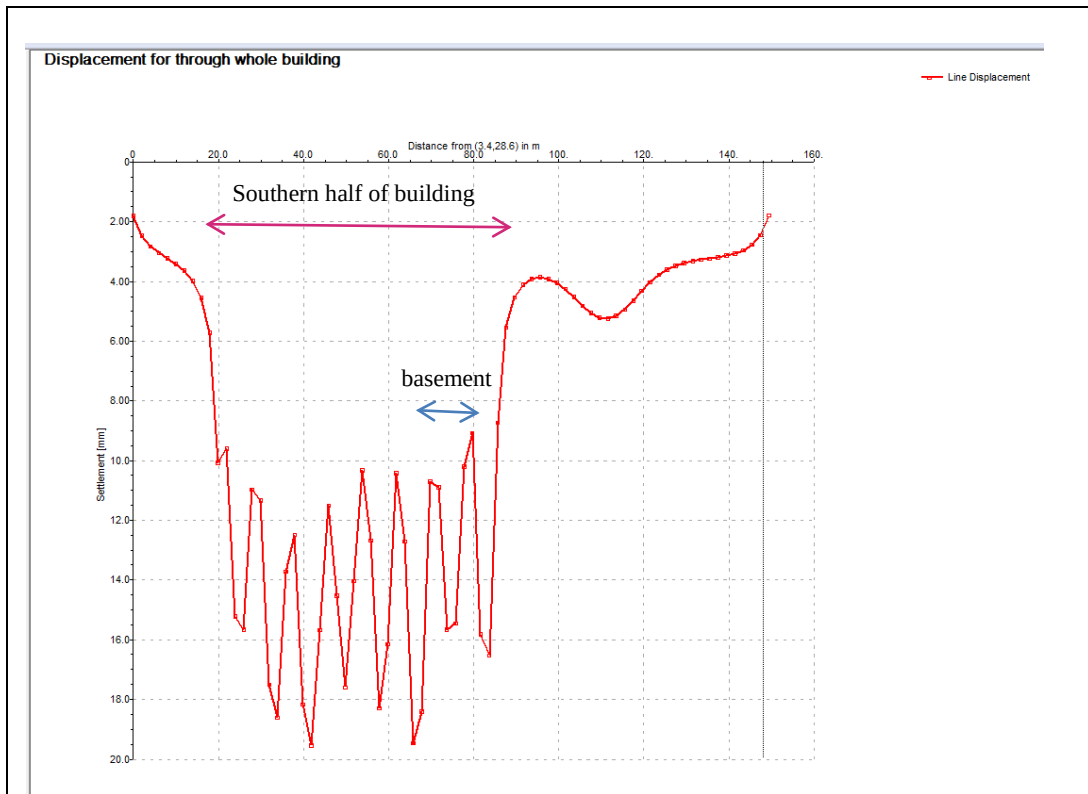
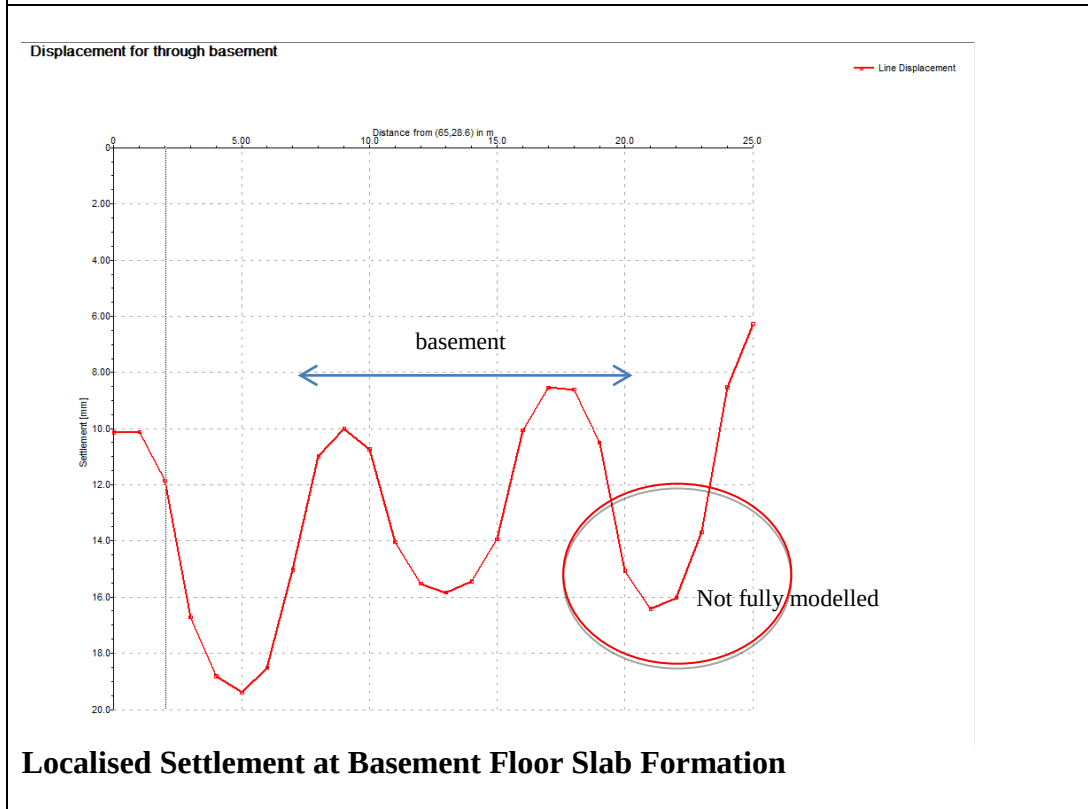
**Figure 22 Run 2 Academy Building Settlement –case: pool full, DL + ave. LL for core pads**

### Settlement at 63.05mOD Ground Floor Slab Formation

### Localised Settlement at Basement Floor Slab Formation

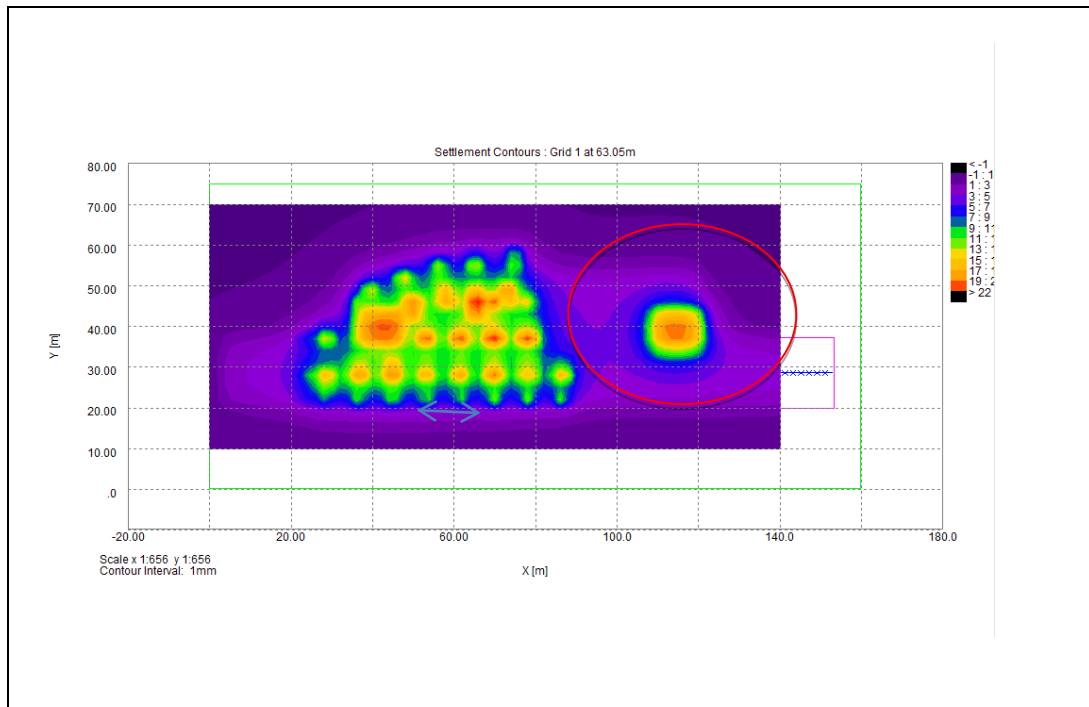
**Figure 23 Run 3 Academy Building Settlement Contours at 63.05mOD  
Ground Floor Slab Formation –case: pool full, DL only for core pads**

**Note: Southern half representative ONLY, based on lower bound E' values**

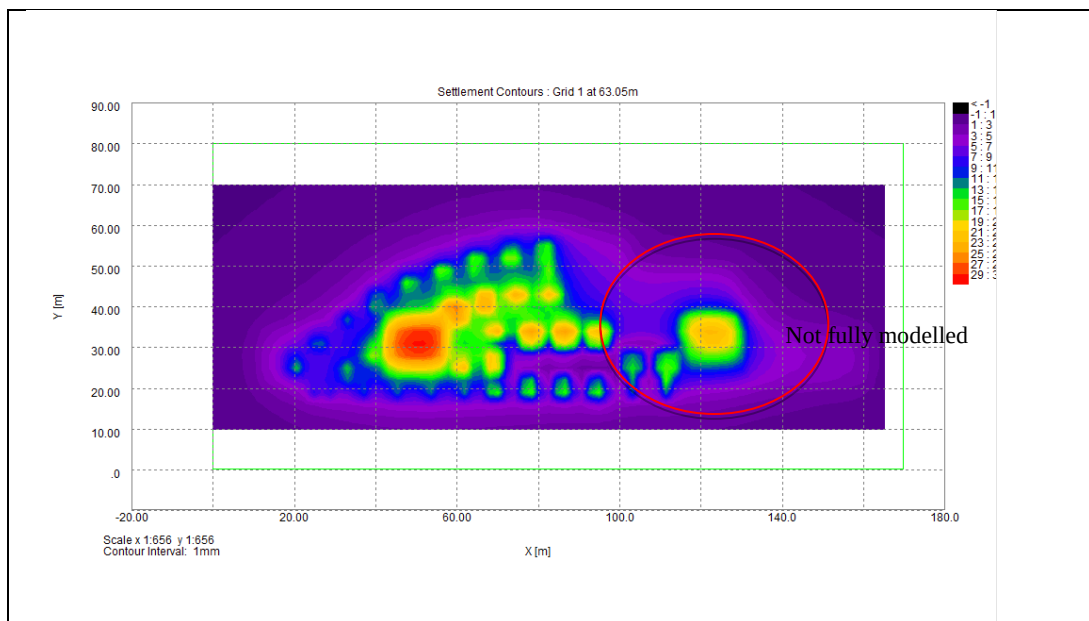
**Figure 25 Run 1 Elite Building Settlement Contours at 63.05mOD Ground Floor Slab Formation –case: pool empty, DL + ave. LL for core pads**

**Note:** Southern half representative ONLY, based on lower bound E' values

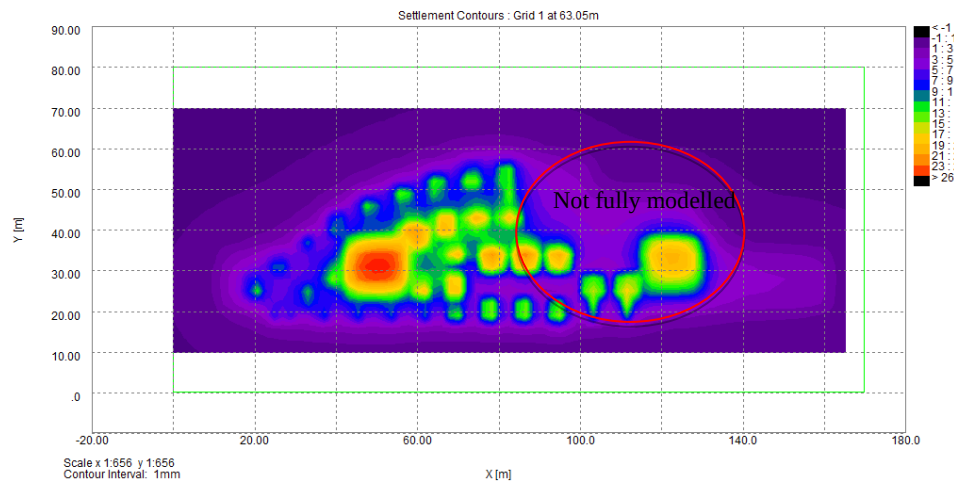
**Figure 27 Run 2 Elite Building Settlement Contours at 63.05mOD Ground Floor Slab Formation –case: pool full, DL + ave. LL for core pads**

**Note: Southern half representative ONLY, based on lower bound E' values**

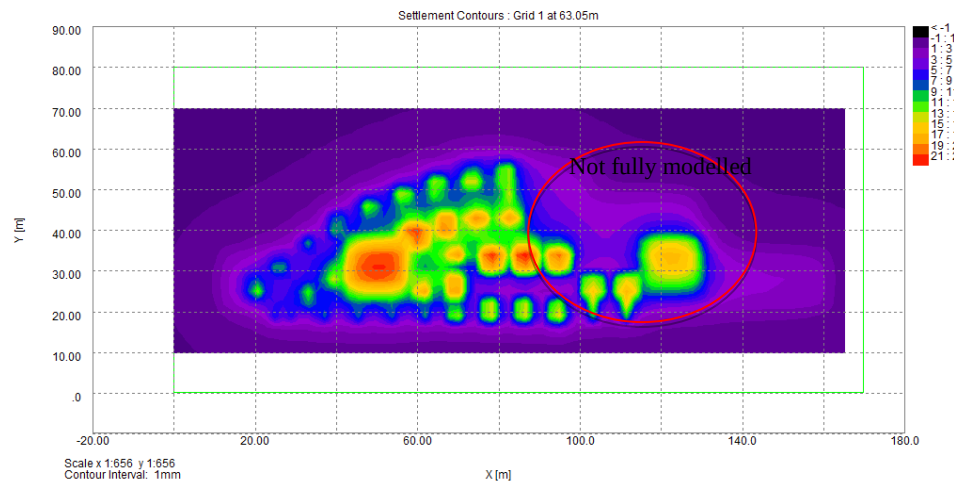
**Figure 29 Run 3 Elite Building Settlement Contours at 63.05mOD Ground Floor Slab Formation –case: pool full, DL only for core pads**

**Note:** Southern half representative ONLY, based on lower bound E' values

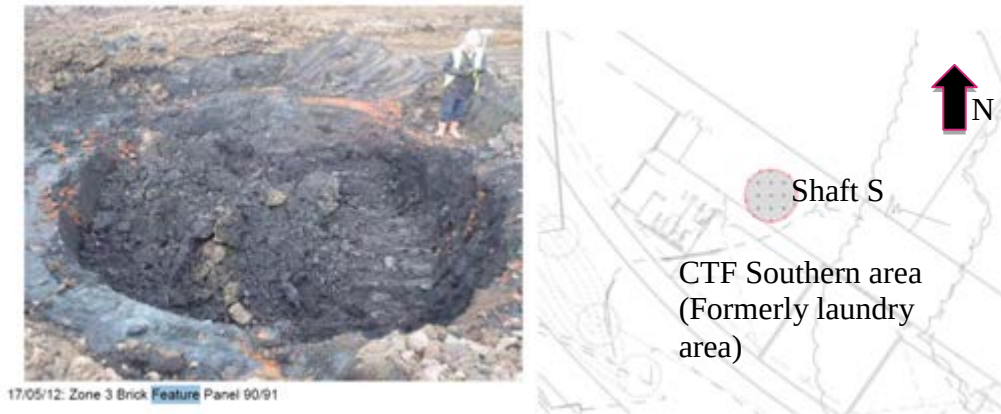
**Figure 30: Shaft Feature S**

The proposed foundation solution includes foundation groups close to a 6m diameter shaft, “feature S”, in the southern CTF area (formerly the Laundry Building). The feature and potential impact on design are discussed in more detail below.

As part of these works a shaft like feature ‘Shaft S’ was identified below the former site of the proposed Laundry Centre, in the south west of the CTF. The records of this are presented in Appendix B of the BWB validation report for mine workings. The feature is identified on one of the photographs within the report and located as indicated in Figure 29.
