**Manchester City Football  
Academy**

**Geotechnical Design Report**

REP/226518/G001

Issue 4 | 2 May 2013

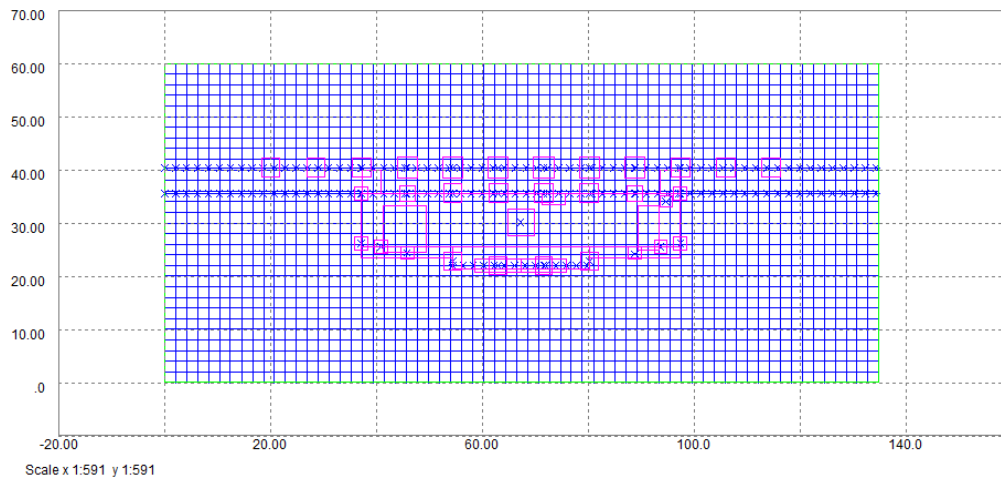
**Figure 31: Energy Centre PDISP model layout**

The input model of the Energy Centre is shown in **Figure 31**; it shows the displacement grid and lines used to monitor the displacement in under the various loading scenarios.

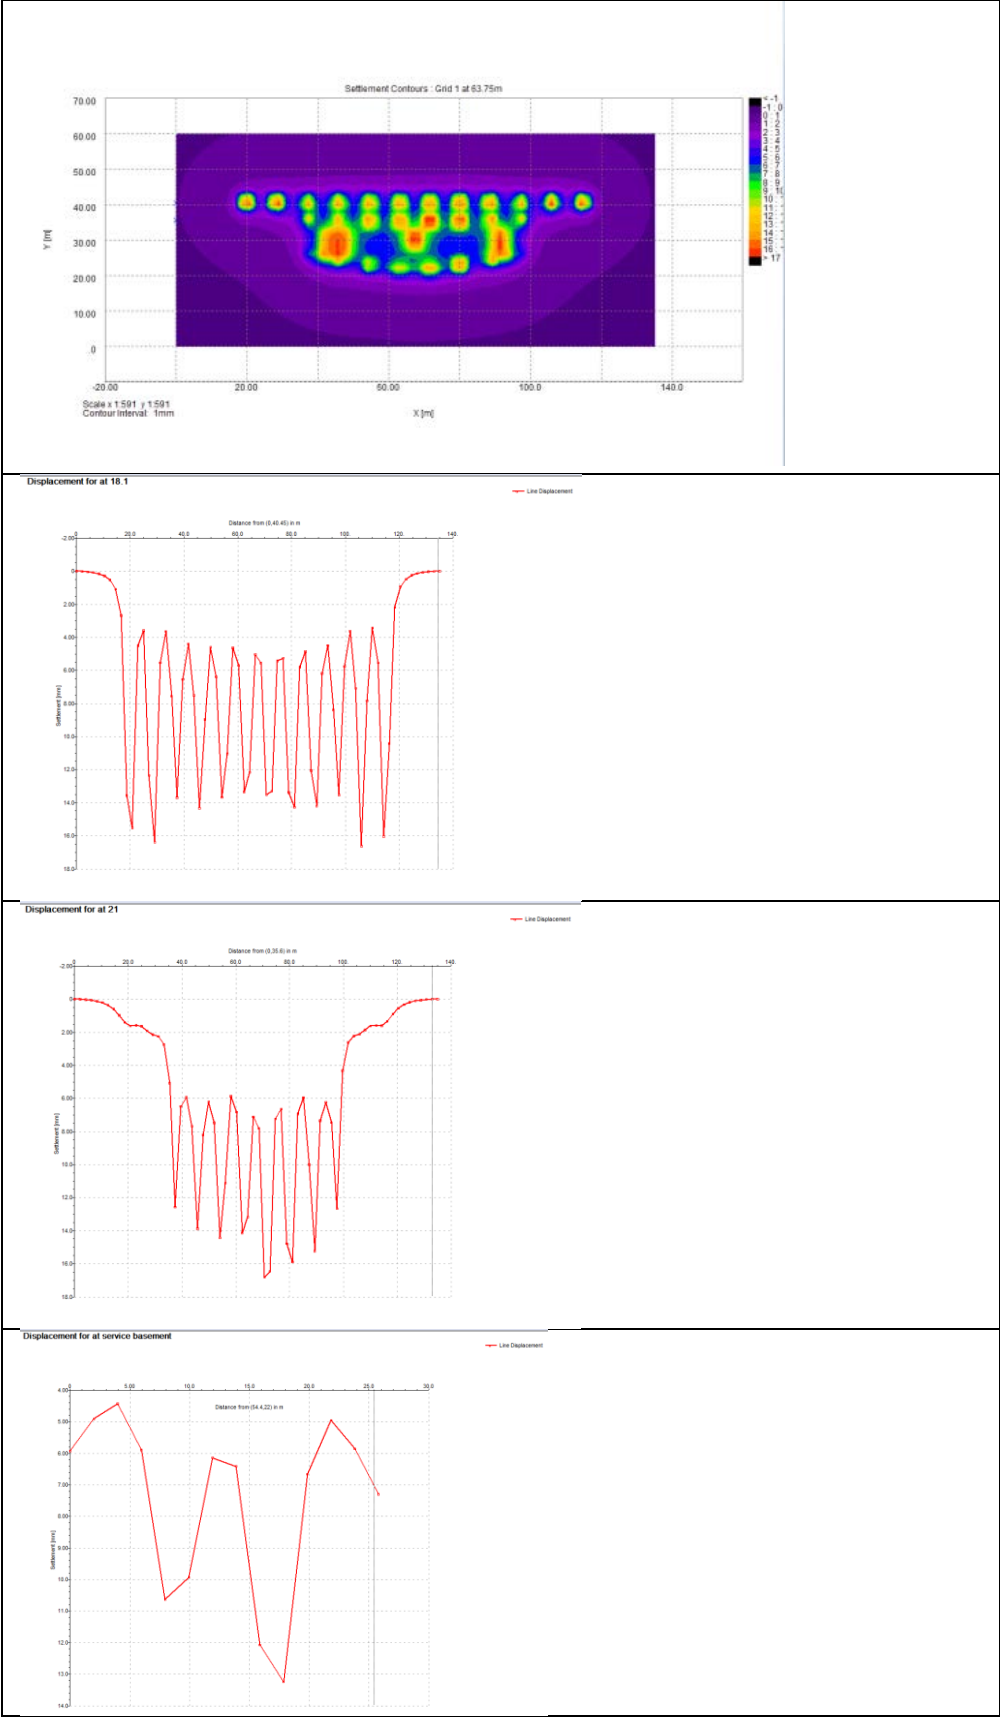
Figure 32: PDISP Run 1 outputs

Run1: Till at 60.5m

| Energy Centre | | | | |
|---|---|---|---|---|
| Run 1 | Pads subject to dead+live+self-weight+pad thickening<br>Slab subject to DL+LL<br>Low Glacial Till level at 60.5mOD<br>Chimney subject to maximum load (90 kPa). | Expected most common scenario.<br>Low glacial till level is a conservative scenario as the assumed stiffness of till is greater than the engineered fill. | Range of settlement = 5-16mm<br>Maximum differential settlement between service basement and slab approx 8mm<br>Contour plan and displacement plots are shown in <b>Figure 31</b> . | Water tanks<br>Chimney<br>Pad 1450 |

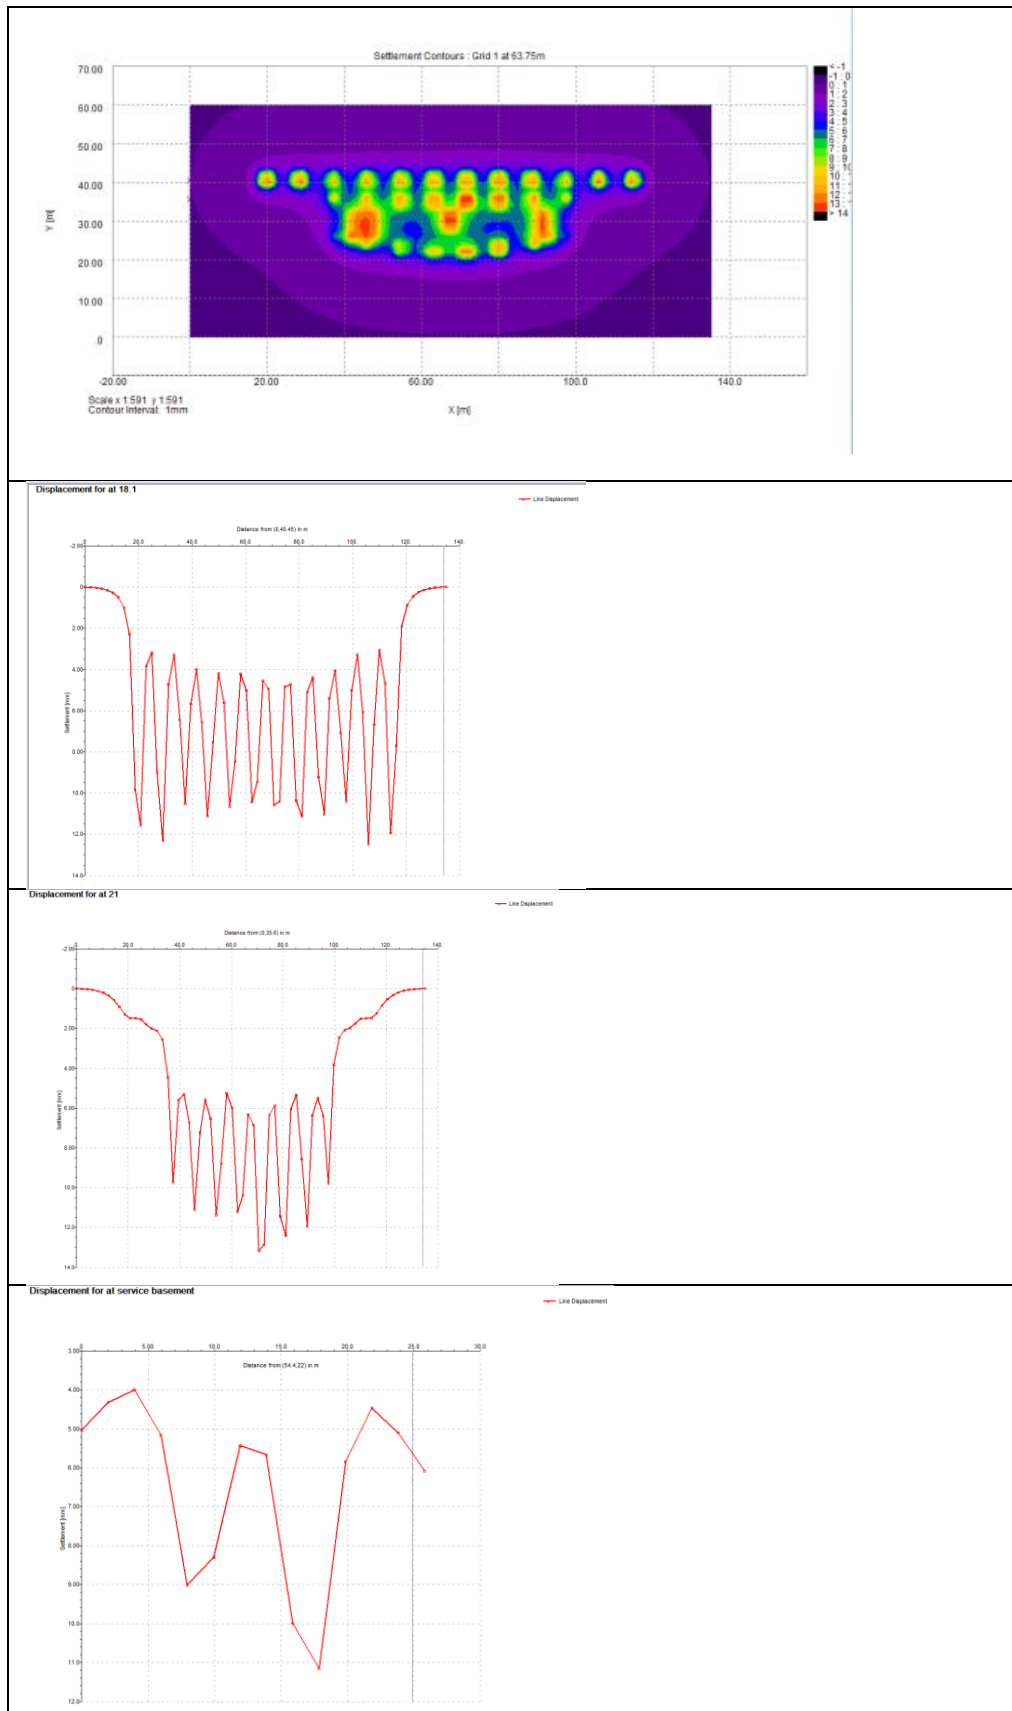
Figure 33: PDISP Run 2 outputs

## Run 2: till at 63.0m

| Energy Centre | | | | |
|---|---|---|---|---|
| Run 2 | Pads subject to dead+live+self-weight+pad thickening<br>Slab subject to DL+LL<br>High Glacial Till level at 63.0mOD<br>Chimney subject to maximum load. | Sensitivity analysis for range of till levels. High till level assumed. | Range of settlement = 4-13mm<br>Maximum differential settlement between service basement and slab = approx 7mm<br>Contour plan and displacement plots are shown in <b>Figure 32</b> . | Water tanks<br>Chimney<br>Pad 1450 |

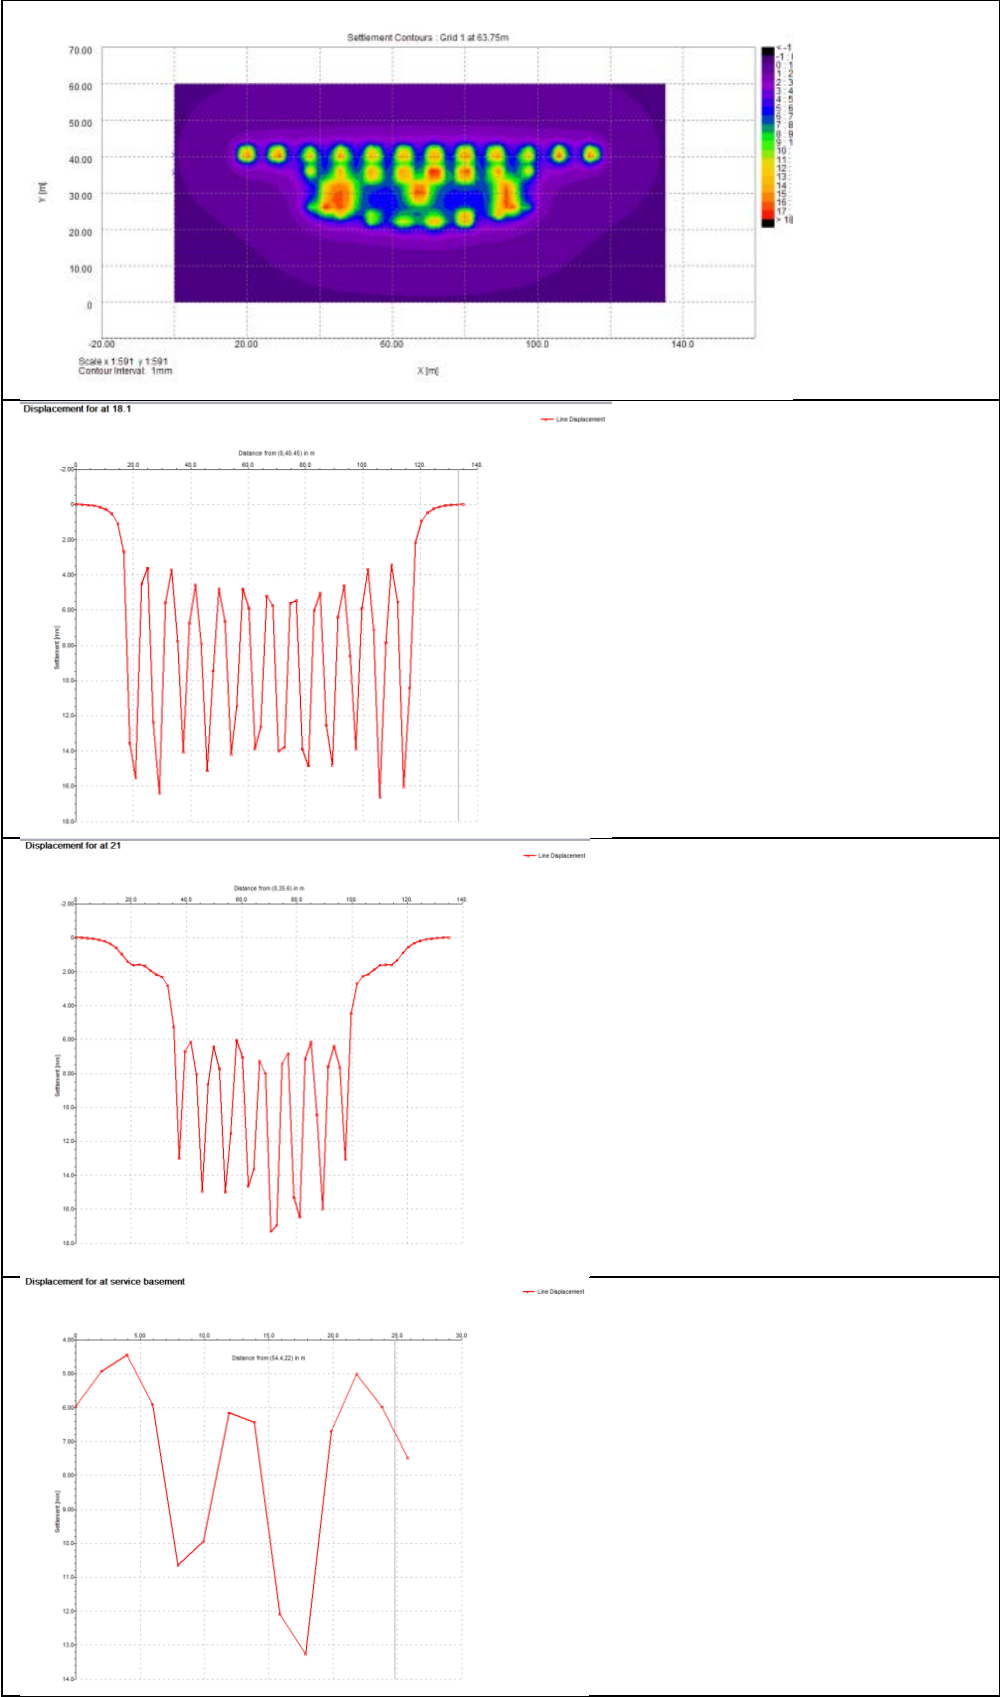
Figure 34: PDISP Run 3 outputs

Run 3: including wind loads

| | Chimney subject to maximum load. | | Contour plan and displacement plots are shown in <b>Figure 33.</b> | |

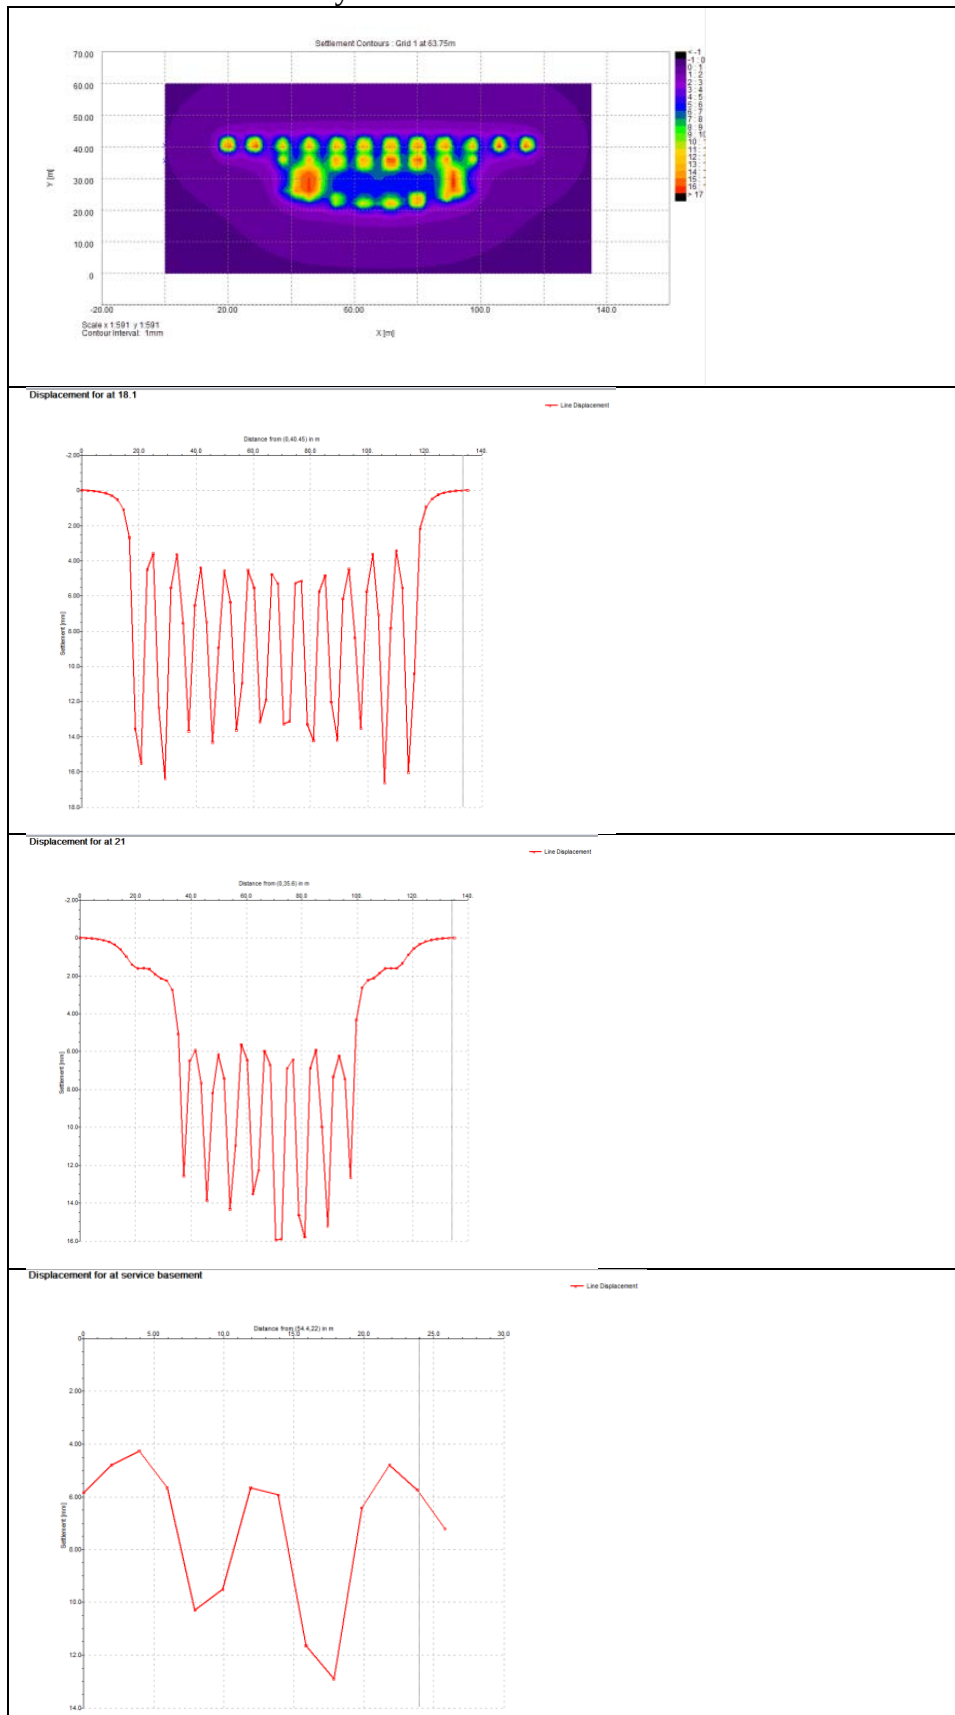
**Figure 35: PDISP Run 4 outputs**

## Run 4 minimum chimney load of 7.45 kPa

| Run 4 | Pads subject to dead+live+self-weight+pad thickening<br>Slab subject to DL+LL<br>Low Till level at 60.5mOD<br>Chimney subject to DL+LL | Sensitivity analysis for chimney load, not including wind load | Range of settlement =5-16mm<br>Maximum differential settlement between service basement and slab =approx 8mm<br>Contour plan and displacement plots are shown in <b>Figure 34.</b> | Water tanks<br>Pad 1450 |

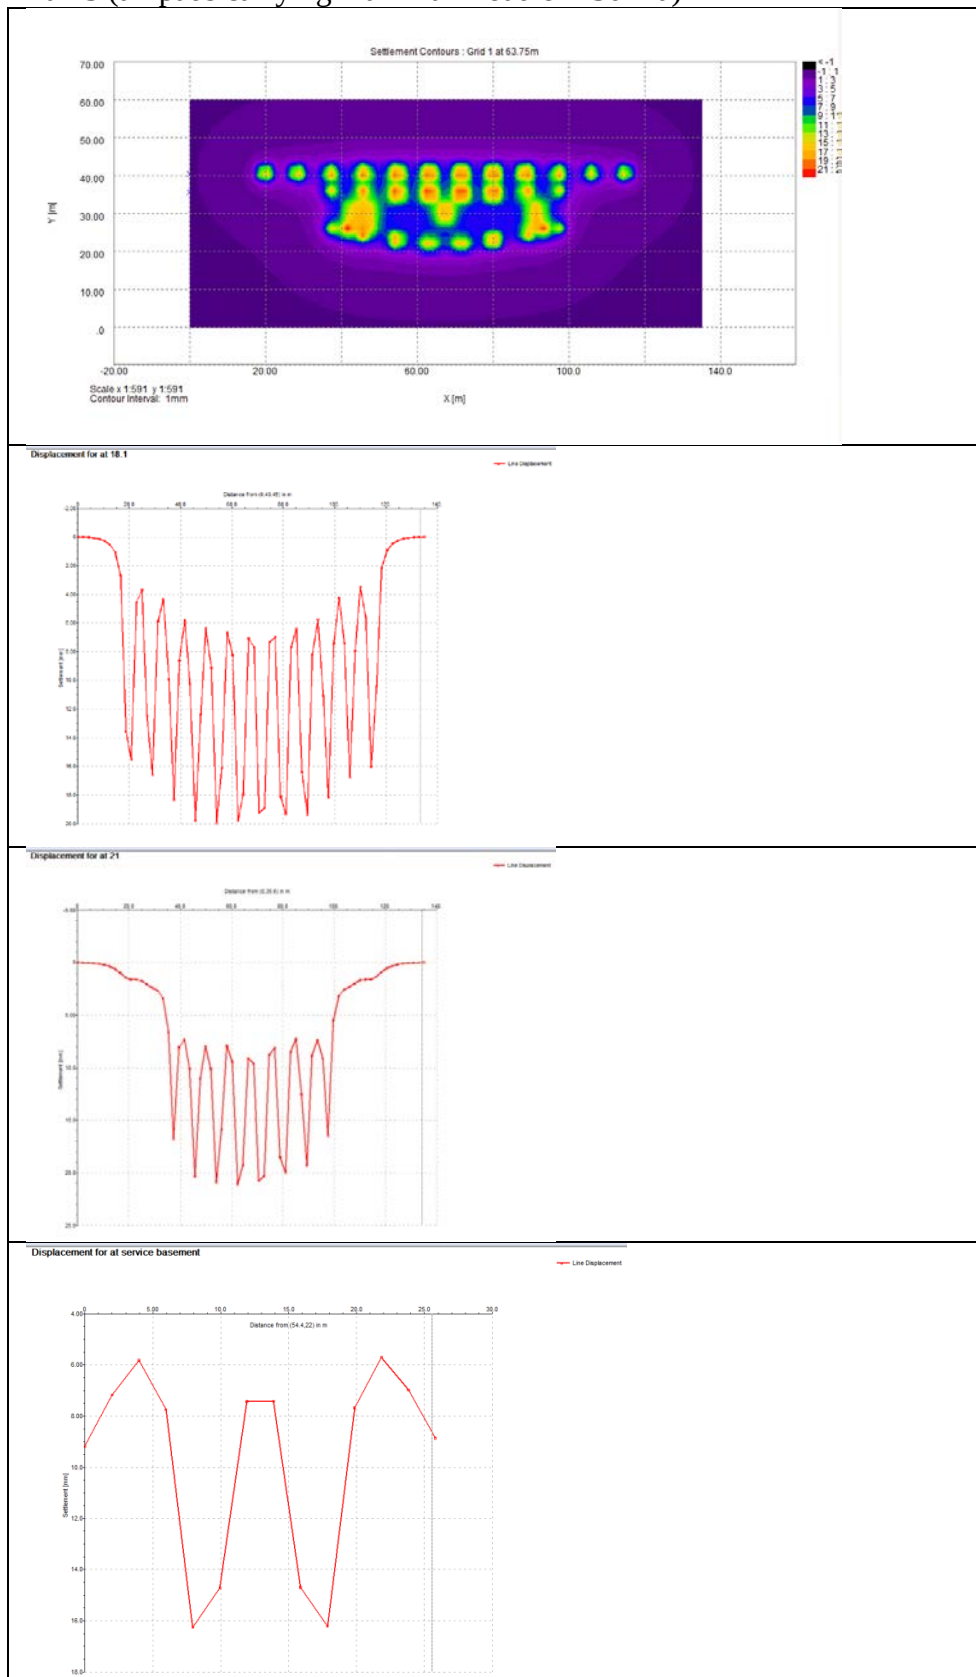
Figure 36: PDISP Run 5 outputs

## Run 5 (all pads carrying maximum load of 150kPa)

| Run 5 | Pads subject to the maximum load of 150kPa<br>Slab subject to DL+LL<br>Low Till level at 60.5mOD<br>Chimney subject to maximum load | Sensitivity analysis for pads under worst case loading | Range of settlement = 5-21mm<br>Maximum differential settlement between service basement and slab = approx 10mm<br>Contour plan and displacement plots are shown in <b>Figure 35.</b> | Pad 2020<br>Pad 2010 |

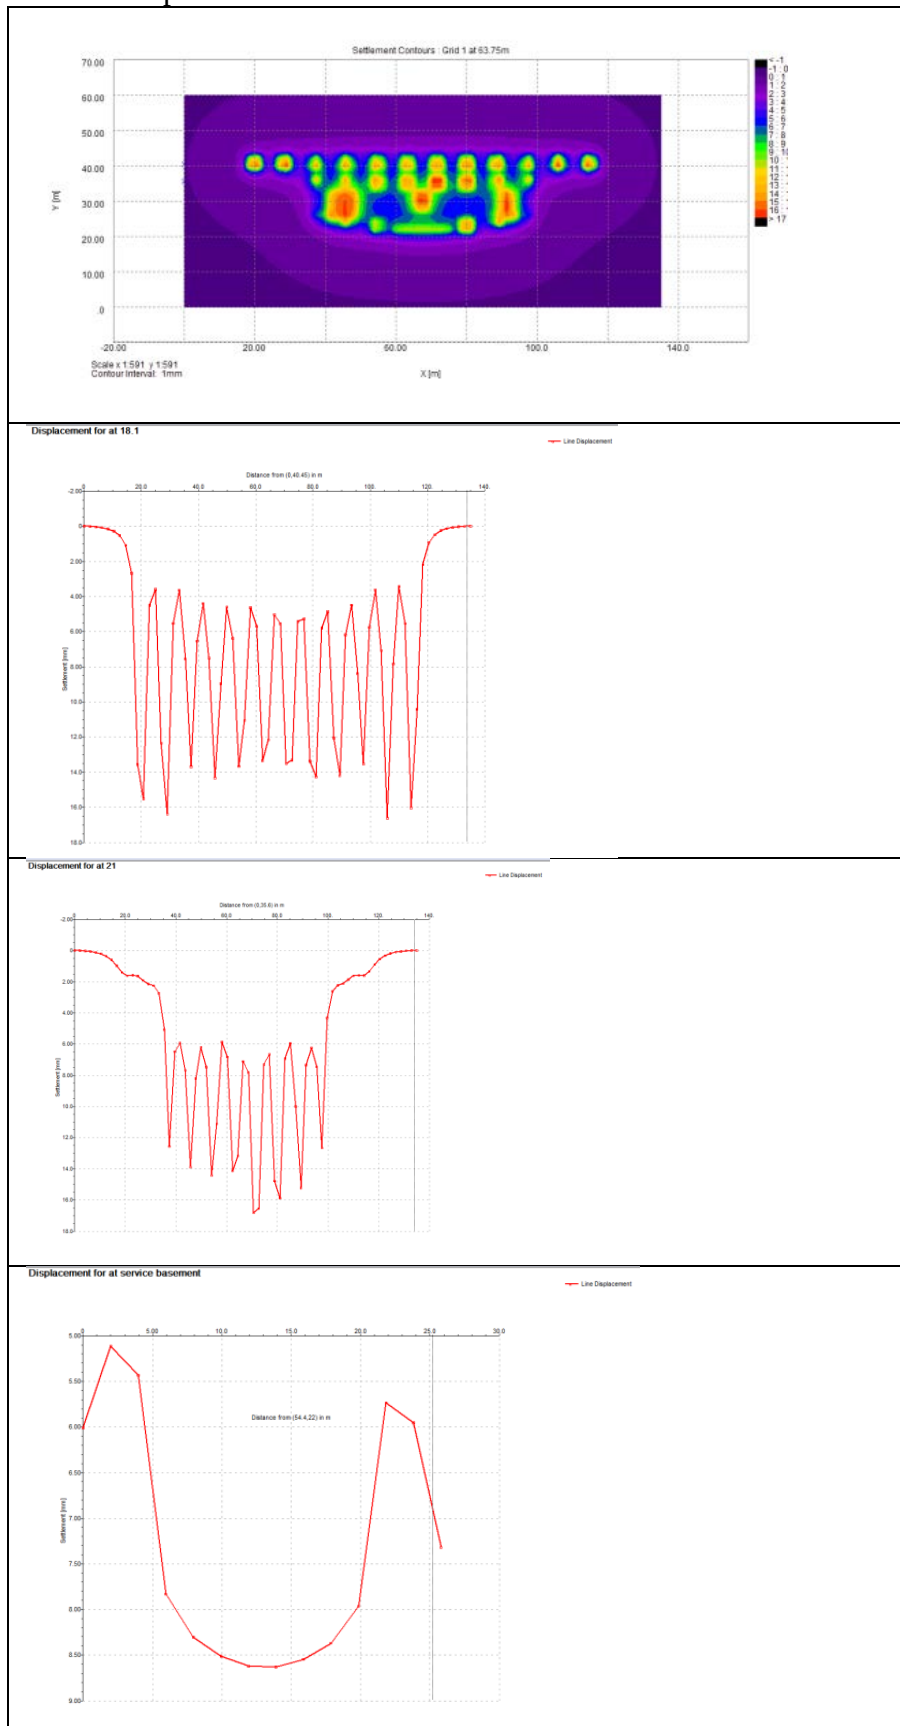
Figure 37: PDISP Run 6 outputs

## Run 6 composite basement

| Run 6 | Pads subject to dead+live+self-weight+pad thickening<br>Slab subject to DL+LL<br>Low Till level at 60.5mOD<br>Chimney subject to maximum load.<br>Basement modelled as composite foundation carrying slab and pad loads over entire area | Sensitivity analysis for basement considering it's slab and pads loads acting as one foundation load | Range of settlement = 5-16mm<br>Maximum differential settlement between service basement and slab = approx 4mm<br>Contour plan and displacement plots are shown in <b>Figure 36.</b> | Water tanks<br>Chimney<br>Pad 1450 |

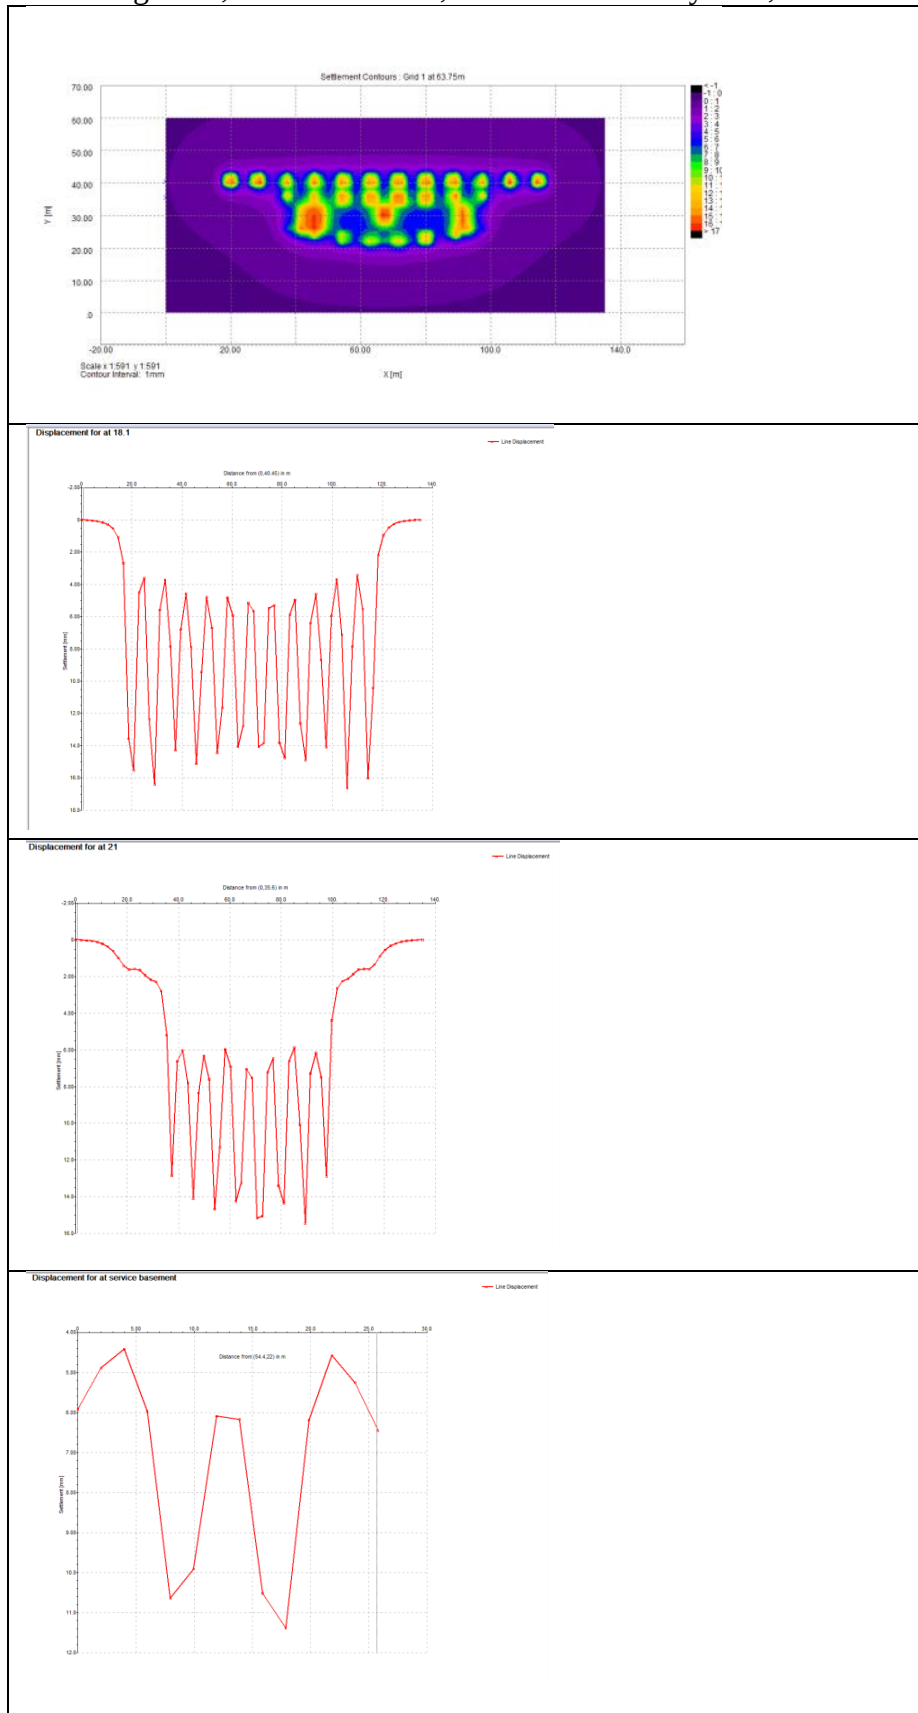
**Figure 38: PDISP Run7 outputs**

Run 7: Energy Centre PDISP results with revised structural loads : pad loads excluding wind; till at 60.5mOD; maximum chimney load;

| Run 7 | REVISED STRUCTURAL LOADS<br>Slab subject to DL+LL<br>Low Till level at 60.5mOD<br>Chimney subject to maximum load | Checking effects of change in structural loads | Range of settlement =5-16mm<br>Maximum differential settlement between service basement and slab = approx 7mm<br>Contour plan and displacement plots are shown in <b>Figure 37.</b> | |

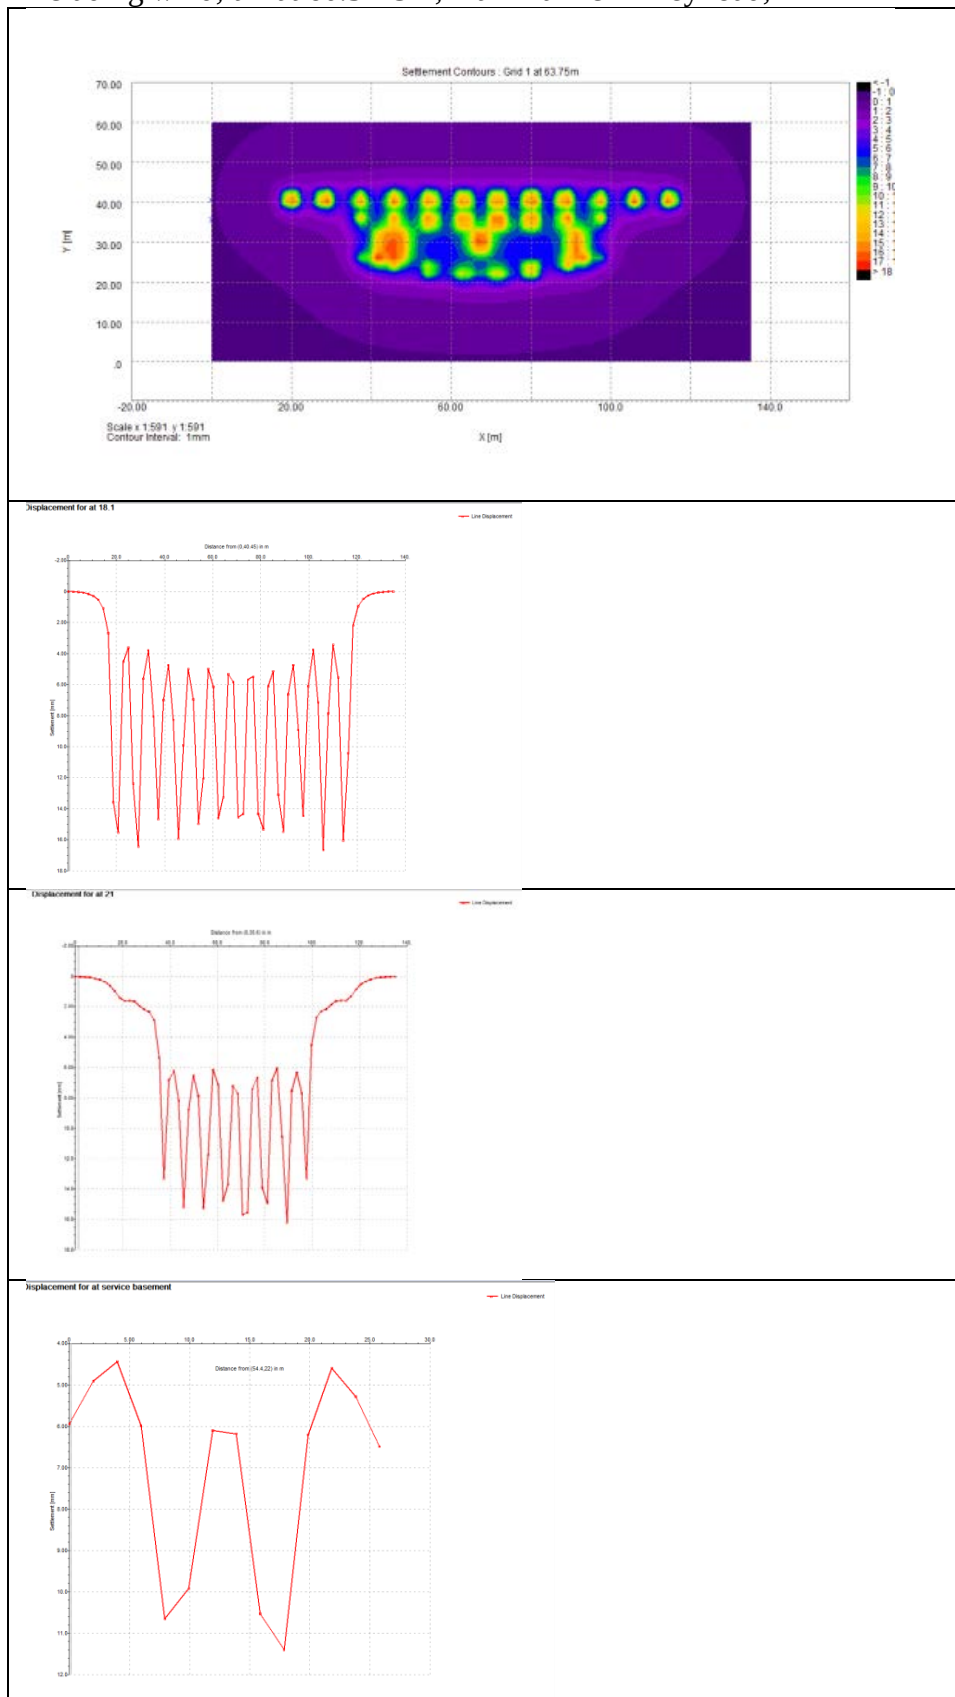
**Figure 39: PDISP Run 8 outputs**

Run 8: Energy Centre PDISP results with revised structural loads: pad loads including wind; till at 60.5mOD; maximum chimney load;

| | Slab subject to DL+LL<br>Low Till level at 60.5mOD<br>Chimney subject to maximum load. | | between service basement and slab =<br>approx 7mm<br>Contour plan and displacement plots<br>are shown in <b>Figure 38</b> . | |

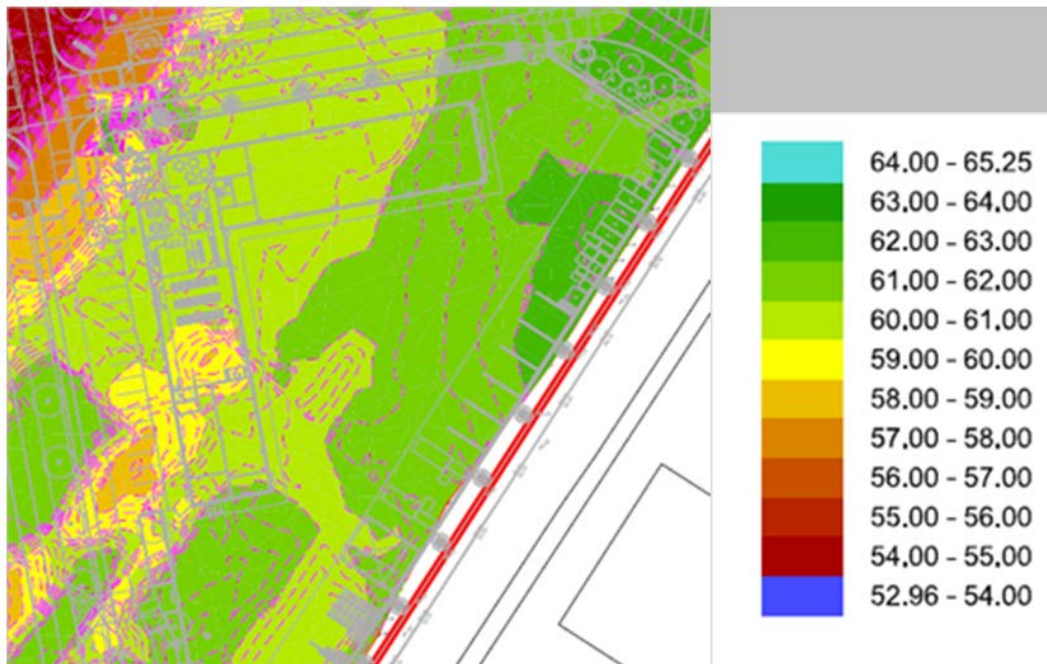
**Figure 40 Base of CRW excavation (mOD)**

The reduced levels of the base of this excavation from the Buckingham CRW works from the validation report (presumably corresponding to the top of the Glacial Till) is between c. 58 and 61.5mOD under the proposed building (see Figure 39 below).

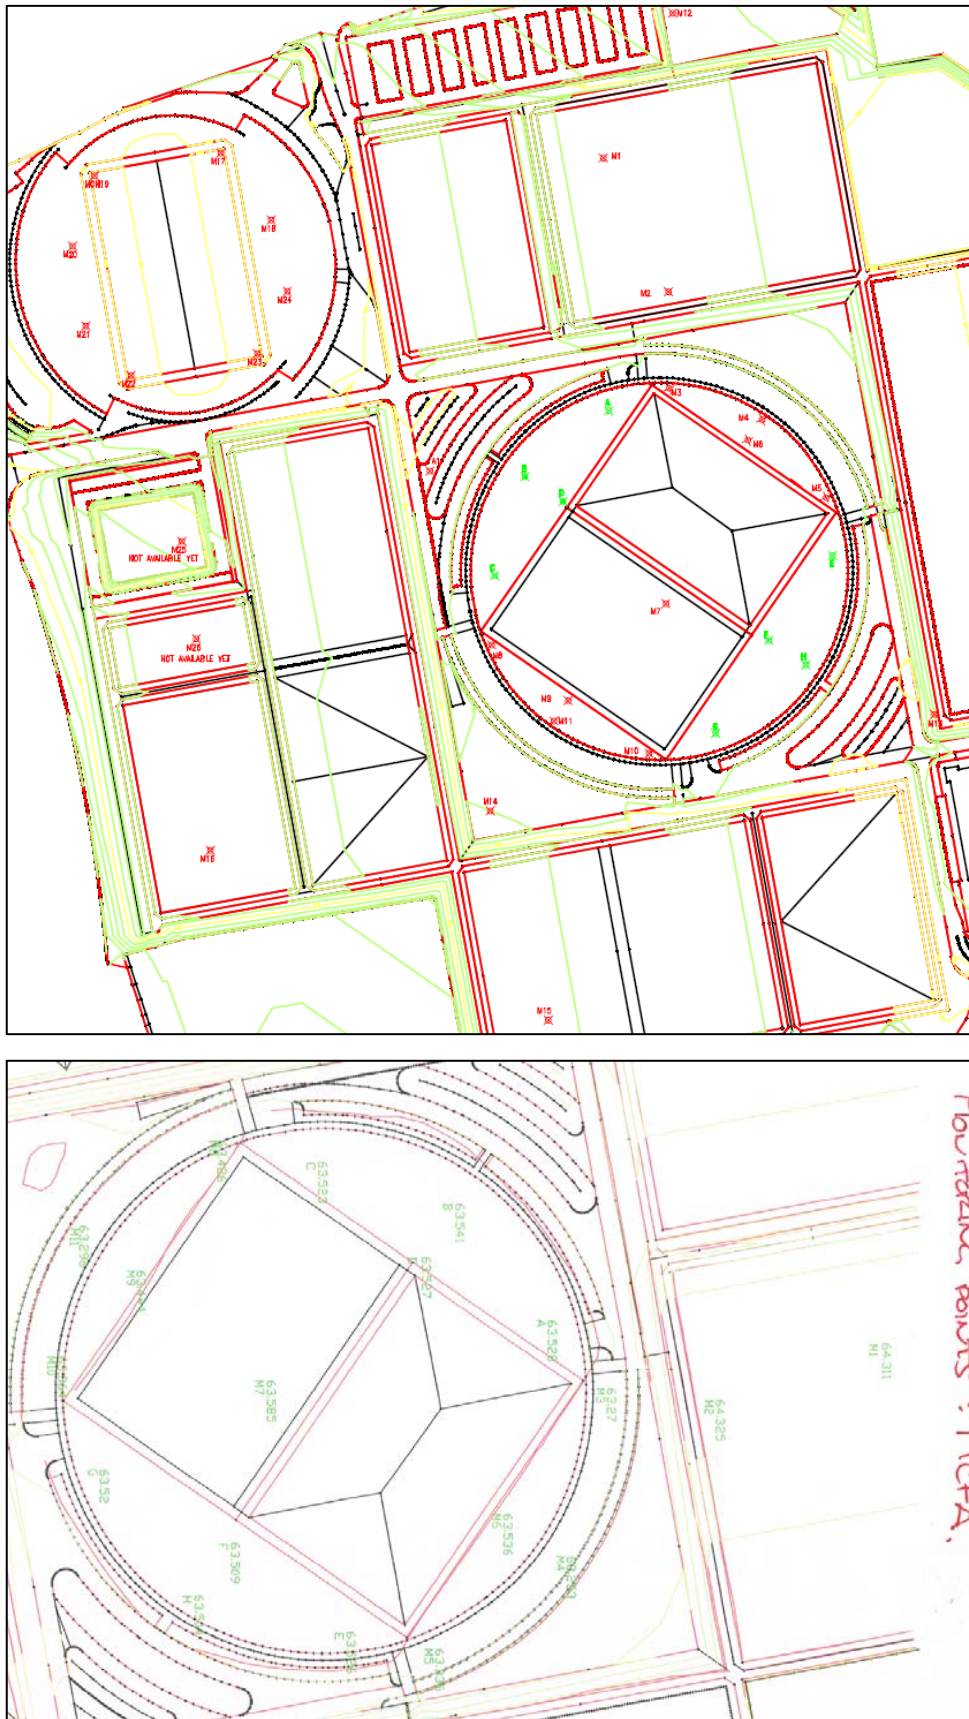
**Figure 41 Sitewide and CTF Settlement Monitoring Points**

Arup recommended that levelling of these pins was to be conducted immediately after construction of the survey station, which should be as soon as possible after placement of the fill, then on a frequency of twice per week initially for a period of 1 month. Following this, Arup recommend that the frequency can be adjusted or points omitted depending on whether a measurable movement is still occurring.

The monitoring points which are currently being recorded are indicated on Figure 41 below.
