## CRIME IMPACT STATEMENT

Erection of a LIDL Foodstore (Class E) with Associated  
Car Parking & Landscaping

440 Hollinwood Avenue, Moston, Manchester

2024/0288/CIS/01

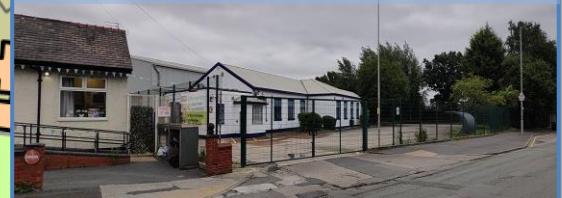
Tall, welded-wire mesh fencing and gates secure the Hollinwood Avenue boundary of the site

The site is currently developed with a large, office and industrial building, which is currently vacant. The site boundary is well defined with green paladin weld metal mesh fencing.
