## Heritage Design & Access – William Kay House

February 2025

The project has been developed by a Team with substantial knowledge and experience of refurbishment works within heritage buildings and is led by Gardiner and Theobald on behalf of the Client. Other team members include Halliday Meecham Architects, Tetratex and WML Consulting. The proposals have been developed through a heritage-led approach with an understanding of the significance and heritage of William Kay House.

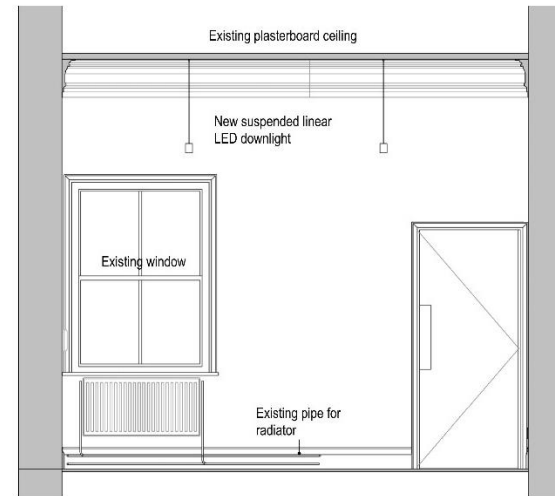
- Walls and ceilings to be painted in line with suitable heritage colourways. Colour TBC by Architect and Client

1.05 Hybrid Meeting/ Office - Elevation A

1.05 Hybrid Meeting/ Office - Elevation B

1.05 Hybrid Meeting/ Office - Elevation C

1.05 Hybrid Meeting/ Office - Elevation D

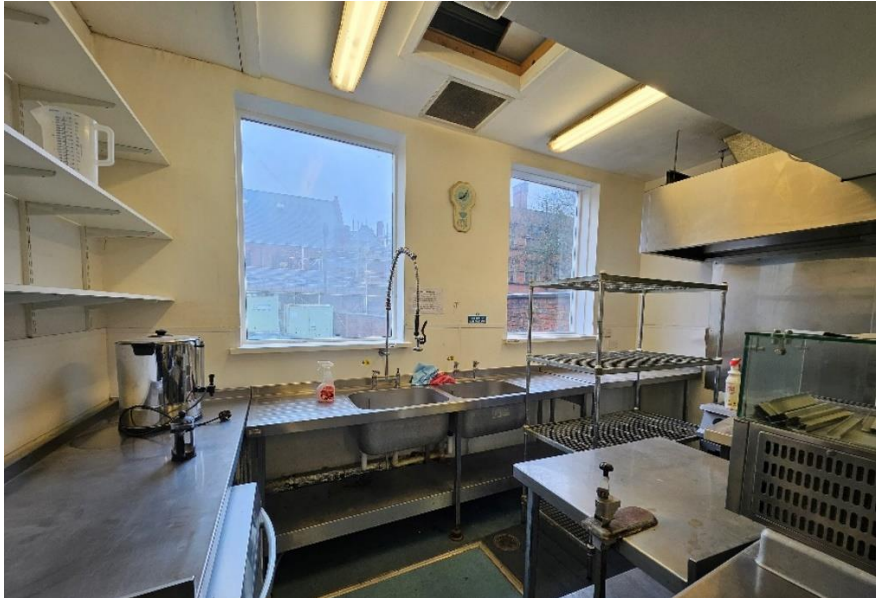
*Kitchen looking to the rear of the building*

Option 01 was chosen to be taken forward. Including a full refurbishment of the kitchen (world café), dining area and same sex WCs.

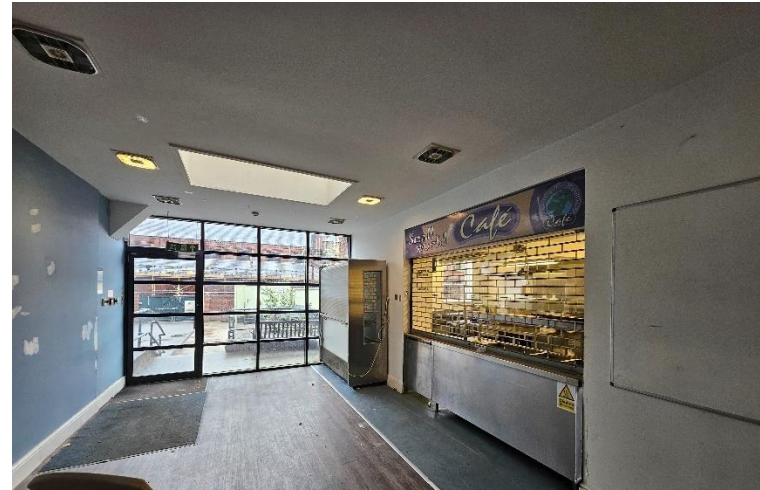
*Dining area looking to the rear of the building.*

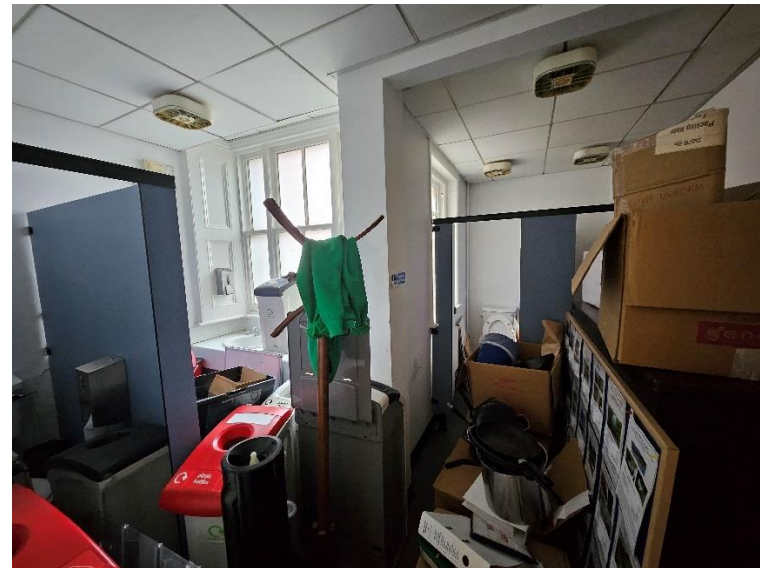
*Female WCs*

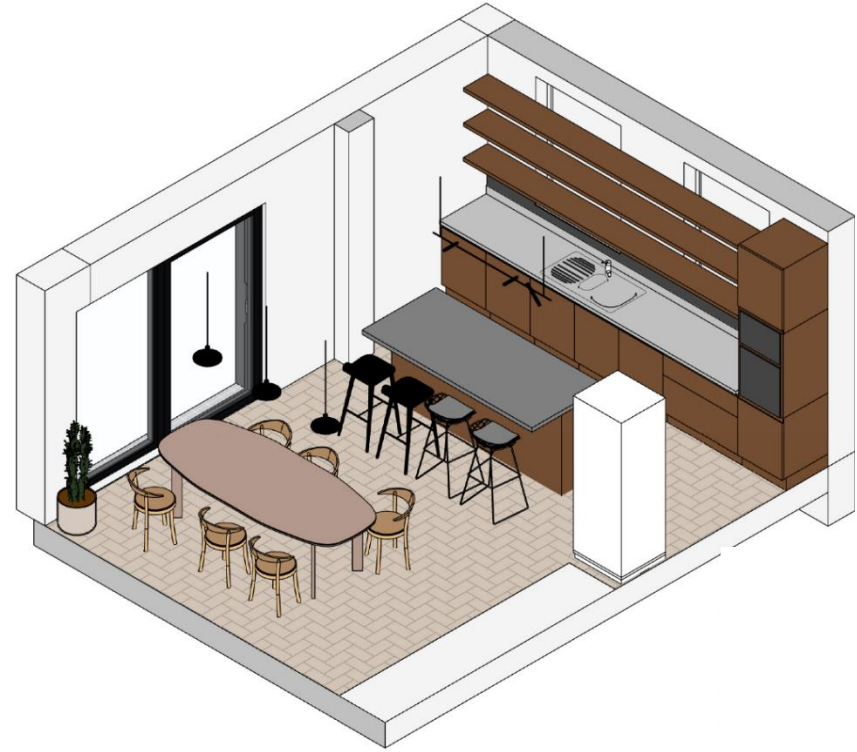
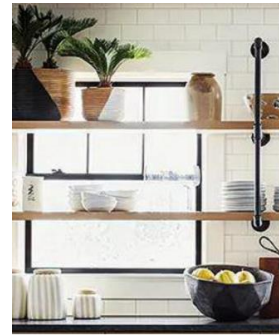
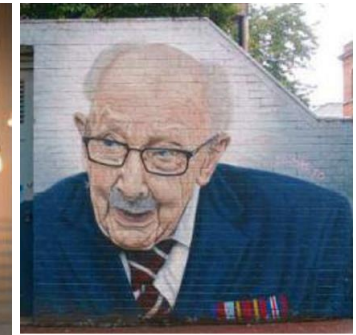
## Kitchen Refurbishment

The brief was to provide space for a large dining table that people could commune around and share ideas and hold informal meetings. It would act as a centre point for staff using the building. This part of the building is in a later extension to the original building. Therefore, adaptations are more acceptable to the heritage officer. New barrier matting will be provided to the rear access door to ensure wet and dirt is not tracked into the space. New pendant lighting sits above the table to zone the area.

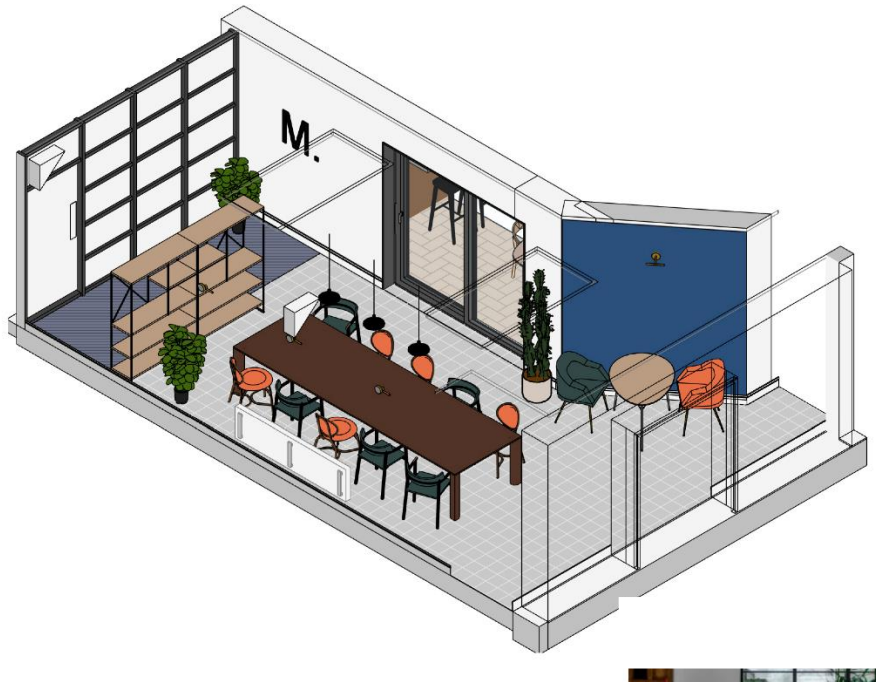
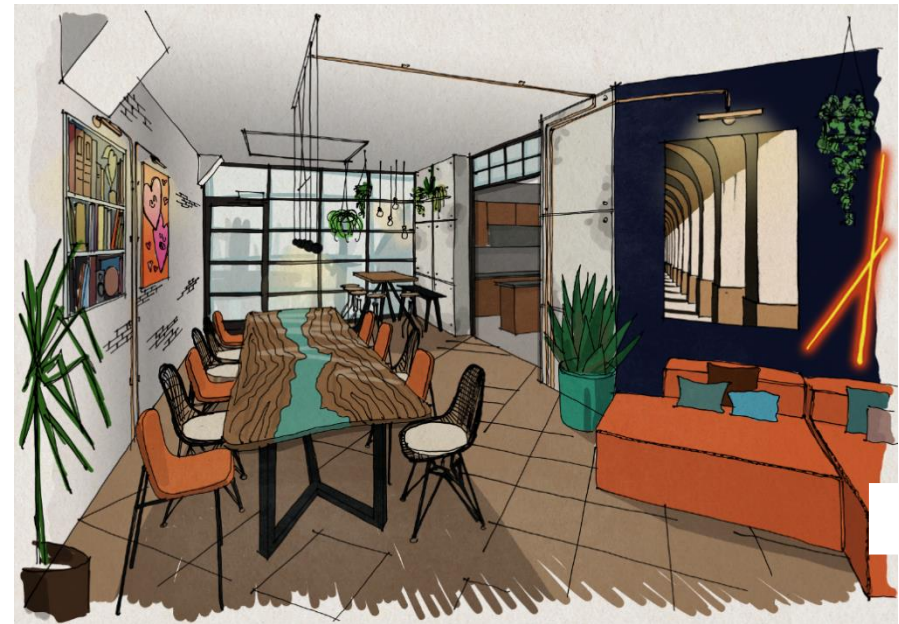
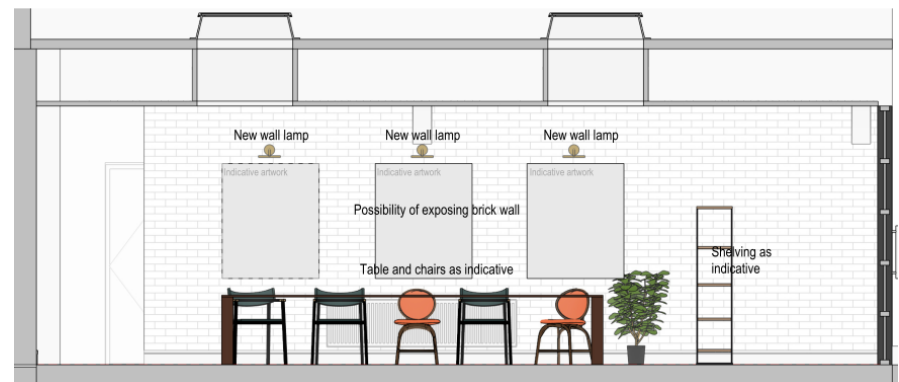
## Dining Area Refurbishment

The brief was to provide space for a large dining table that people could commune around and share ideas and hold informal meetings. It would act as a centre point for staff using the building. This part of the building is in a later extension to the original building. Therefore, adaptations are more acceptable to the heritage officer. New barrier matting will be provided to the rear access door to ensure wet and dirt is not tracked into the space. New pendant lighting sits above the table to zone the area.

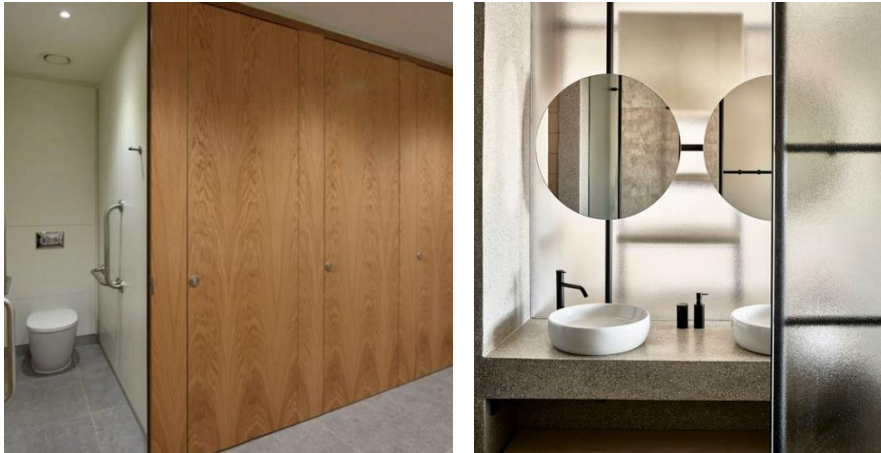
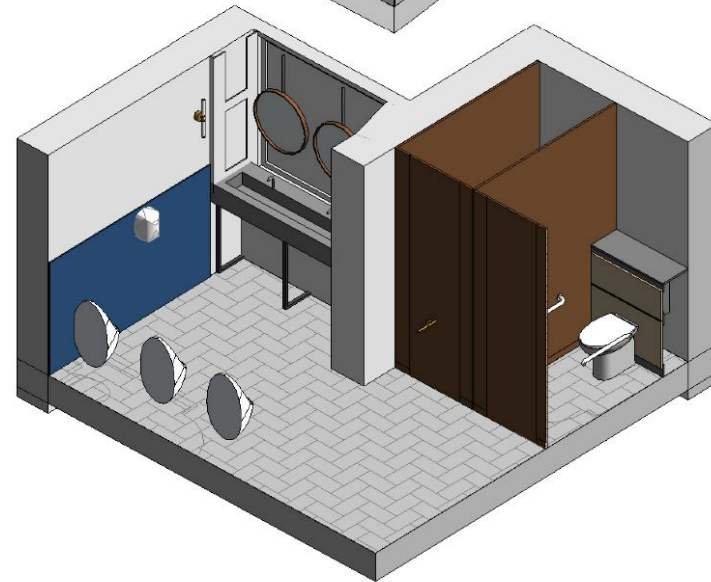
## WC Refurbishment

As these newly refurbished spaces will provide a convening point for some of the core university business engagement and innovation functions the toilet facilities require refurbishment also. Full refurbishment of toilets including cubicles, sinks, toilets, floors, ceilings and decoration.

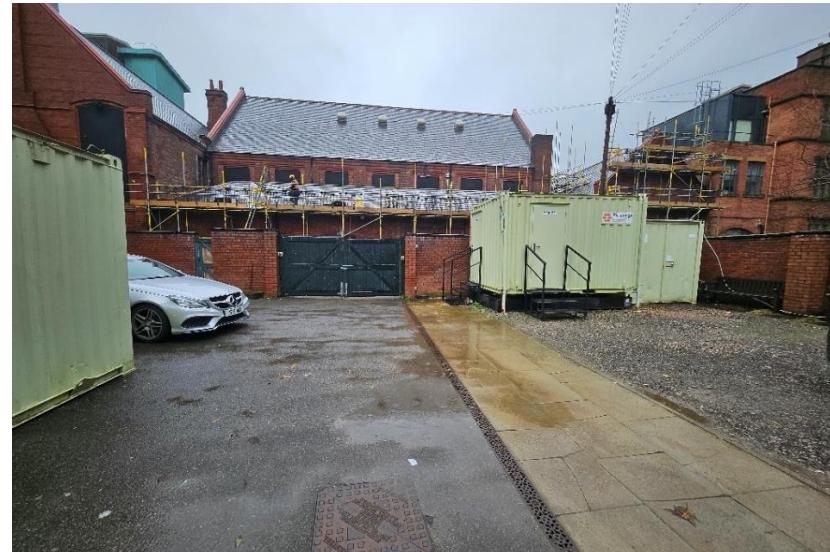
It has been confirmed that the rear ramp is not compliant for wheelchair users.

*Rear access of the site*

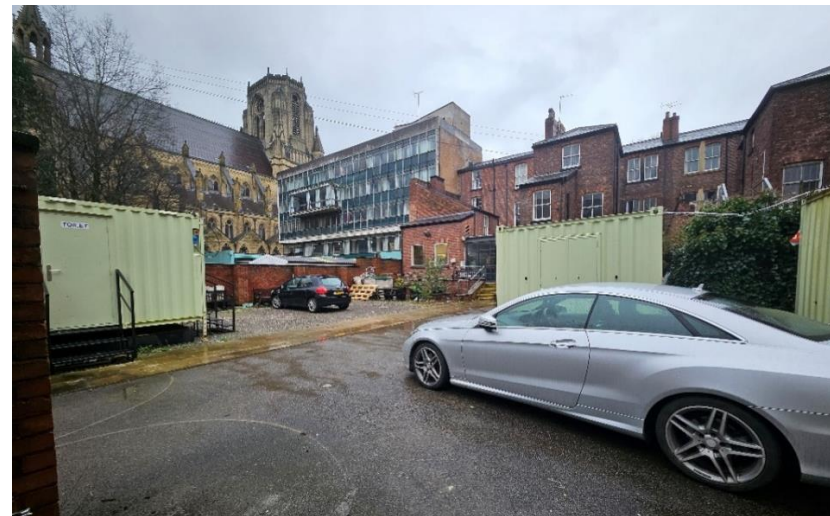
The cabins to the rear of the site are to be removed with all cracked flags to be remediated and reinstatement of the grass where gravel is currently. Vegetation to the building and site will be removed.

*Rear of the building*

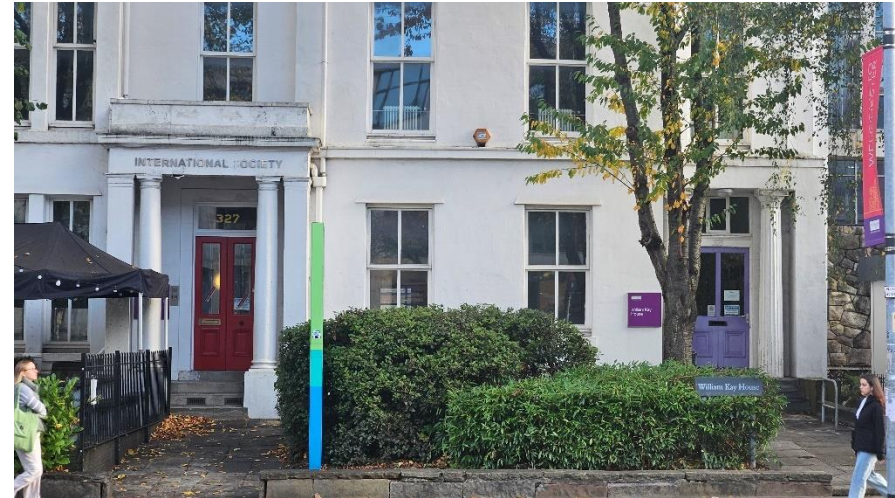
Timber fascia and soffit boards have been identified for replacement and painting.

Surveys to the render and roof are to be carried out once scaffold is erected for the painting of the building. Provisionally this may lead to repairs and new flashing to the gable elevation.

*Front of the building*

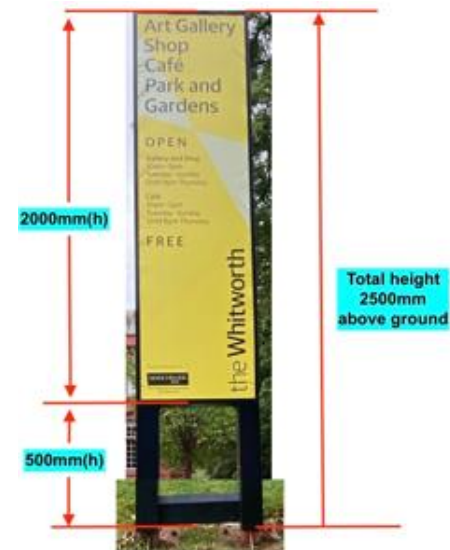
The existing plinth signage to the front of the site is to be removed and replaced with a new design, in line with UoM's signage design for the Whitworth Gallery. Heritage and Planning accepted the new monolith as it is more slim line. Please see image right.

*Signage Precedent*

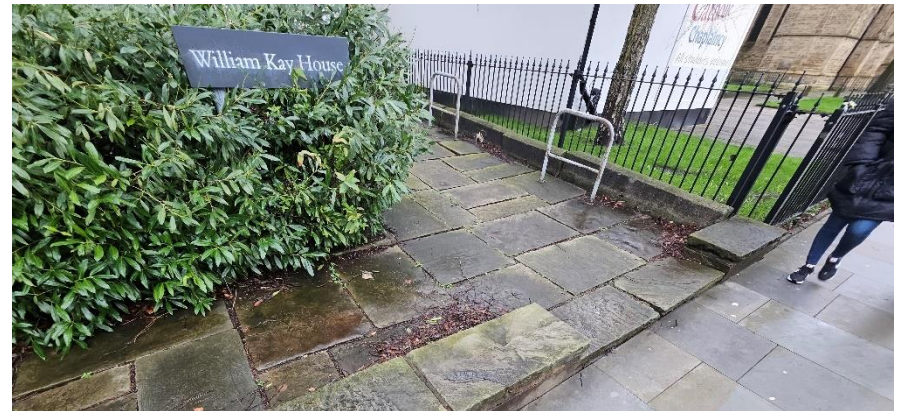
HMA received a levels survey of the front garden which proves the threshold is generally 1.3m above the street level and has therefore complicated a ramp design. An access proposal for the building is still in abeyance at this time. The proposal will be made as a separate application to this one.

*Front of the site. Right.*

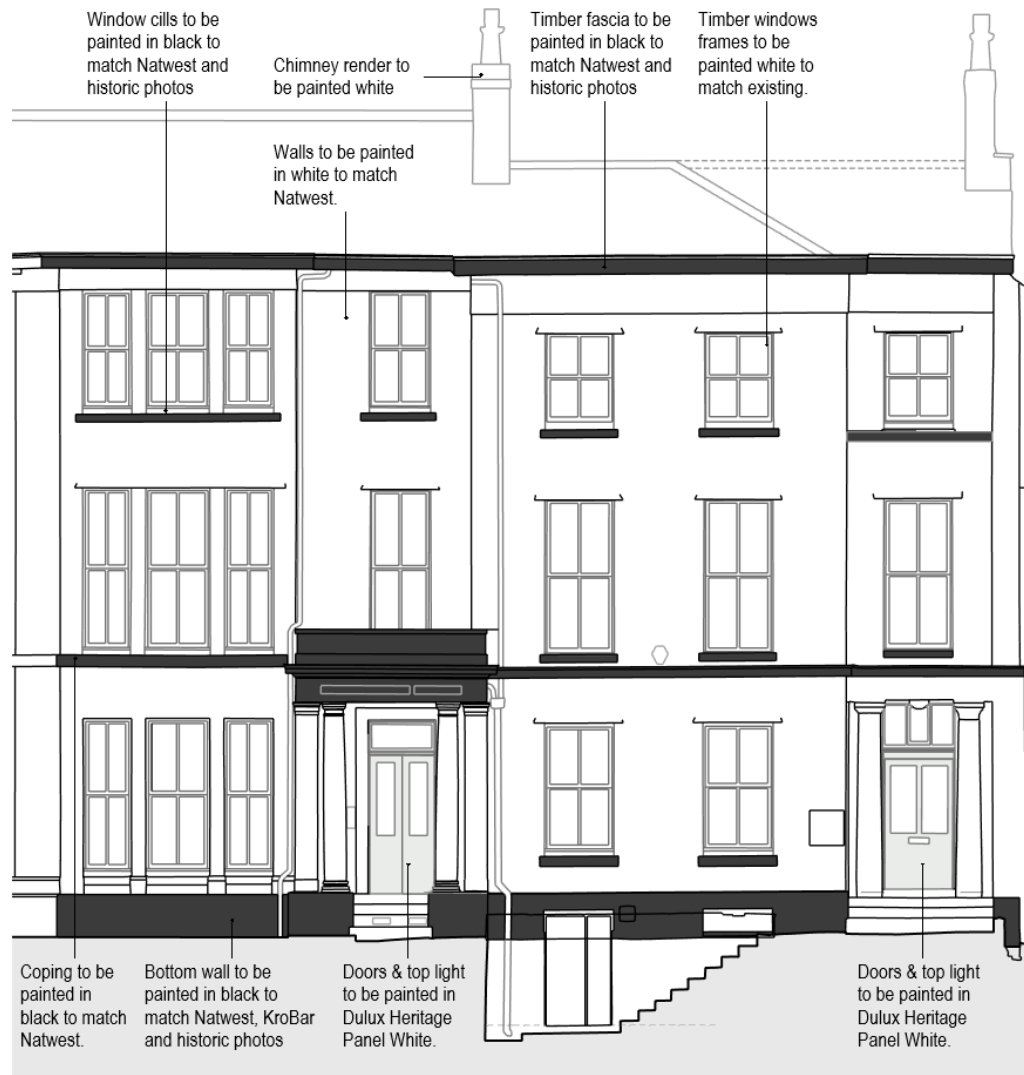
William Kay South West Elevation as Proposed

1 : 50 @ A1
