# fabric church

# 01 introduction

This Design Statement has been prepared on behalf of Fabric Church in support of Planning and Listed Building applications for works to Ardwick Barracks.

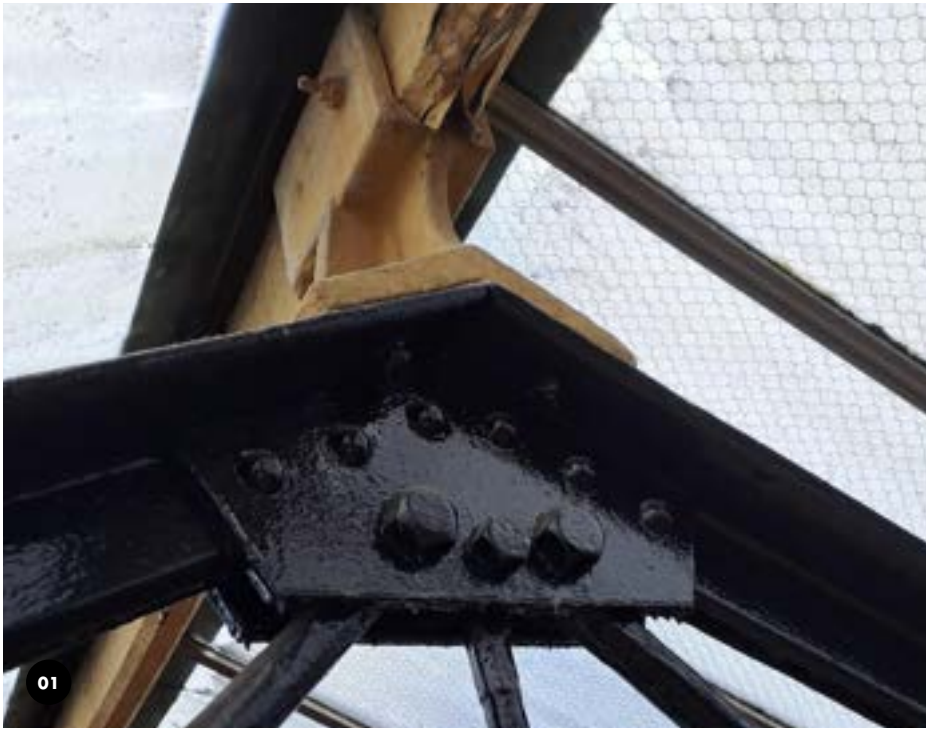
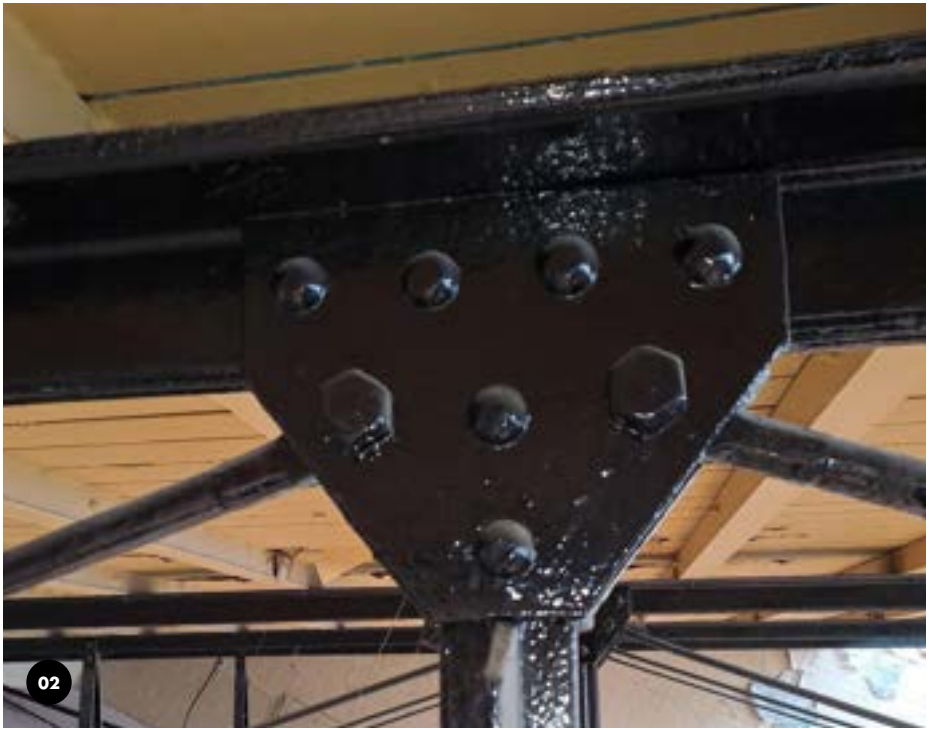
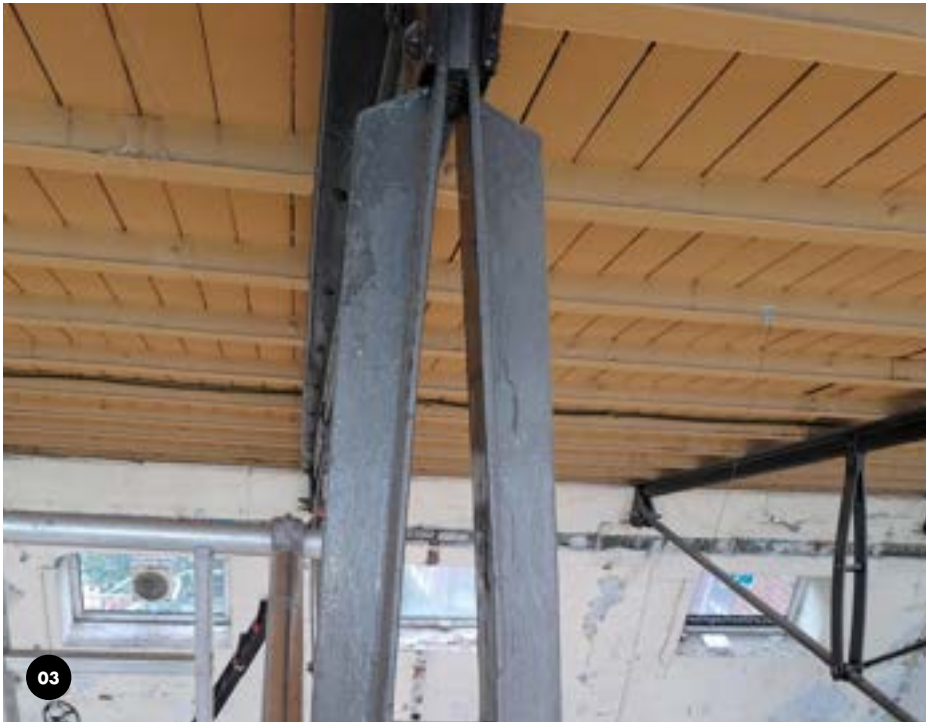
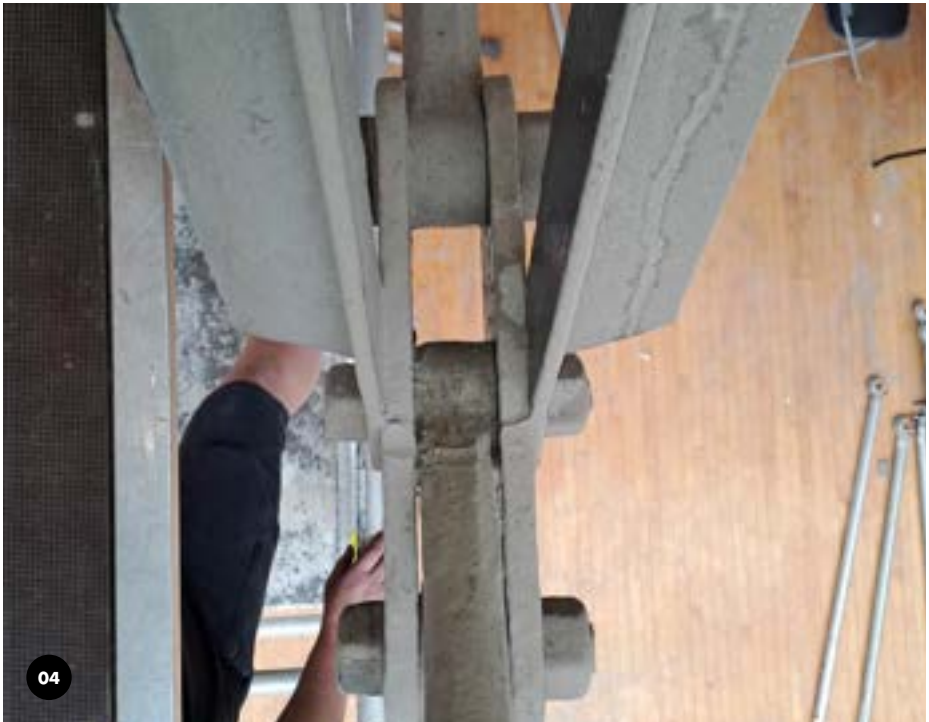
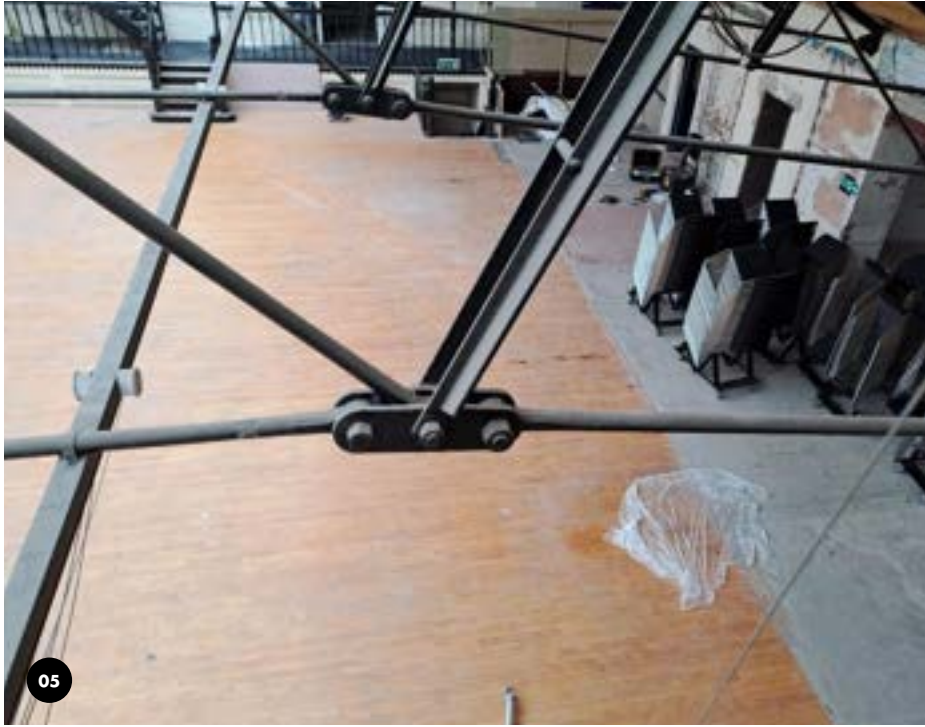
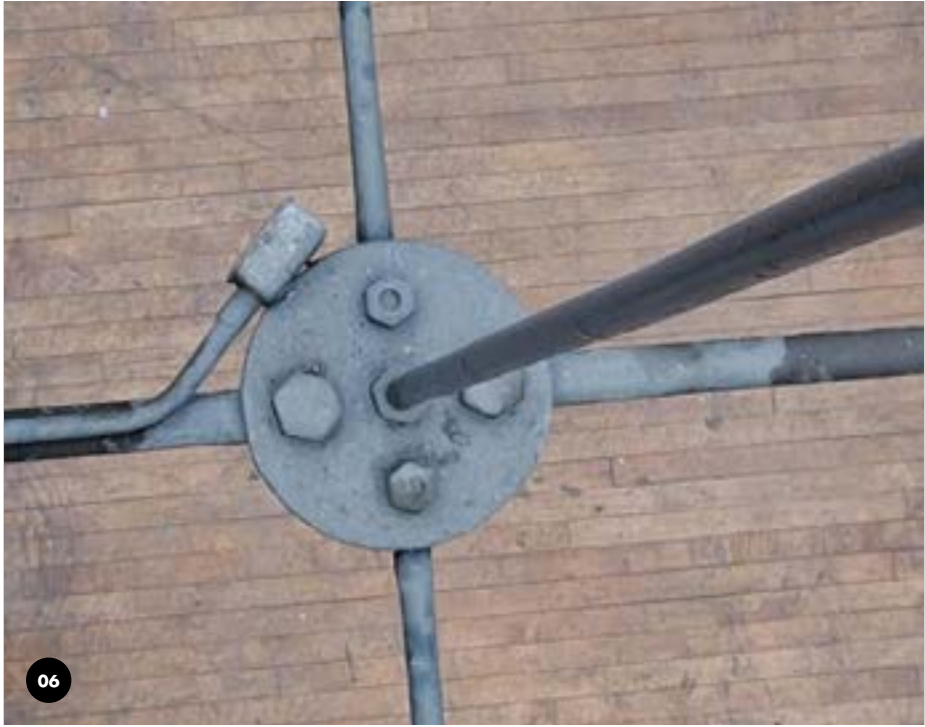
key (ref following pages)

- 01 Element K/G (steel ridge beam shoe atop steel gusset)
- 02 Element D (steel gusset)
- 03 Element E (truss web)
- 04 Element B (bottom chord tie beam)
- 05 Element B (bottom chord tie beam)
- 06 Element H
- 07 Element N (heel)
- 08 Element K (steel ridge beam shoe)
- 09 Element K (steel ridge beam shoe)
- 10 Element M (roof light angle)

The Drill Hall truss is an original late-19th century feature of the Grade II listed Drill Hall. The truss is composed of wrought iron, a material widely used at the time for structural elements due to its advantageous tensile strength. The durable nature of the material means that the trusses still provide structural integrity to the existing roof today. Their structural integrity combined with their heritage value deems the trusses key elements for retention and subject to minimal intervention.

The delicacy and slenderness of the existing trusses are a key factor in the character of the space and avoiding the need for any cumbersome modern strengthening members was paramount.

Whilst the proposals retain the existing trusses unaltered, we are proposing to remove the existing composite iron and timber purlins that span between trusses at approximately 600mm centres. These will be replaced with new steel PFC members that are placed at truss node points (approximately 3.2m centres) and thus avoid overloading the top chord of the truss and channel loads more efficiently, avoiding the need for new strengthening members to be added to the existing trusses.

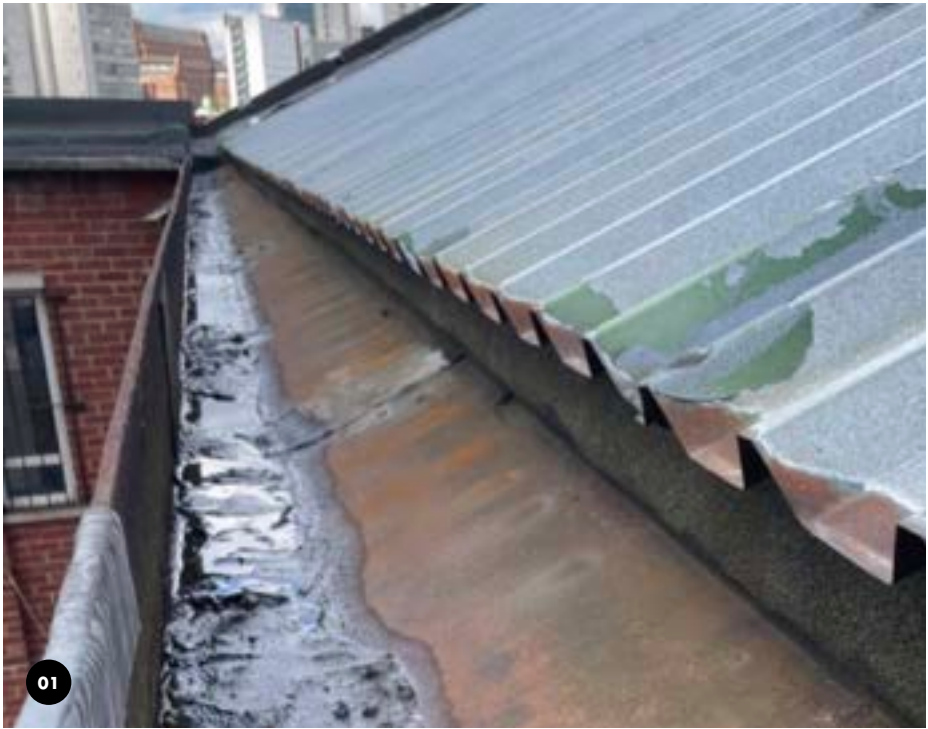
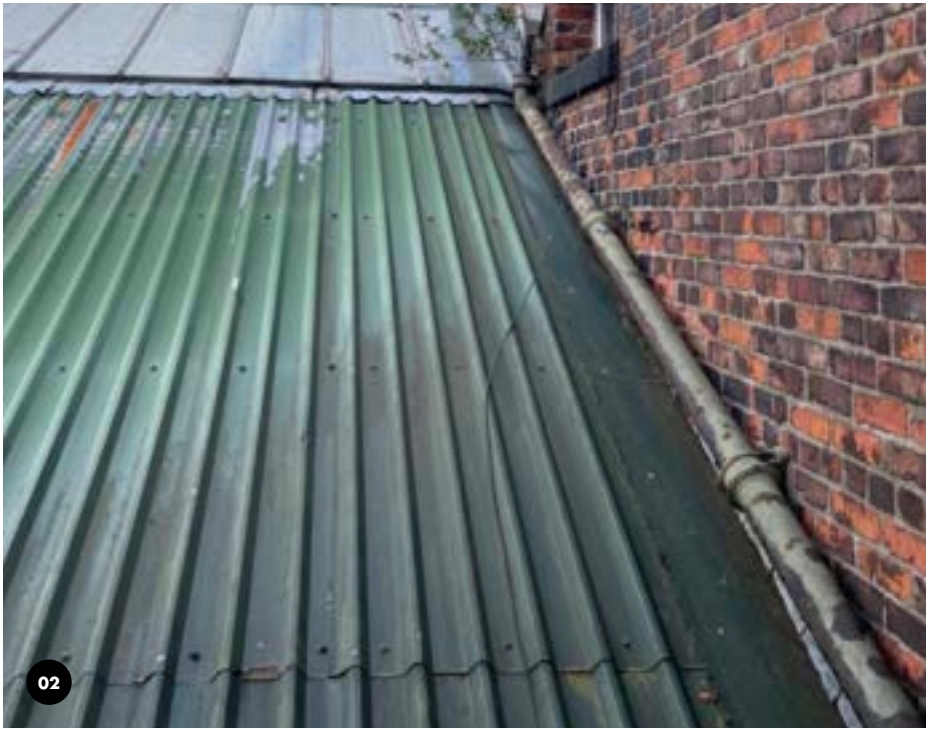
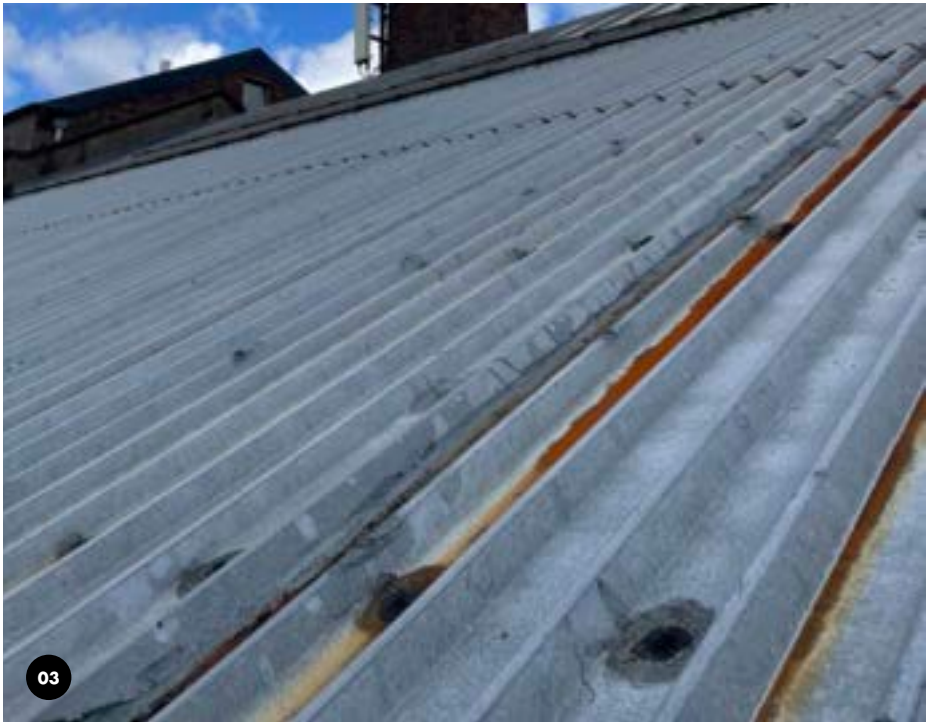
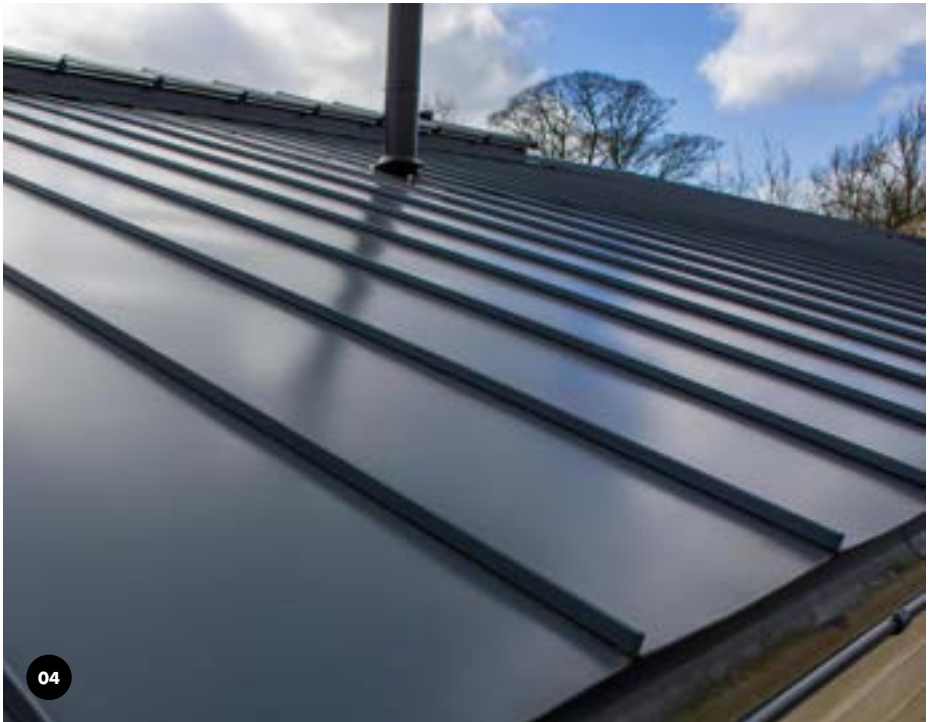
key

- 01 Existing roof - steel gutter and corrugated steel sheet roof finish
- 02 Existing roof - corrugated steel sheet roof finish with remains of green colour coating
- 03 Existing roof - corrugated galvanised steel sheet roof finish (coating worn away)
- 04 Proposed roof - aluminium standing seam roof sheet with anthracite coating

Poor condition and significant water ingress through the existing roof has made the need for replacement urgent. Whilst the structural roof trusses are of significant heritage value, the existing corrugated sheet metal external finish was added in the latter half of the 20th century and therefore are deemed less significant. The existing profiled steel sheeting originally featured a green colour coating, although this has mostly now worn away as the material has exceeded its original design life.

In order to establish the most appropriate replacement roof finish material and associated roof build-up, a number of loading tests were carried out by the structural engineers (Hexa). These all started from the basis of a new insulated roof to achieve the minimum U-value required under Building Regulations of 0.16W/m2K, which equates to circa 230mm of insulation. Some adjacent walls will need to be extended - with matching brick masonry - to suit the new, deeper roof build-up.

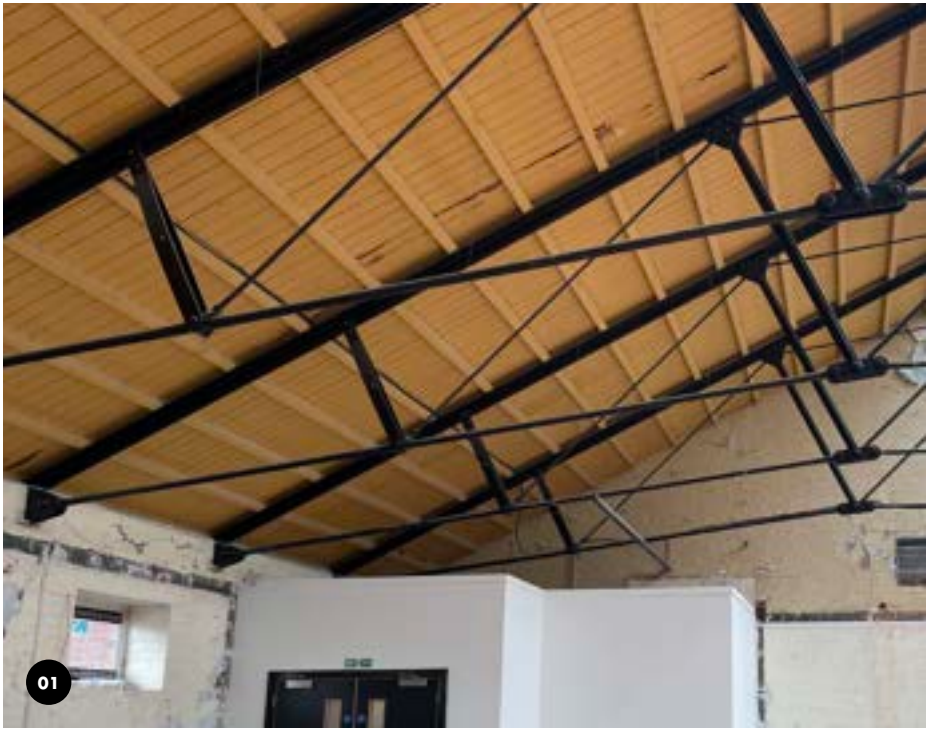
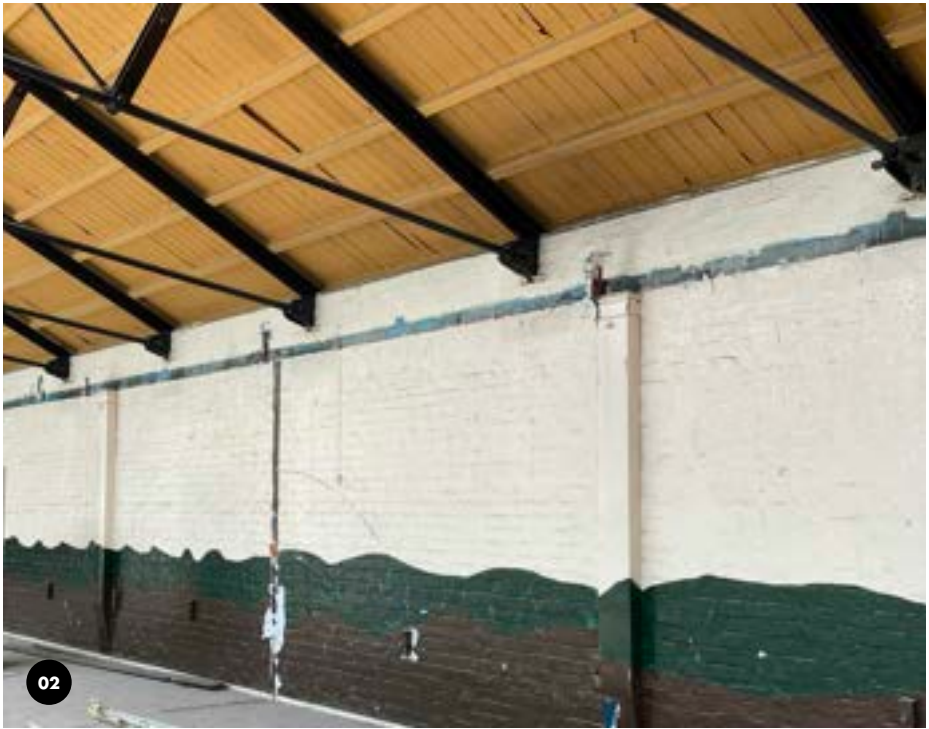
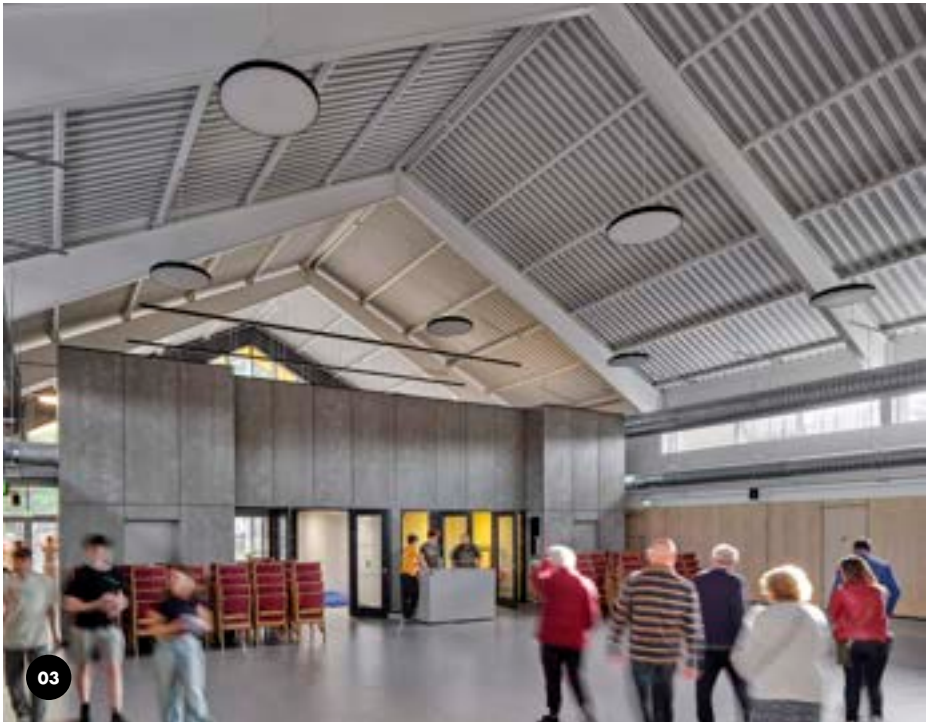
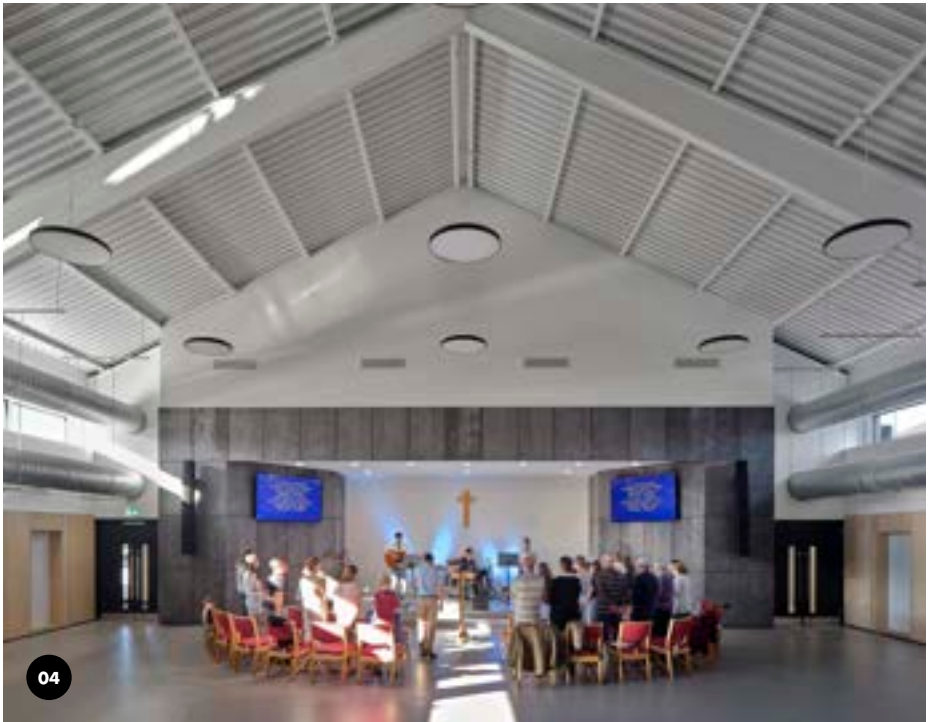
key

- 01 Existing soffit - timber roof boards (painted)
- 02 Existing soffit - timber roof boards (painted)
- 03 Proposed soffit - perforated structural metal deck
- 04 Proposed soffit - perforated structural metal deck

Internally the existing finish to the underside of the Drill Hall roof is the timber roof boards which span up the roof pitch between purlins. This directly support the existing metal sheet external finish. The boards are thought to date from the latter half of the 20th century when the original roof finish was replaced. The timber soffit boards are painted internally.

Our proposal is to replace the timber roof boards with a profiled structural metal deck which can carry the necessary loads and span the greater distance between the new steel purlins at truss node points.

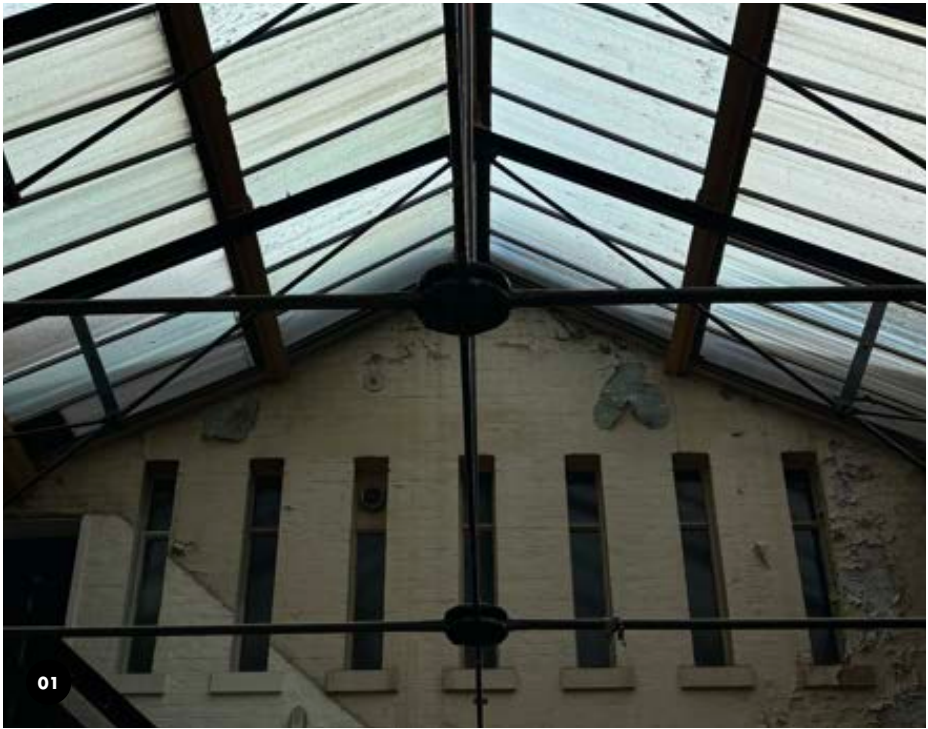
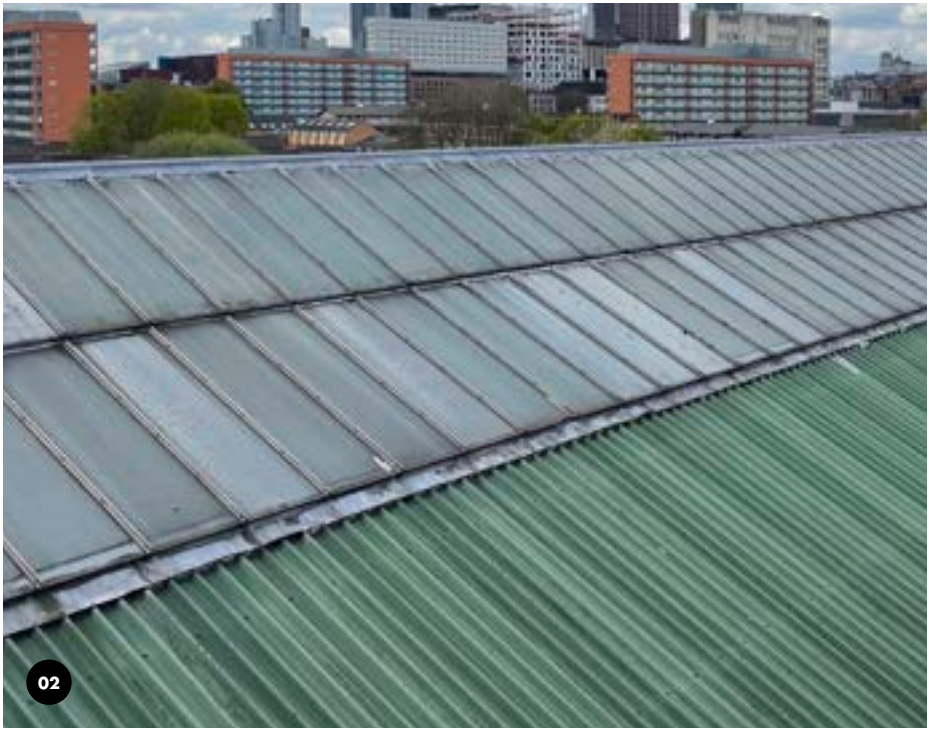
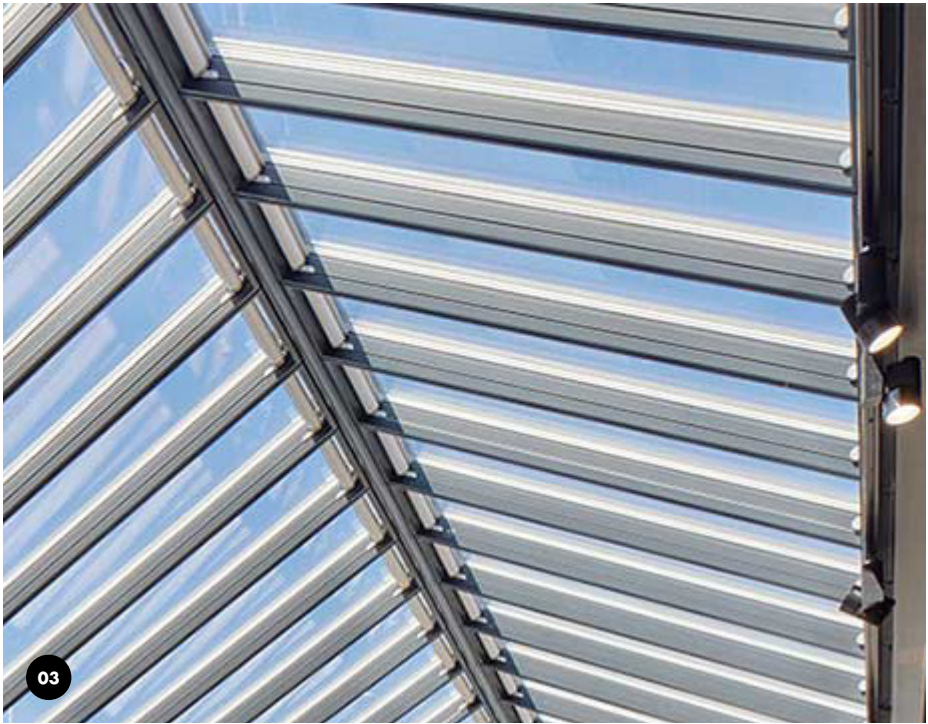
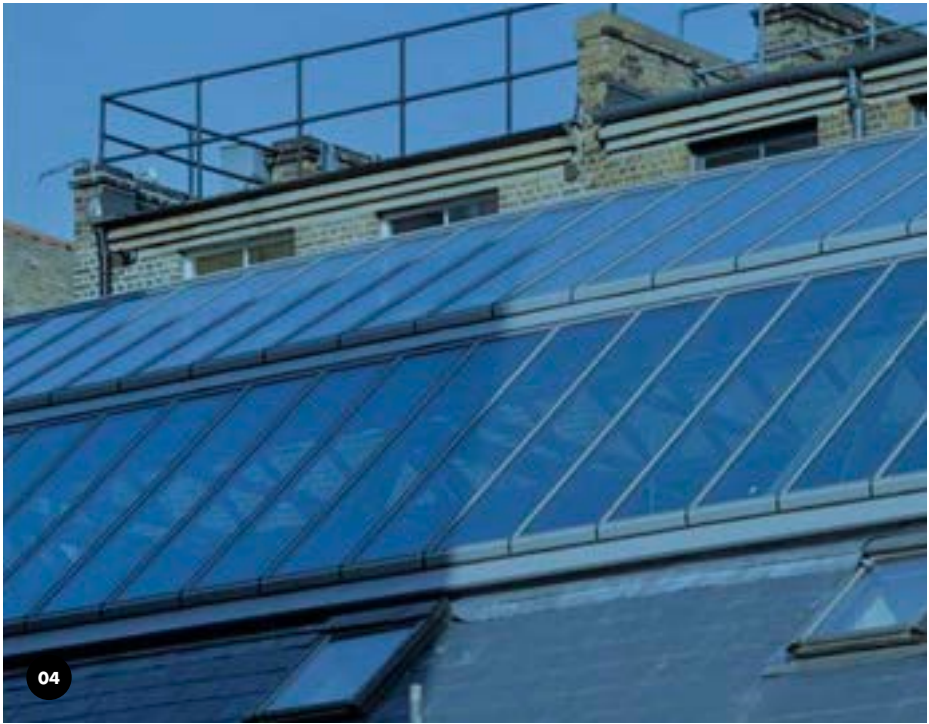
key

- 01 Existing roof light - internal view
- 02 Existing roof light - external view
- 03 Proposed roof light - internal view
- 04 Proposed roof light - external view

The existing single-glazed roof lights have reached the end of their design life and are in poor condition, as well as performing poorly in terms of thermal and acoustic performance. The existing roof lights date from the latter half of the 20th century, however, the provision of a large ridge roof light running the entire length of the Drill Hall is evident on much earlier plans. Therefore, whilst the fabric of the existing roof light itself is not of great significance, the provision of extensive roof glazing in this location is significant to the original character of the Drill Hall.

The intention is to replace the roof light with a modern aluminium-framed double glazed roof light that can meet the thermal performance requirements of current Building Regulations Part L2 and support the client’s desire to strive to meet the Church of England’s ambitious Net Zero Carbon targets. Opening vents are incorporated to improve ventilation of the Drill Hall space, in preparation for bringing the space back in to use. The roof light system has been chosen to ensure that the opening vents have the same profile and sight lines as the fixed panes.

The new roof light is proposed to follow the same form as the existing roof light in that it runs the entire length of the Drill Hall roof and is subdivided into two rows of glazed panels either side of the ridge; panels are approximately 600mm wide (4 per structural bay) and held in an aluminium frame. The roof light depth is reduced slightly compared with the existing condition (approximately 500mm either side of the ridge). This is driven by the structural solution to avoid placing significant extra structural load on the top chords of the trusses by positioning new steel purlins at the truss node points. This has necessitated the reduction in the depth of the roof light so that the roof light aligns with the truss node points and new purlin locations. The length and subdivision remain unaltered and the reduction in depth is only circa 12%, thus, ensuring that the roof light follows a rhythm largely similar to the existing layout and retains the character of the space. The reduced area of glazing, whilst proportionally small, does have a helpful impact in terms of reducing overheating in the space in summer.

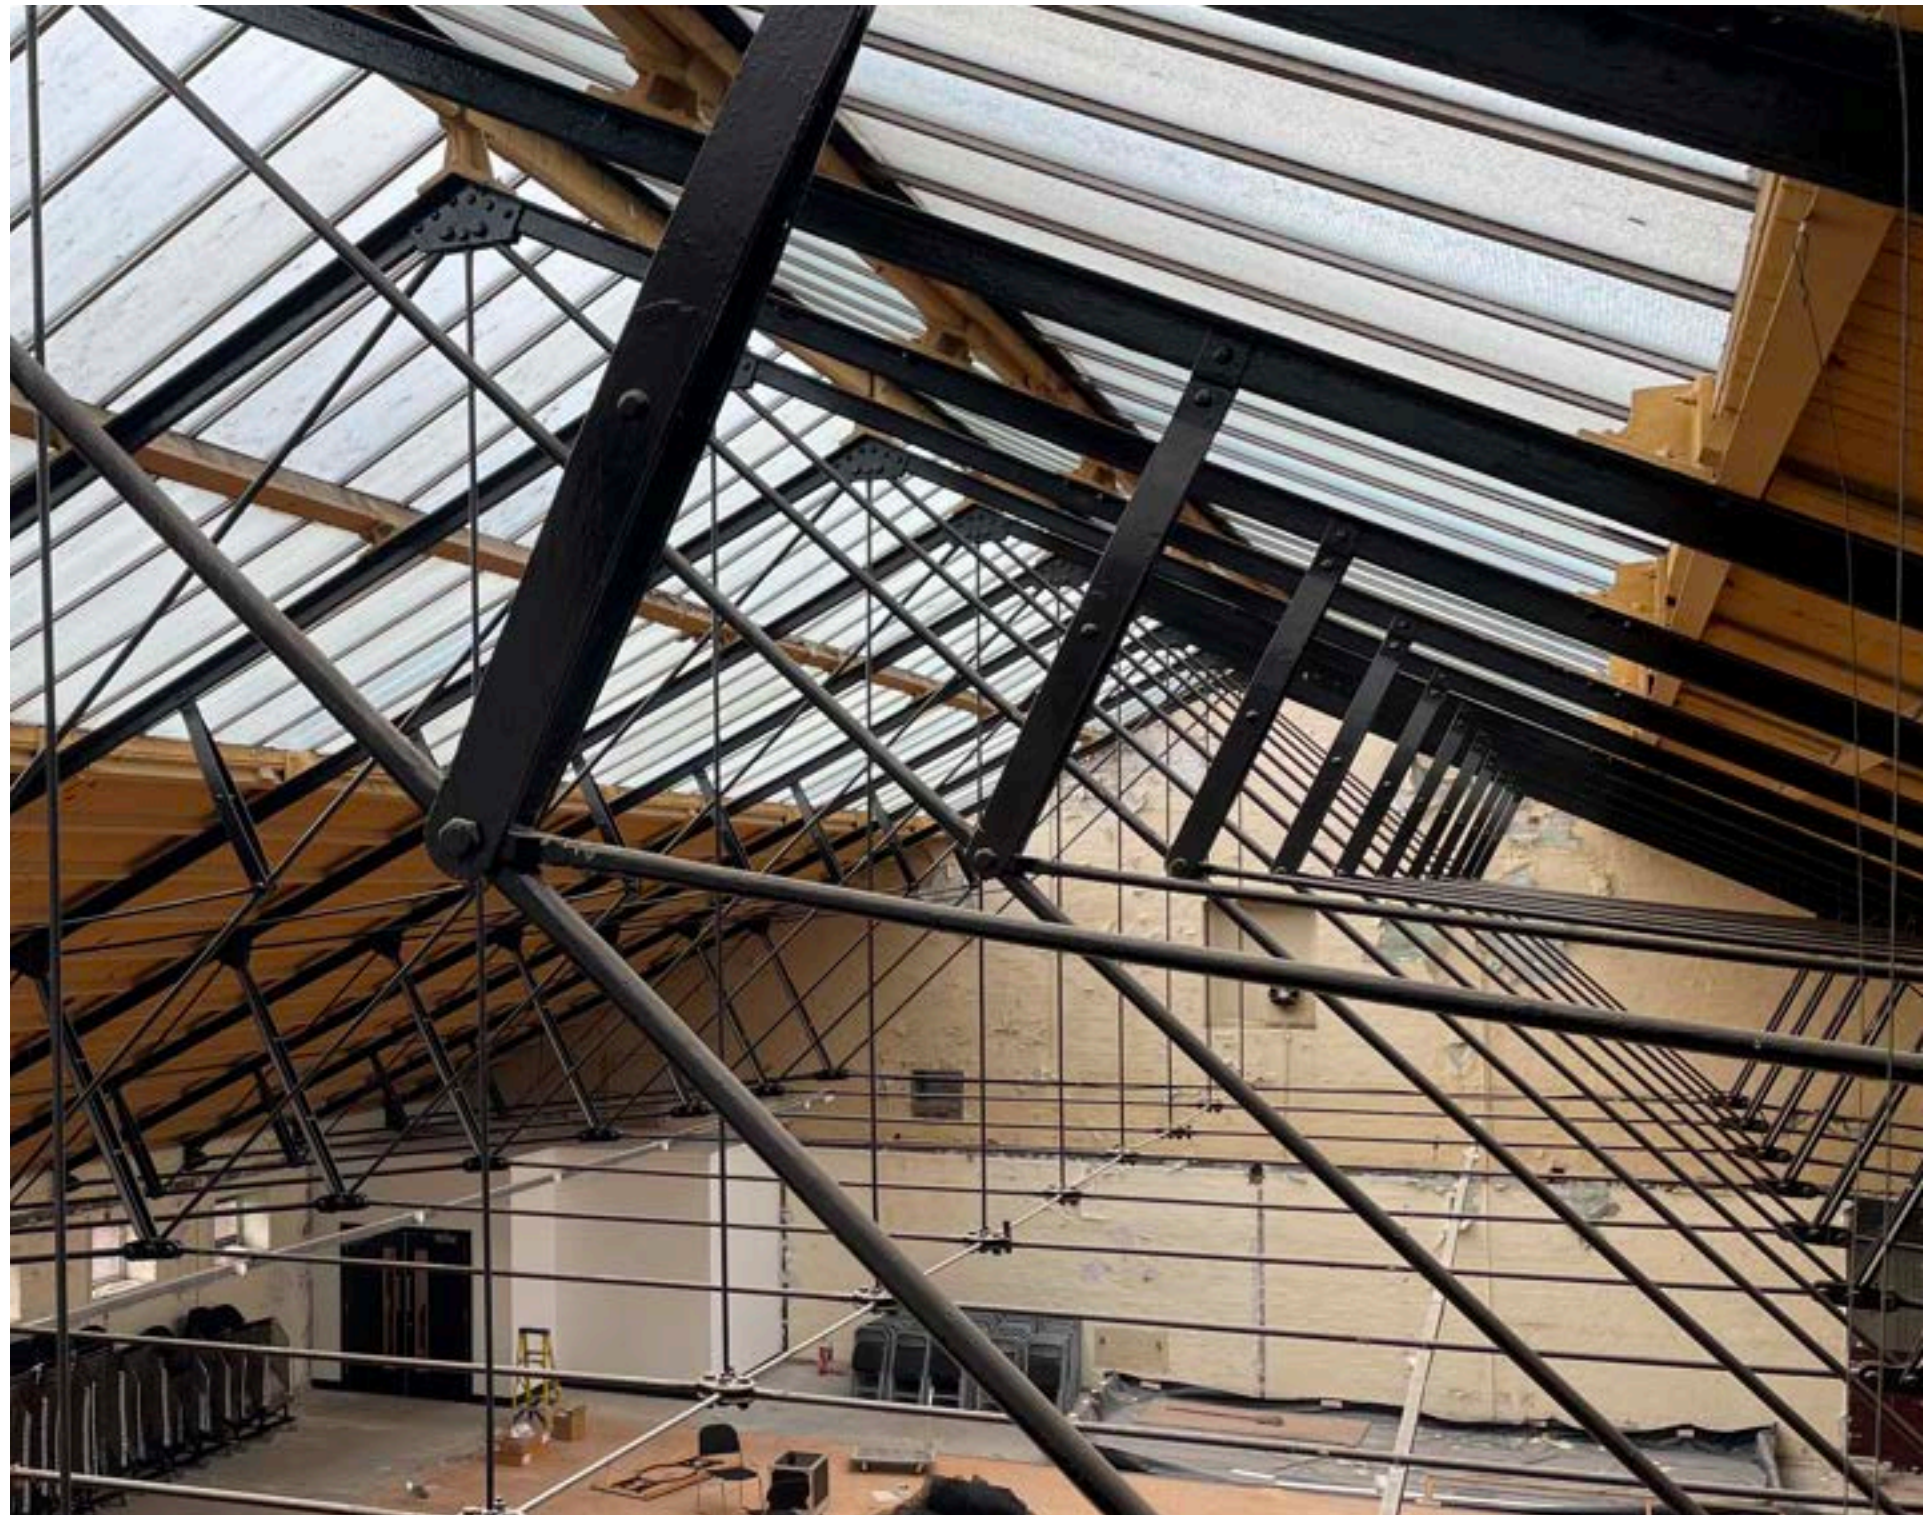
- 01 Exploded axonometric drawing of the Drill Hall roof structure, highlighting those elements which are to be retained and those which are to be replaced

- Retain and clean existing late-19th century wrought iron roof trusses
- Existing wrought iron shoe details at ridge to be retained and cleaned
- Replace existing wrought iron/timber composite purlins at 600mm centres with new larger PFC steel purlins at wider (3.2m) spacings, thus allowing increased roof loads to be transferred through the truss without intrusive strengthening works to the trusses

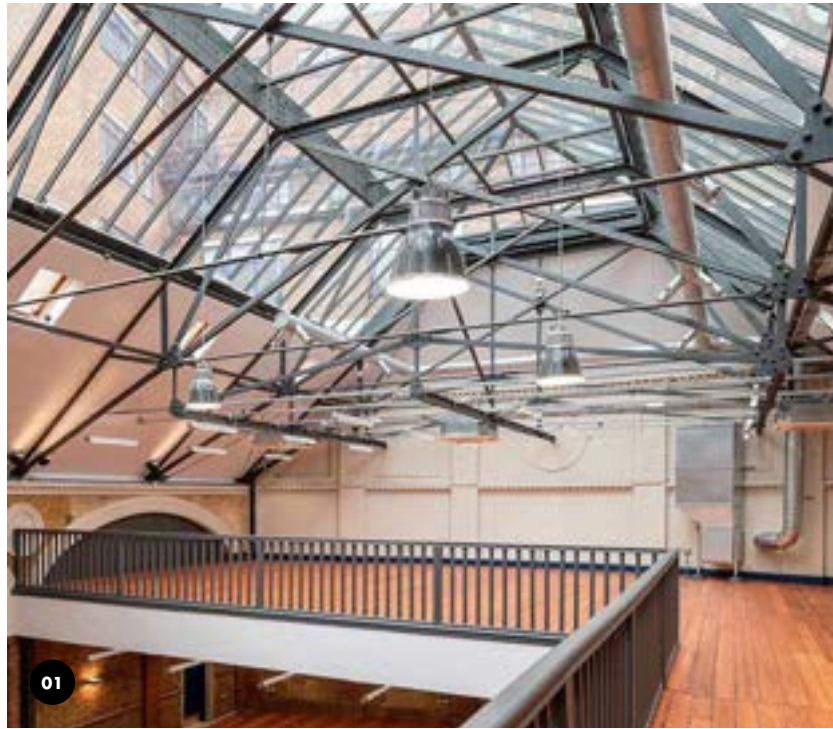
- 01 Roof light replacement in a former Drill Hall in Farringdon
- 02 Modular skylights in Norrebro Library, Copenhagen
- 03 Repurposed warehouse featuring steel trusses + roof lights, London

There are numerous examples of Grade II listed buildings locally in Manchester, and further afield, where the replacement of single glazed roof lights with modern double glazed roof lights of a similar specification to that proposed has been deemed acceptable and completed successfully.

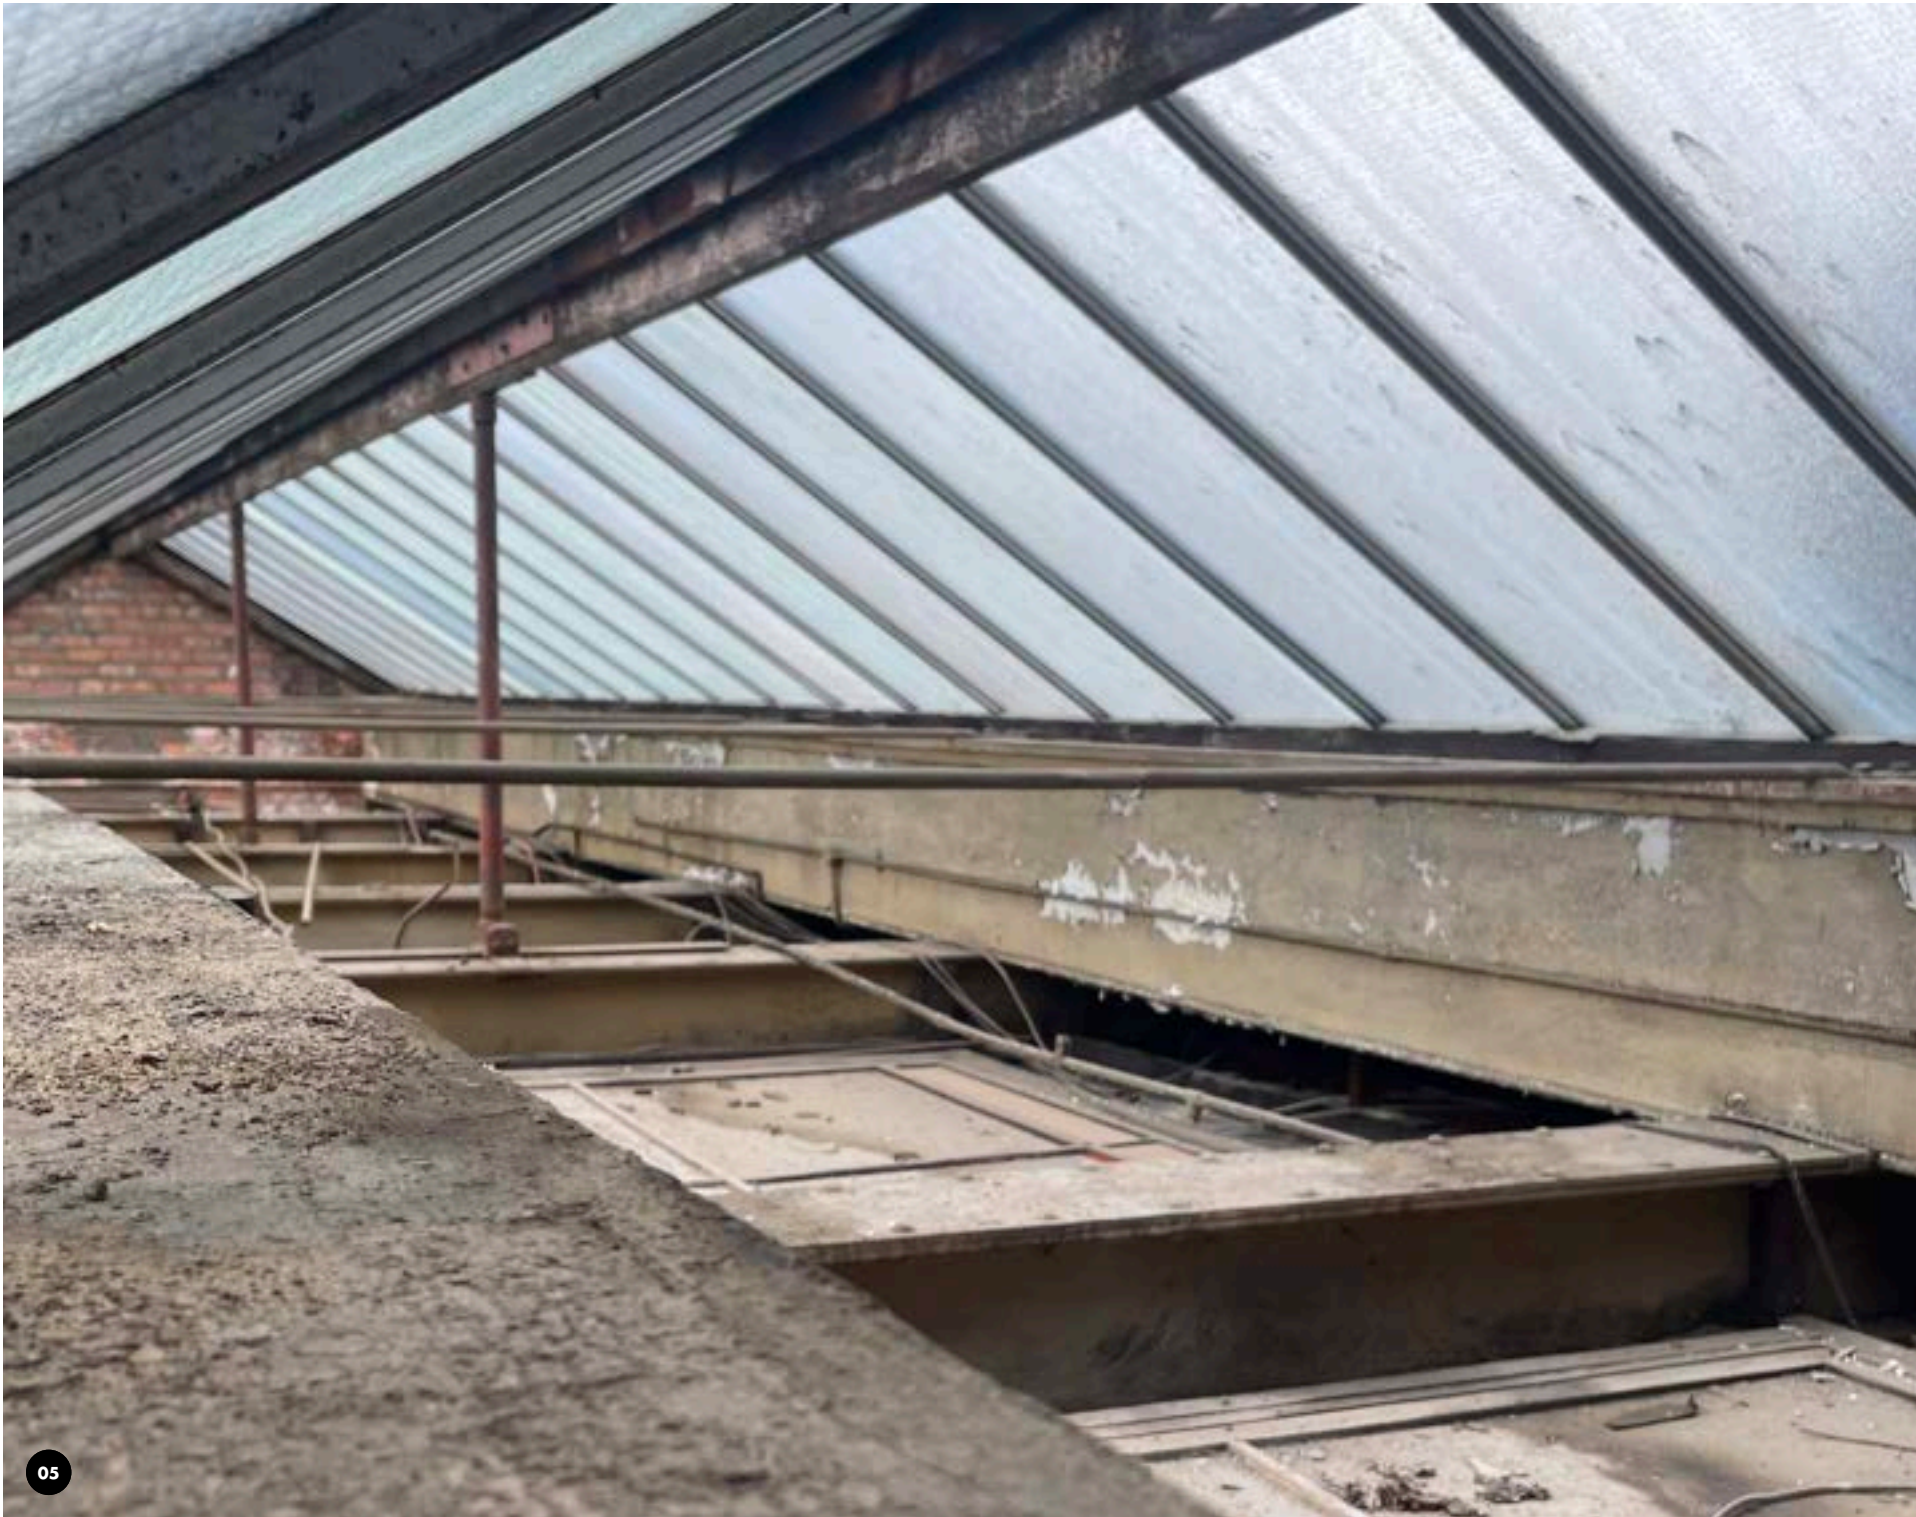
- 01 Exterior of the Barracks building roof light, looking towards adjacent property
- 02 Exterior of the Barracks building roof light, looking towards the caretaker's apartment
- 03 Underside of the roof light is hidden by a 20th-century suspended ceiling featuring secondary skylights
- 04 Exploded axonometric drawing of the Barracks building roof light structure, highlighting those elements which are to be retained and those which are to be replaced
- 05 Photograph of the existing condition

- Existing single glazed roof light replaced with double glazed aluminium framed roof light, incorporating opening vents
- Existing roof light upstand to be retained, but condition to be inspected once finishes removed and remedial works to be undertaken if required

- Existing steel tie rods to be retained and cleaned
- Existing steel beams running beneath the roof light to be retained and cleaned
- Existing timber ridge beam to be replaced with new timber beam

- New roof light installed on to existing upstands, made good where required
- New flashings and trims as required
- Existing brick gable walls to be repointed in suitable like-for-like mortar

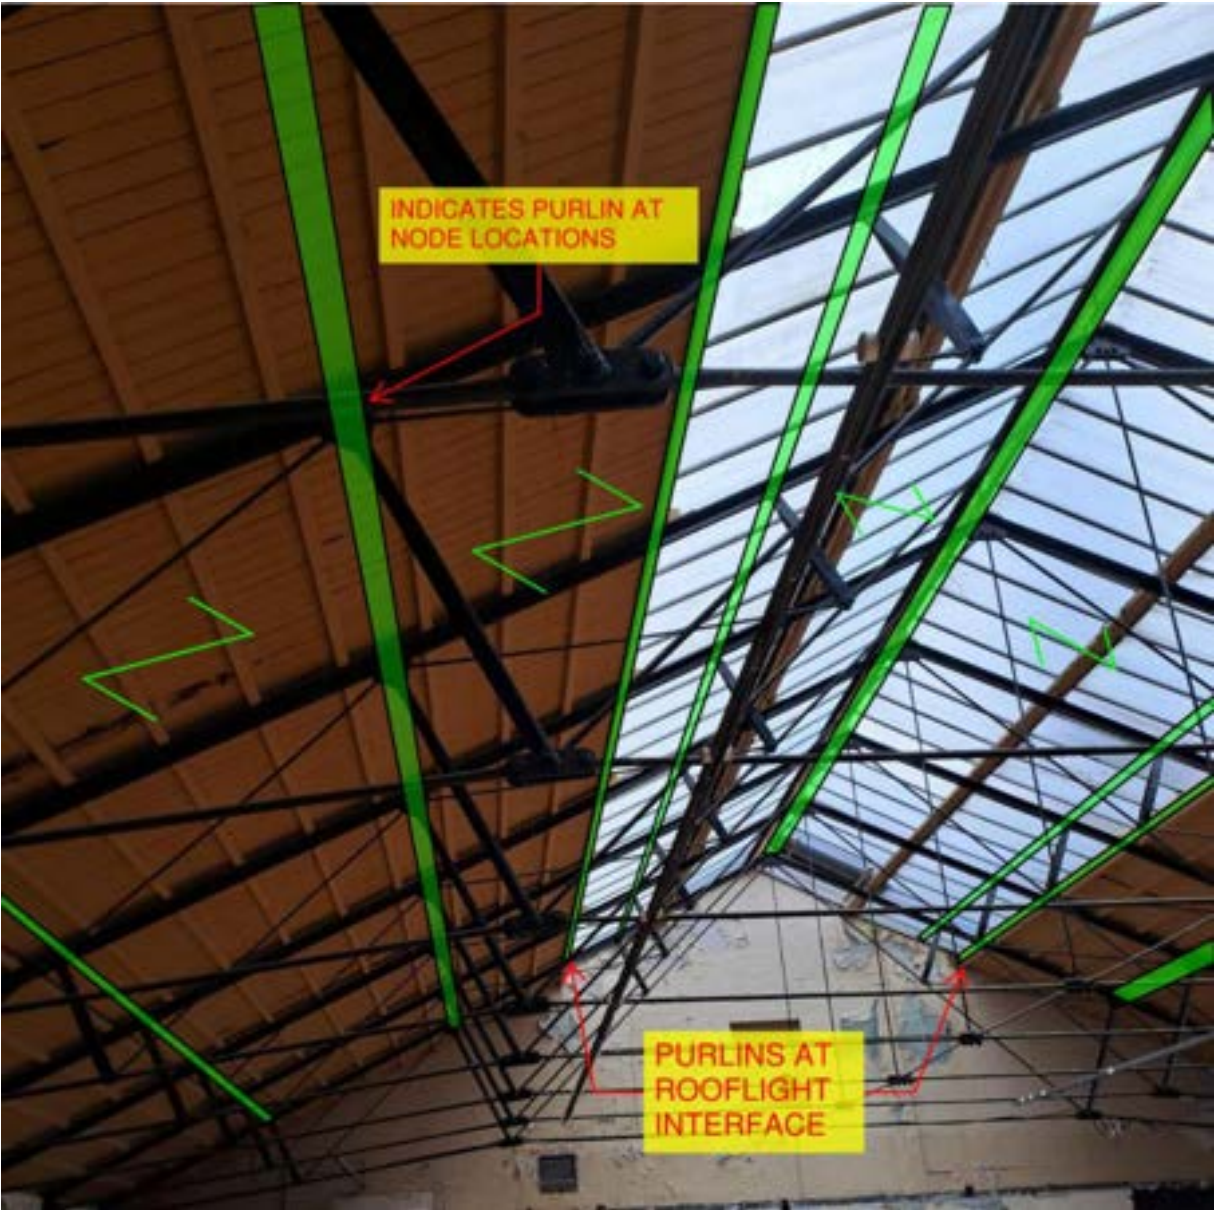
Figure 8 Image/Mark Up indicating proposed purlin locations and roof span direction.

The existing timber boarding will need to be removed to facilitate the installation of the proposed roof. Once removed, the condition of the boards can be assessed, with the best-preserved boards possibly being reclaimed to be used elsewhere within the building.
