# LAND AT GREENBROW SOCIAL CLUB, WYTHENSHAW, MANCHESTER

## Gas Verification Plan

Report Ref: BEK-24100-2

- 1.2.2 Manchester City Council has granted planning permission (subject to conditions) for the *'Erection of a three storey building to form fifteen flats (10 x 1 bed, 5 x 2 bed) and eight two storey dwellinghouses (2 x 2 bed, 4 x 3 bed, 2 x 4 bed) with associated landscaping and parking, following demolition of existing social club'* at the site located to the west of Greenbrow Road, Wythenshawe, Manchester, M23 2TU (Approval Ref: 137485/FO/2023).

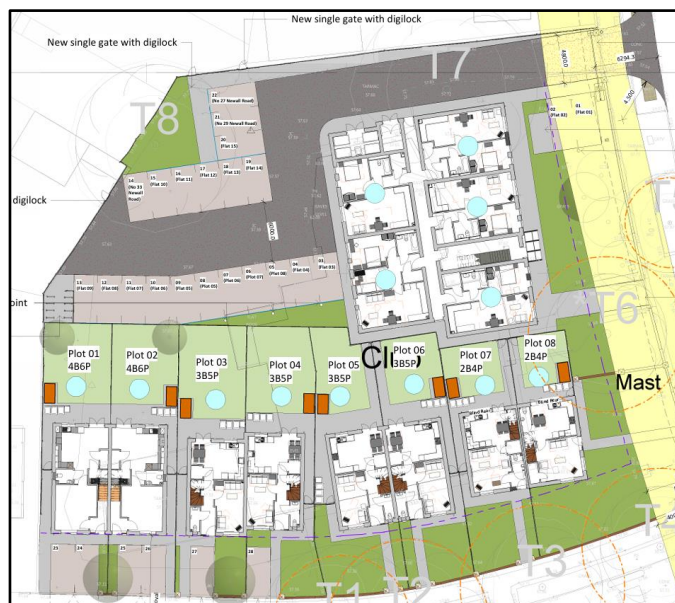
- 1.2.3 The development layout plans are presented on BTP Architects Drawing Ref: GR-BTP-00-SP-DR-A-3953\_203 entitled 'Proposed Site Plan', a copy of which is presented in Appendix B and an extract of which is presented below.

Figure 1: Extract from BTP Architects 'Proposed Site Plan'
