## **Historic Building Investigation and Watching Brief Report**

Chorlton Leisure  
Centre, Manchester  
Road, Manchester

Document Type: Historic Building Investigation and Watching Brief Report

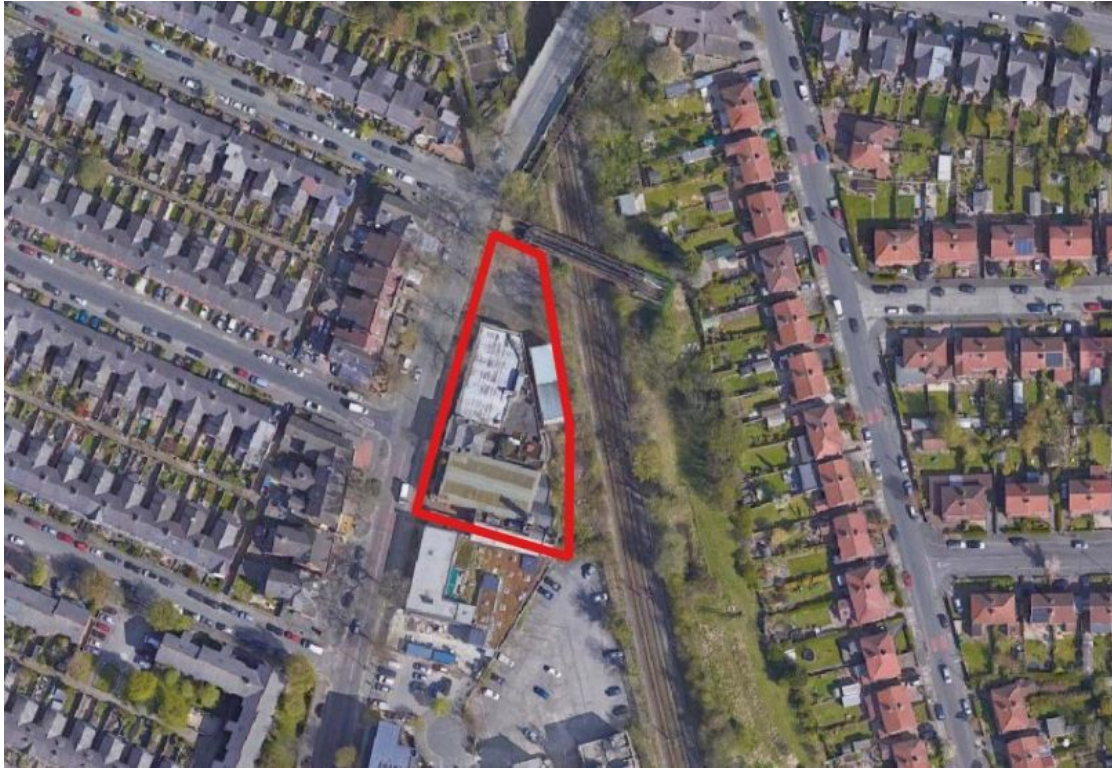
*Plate 1: Recent aerial shot, showing the Site boundary looking north*

Chorlton Leisure Centre lies 3km southwest of Manchester City Centre, just south of Old Trafford, and 1.17km north of Chorlton Brook (centred on NGR 381708 394516). The Site is bounded by the Thirlmere Aqueduct to the north, Manchester Road to the west, a Metrolink tramline to the east and a grocery store to the south (Plate 1; Fig 1).

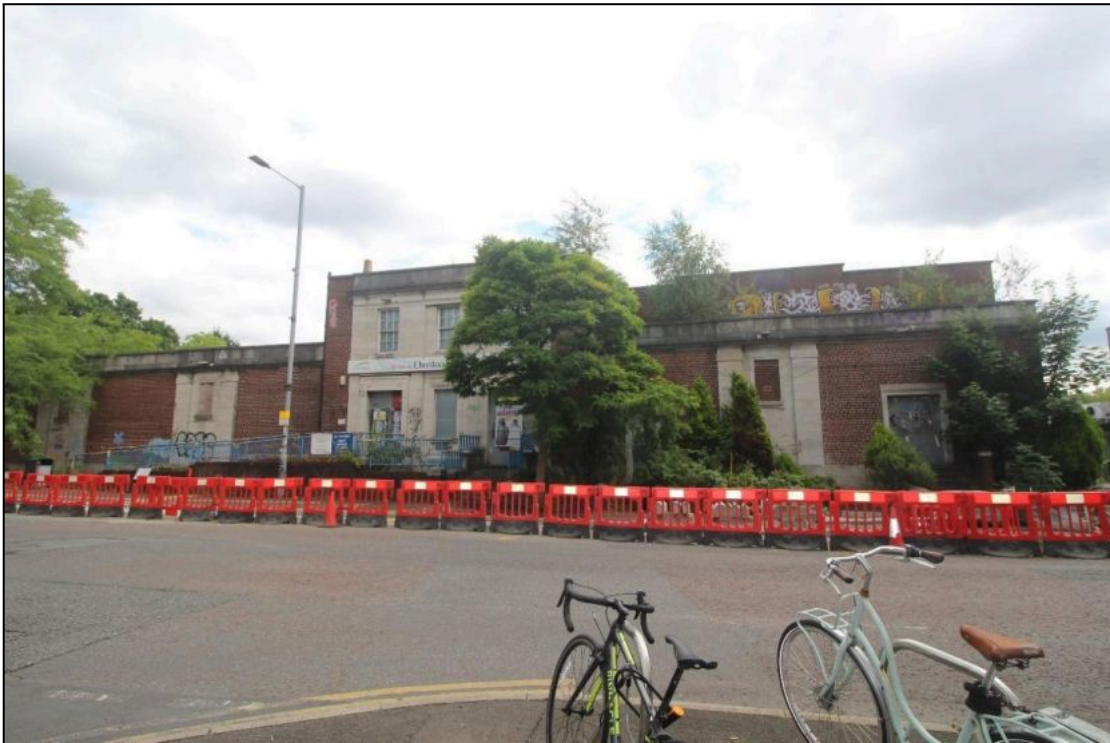
*Plate 9: General view of the western elevation of Chorlton Leisure Centre, looking east*

The western elevation formed the principal façade fronting Manchester Road and comprised the western elevations of the female bath to the north, the reception to the centre and the male bath to the south (Fig 2; Plate 9). The western elevation of a plant room was set back at the northern end of the elevation.

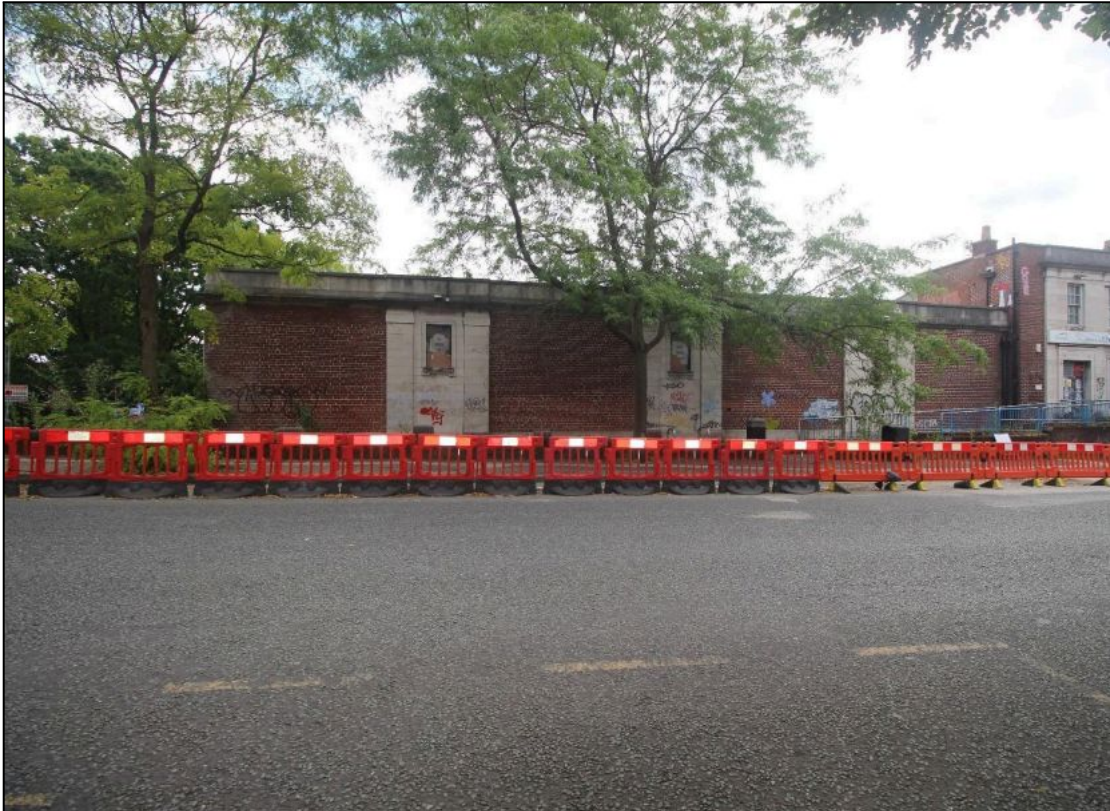
*Plate 10: General view of the western elevation of the female baths, looking east*

The female bath was constructed in a three-stretcher English Garden Wall bond with a Portland stone plinth rising 2'8½" (0.83m) from ground level. The flat roof had a stepped Portland stone parapet wall capped with stone copings (Plate 10). The elevation was divided into four equal recessed brick sections with projecting Portland stone panels. The panels comprised Portland stone pilasters with moulded Doric order capitals. The recessed central panel housed a 2'6" (0.76m) wide window aperture. The openings were blocked with brick infilling and plywood was fixed to the outer face (Plate 11). A cellar light, which was infilled with brick, was also set within each of the stone panels.

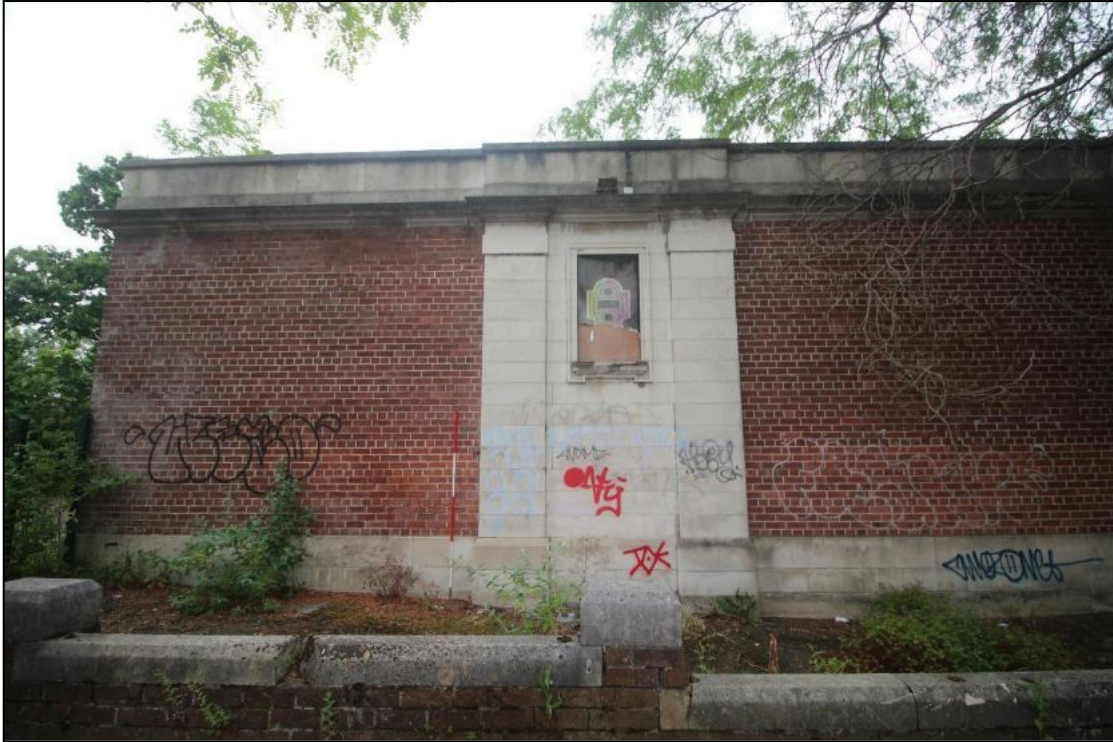
*Plate 11: Detail of the Portland stone recessed panel at the northern end of the western façade, looking east*

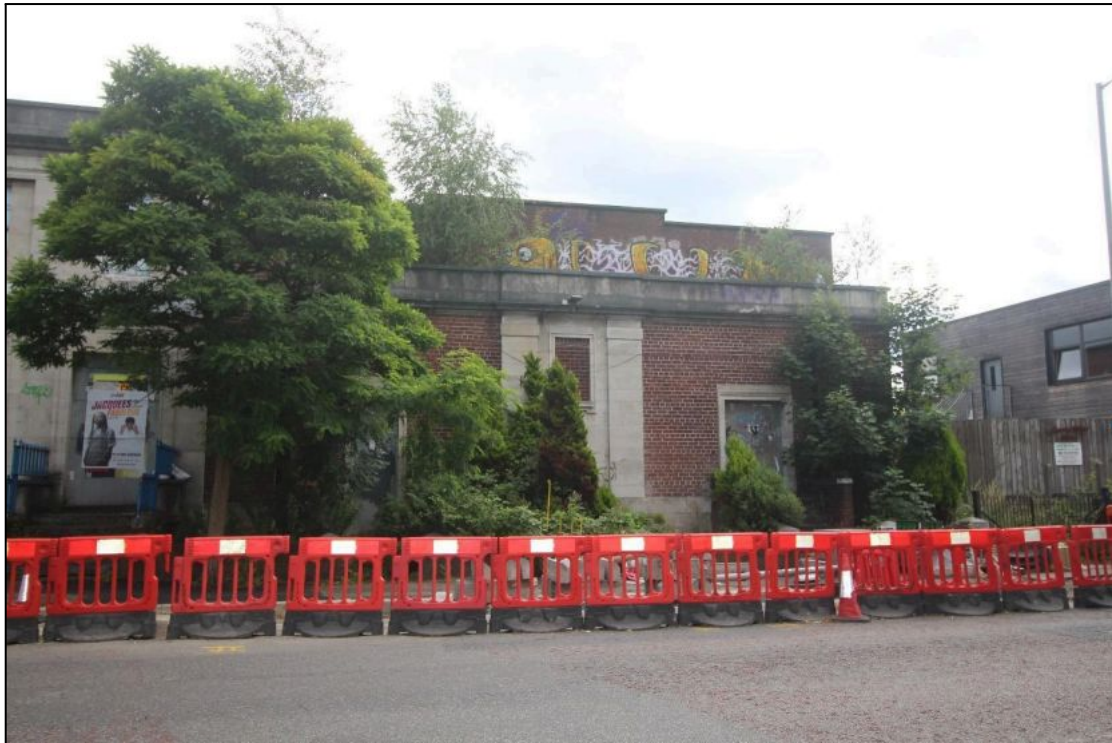
*Plate 12: General view of the western façade of the male bath, looking east*

The male bath's western elevation was constructed in a three-stretcher English Garden Wall bond with a Portland stone plinth rising 2'8½" (0.83m) from ground level. The pitched roof was a modern replacement, however the original stepped parapet wall with Portland stone with stone copings had been retained (Plate 12). The elevation was divided into two equal recessed brick sections flanking a projecting Portland stone panel to the centre. The stone panel had Portland stone pilasters with moulded Doric order capitals. The recessed central panel housed a 2'6" (0.76m) wide window aperture. As with those to the female baths, the opening was blocked with brick infilling and a plywood was fixed to the outer face (Plate 12).

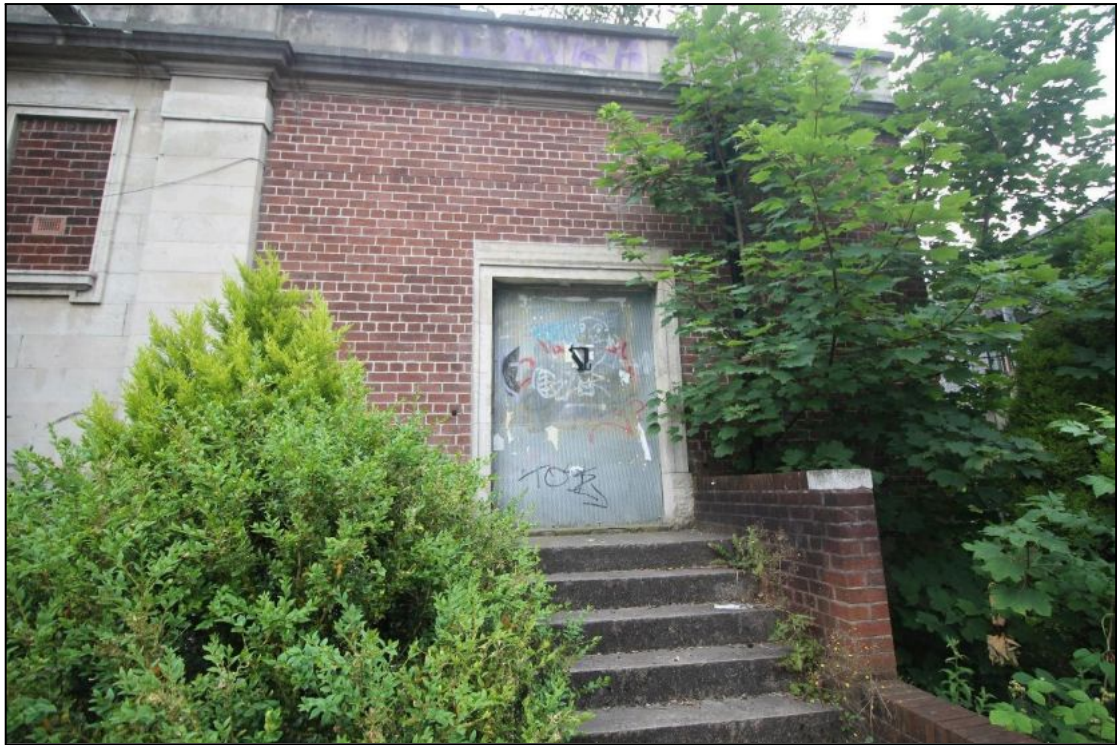
*Plate 13: The southern doorway within the male bath western elevation, looking east*

Two doorways were situated at the centre of the brick panels, affording access into the building (Fig 2). These comprised moulded Portland stone surrounds with the openings blocked with modern steel mesh fixed to the timber doorframes (Plate 13 and 14). The southern doorway was accessed by a set of concrete and brick steps due to the ground level slopping away from the building (Plate 13). A blocked 1'5½" (0.44m) wide window had been situated to the northern end of the façade (Fig 2). The lintel and sill were removed with the opening infilled with modern brick (Plate 14).

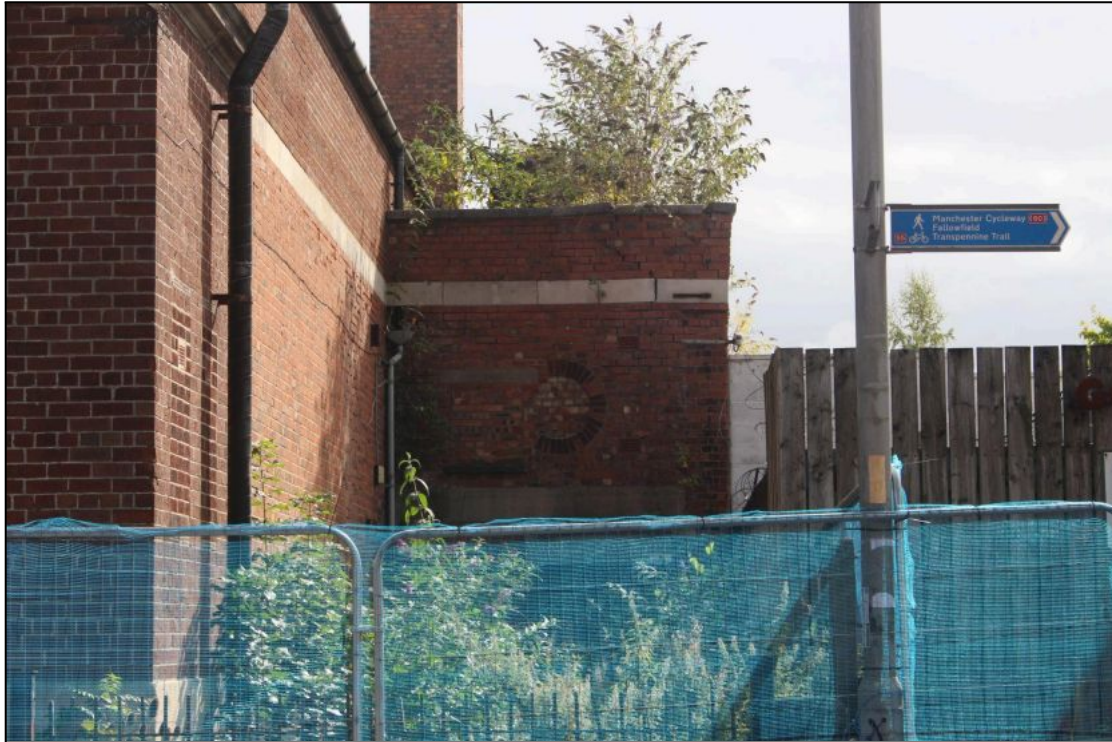
*Plate 15: General view of the western elevation of the attached plant room, looking east*

The western elevation of the attached boiler house was set back (14m) from the male bath. This had largely been obscured with vegetation; however, some features could be observed. The elevation was constructed from a three-stretcher English Garden Wall bond with a light ash mortar. The pitched roof was obscured below a brick

parapet wall with stone copings and a Portland stone string band at eve height (Plate 15). A block round-lit window was situated to the centre of the elevation. Directly below this was a concrete lintel for the loading bay doorway, which was obscured by the overground vegetation (Plate 15).

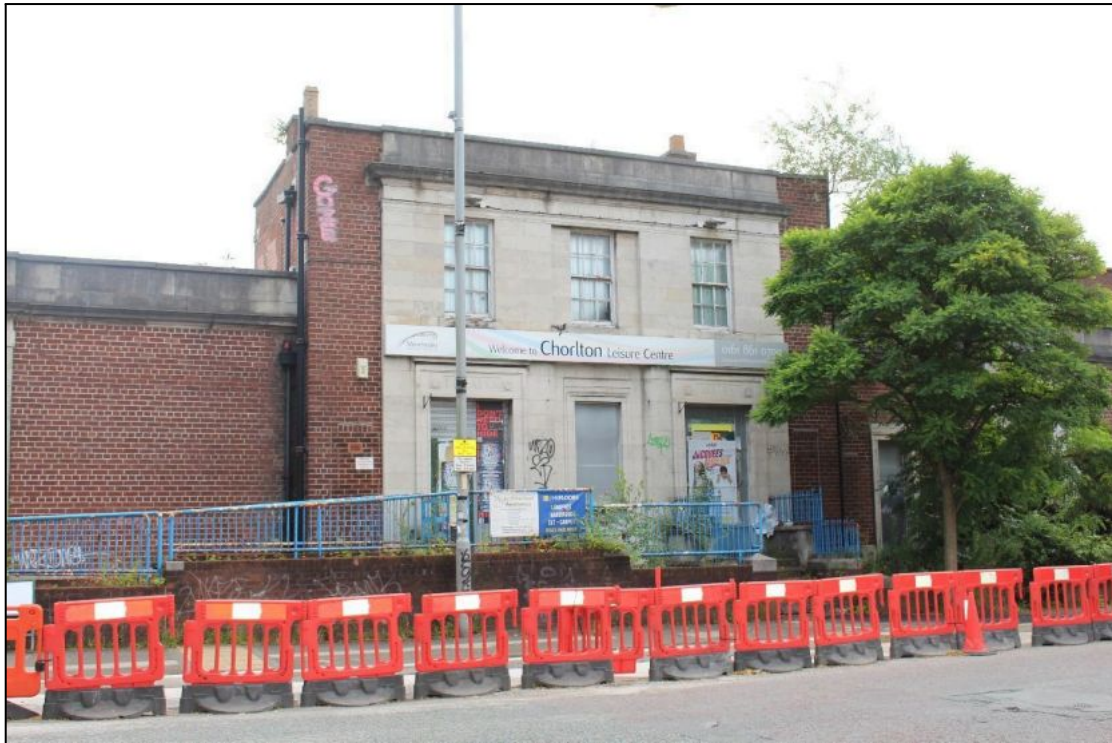
*Plate 16: General view of the western elevation of the office and reception building, looking south-east*

The western elevation of the office and reception building was constructed in a three-stretcher English Garden Wall bond rising to two storeys with a small basement (Fig 2; Plate 16). The centre of the elevation had been constructed with Portland stone that projected out 4½" (0.115m) from the main body of the building (Plate 16).

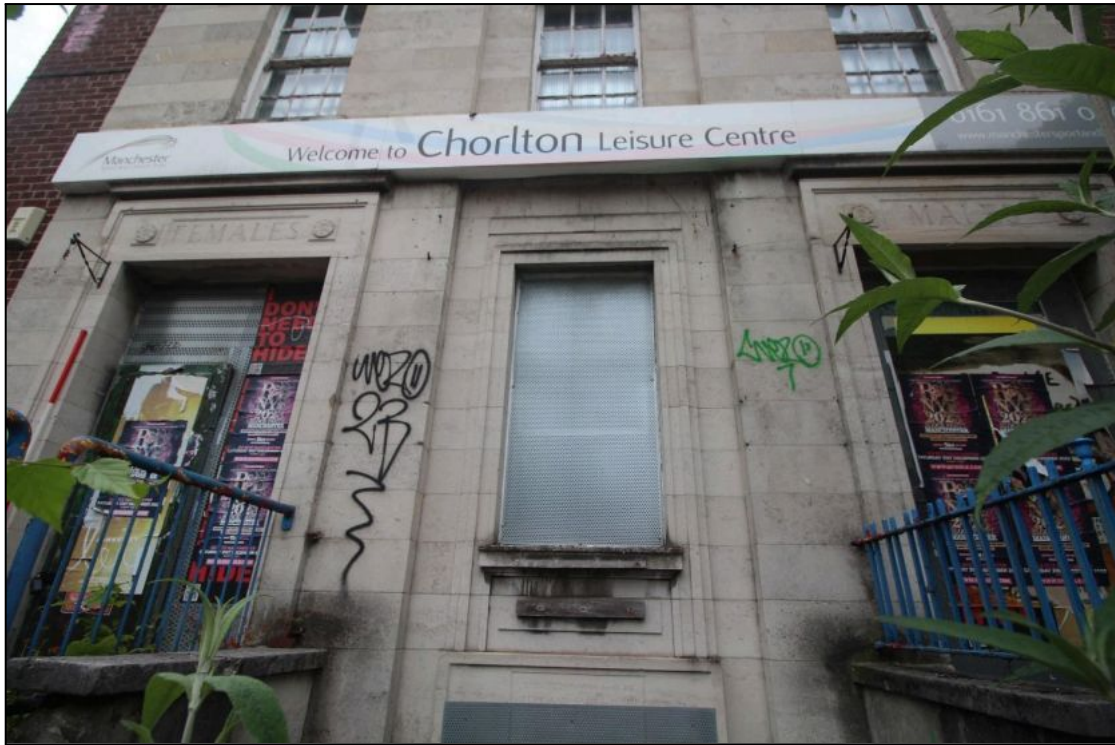
*Plate 17: Detail of the central window aperture of the office building, looking west*

The ground floor of the office and reception building comprised a central window aperture flanked by two doorways that originally afforded separate access into the male and female baths (Fig 2). The window consisted of moulded stone reveals and lintel with a projecting sill (Plate 17). The timber-framed window was obscured externally by modern steel mesh (Plate 17). Directly below the sill was a recessed frieze with a timber bracket fixed to a central stone embossment (Plate 17).

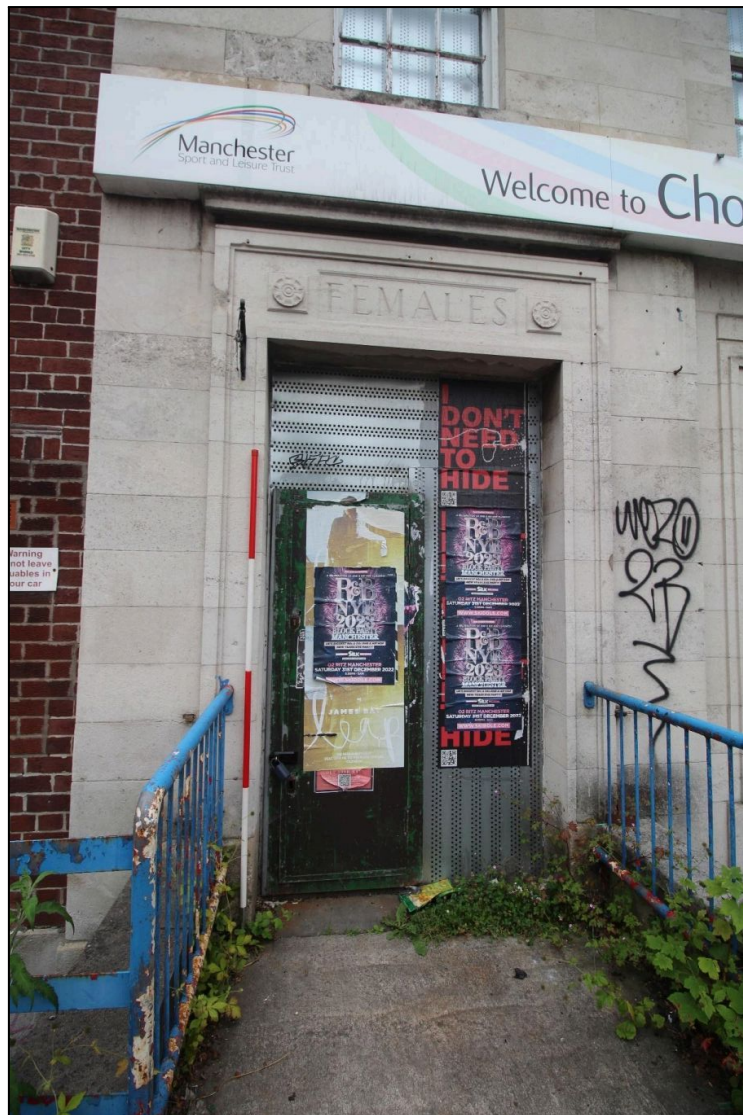
*Plate 18: Detail of the northern doorway affording access into the female baths, looking west*

The northern doorway originally afforded access into the female baths which was later modified to form the principal entrance into the complex. The doorway consisted of a moulded stone surround and a recessed frieze with 'FEMALES' carved into the stone, flanked by two floral motifs (Plate 18). The southern doorway was of similar design, but with 'MALES' carved into the frieze (Plate 19). The northern doorway was modified during the latter half of the 20<sup>th</sup> century with access afforded by a concrete ramp, whilst the southern entrance retained the original concrete steps (Plates 18 and 19). The doors to each of the openings were obscured by modern security steel mesh.

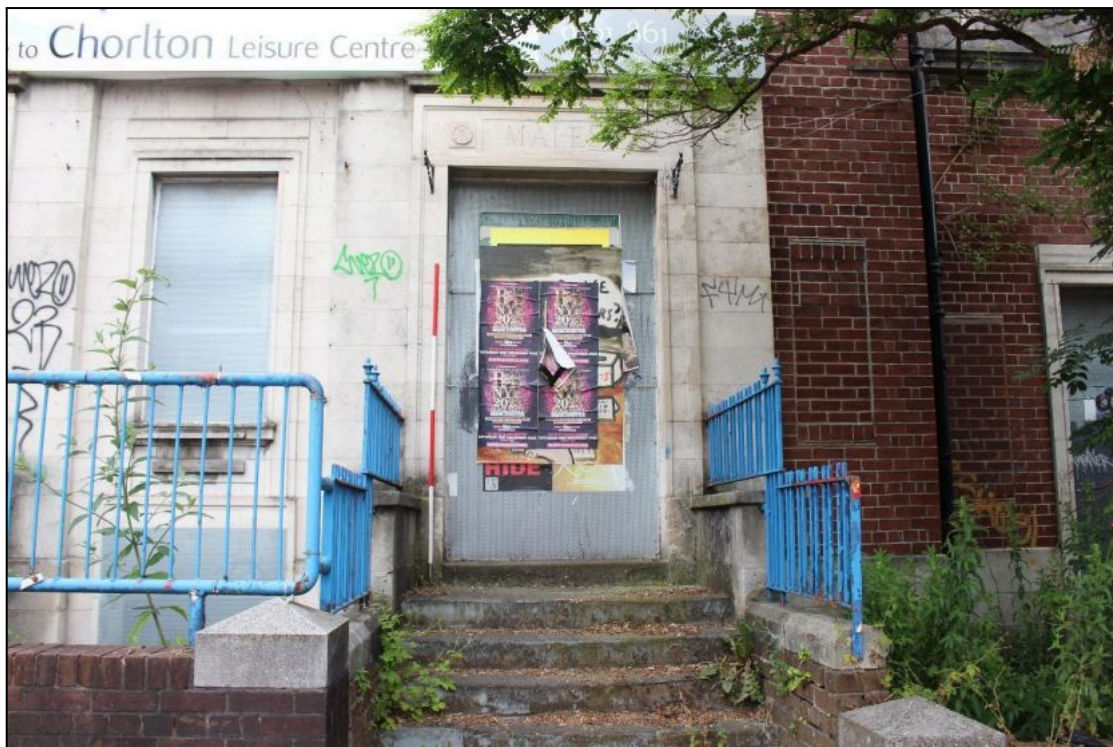
*Plate 19: Detail of the southern doorway affording access into the male baths, looking west*

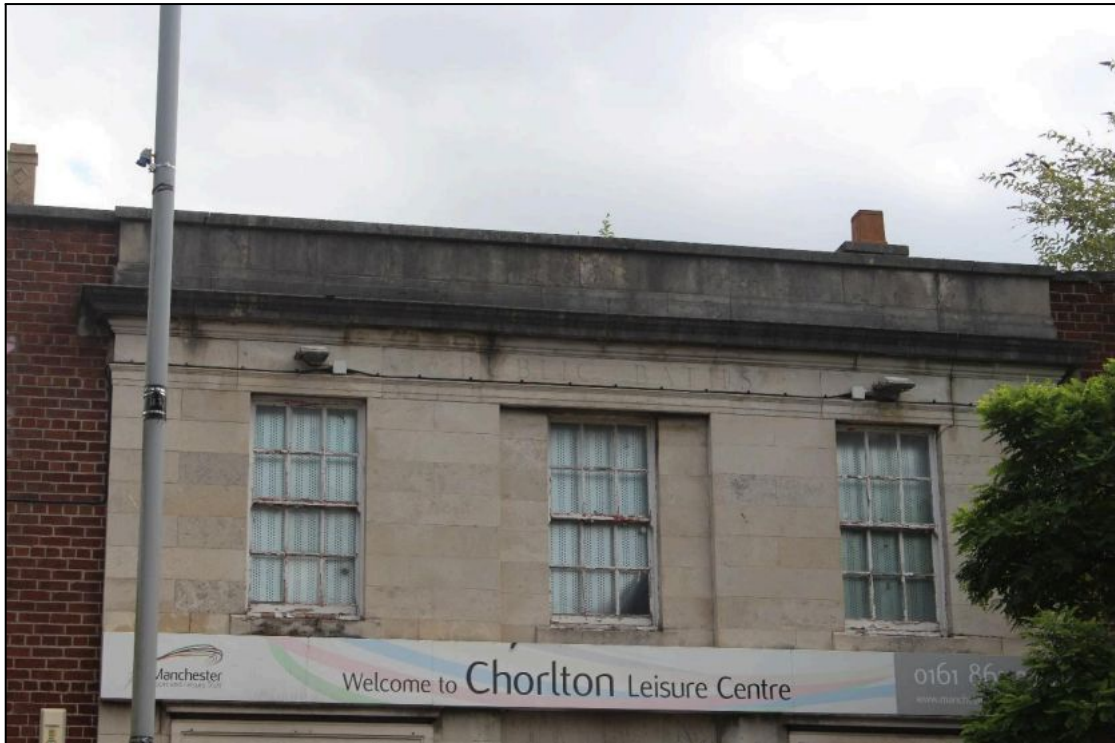
*Plate 20: Detail of the first floor of the eastern elevation, looking west*

The first floor comprised three recessed window apertures with an oversailing moulded stone cornice situated at ceiling height. The 3'1" (0.93m) wide windows comprised Portland stone surrounds with 12-light timber framed sash windows with horns (Plate 20). The frieze above had the inscription 'PUBLIC BATHS' to the centre (Plate 20).

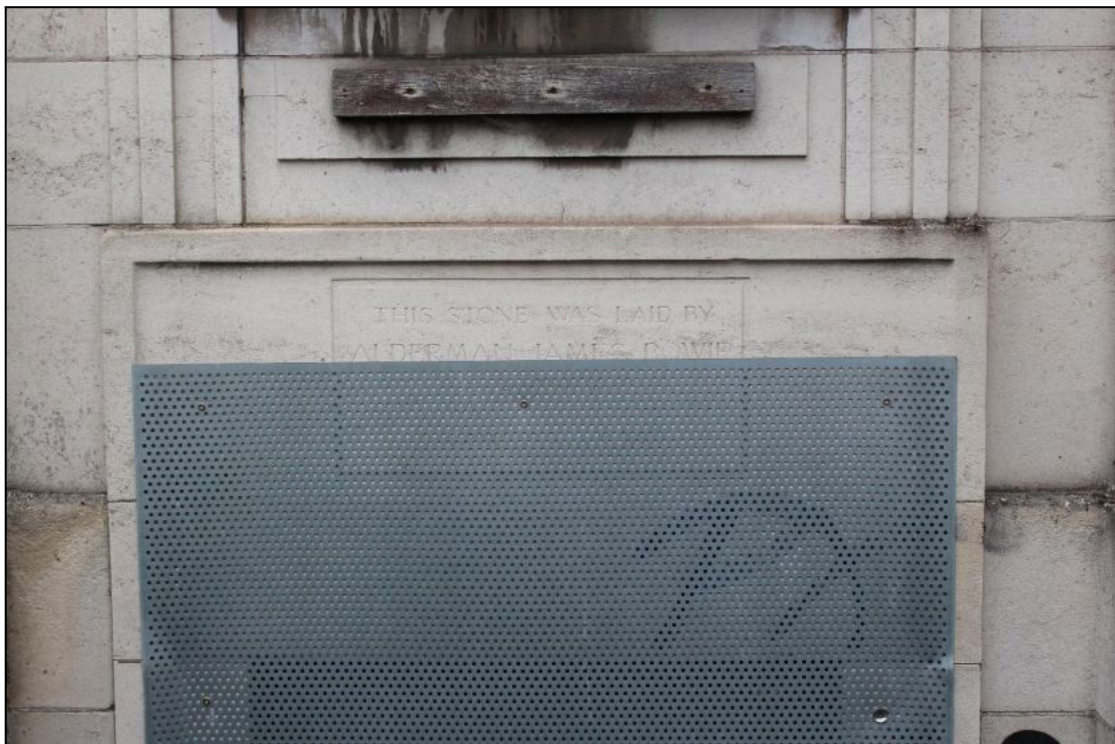
*Plate 21: Detail of the inscription above the doorway affording access into the basement, looking west*

The basement comprised a central doorway with a moulded Portland stone surround and a projecting stone hood mould. The door within the opening was obscured by modern steel mesh. A partially visible inscription carved into the stone frieze read 'THIS STONE WAS LAID BY ALDERMAN JAMES BOWIE' (Plate 21).

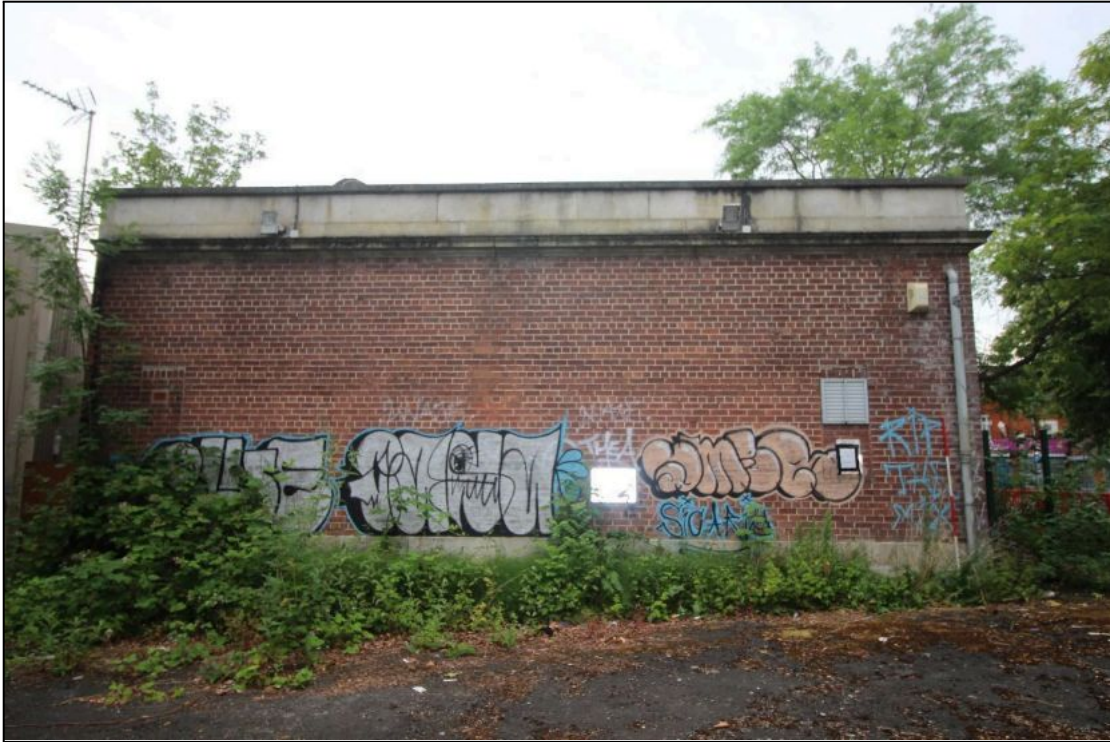
*Plate 22: General view of the northern elevation of the female baths, looking south*

The northern elevation of the complex was formed by the northern elevation of the female baths (Plate 22; Fig 3). This was constructed in a three stretcher English Garden Wall bond with a Portland stone plinth and parapet wall capped with concrete copings (Plate 22). The elevation contained two blocked windows to the eastern and western ends. These had been infilled with brick with vents inserted into the upper section of the blocking (Plate 22).

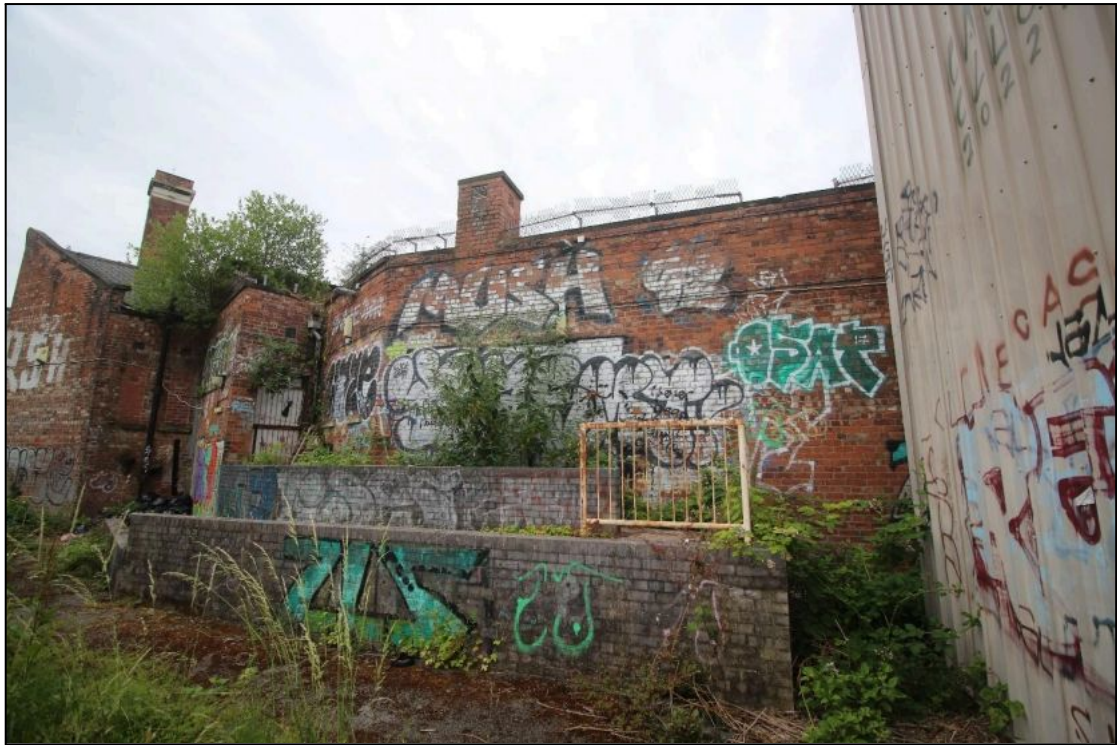
*Plate 23: General view of the northern section of the eastern elevation, looking west*

The eastern elevation was constructed in a three stretcher English Garden Wall bond and comprised two gables to the south and an angled elevation to the north (Fig 2; Plate 23). The northern section was largely obscured by the 1970s constructed squash courts, but some elements had been observed. Two blocked windows were situated to the southern end of the section. The 1'5½" (0.44m) wide apertures consisted of gauged brick flat arched heads with projecting sandstone sills. The openings were infilled with modern bricks (Plate 24).

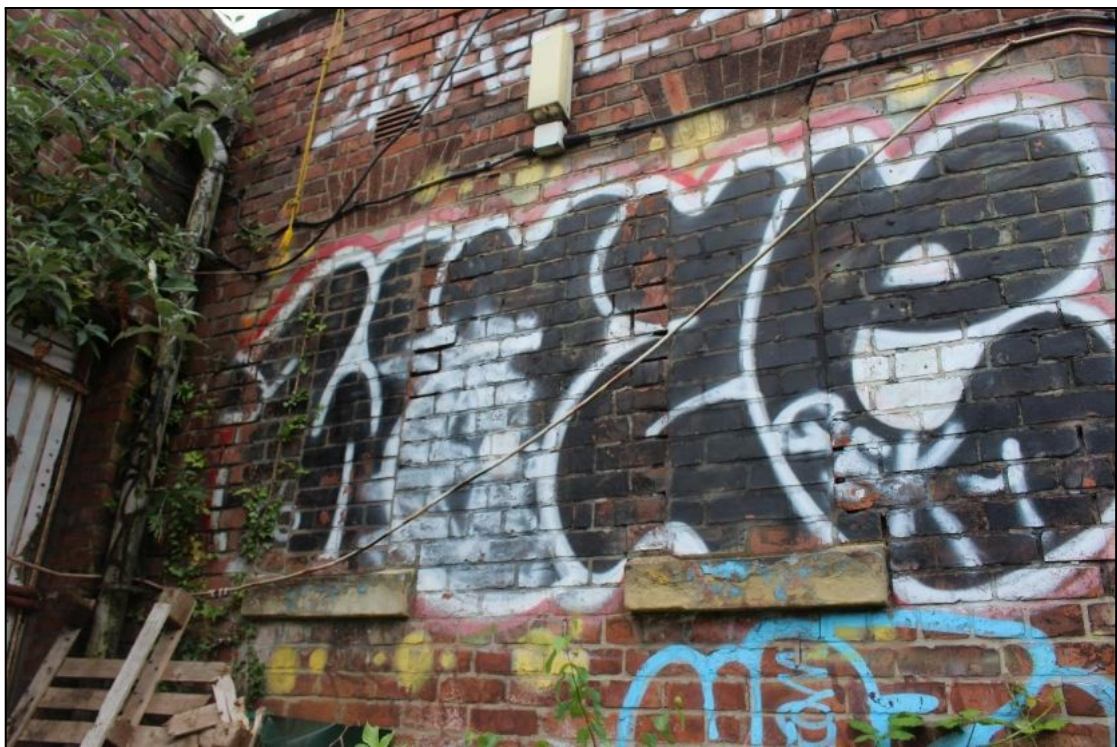
*Plate 24: Detail of the blocked windows within the northern section of the eastern elevation, looking south-west*

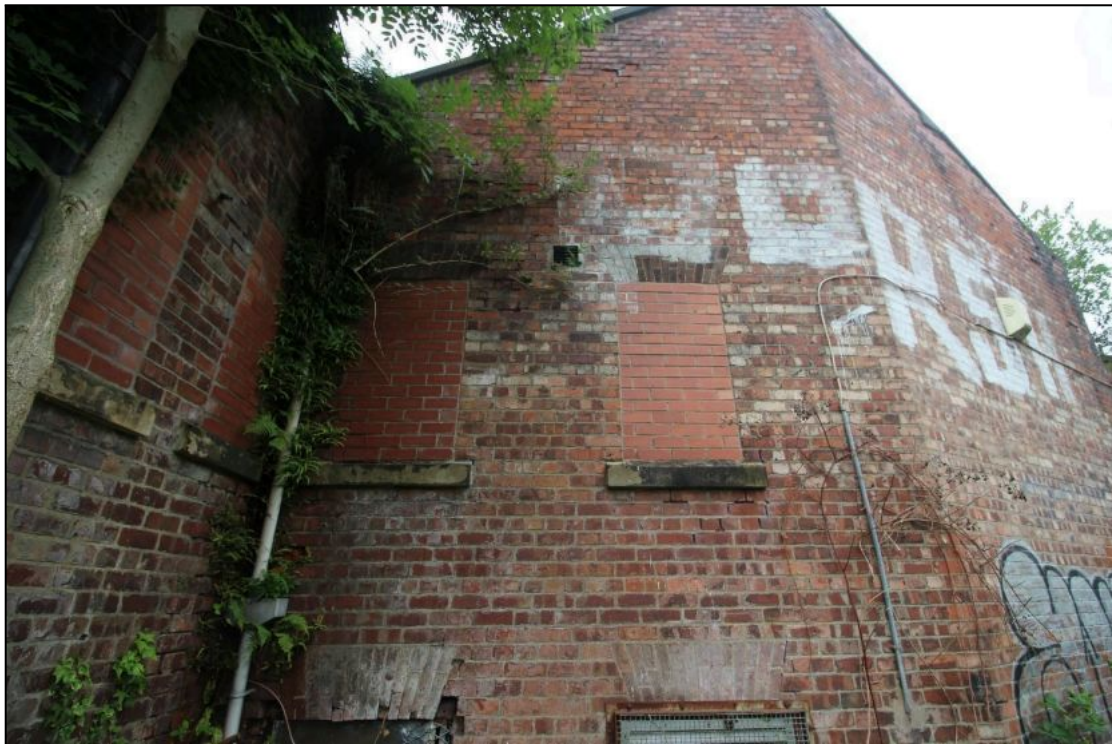
*Plate 25: Detail of the blocked windows within the southern half of the gable walls, looking west*

The southern section of the elevation contained two projecting bays with gable walls. Each gable was constructed with a small obtuse angle to the northern half of each. These were constructed in a three stretcher English Garden Wall bond. The southern half of the gables contained two sets of window apertures to the ground floor and basement. The 2'7½" (0.79m) wide apertures consisted of gauged brick flat arched heads with projecting sandstone sills. The openings were infilled with modern bricks (Plate 25). A further set of windows were situated within the southern wall of the southern projecting bay. These were also 2'7½" (0.79m) wide apertures comprising gauged brick flat arched heads with projecting sandstone sills. The openings were infilled with modern bricks (Plate 26).

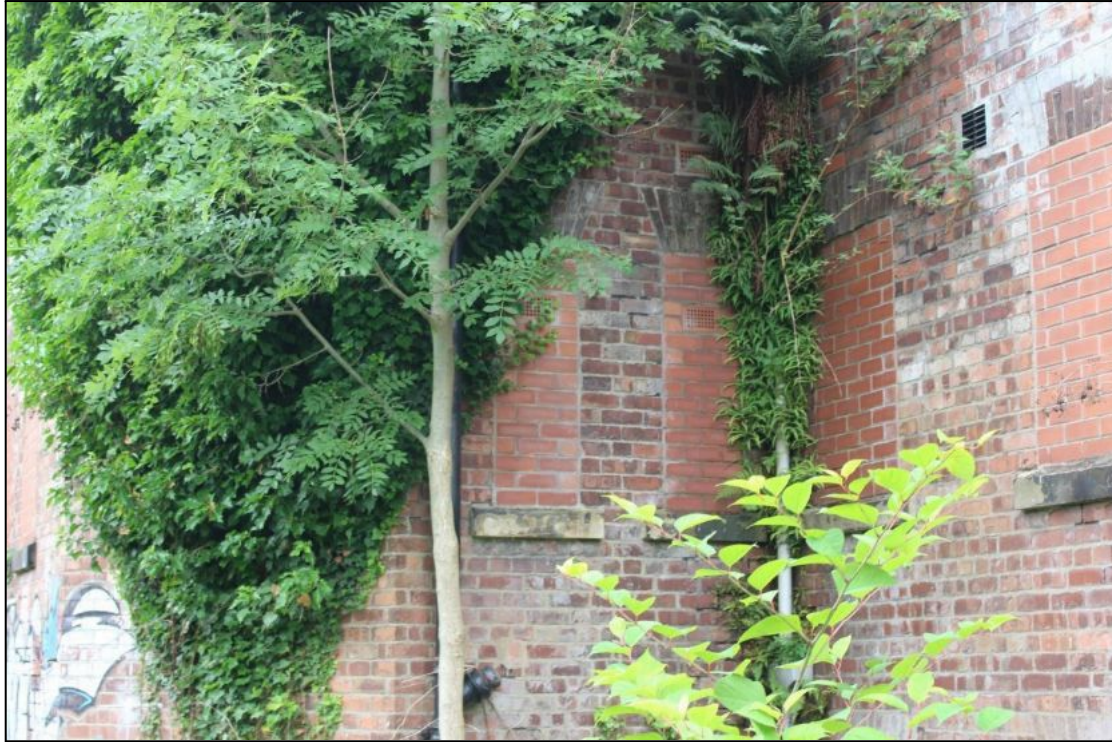
*Plate 26: Detail of the blocked windows within the southern elevation of the southern bay, looking south*

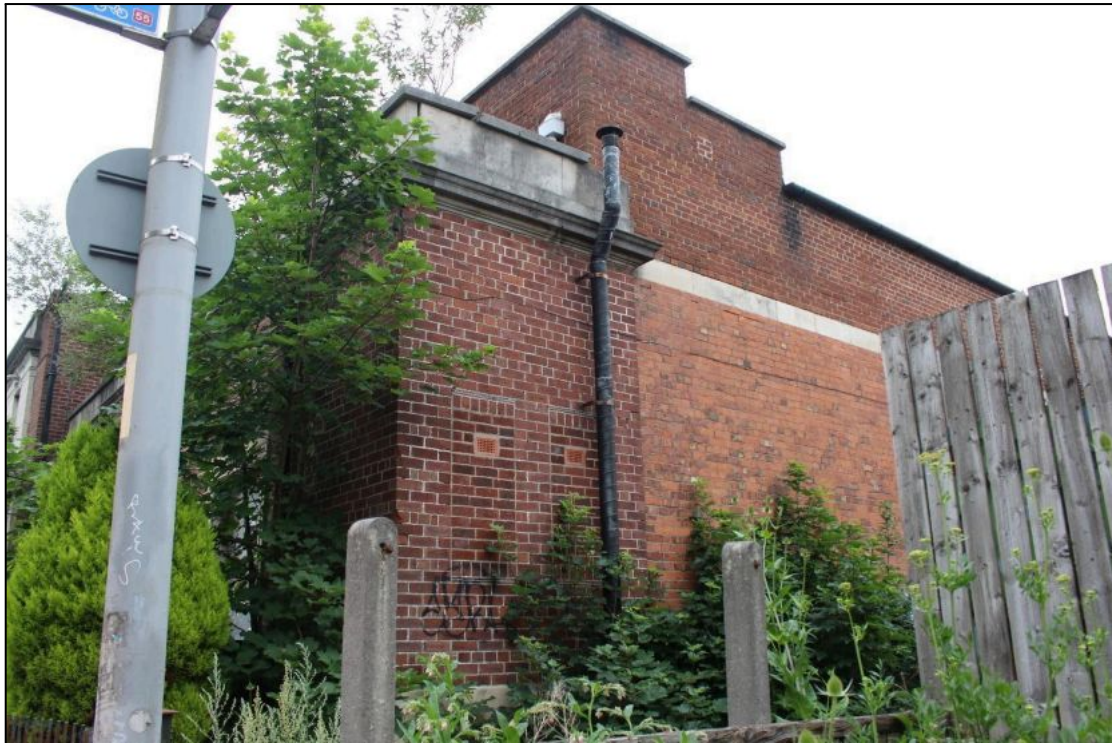
*Plate 27: General view of the southern elevation of the male baths, looking north-east*

The southern elevation was largely obscured by vegetation and the adjacent property to the south of the site (Fig 3; Plate 27). The single-storey stepped elevation was built in a three stretcher English Garden Wall bond with a small parapet wall capped with concrete copings (Plate 27). A Portland stone string course was situated at ceiling height.

The Portland stone plinth and entablature to the eastern elevation continued around and terminated 8'1½" (2.47m) in from the eastern end. The elevation contained two blocked windows at the western end with each infilled with brick and a modern terracotta vent was inserted to the upper section of the blocking (Plate 27).

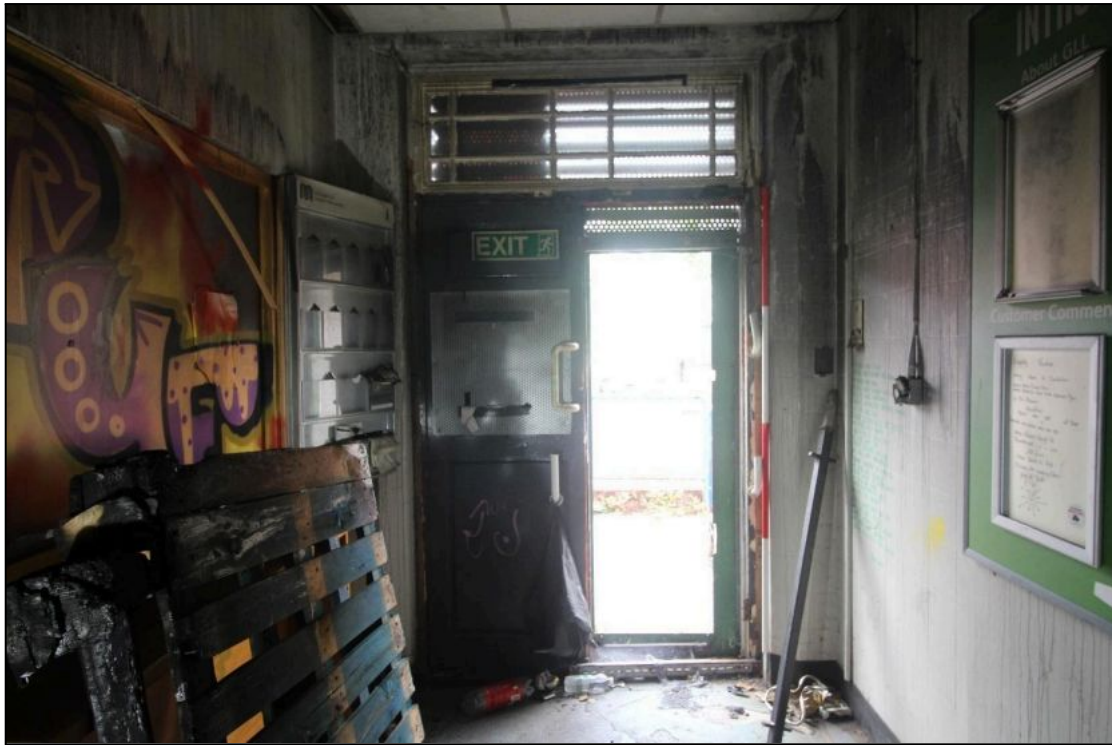
*Plate 28: Detail view of the principal entrance into the leisure centre, looking west*

Principal access into the complex was afforded by the doorway within the original female entrance. The doorway was recessed within the opening and comprised moulded timber architraves housing a pair of timber fire doors and a 15-light transom window above (Plate 28). The jambs and head to the recess were tiled with white glazed 6" (0.15m) squared tiles (Plate 28).

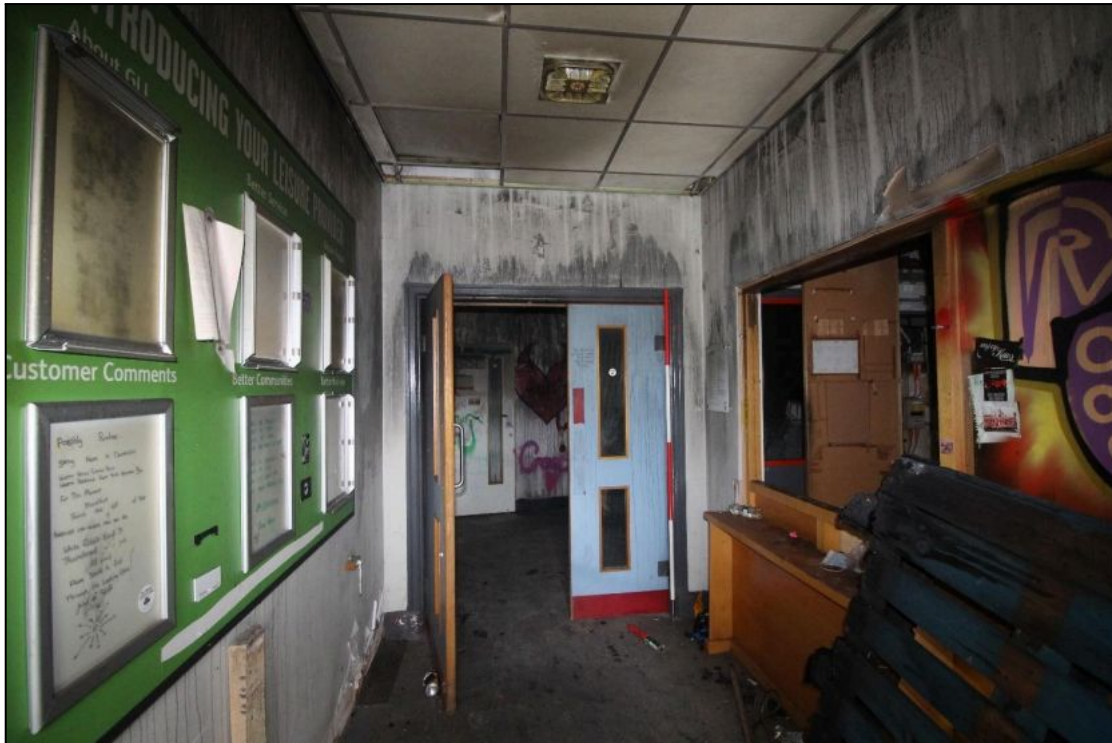
*Plate 29: General view of Room 1, looking east*

The doorway entered a reception room, (Room 1, Fig 4), comprising a concrete floor and a false suspended ceiling. The walls were tiled with white glazed 6" (0.15m) squared tiles with a band of decorative tiles at a height of 1.8m (Plates 29 and 30). The original flat ceiling with a concave cornice was partially observed after the removal of one of the ceiling tiles (Plate 31).

The southern wall had been remodelled with the insertion of a large reception window with modern timber architraves and desk (Plate 32). The western wall contained a large doorway that afforded access into Room 2. The opening comprised moulded timber architraves rising from square pedestals (Plate 29). A pair of replaced timber fire doors with modern door furniture was housed within the opening (Plater 29).

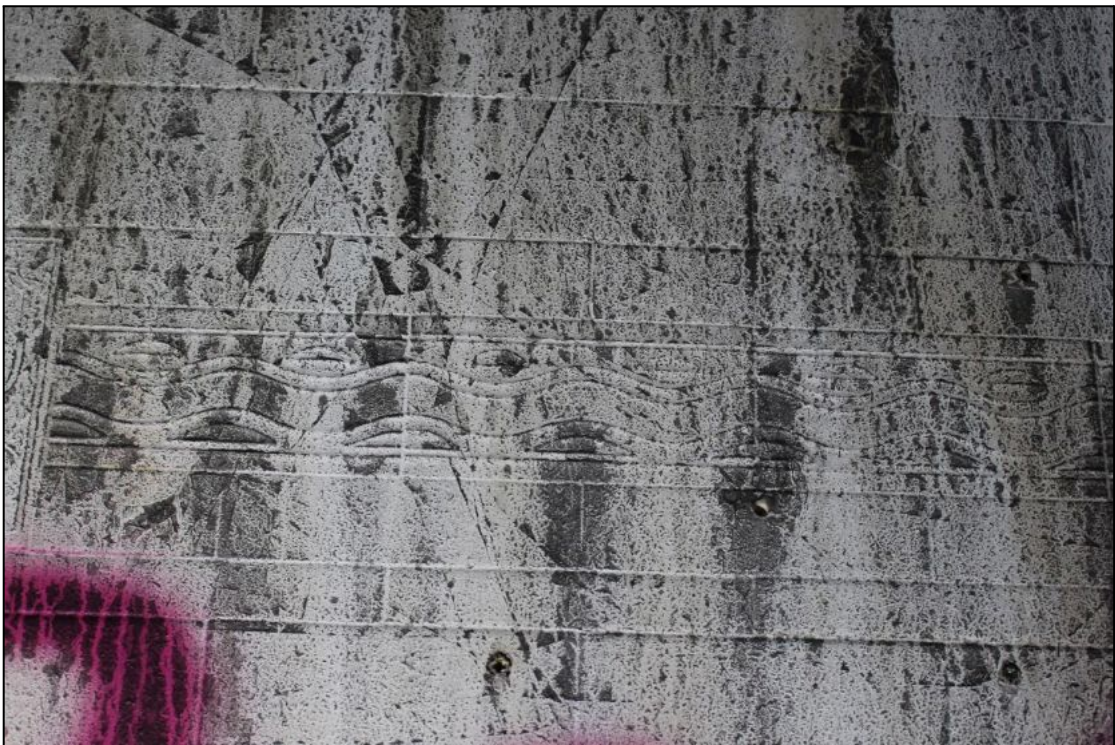
*Plate 33: General view of Room 2, looking east*

Room 2 (Fig 4) comprised a concrete floor and a false suspended ceiling. The walls were tiled with white glazed 6" (0.15m) squared tiles with a band of decorative tiles at a height of 1.8m (Plates 33 and 34). The original flat ceiling with a concave cornice was partially observed after the removal of one of the ceiling tiles. The room acted as

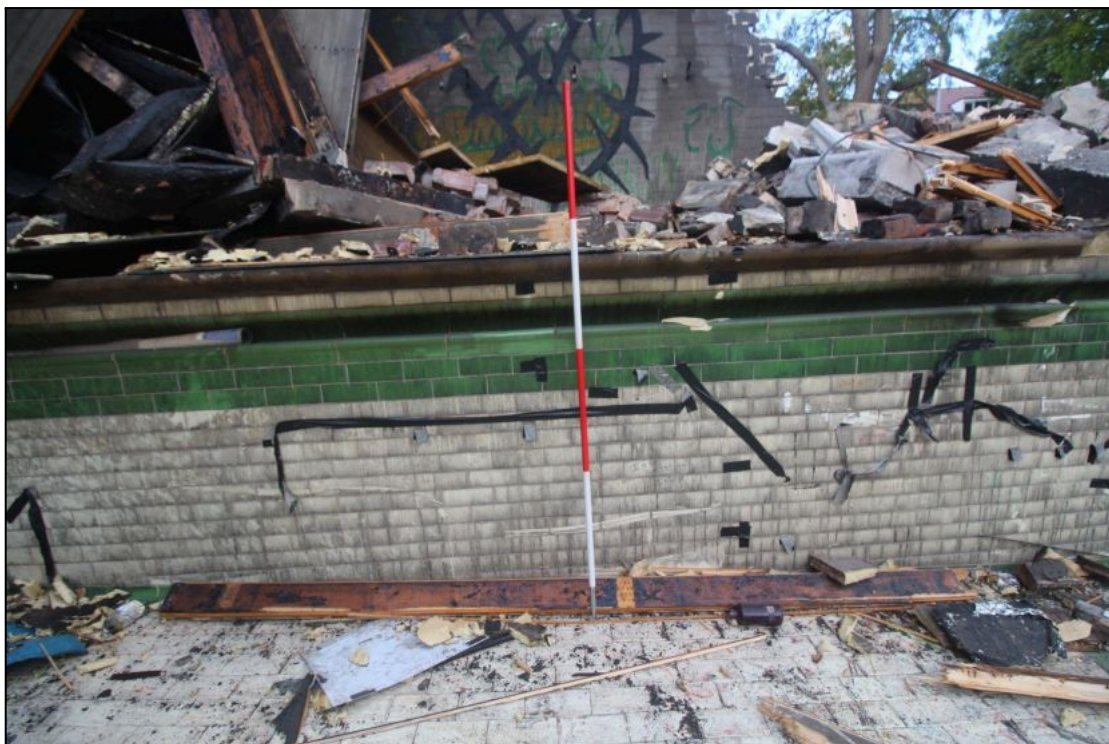
*Plate 37: Detail of the female pools tiled wall and floor*

The floor was of maroon glazed tiles with stone edging around the pool. The pool (22.7m long by 7.46m) contained the original glazed white tiled floor and walls with a green tiled band at the upper edge (Plate 37 and 38). During the watching brief the floor of the bath was largely uncovered. The white tiles bordered a series of centrally set rectangles of glazed green tiles (Plate 39).
