## **Historic Building Investigation and Watching Brief Report**

Chorlton Leisure  
Centre, Manchester  
Road, Manchester

Document Type: Historic Building Investigation and Watching Brief Report

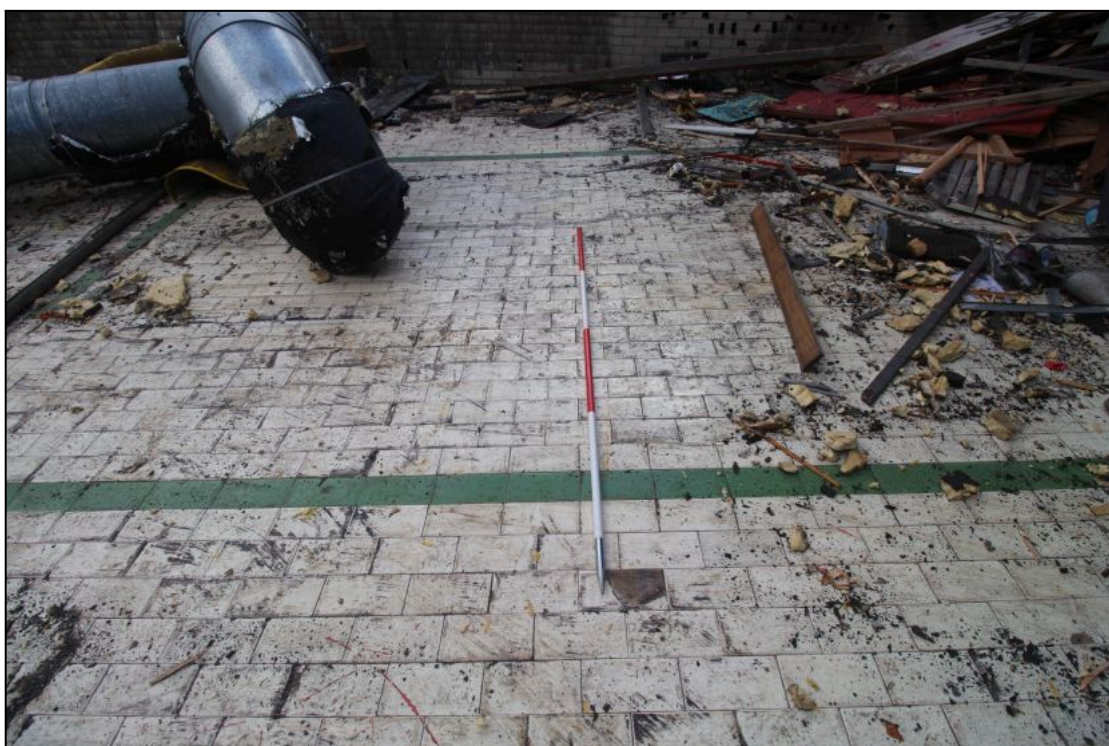
*Plate 38: Detail of the female pools tiled wall and floor during the watching brief*

The floor was of maroon glazed tiles with stone edging around the pool. The pool (22.7m long by 7.46m) contained the original glazed white tiled floor and walls with a green tiled band at the upper edge (Plate 37 and 38). During the watching brief the floor of the bath was largely uncovered. The white tiles bordered a series of centrally set rectangles of glazed green tiles (Plate 39).

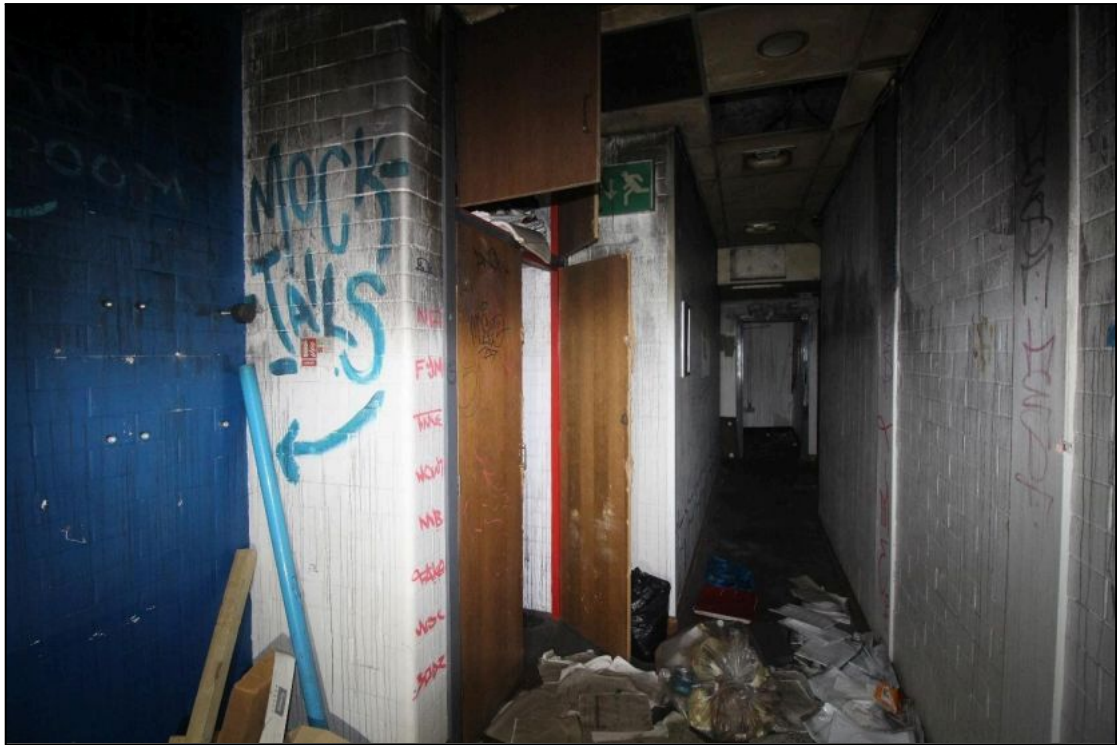
*Plate 40: The north-western changing cubical within the female baths*

Two of the original small slipper changing rooms were situated to the northern end of the room. These were constructed in glazed brick walls, with a tiled floor and ceiling. A doorway with a flat arched head afforded access into each cubical. The doors were modern replacements (Plate 40).

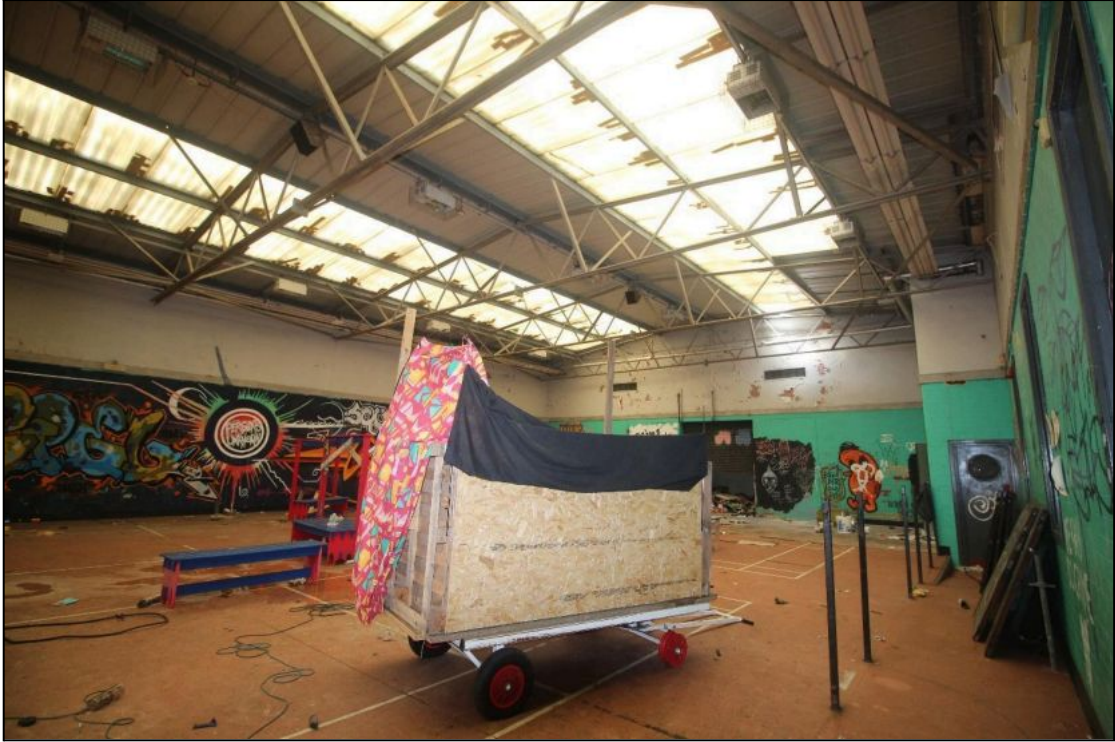
*Plate 46: General view of the gymnasium now occupying the location of the original male pool, looking south-west*

The original male pool to the southern end of the complex was heavily modified with the pool infilled, and a modern gymnasium timber floor was installed (Plate 46). The modern corrugated steel roof had been supported by modern L-section angle iron trusses (Plate 46). During the demolition of the building the original fabric of the male pool was uncovered. The pool comprised glazed cream and green tiles to the floor

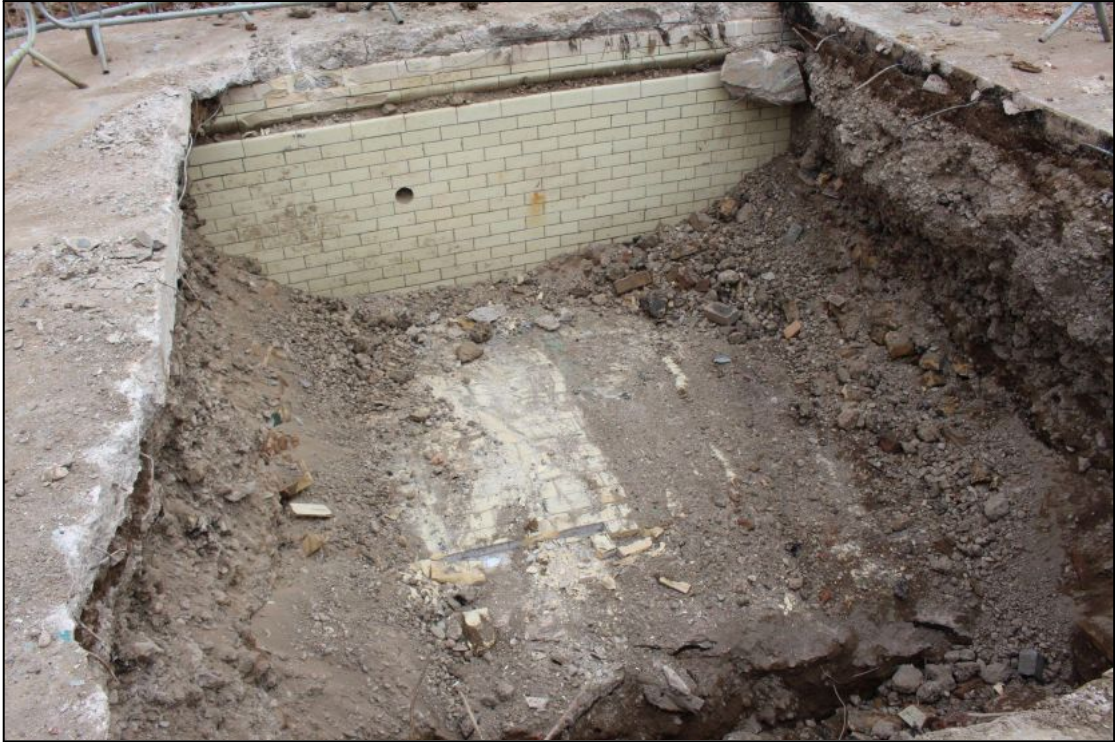
*Plate 47: Detail of the male pool's tiled wall and floor during the watching brief, looking north*

and cram tiles to the walls. A drainage channel was partially retained within the wall and was constructed with glazed cream bullnose tiles (PLate 47). The floor tiles were laid directly upon a bed of 0.1m (4ins) thick concrete. During the remodelling of the complex in the 1980s the pool was instilled with sand and stone and capped with a 0.1m (4ins) concrete slab (Plate 47)

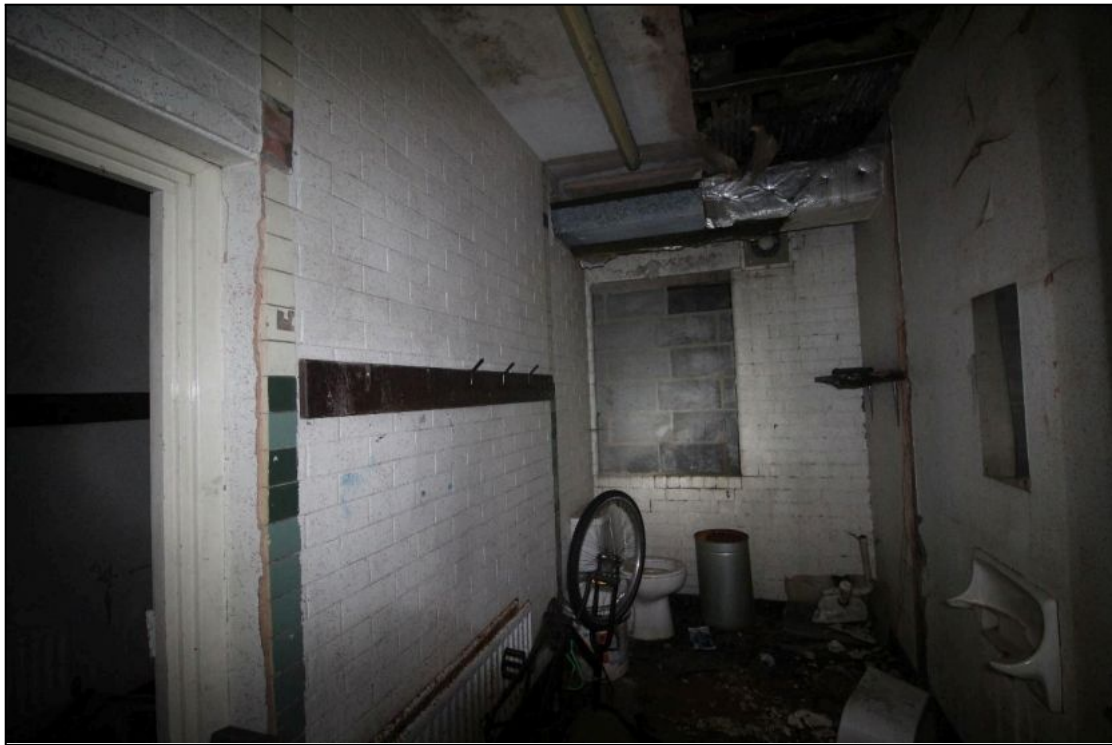
*Plate 49: General view of Room 19, looking east*

Rooms 19-21 had retained the original fabric consisting of concrete floors, flat ceilings and glazed brick walls (Plate 49). The eastern wall of Room 19 and 20 contained a blocked window with glazed bullnose brick reveals, sills and lintels. The window frames had been removed with the openings infilled with modern concrete blocks (Plate 49).

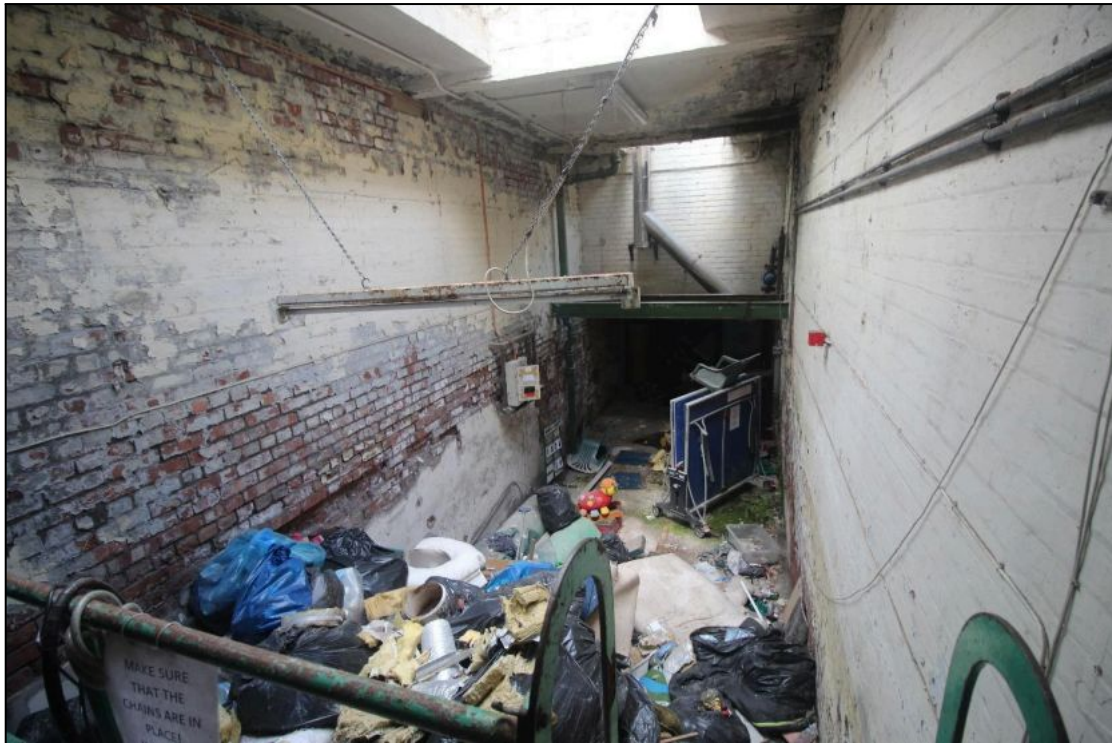
*Plate 51: The western room of the plant room, looking west*

The boiler house was divided into two sections with the western section (16.4m by 3.79m) originally housing a boiler. The rooms (23 and 24) were constructed in red brick with an open ceiling and a concrete floor that was on two levels (Plate 51). The roof was constructed with concrete beams and contained two L-section angle-iron framed lantern skylights with replaced clear glass glazing. The lower section of the room was afforded descending access by a steel ladder and by a doorway to the western end of the northern wall from the basement. All features associated with the boiler had been removed, however areas of heat scarring was partially observed on the side walls.

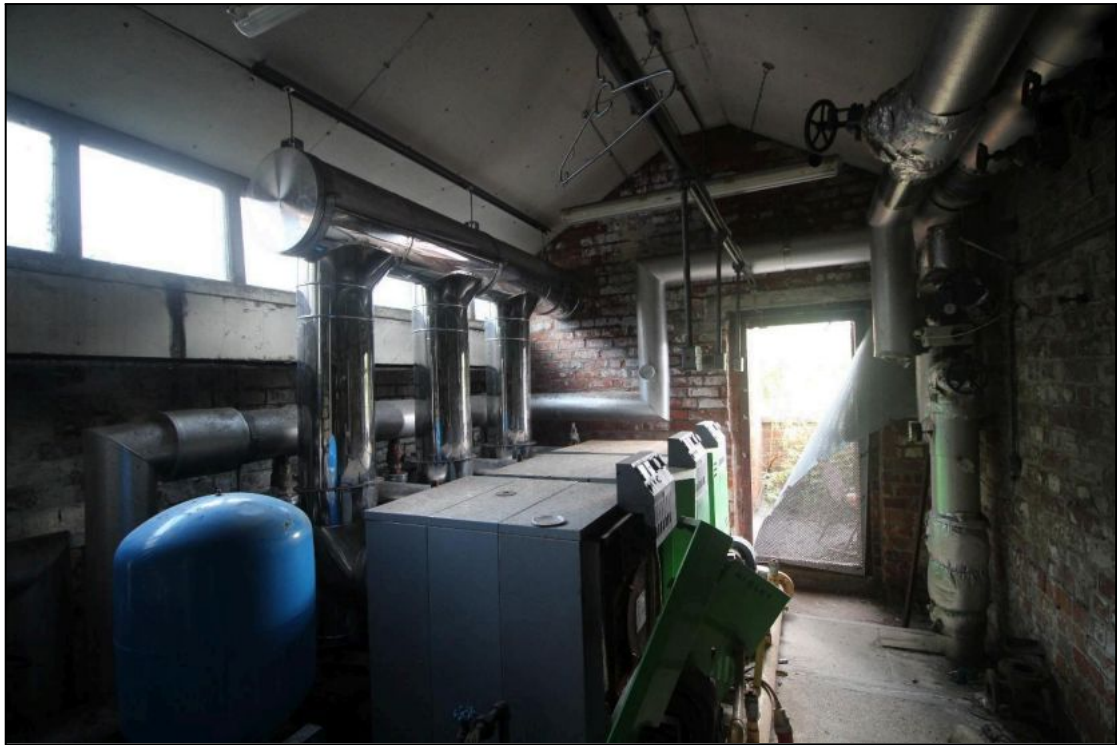
*Plate 52: The eastern room of the plant room, looking east*

The eastern room, (Room 25), was afforded ascending access by a set of concrete steps located at the south-eastern corner of Room 23 (Fig 4). This room contained an early 21<sup>st</sup>-century boiler and calorifier system and associated pipework (Plate 52). The room comprised brick walls, a concrete slab floor with a pitched ceiling having modern fireboard that fireproofed the roof (Plate 52). The eastern wall formed the gable wall of the plant room with an external doorway situated to the southern end (Plate 52). The doorway afforded access onto the eastern end of the boiler house roof with a small privy situated to the north-eastern corner (Fig 4).

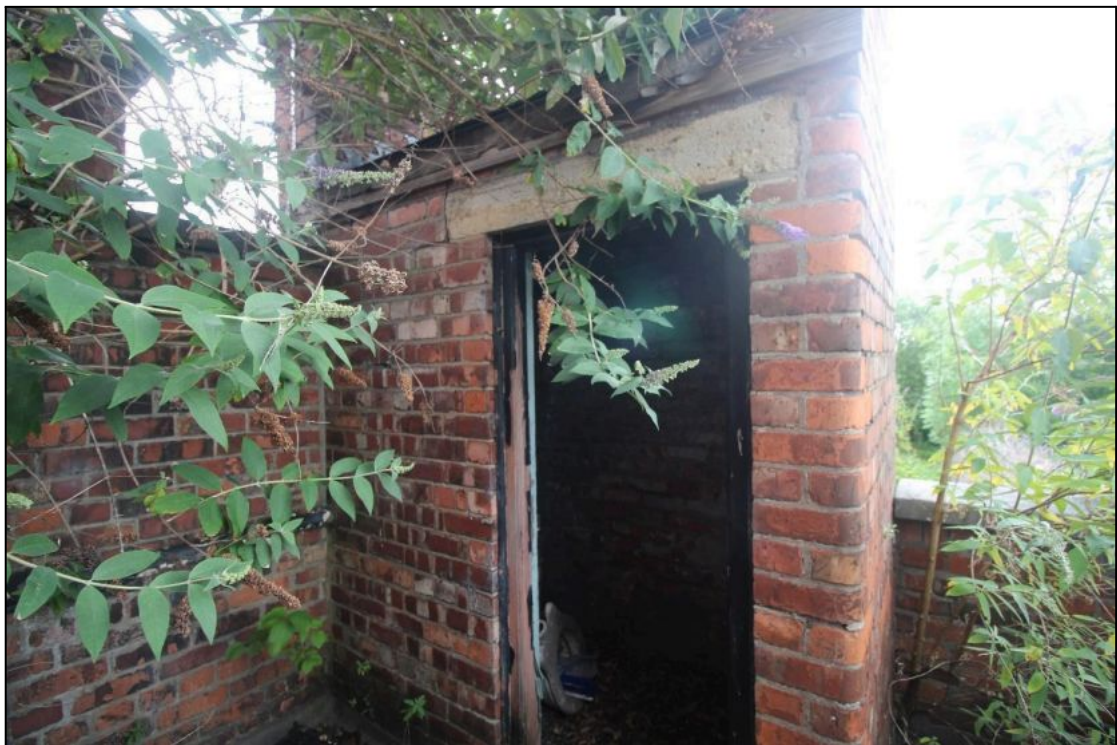
*Plate 53: The outside privy at situated to the north-eastern corner of the plant room*

The privy (Room 26) was constructed in a three-stretcher English Garden Wall bond with flat roof below a small parapet wall capped with concrete copings (Plate 53). The doorway entering the privy had retained the original timber doorframe and flush concrete lintel (Plate 53). Internally, the sanitaryware had been removed, however, a steel bracket which supported the gravity fed cistern was situated high on the northern wall.

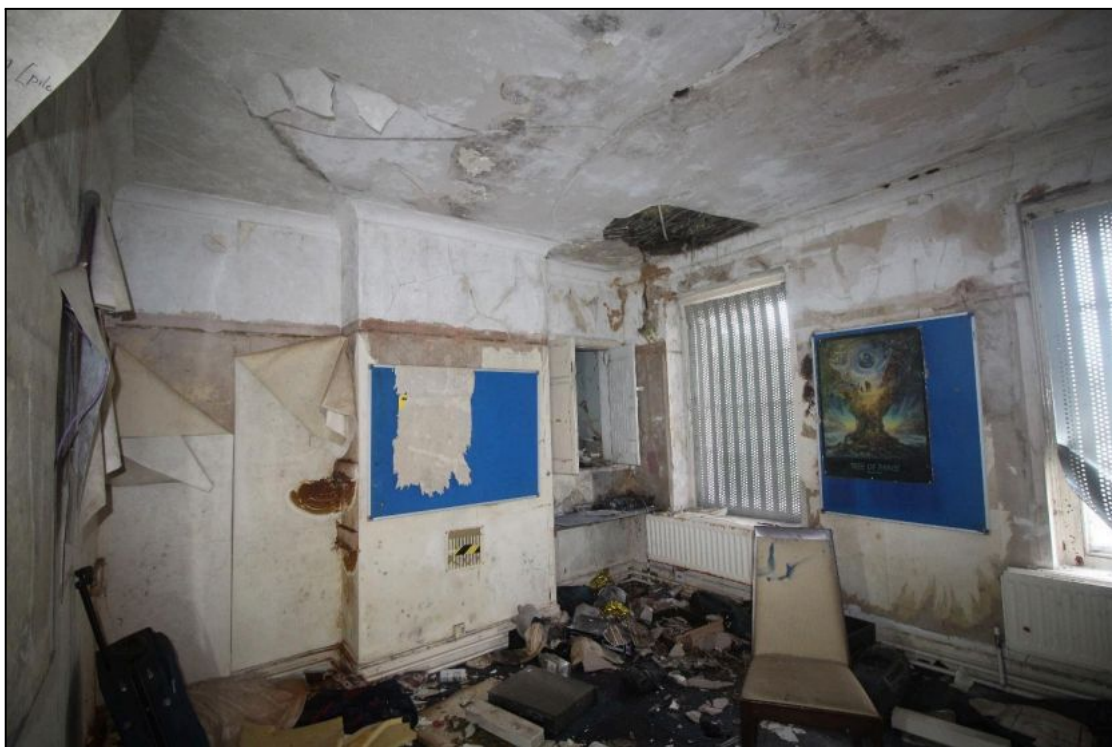
*Plate 59: Detail of the chimney breast at the centre of the southern wall of Room 34, looking south*

Room 34 was situated to the south-western corner and comprised a timber floor, lath and plaster walls and ceiling with concave coving (Fig 5; Plate 58). The western wall contained two window apertures measuring 3' (0.91m) wide with moulded timber architraves and a timber internal sill (Plate 58). At the centre of the southern wall was a projecting chimney breast. The fireplace was infilled with a modern vent inserted into the centre of the original opening (Plate 59).

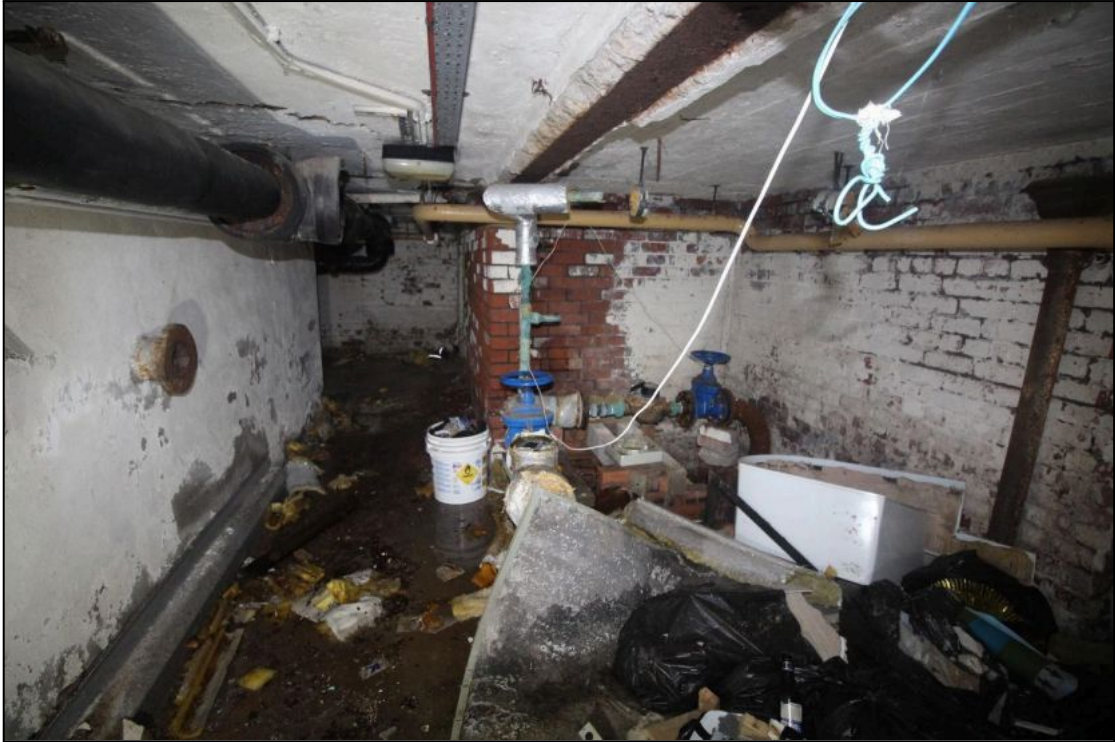
*Plate 62: General view of the basement area, detailing the modern pipework that had replaced earlier cast-iron pipework*

The basement was a low-level area with a maximum height of 1.75m and consisted of painted brick walls, a concrete floor and ceiling (Plate 62). The basement was primarily used for the utilities and extended below the entire footprint of the main building above. The basement was divided into several rooms with access around both pools. All rooms, except for one in the north-east corner had been stripped of any historical fixtures and fittings and replaced with late 20<sup>th</sup>-century fixtures, including all pipework.

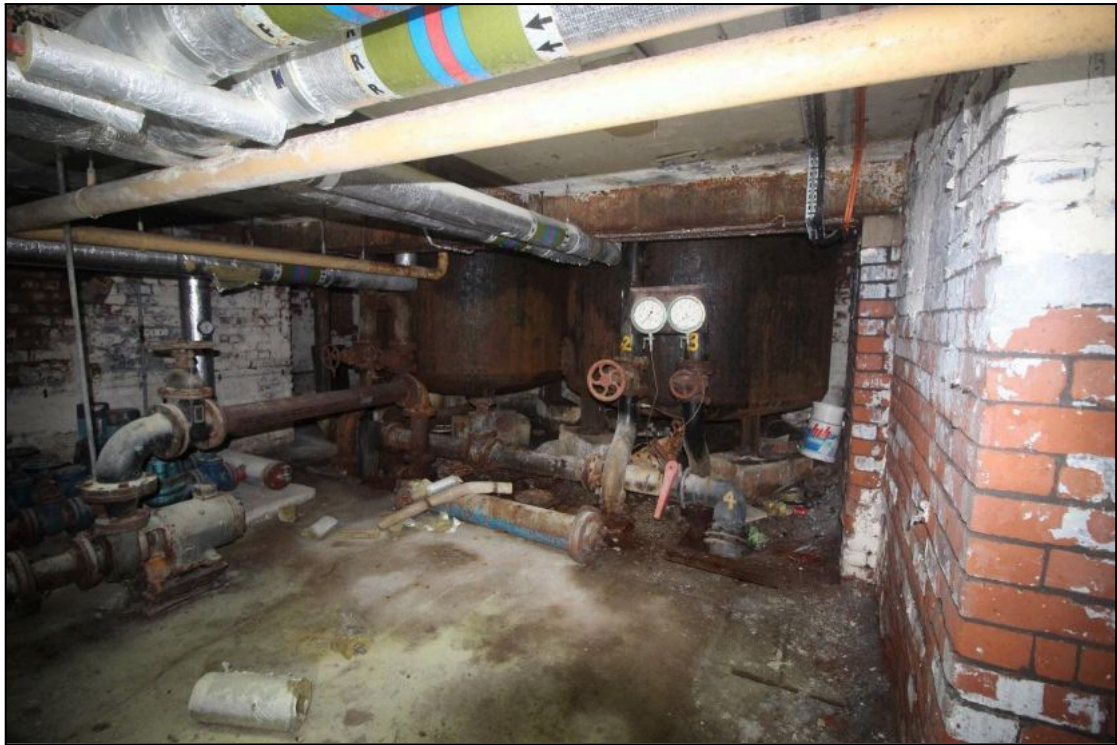
*Plate 63: The two calorifier tanks within the basement*

The north-eastern room contained the two original cast-iron calorifier cylinders that were bolted to concrete plinths. The water would have originally been filtered within these tanks through sand and gravel then reheated by heat exchanger coils then sent back to each of the pools. The original cast-iron pipework around the tanks had been retained, however, these had been bolted to later 20<sup>th</sup>-century pipes that transported the treated water out to each of the pools with metric bolts (Plate 63). This system was superseded by the modern calorifier which was installed in the 2003/04 constructed plant room, located on the rear to the boiler house (Plate 52).
