# LAND AT OLDHAM ROAD, NEWTON HEATH - PHASE CONTAINING 28 HOUSES AND 6 APARTMENTS

## Remediation Method Statement

| Report No | BEK-23007-3 |
| Date | December 2024 |

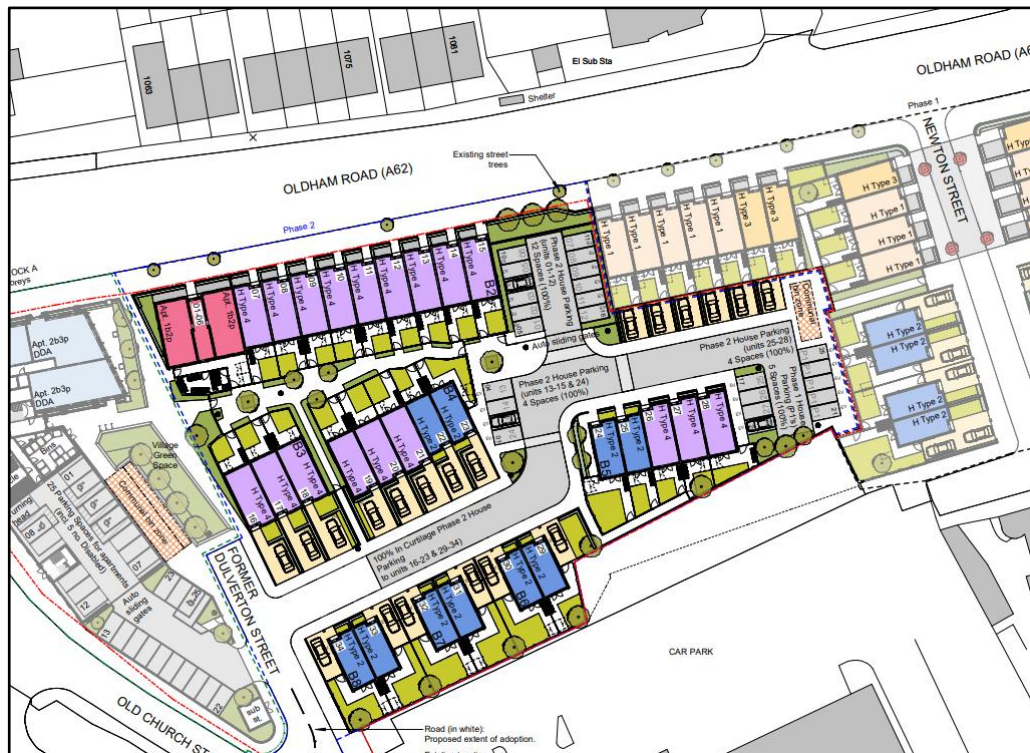
**Figure 1:** Proposed Development Plan

- 1.2.3      The proposed development can be seen on TP Bennett Architecture and Design drawing entitled ‘Proposed Site Plan’ (Drawing No.T8170-G-0-020-T1, dated November 2023), a copy of which is presented in Appendix B and an extract of which can be seen below.

- 1.2.4      Note the development of the site is to be completed in two phases. The remediation strategy presented herein applies to the ‘Phase containing 28 houses and 6 apartments Development Area’ only (as illustrated in Figure 1). A separate remediation strategy (BEK - Remediation Method Statement, Land at Oldham Road, Newton Heath, Report RefBEK-23007-1, February 2023) has been prepared to support the development of the Phase 1 area of the site (to residential dwellings).

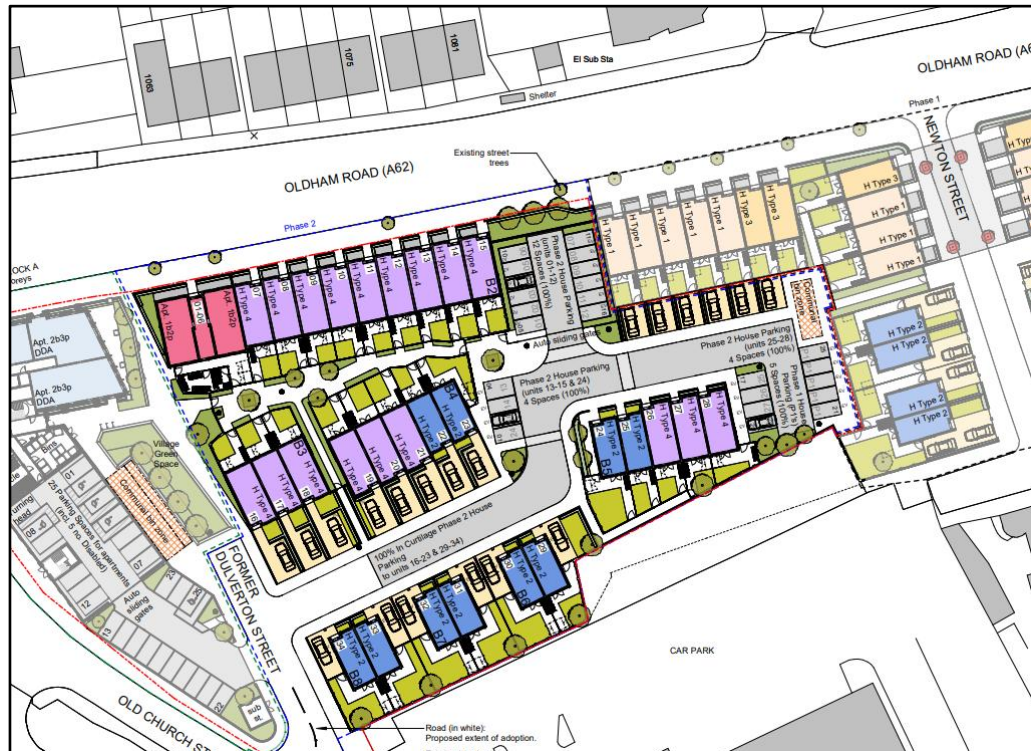
**Figure 4: Proposed Development Plan (Zone 1 and Zone 3 of Site 1)**

- 2.4.2 The amended proposed development plans for Phase containing 28 houses and 6 apartments of the site (i.e. Zone 1 and Zone 3 of Site 1) as shown on the plan below:

- 2.4.3 Due to the presence of residential housing BEK considers it necessary to re-assess the available site investigation data against residential with home grown produce assessment criteria.
