| Project<br>Pall Mall<br>Manchester<br>Refurbishment Works | | | | |
| Drawing Title<br>Floor Investigation Works<br>Marsden St & King St Blocks<br>Roof & 4th Floor Levels | | | | |

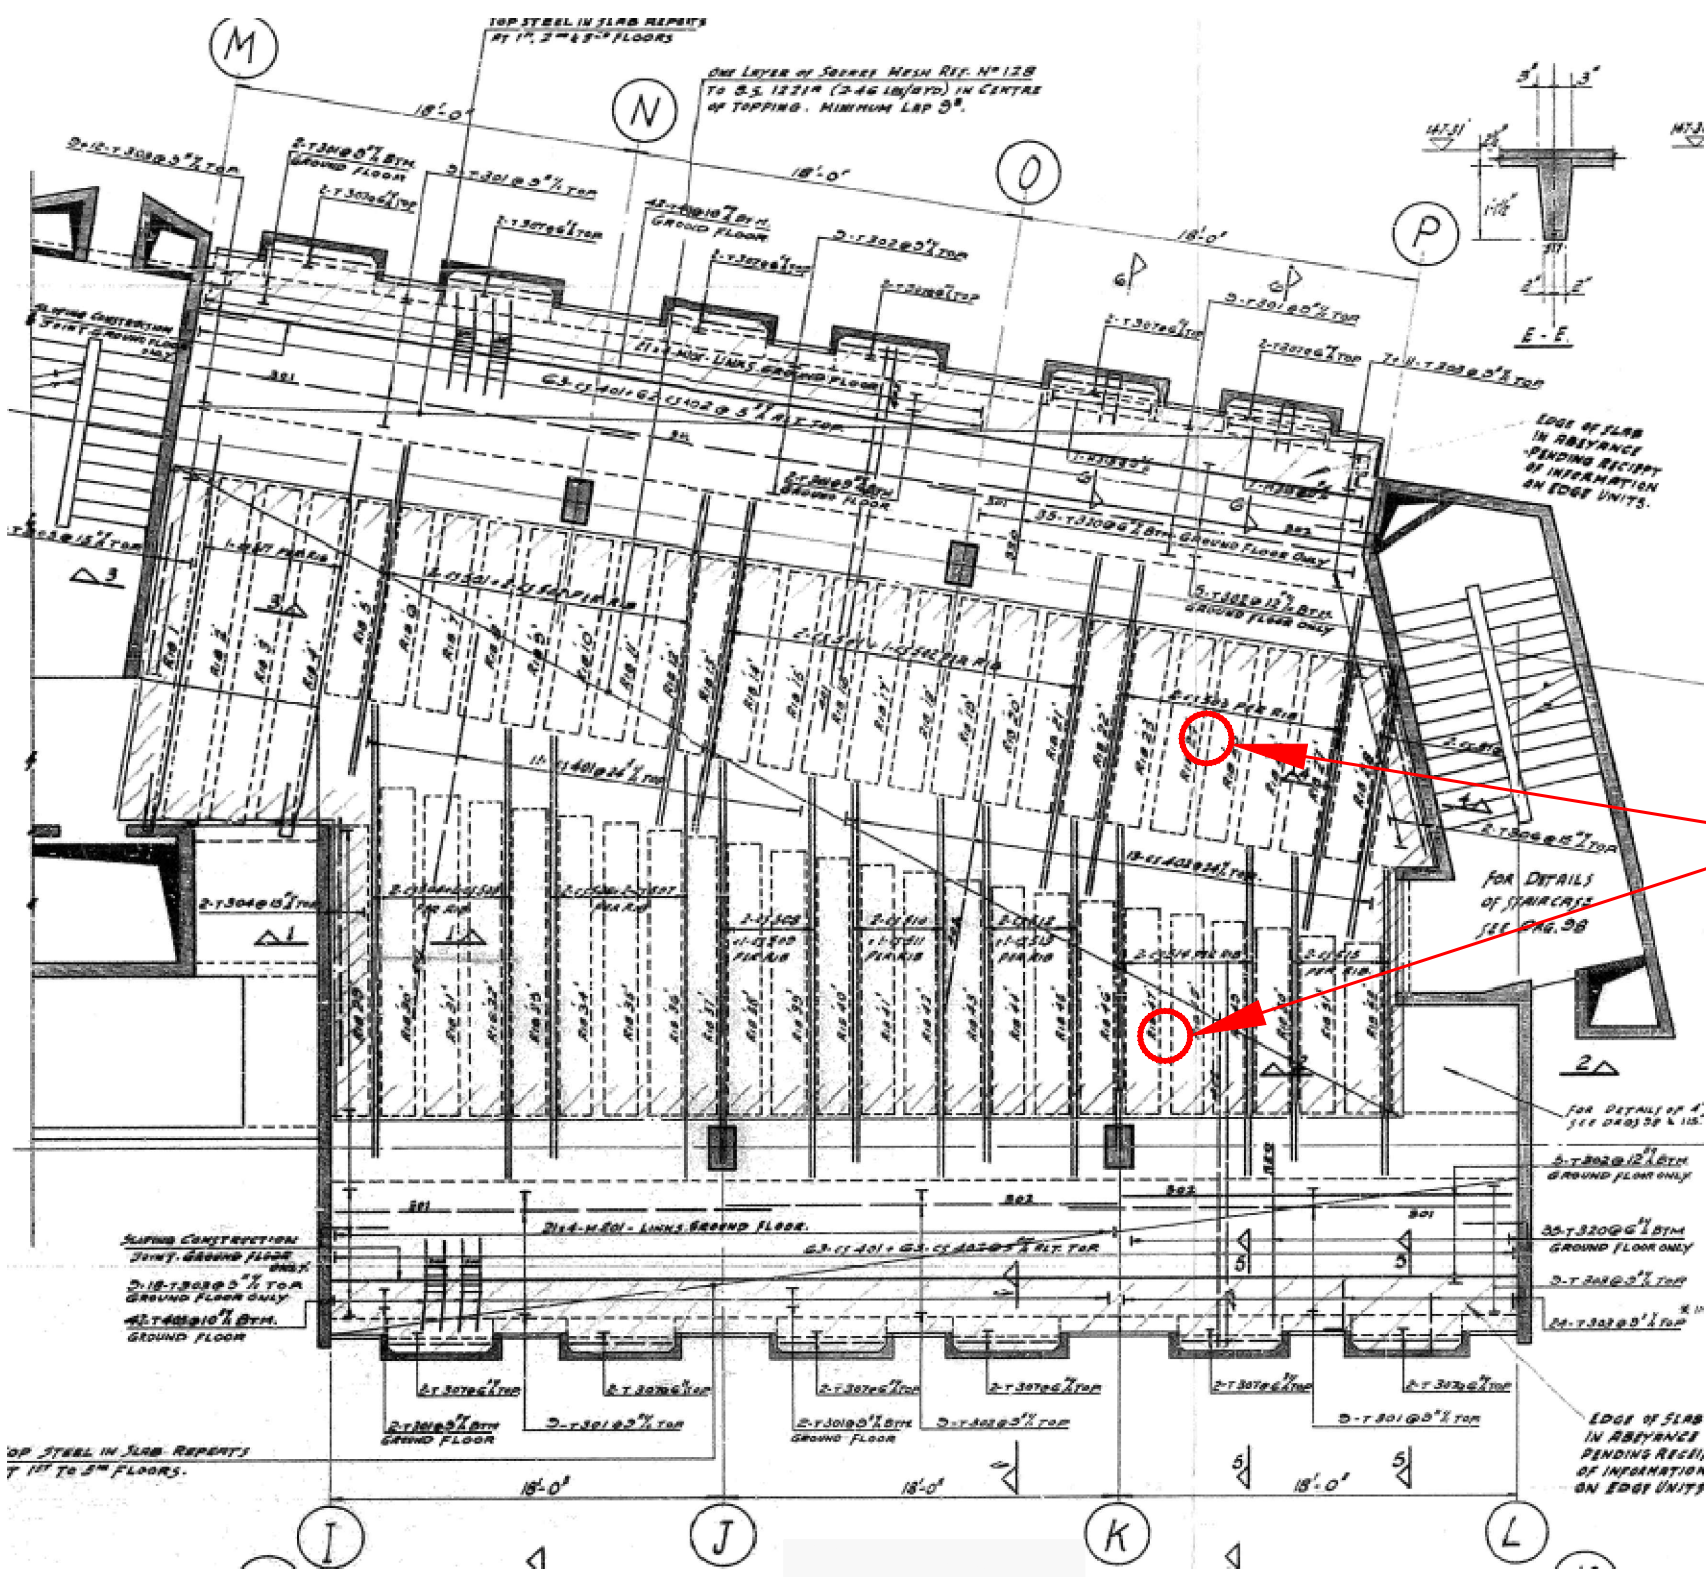
### Marsden Street Block.

Rib Investigation Locations at Underside of Roof and Underside of 4th Floor.  
2 Locations at Both Levels.

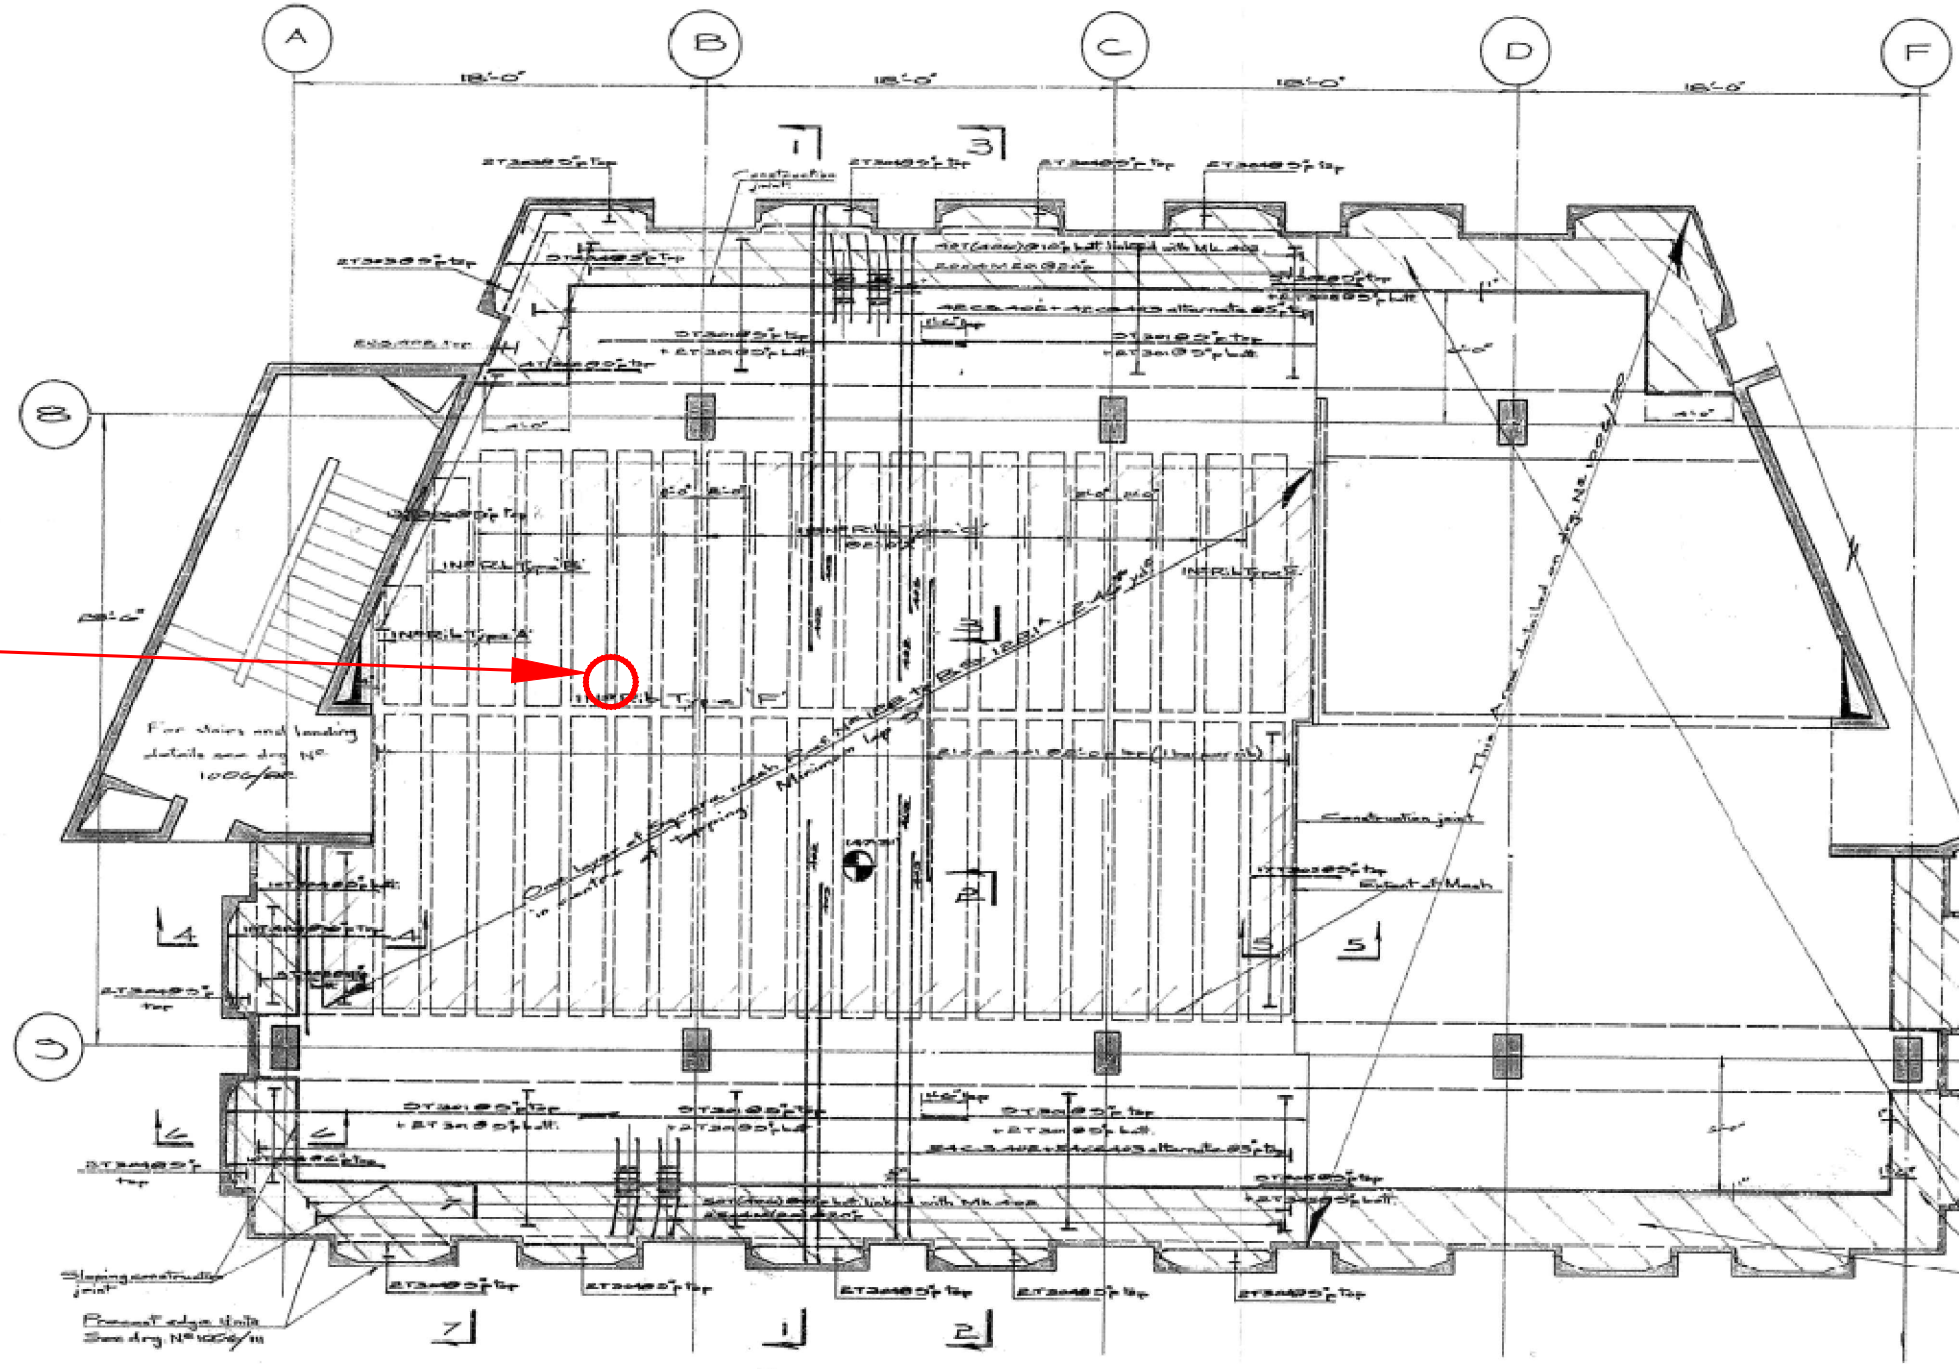
### King Street Block.

Rib Investigation Location at Underside of Roof and Underside of 4th Floor.  
One Location at Both Levels.

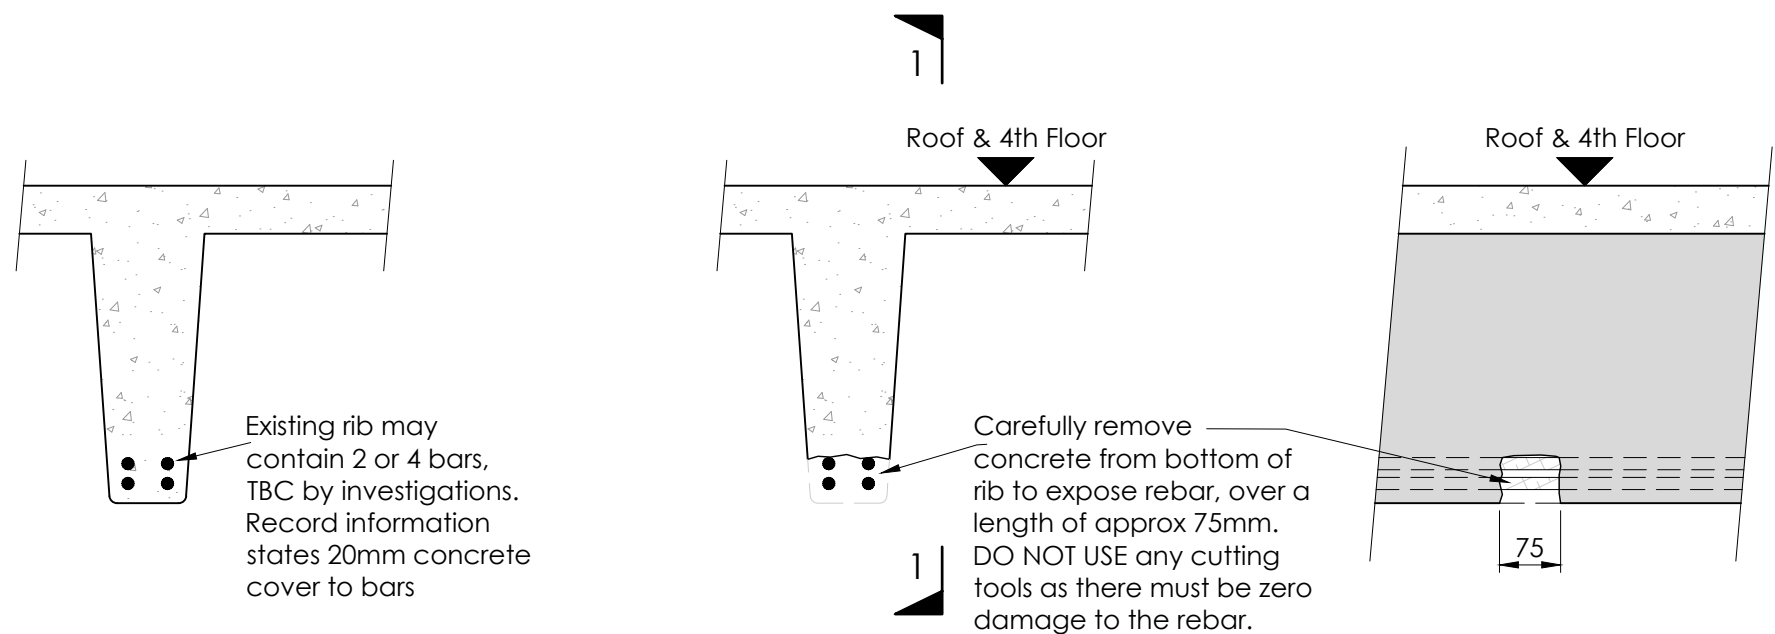
### Sequence of Works

- Carefully remove concrete from bottom of rib to expose rebar, over a length of approx 75mm.
- DO NOT USE any cutting tools as there must be zero damage to the rebar.
- Contact DW Consulting to inspect exposed rebar and rib.
- Following inspections fully repair & replace removed area with Fosroc Rendoc H8 concrete repair mortar, installed fully in accordance with Fosroc specification.

Anticipated Rib Details  
1:10 at A1

Rib Rebar Investigation Works  
1:10 at A1

Section / Elevation 1-1  
1:10 at A1

Note:- Rib exposure must be at EXACTLY the same position on plan at both levels being investigated to ensure a 'like-for-like' comparison of the rebar at both levels. The ribs at both levels must be carefully inspected prior to carrying out any works to ensure that the same position can be investigated at both levels.
