# 10 Chorlton Green\_ Grade II Listed, Formerly Higginbottom Farmhouse

# Executive Summary

The purpose of this document is to demonstrate how our proposals to modify this Grade II listed farmhouse to a usable, comfortable family dwelling, whilst preserving and enhancing character of existing building. Our proposals include connecting the ground floor living accommodation by inserting a lightweight glazed extension, omitting a second staircase from the kitchen, and adding a second bathroom to serve the five existing bedrooms. We have developed our proposals in consultation with Dave Morris, formerly of the local planning authority, and Jenny Wetton, of JW Conservation.

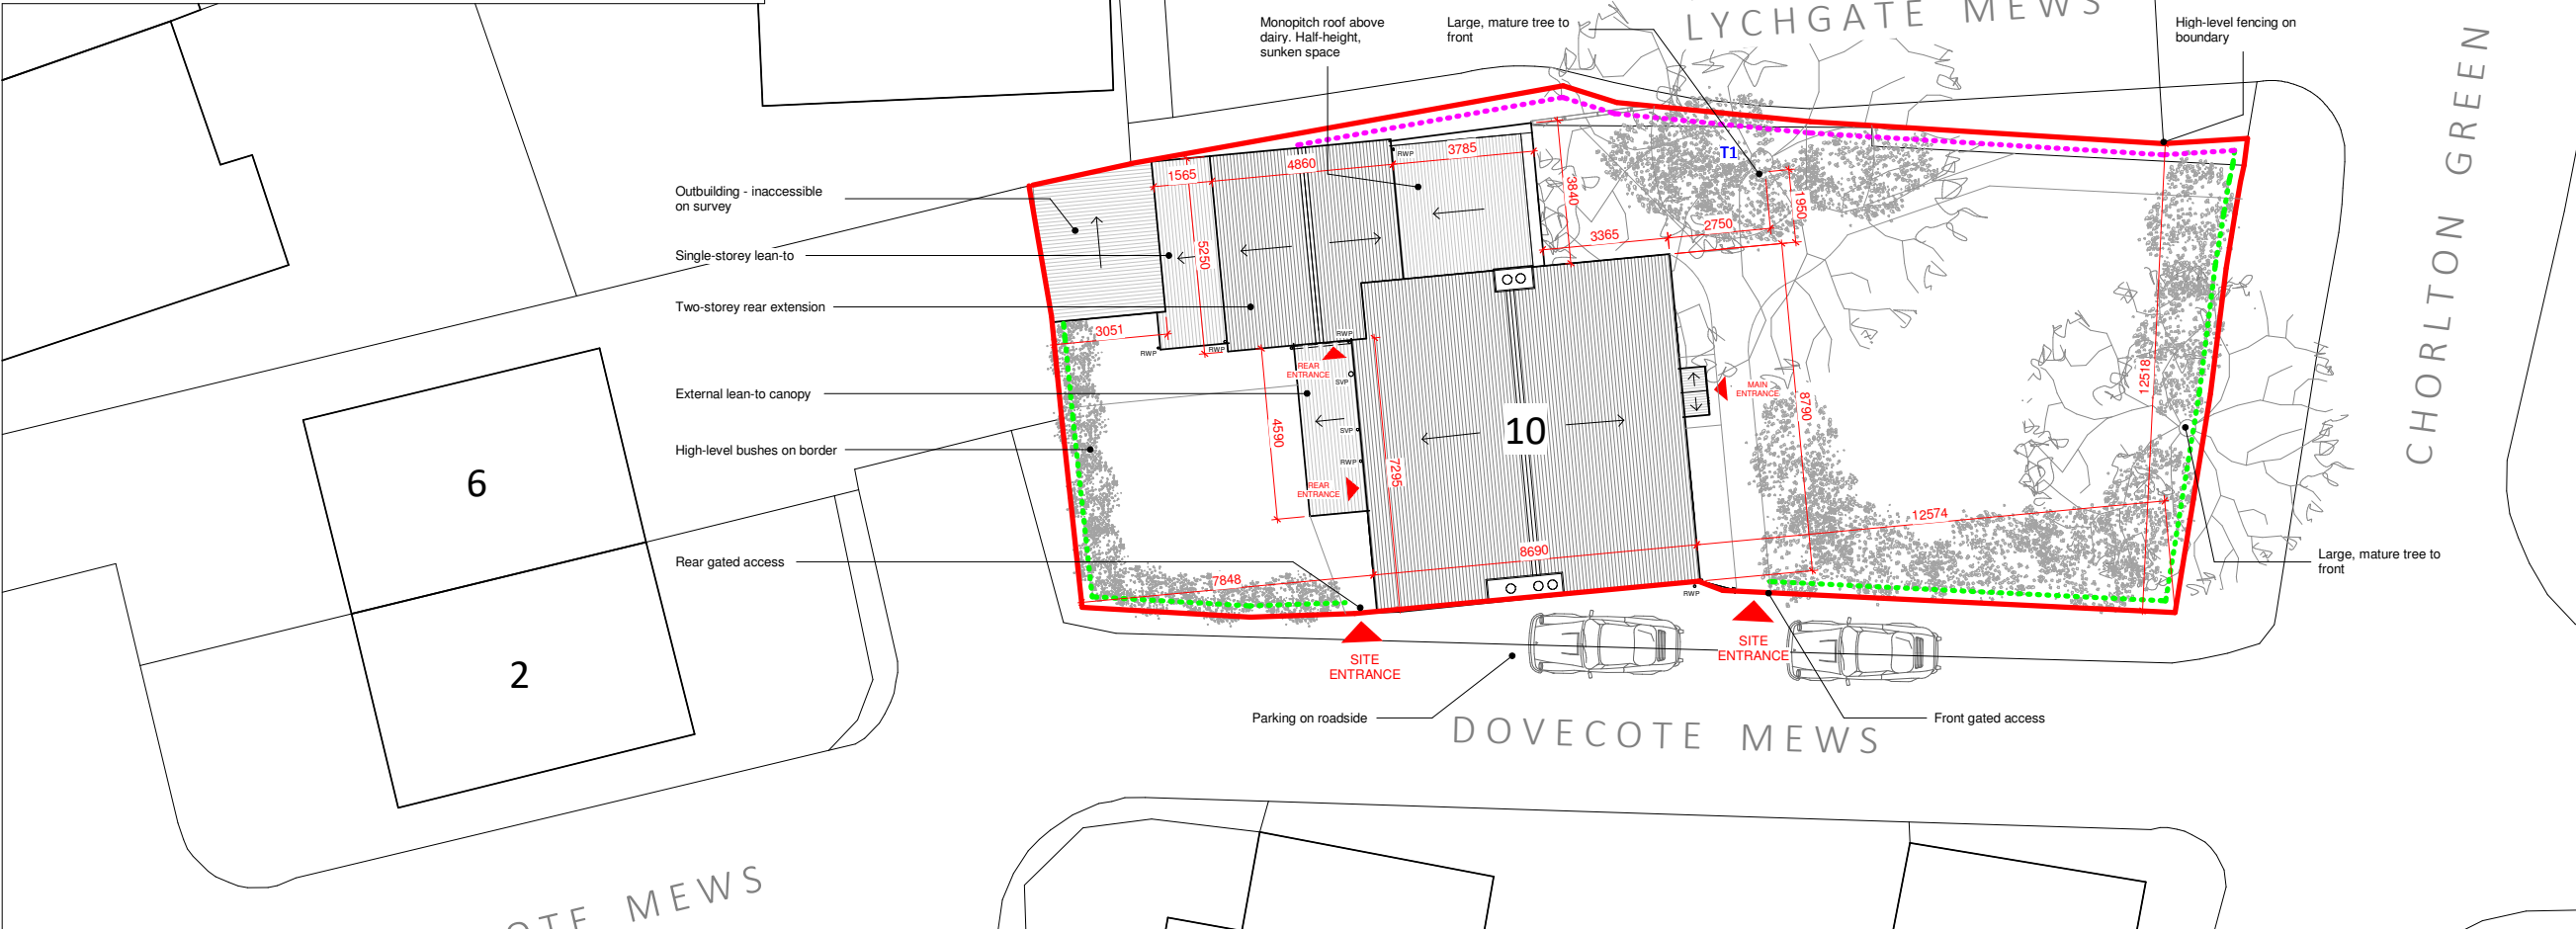
01 EXISTING SITE PLAN @ 1 TO 100

EXISTING SITE AREA: 393 sqm

EXISTING BUILDING FOOTPRINT: 133 sqm

EXISTING SITE COVERAGE: 33.8 %

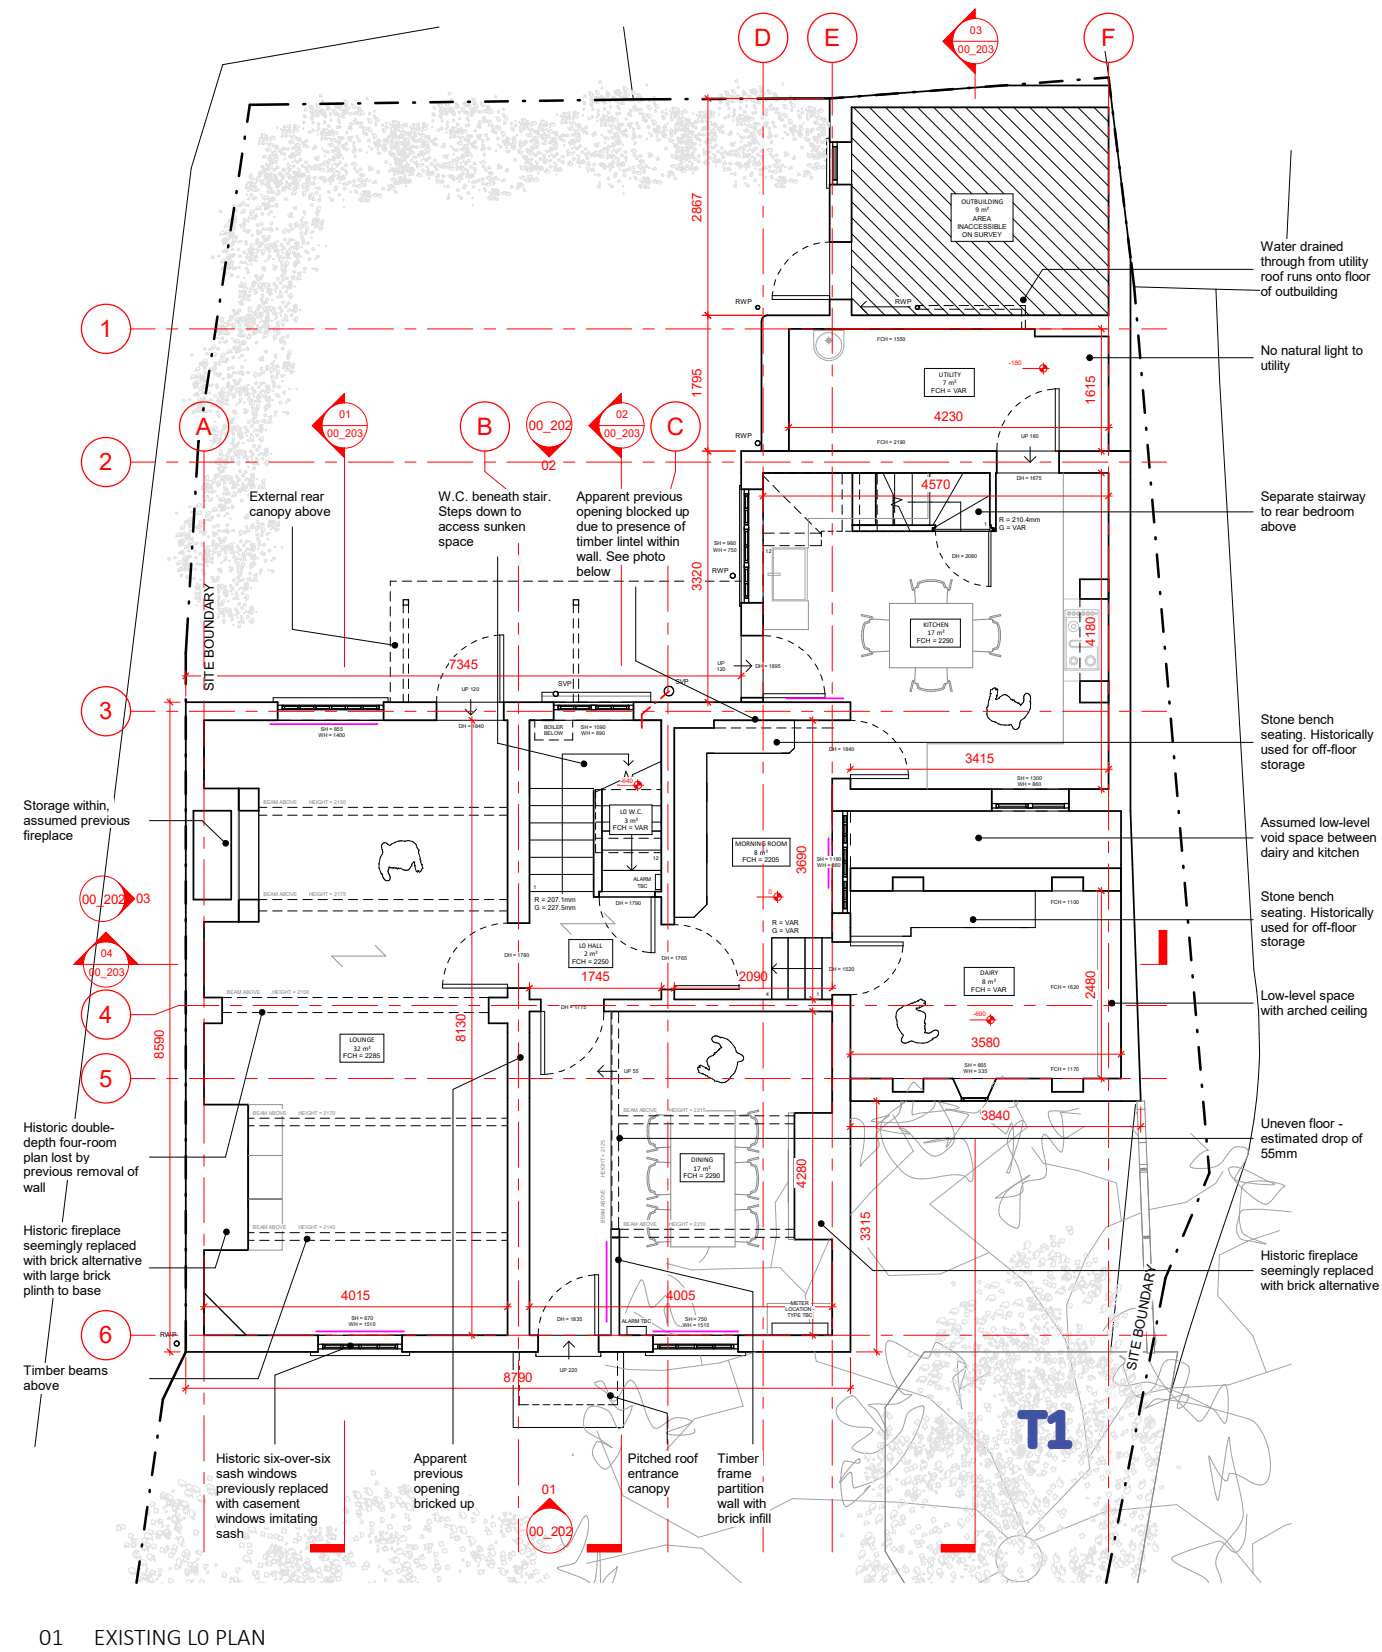
### 02. Existing L0 Plan

01. Two staircases reduce flow and connectivity across first floor and constrain kitchen space
02. Poor head height within existing Dairy
03. Poor head height within existing utility lean-to
04. Staircase up to bedroom within kitchen does not conform to fire regulations
05. Only one bathroom, shared between five bedrooms
06. Modern replacement fireplaces to ground floor lounge overbearing and encroach on space
07. Much of existing detail has been stripped from property
08. Several unusable, awkward spaces

01. Omit secondary staircase from kitchen. Add new stair off existing half-landing
- ~~02. Connect utility and outbuilding by demolishing internal wall to create usable space. These outbuildings were later additions and hold no architectural merit.~~
03. Re-instate wall on grid line 4 to re-introduce 4-chamber plan
04. Add new lightweight extension that touches the existing building lightly to form open-plan kitchen / diner, and better connectivity to living room areas.
05. Add lightweight first-floor extension above Dairy to accommodate en-suite and walk-in wardrobe
06. Remove modern, overbearing brickwork to ground-floor fireplaces

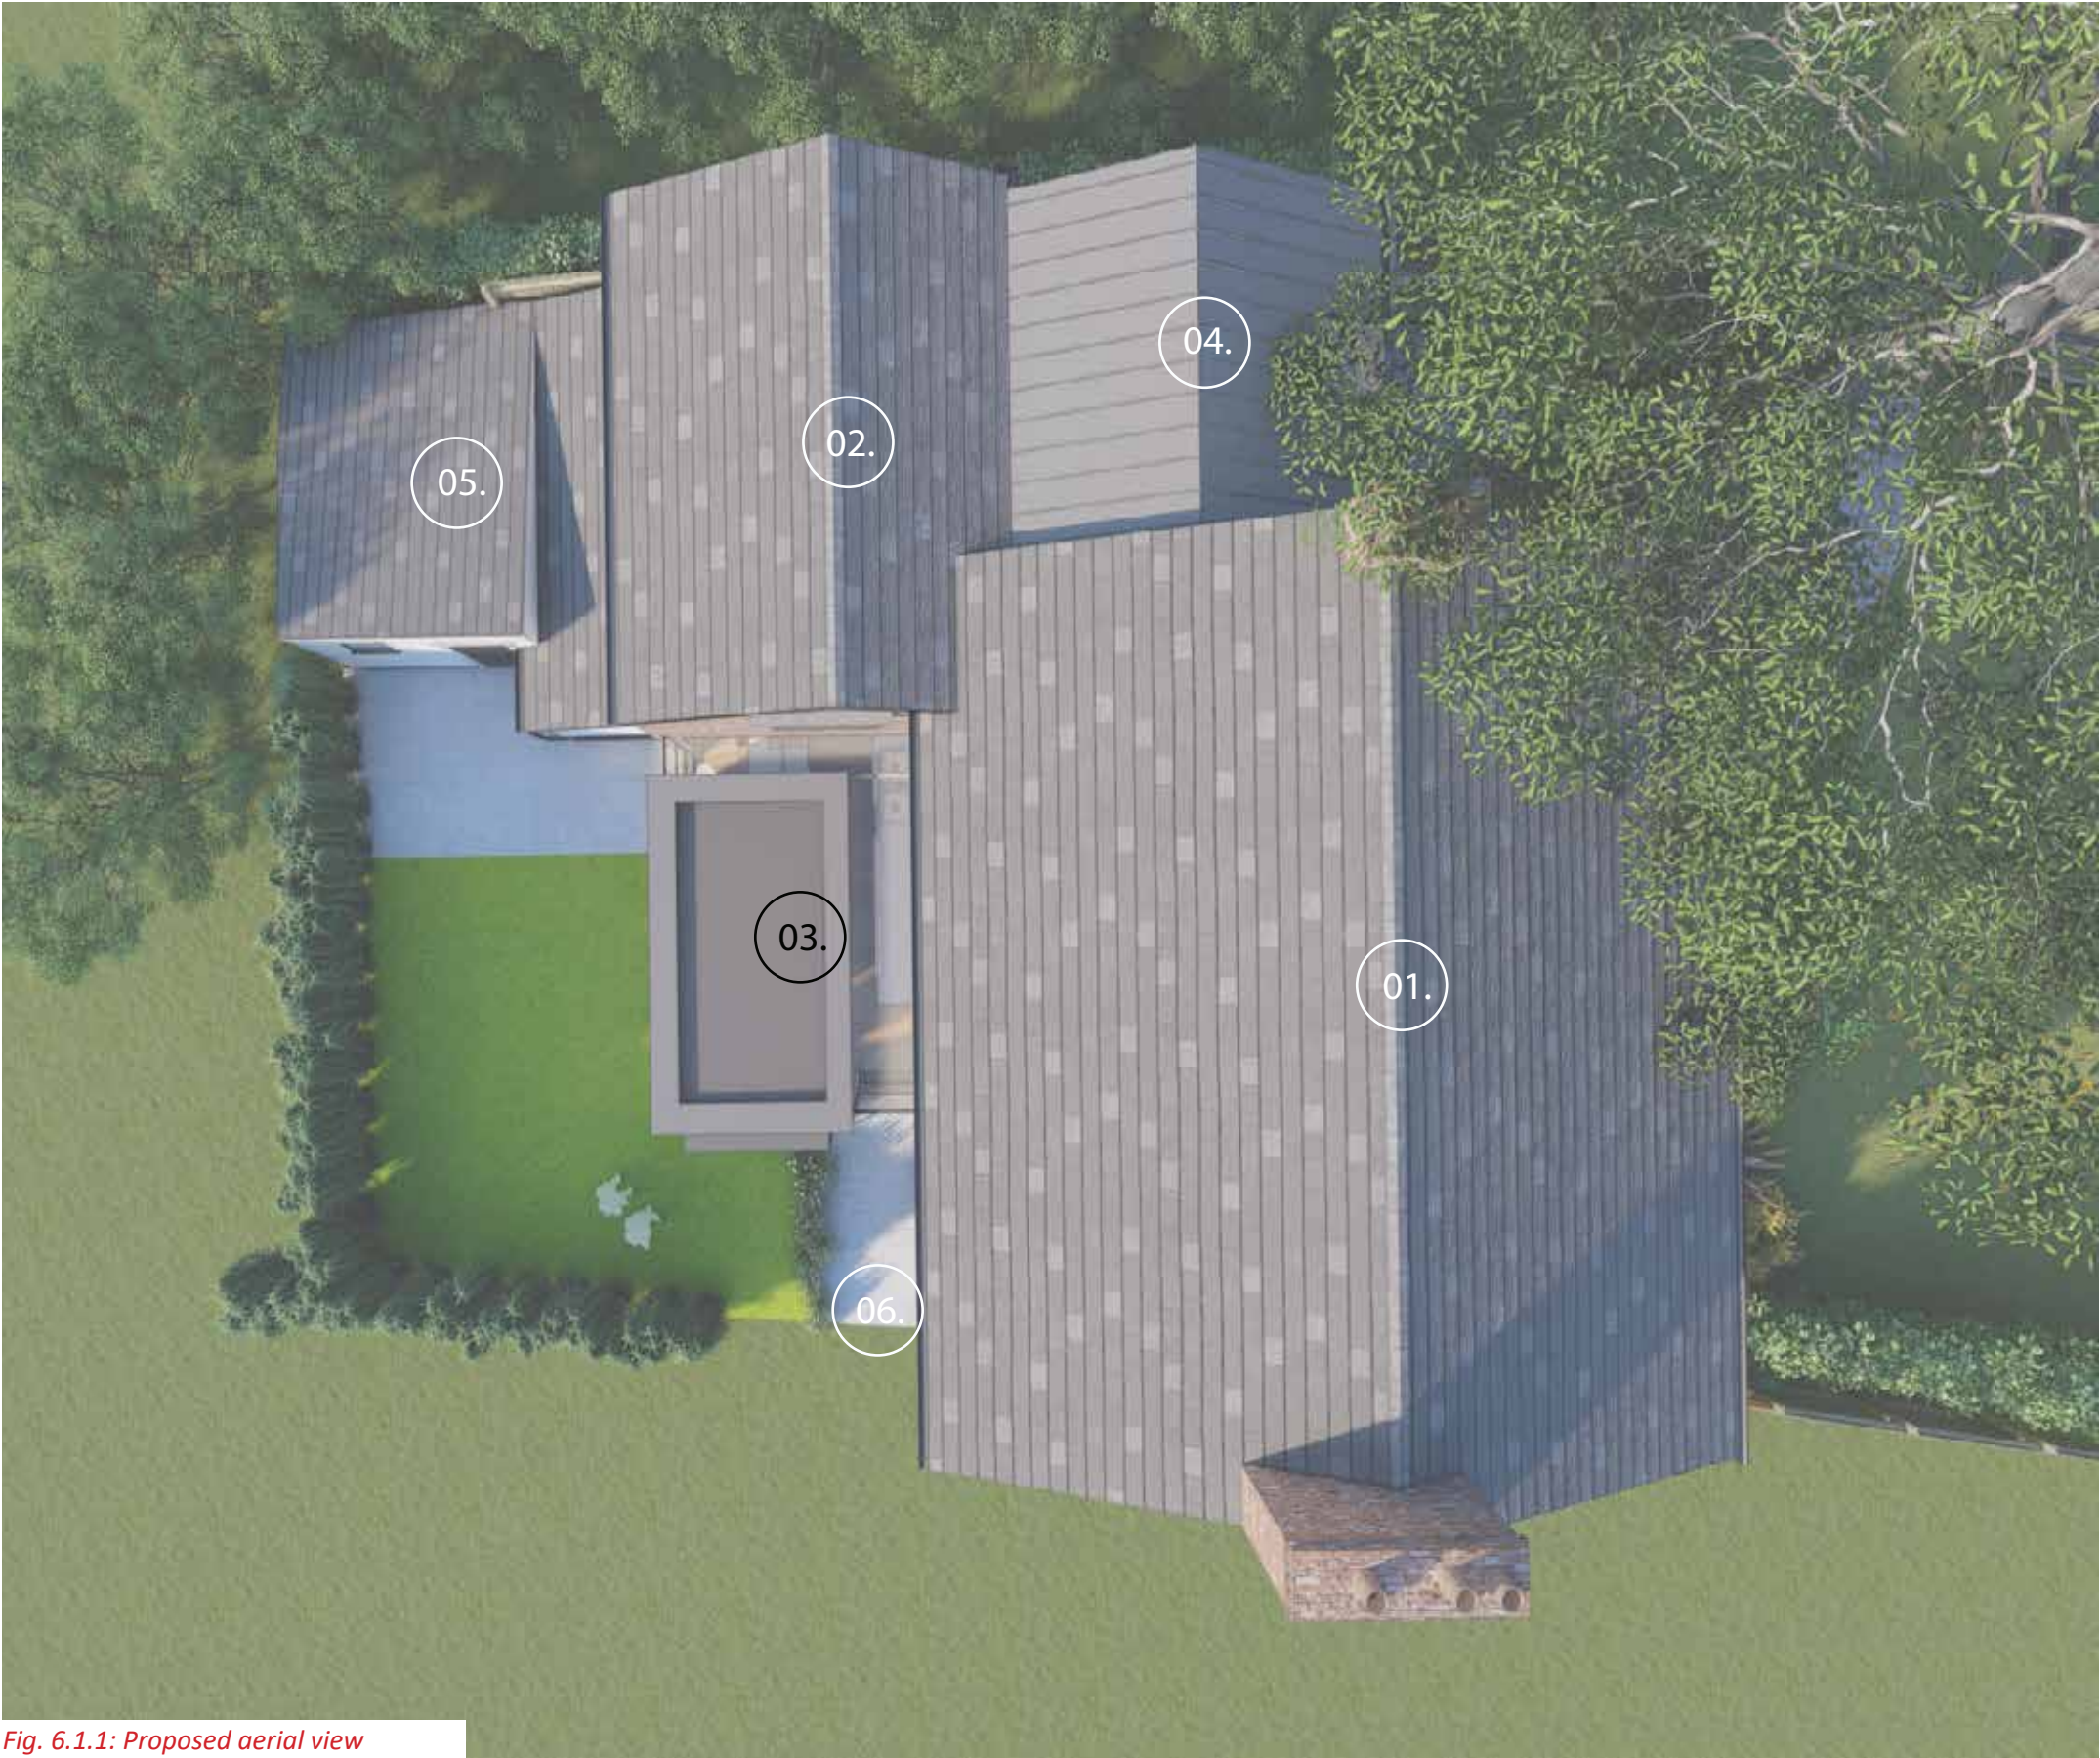
Fig. 6.1.1: Proposed aerial view

- 01. Original dwelling (early 19th Century)
- 02. Two-storey rear range (late 19th Century)
- 03. Proposed single-storey flat-roof extension
- 04. Proposed pitched roof extension over existing dairy
- 05. Existing outbuilding (early 20th Century)
- 06. Existing gated entry to rear garden

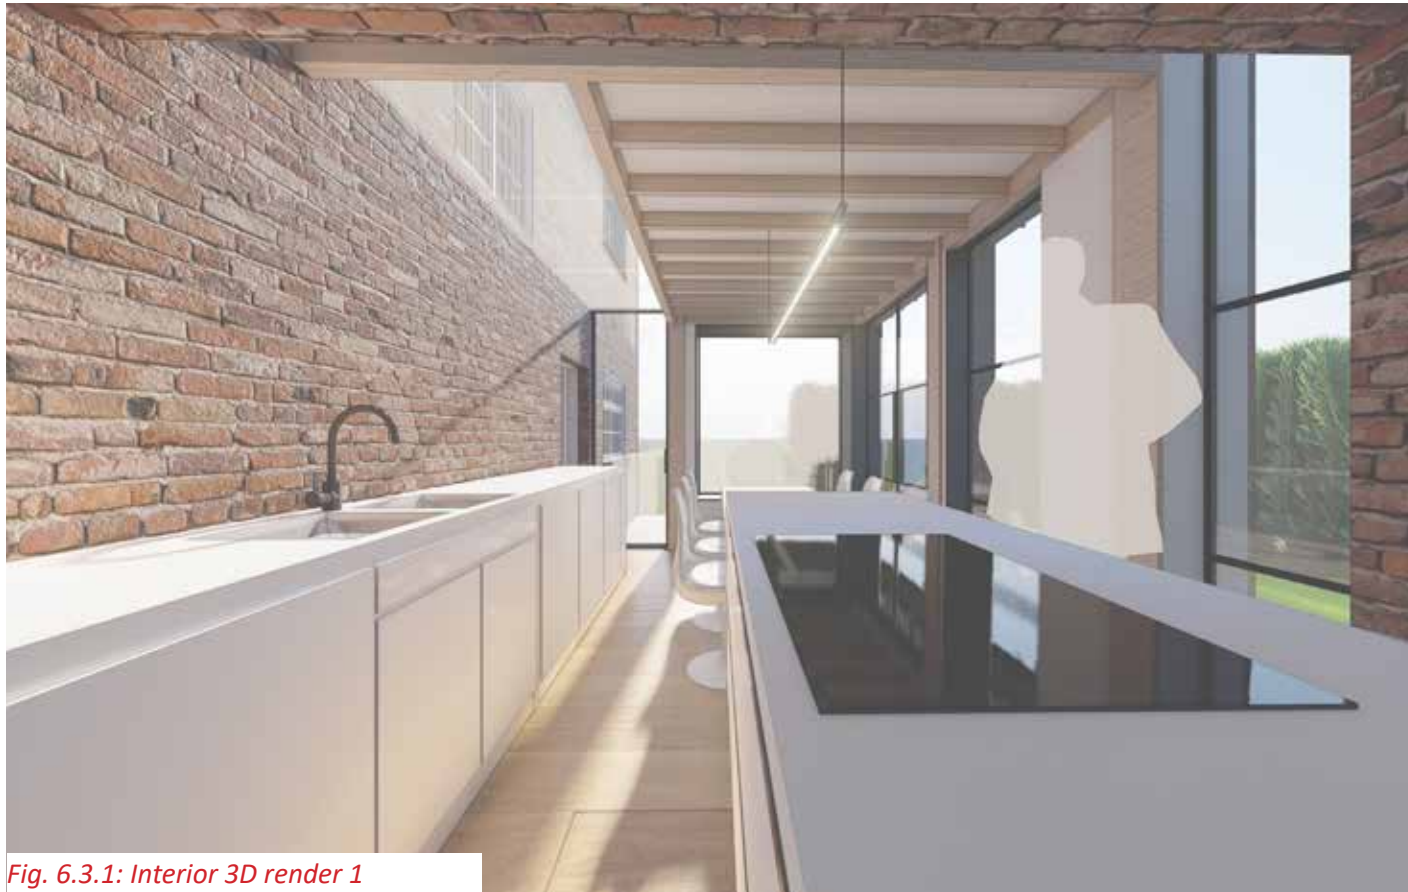
Fig. 6.3.1: Interior 3D render 1

A thin slot rooflight touches the existing building lightly and provides visual separation between old and new. Low-level kitchen units retain as much of the existing brick wall as possible, while allowing for plentiful glazing to the rear, meaning borrowed light floods deep into the plan. Aligned to existing openings and building elements along the rear facade, the proposal is respectful and subservient to the historic fabric, whilst its minimalist, paired back interiors draw the attention to the existing dwelling.

The lightweight glulam frame is left exposed, using materials softer in form and tone that also speak to the historic timber framed internal walls. A singular beam runs into the existing external wall of the farmhouse, while the rest of the threshold is defined by clear glass and soft join detail. The lightweight nature of the timber frame and soft join detail means the extension could at any point be removed with minimal disturbance to the existing building.

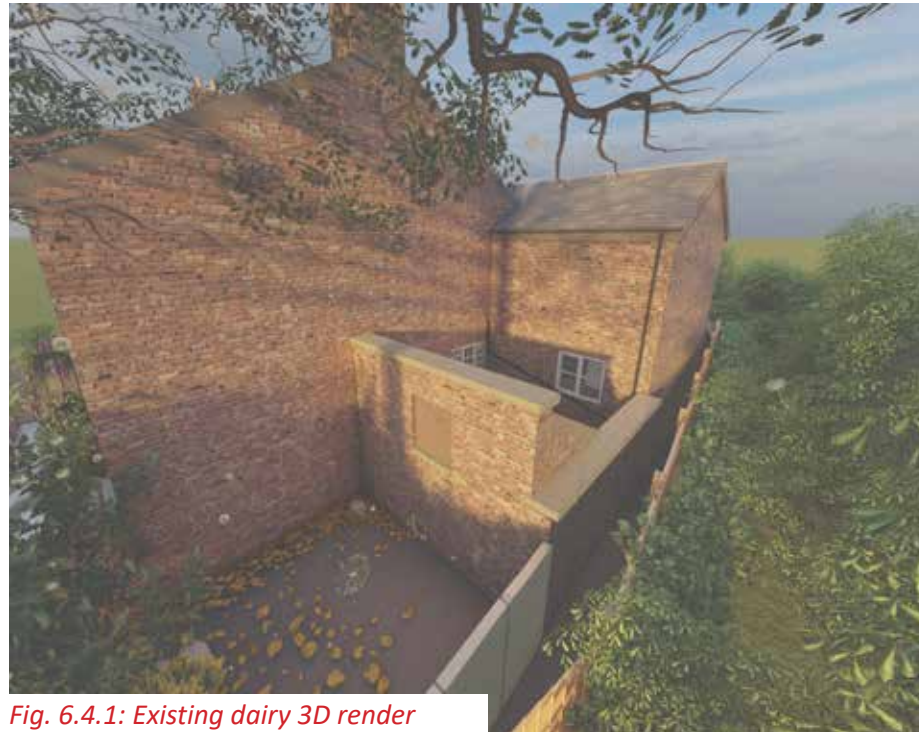
Fig. 6.4.1: Existing dairy 3D render

Currently, a mono-pitched roof sits above the dairy, with an inaccessible void space within the roof. A lightweight extension is proposed to sit above the existing sunken dairy space to the north, housing a walk-in wardrobe and en-suite to the master bedroom in the rear range first floor. The height and pitch of the roof will match that of the existing rear range adjacent, and be subservient to the original farmhouse.

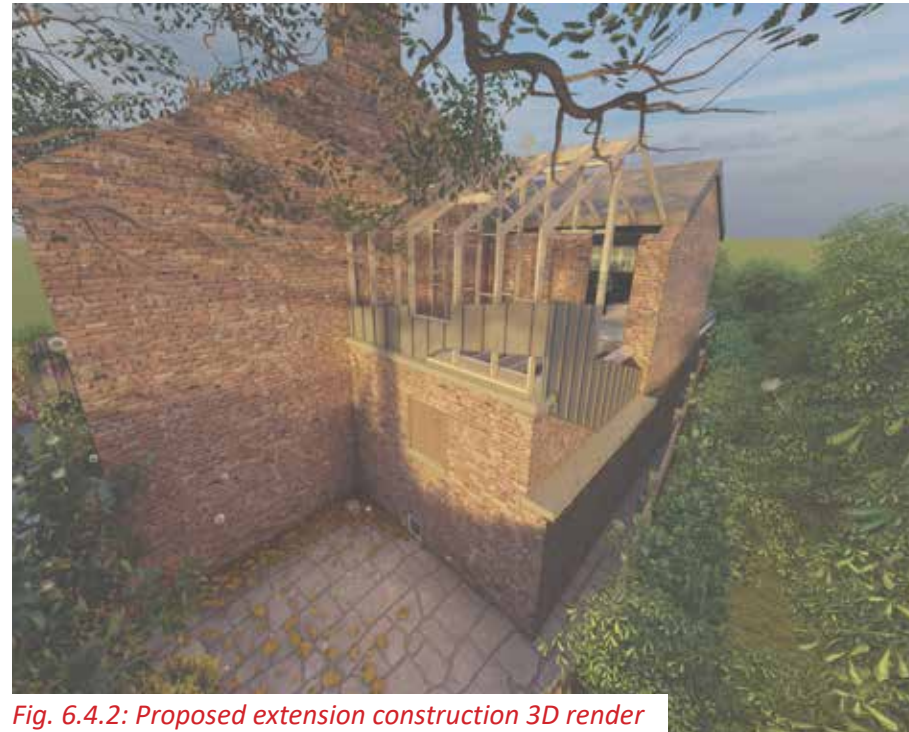
Fig. 6.4.2: Proposed extension construction 3D render

A lightweight timber frame will be supported by a new blockwork plinth above the existing walls, while internal stud walls and a suspended lightweight timber floor will sit above the existing dairy space.

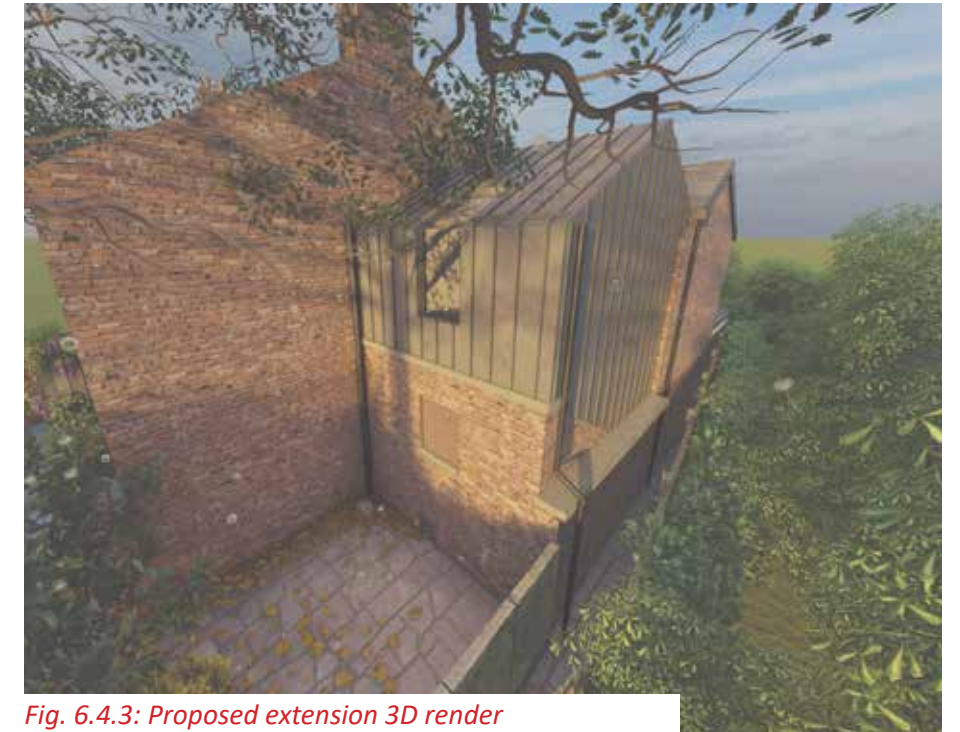
Fig. 6.4.3: Proposed extension 3D render

The proposed extension will be clad in lightweight, dark standing seam cladding, both to the walls and roof. This will visually separate the new proposals from the existing fabric, and speak of its time. Its lightweight nature means the extension could at any point be removed with minimal disturbance to the existing building.

We are proposing a lightweight extension above the existing sunken dairy space. Currently, one bathroom is shared between five bedrooms, which we believe is inadequate for modern family living. We propose an additional bathroom, serving as an en-suite for the master bedroom within the two-storey range. The extension will also house a dressing area for the master bedroom. From the front of the property, the existing dairy is barely visible due to being set back from the primary facade, as well as the abundant mature vegetation to the front, as shown in the photo-matched render opposite (Fig. 8.8.5)

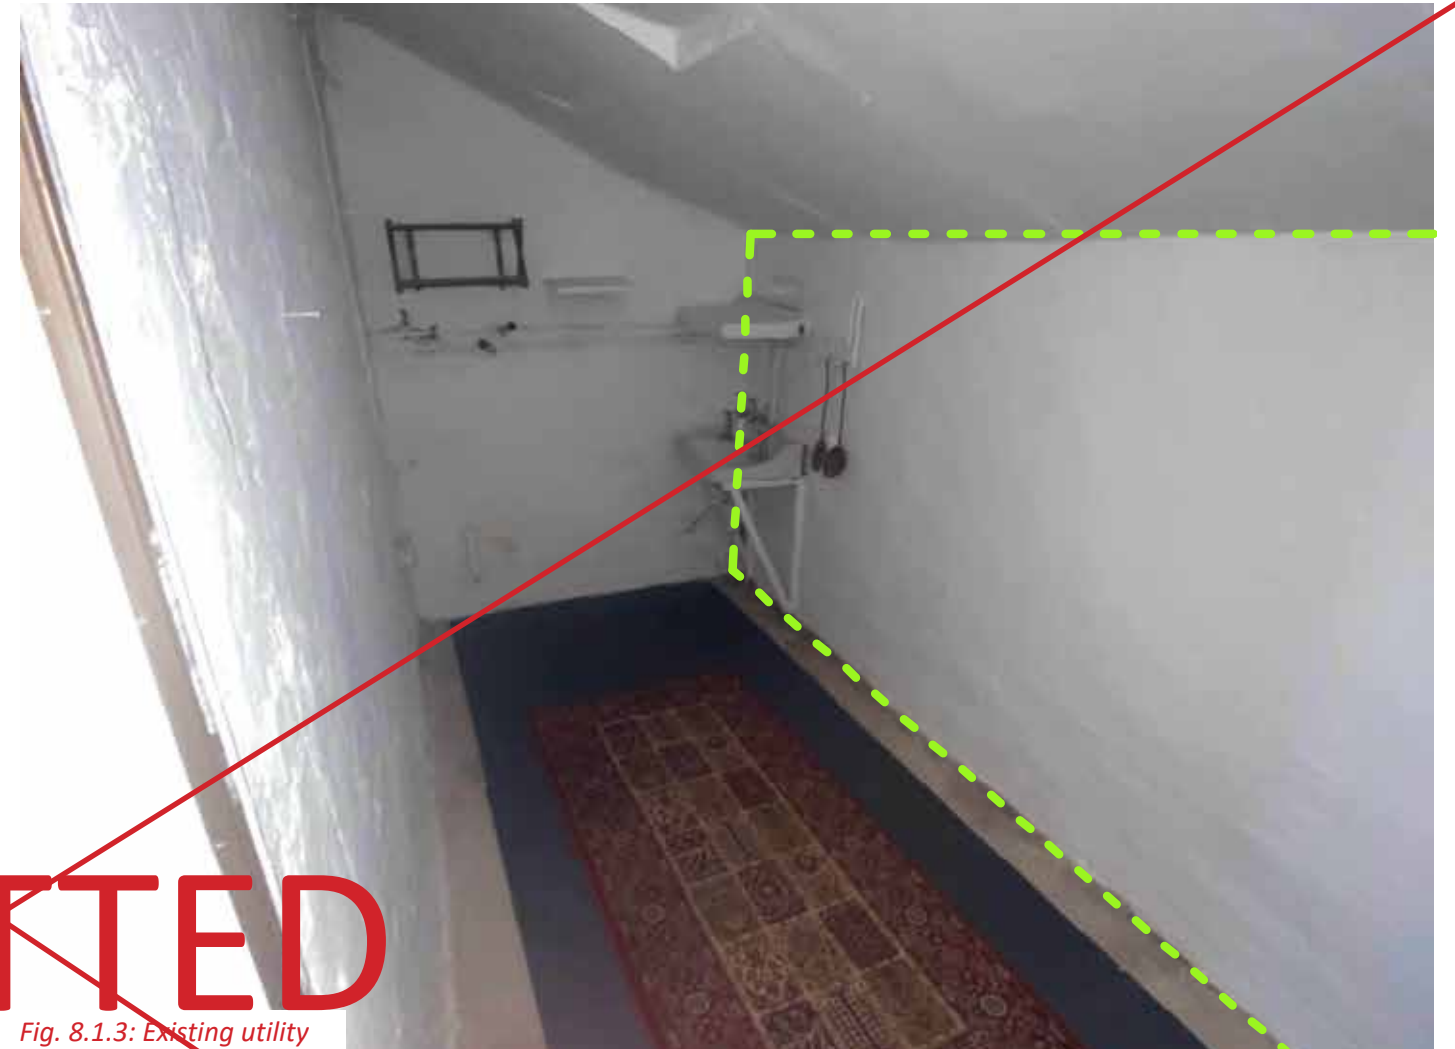
Fig. 8.1.3: Existing utility

We are proposing a new opening between the existing utility and outbuilding to create a usable gym space. Currently the utility has no natural light and is a tight, cramped space. The utility was a later addition to the property, built in the late 19th Century, and includes no special architectural detailing. The outbuilding, erected in the early 20th Century, is not built in the same architectural style as the historic house. The stepped wall to the north side of this room indicates more than one phase of construction - meaning that the wall may not be original. We are proposing to retain what is believed to be the historic part of the wall to the north of the room.

01. Demolition of wall between utility and outbuilding, along Gridline 1

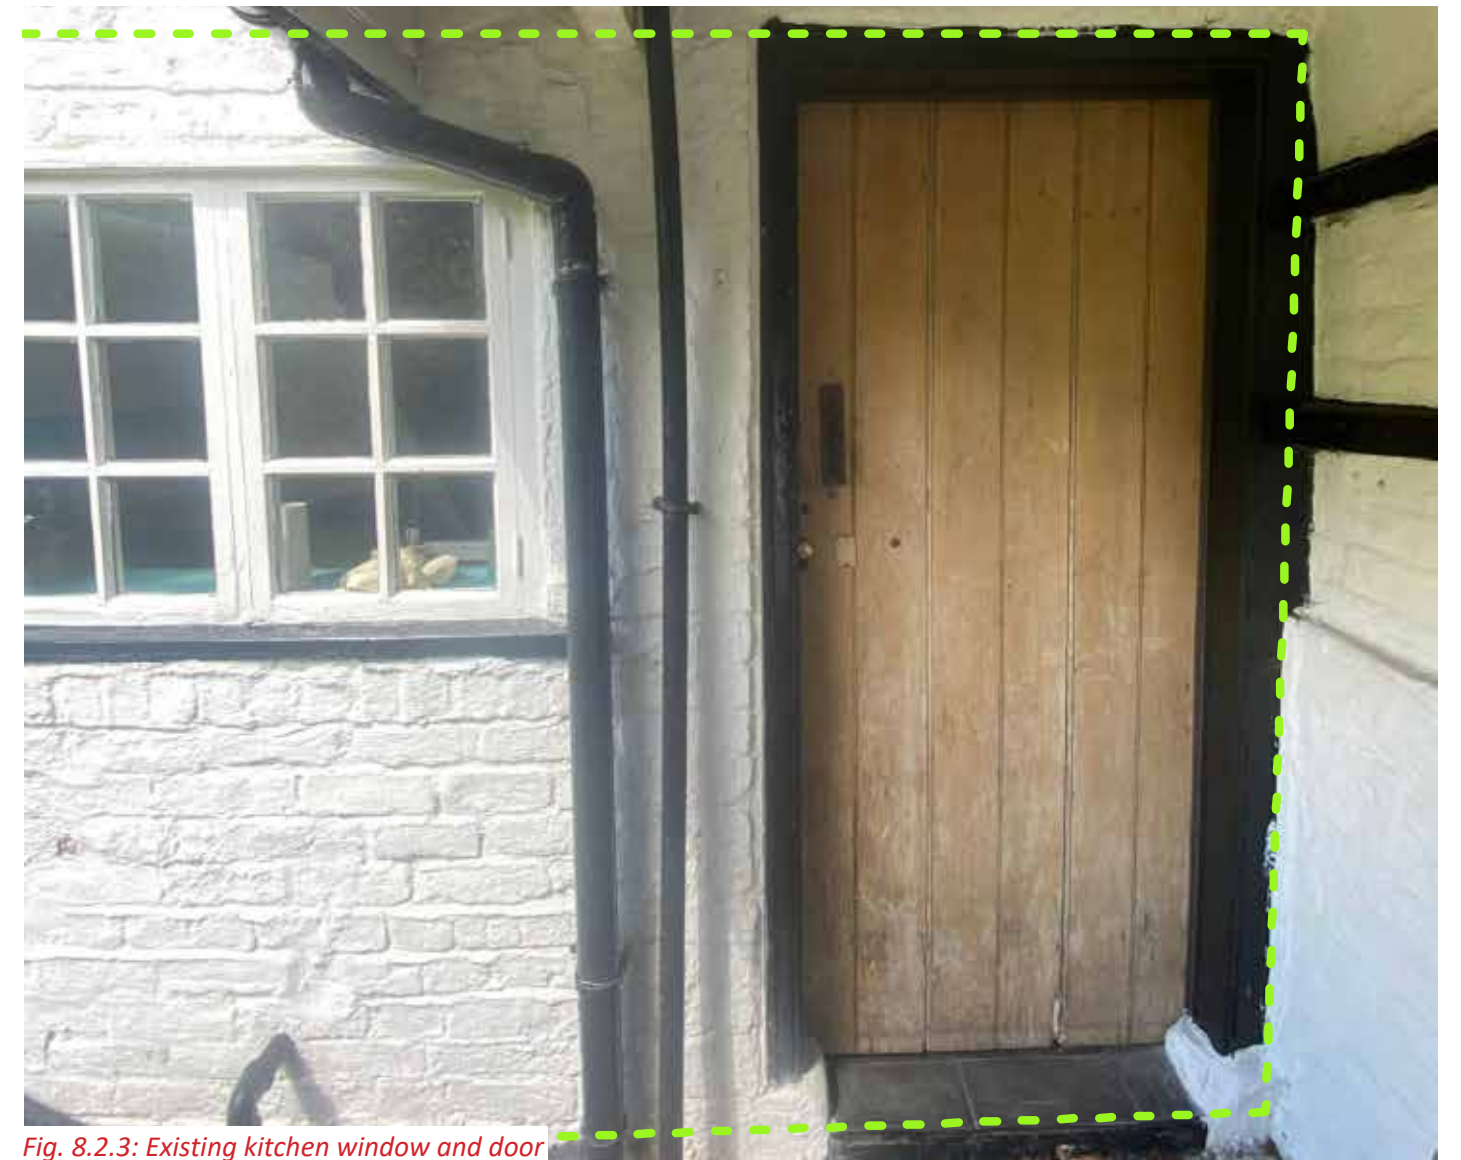
Fig. 8.2.3: Existing kitchen window and door

We are proposing to connect two existing openings on the south facade of the kitchen - located within the two-storey rear range - to create a larger opening. Currently a door sits beside a window with a high sill, which we propose to lower to floor level to create the larger opening. By doing this, we create a larger kitchen-diner, with plentiful natural light. The two-storey range is not part of the original building fabric, added later in the 19th Century. There is a suggestion the window was added at a later date, evidenced by the surrounding brickwork. A minimal steel lintel will support this new opening.

**02.** Enlarge existing window and door openings into one larger opening, along **Gridline D**

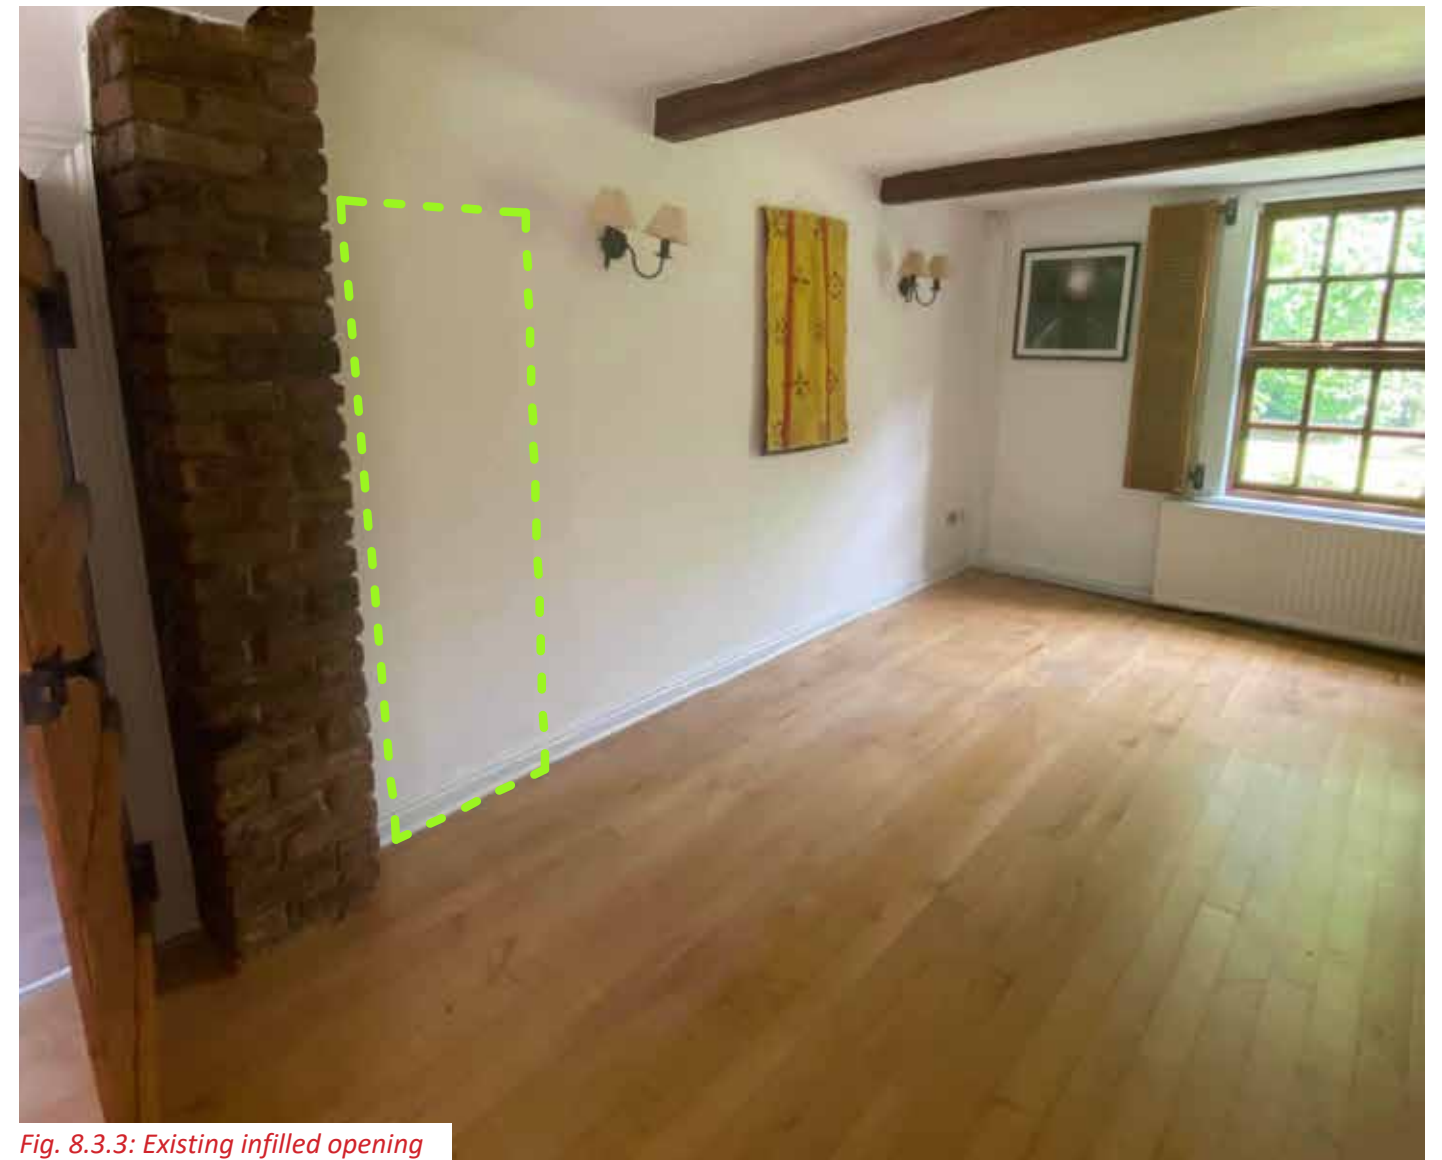
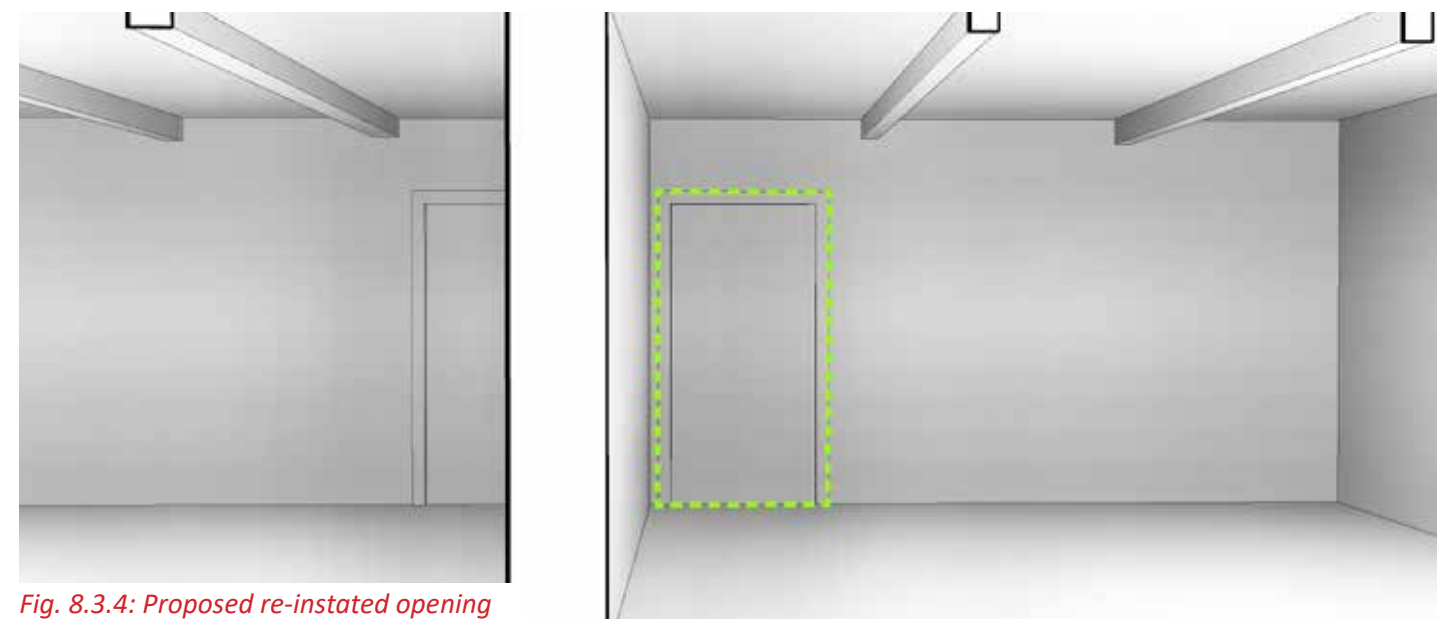
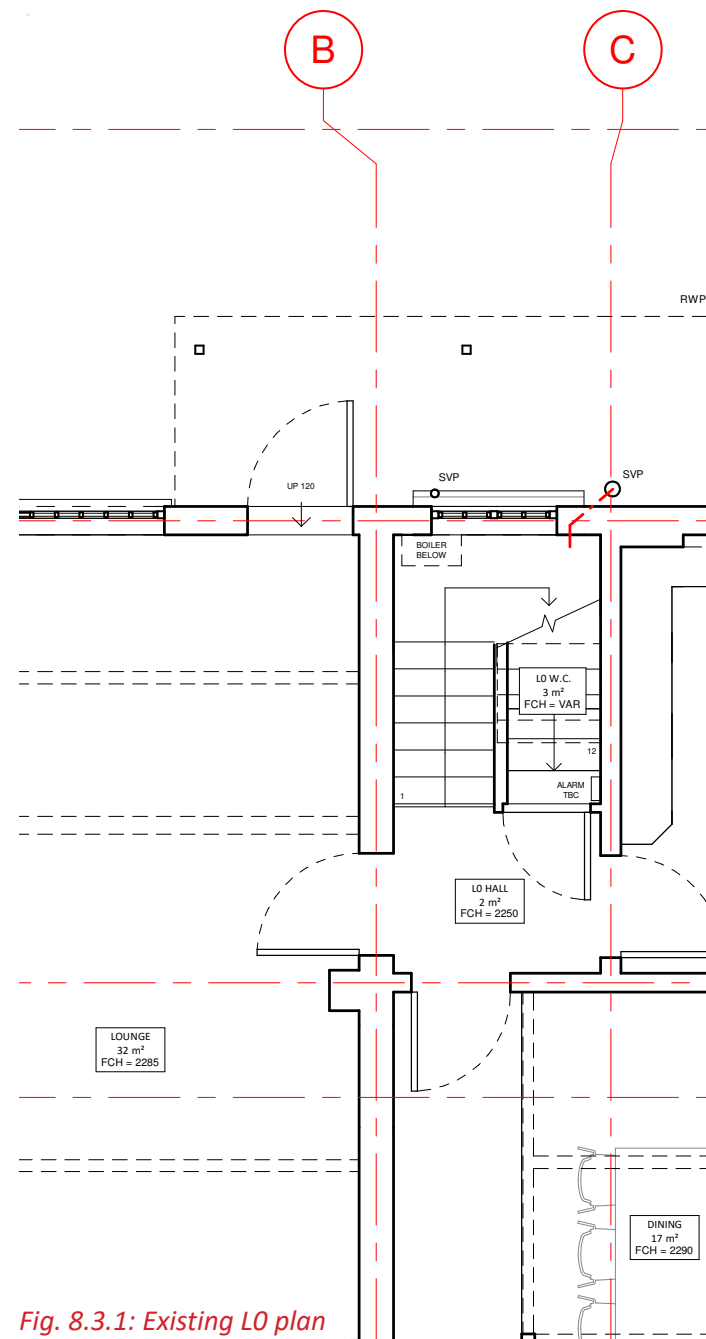
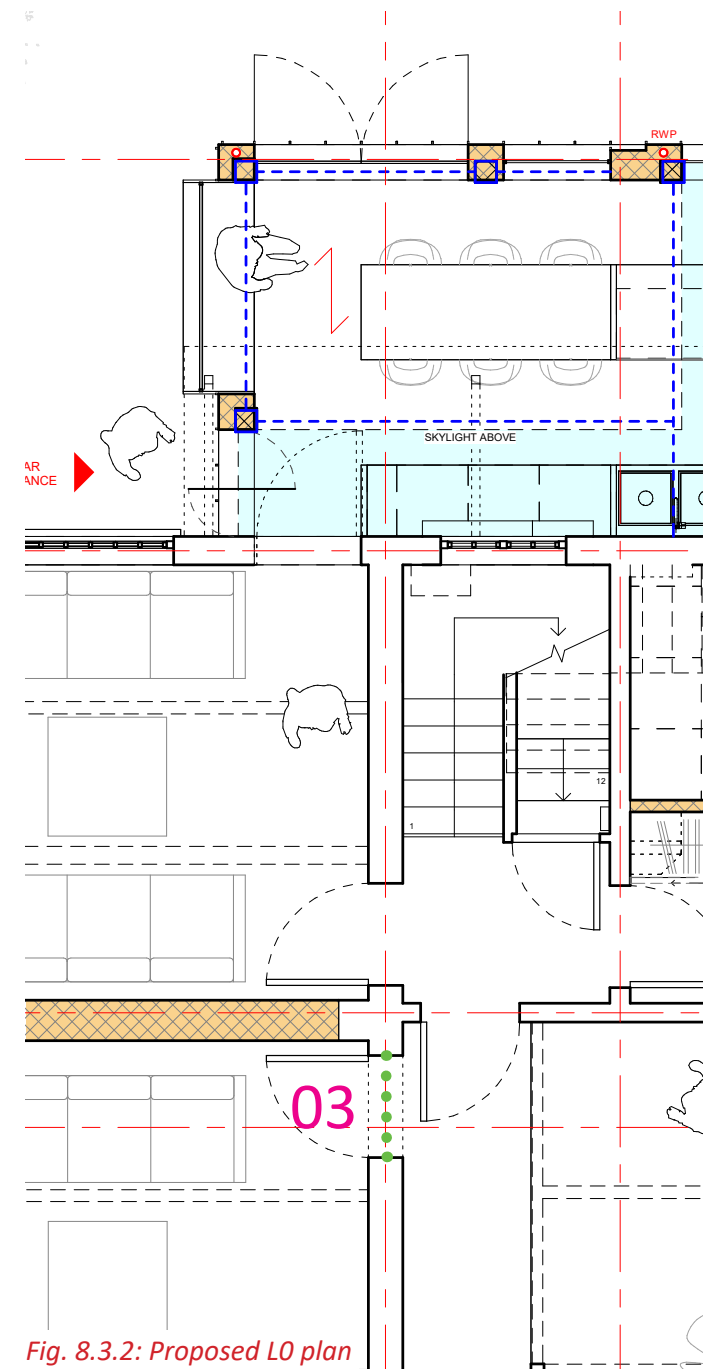
Previous harmful alterations to the building have removed an internal wall between the two chambers to the south of the plan, resulting in the historic double-depth four room plan being lost. As a result, it also seems a historic opening between the two east chambers was in-filled. We are proposing to re-instate this internal wall, reverting back to the building's historic plan, and re-opening the previous door opening. This will re-instate important historic building fabric of architectural interest.

03. Re-instate historic opening between existing dining room and lounge, along **Gridline B**
