# 10 Chorlton Green\_ Grade II Listed, Formerly Higginbottom Farmhouse

# Executive Summary

The purpose of this document is to demonstrate how our proposals to modify this Grade II listed farmhouse to a usable, comfortable family dwelling, whilst preserving and enhancing character of existing building. Our proposals include connecting the ground floor living accommodation by inserting a lightweight glazed extension, omitting a second staircase from the kitchen, and adding a second bathroom to serve the five existing bedrooms. We have developed our proposals in consultation with Dave Morris, formerly of the local planning authority, and Jenny Wetton, of JW Conservation.

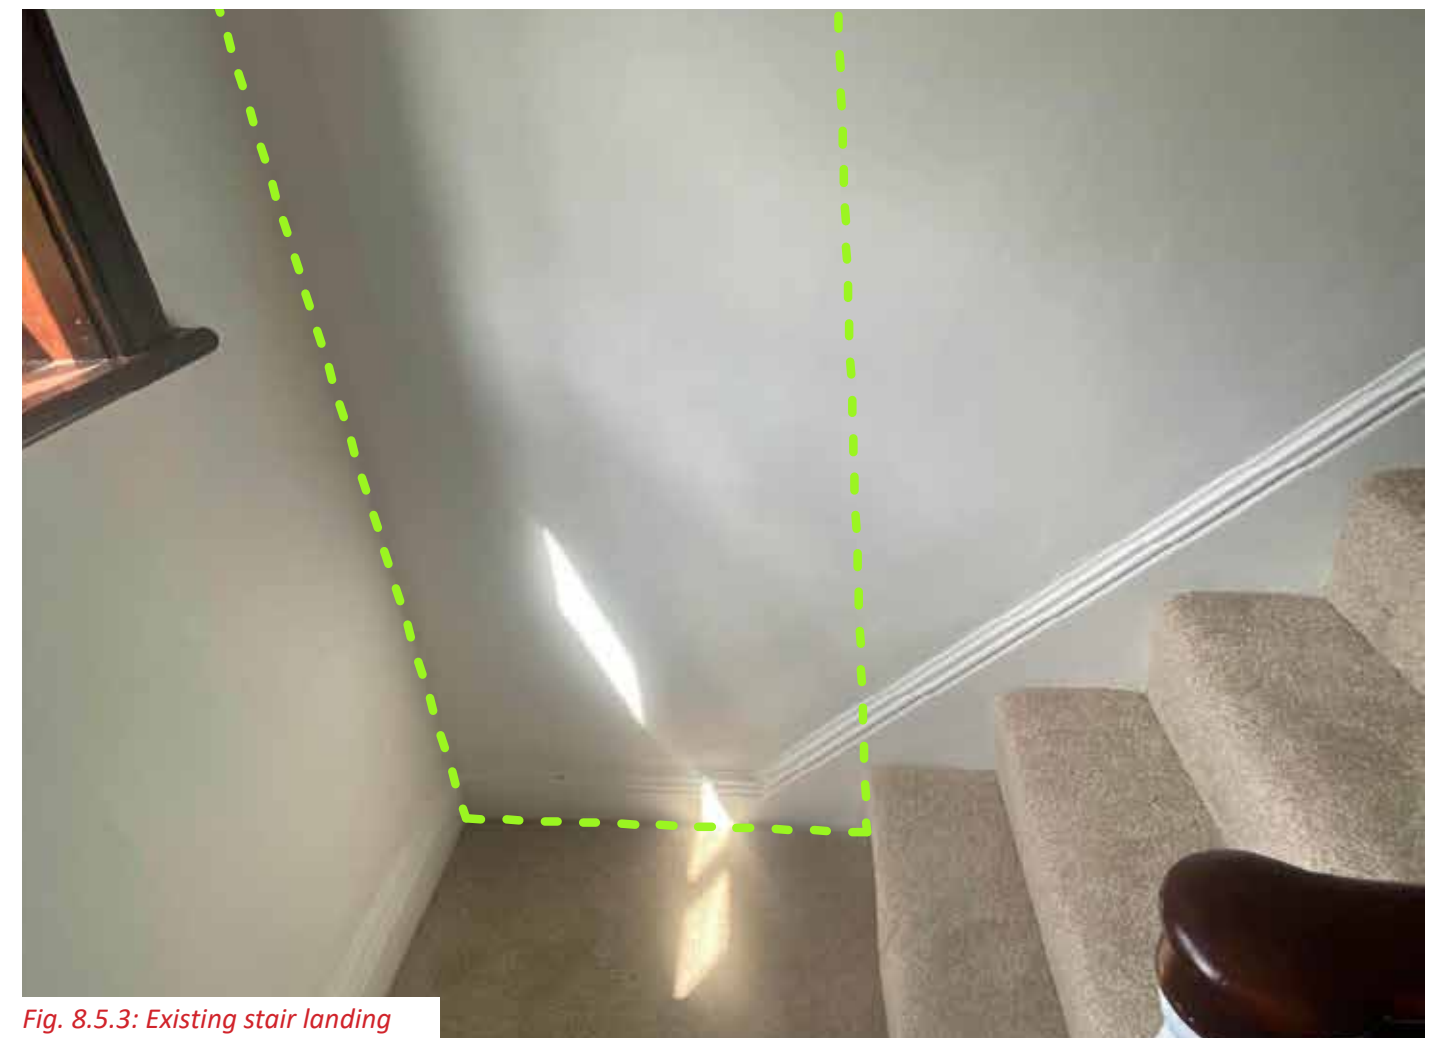
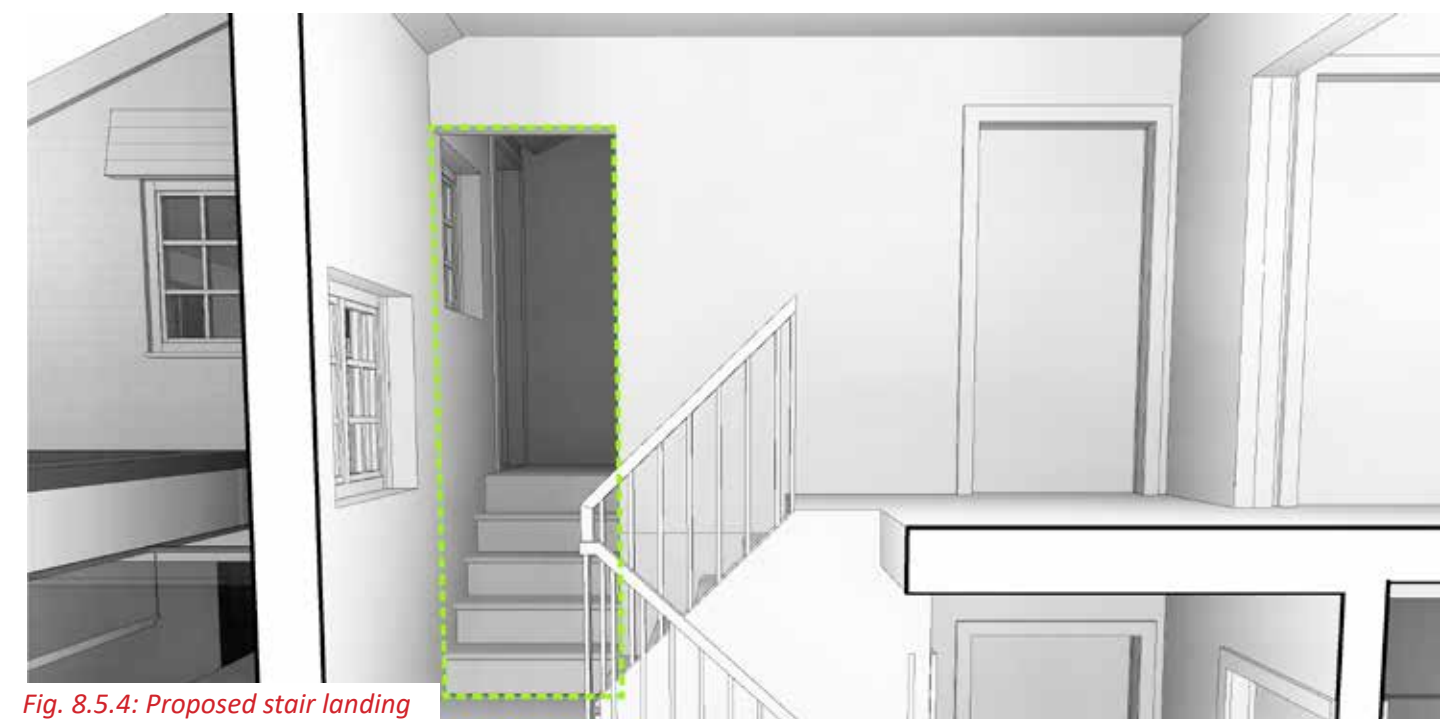
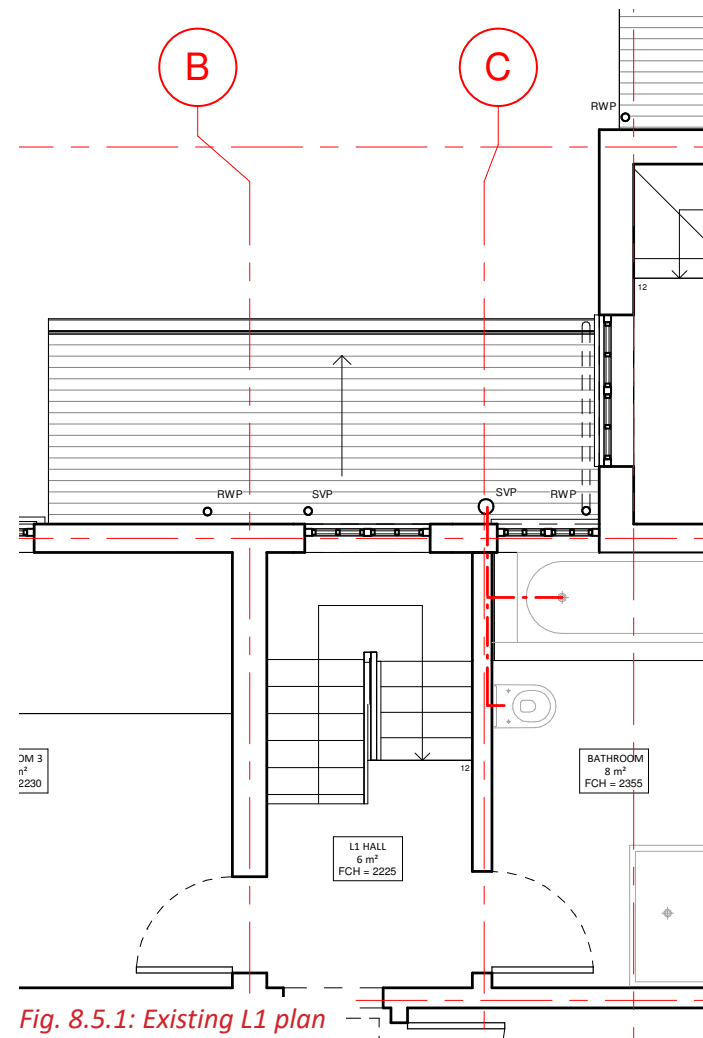
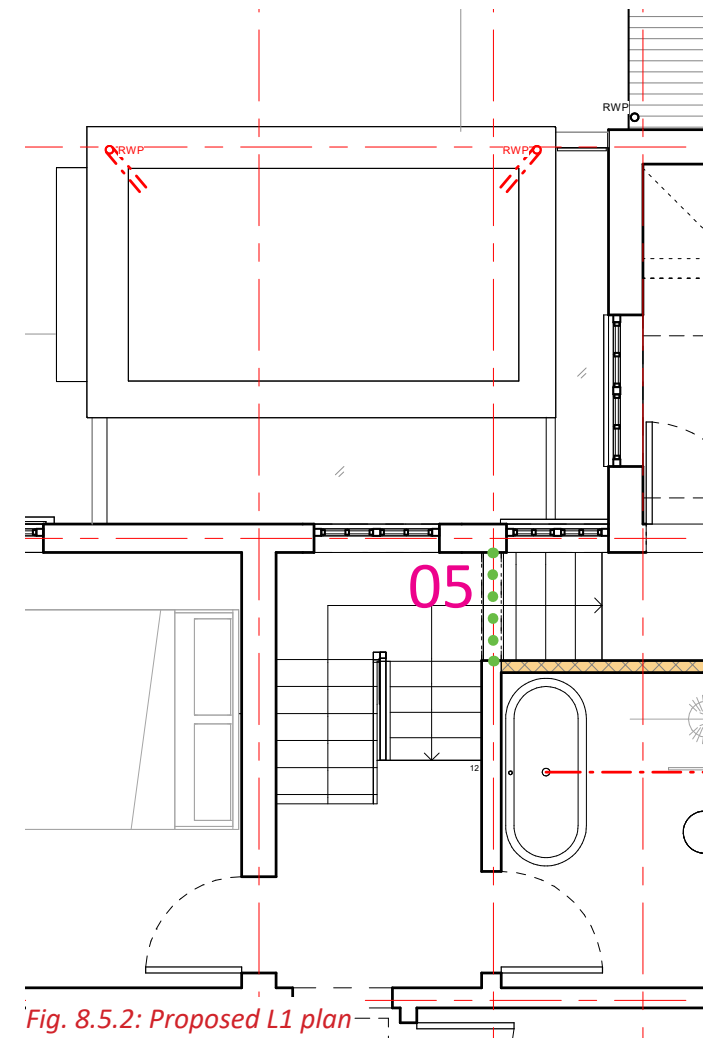
In order to bring the first floor of the two-storey range back into use, we have proposed to add a secondary stair run off the landing of the existing central stair, requiring an opening in the wall along gridline C. Our proposed opening will not affect the original staircase or its historic stick balusters, which are to be retained. The opening will also not affect any door mouldings or surrounds in the hall.

**05.** New opening at stair landing level, along **Gridline C**

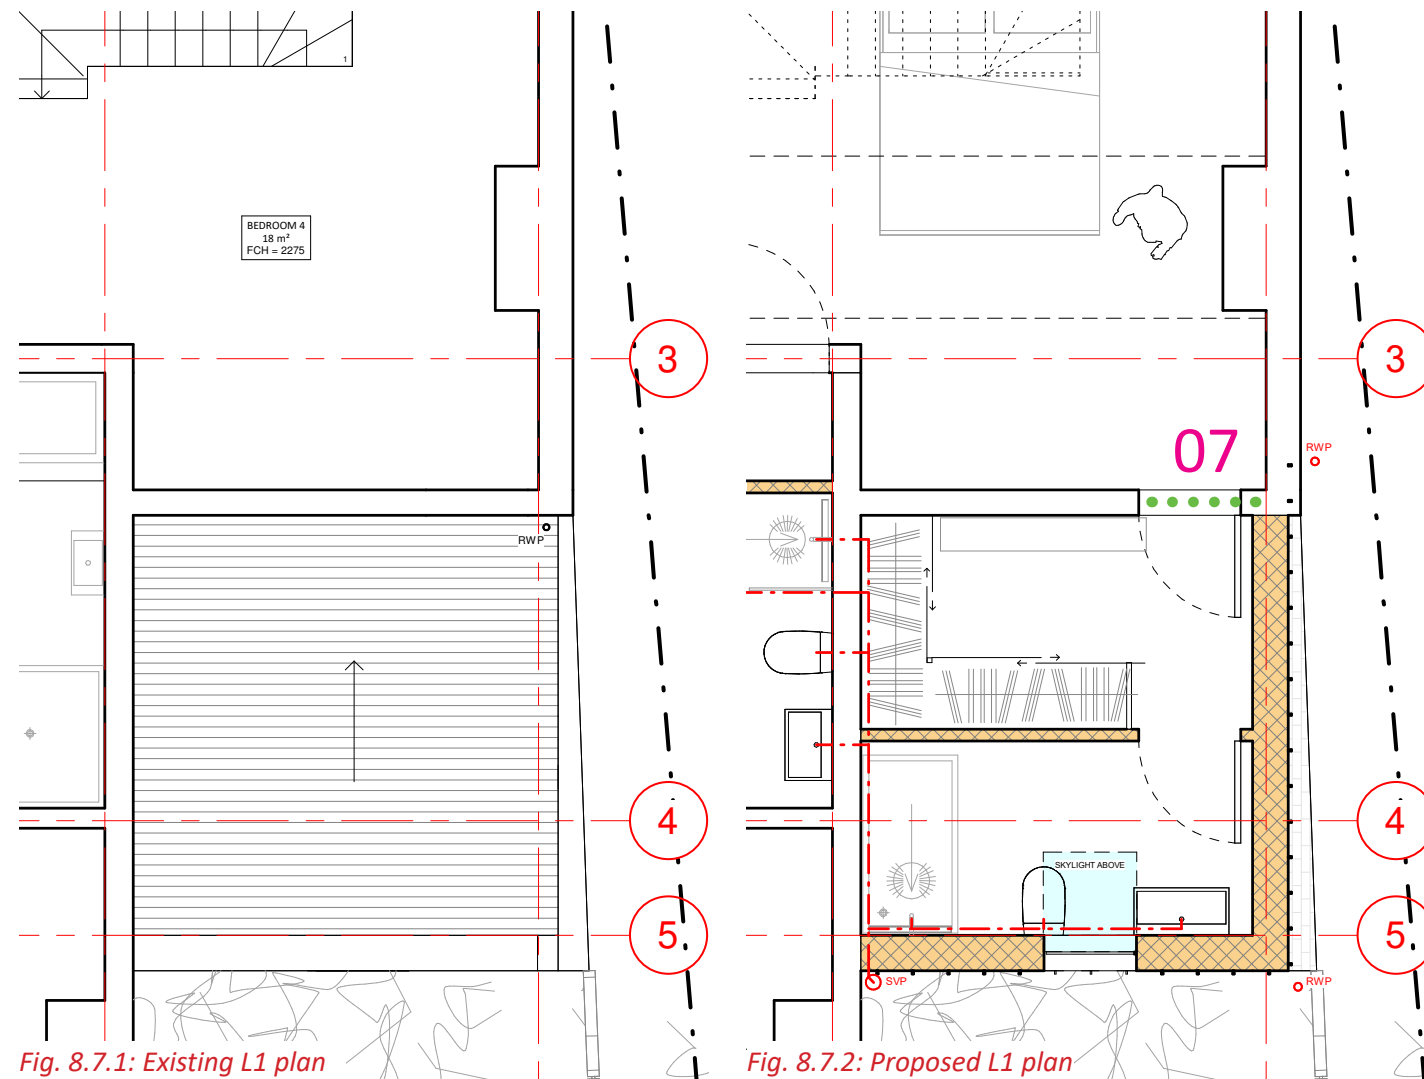
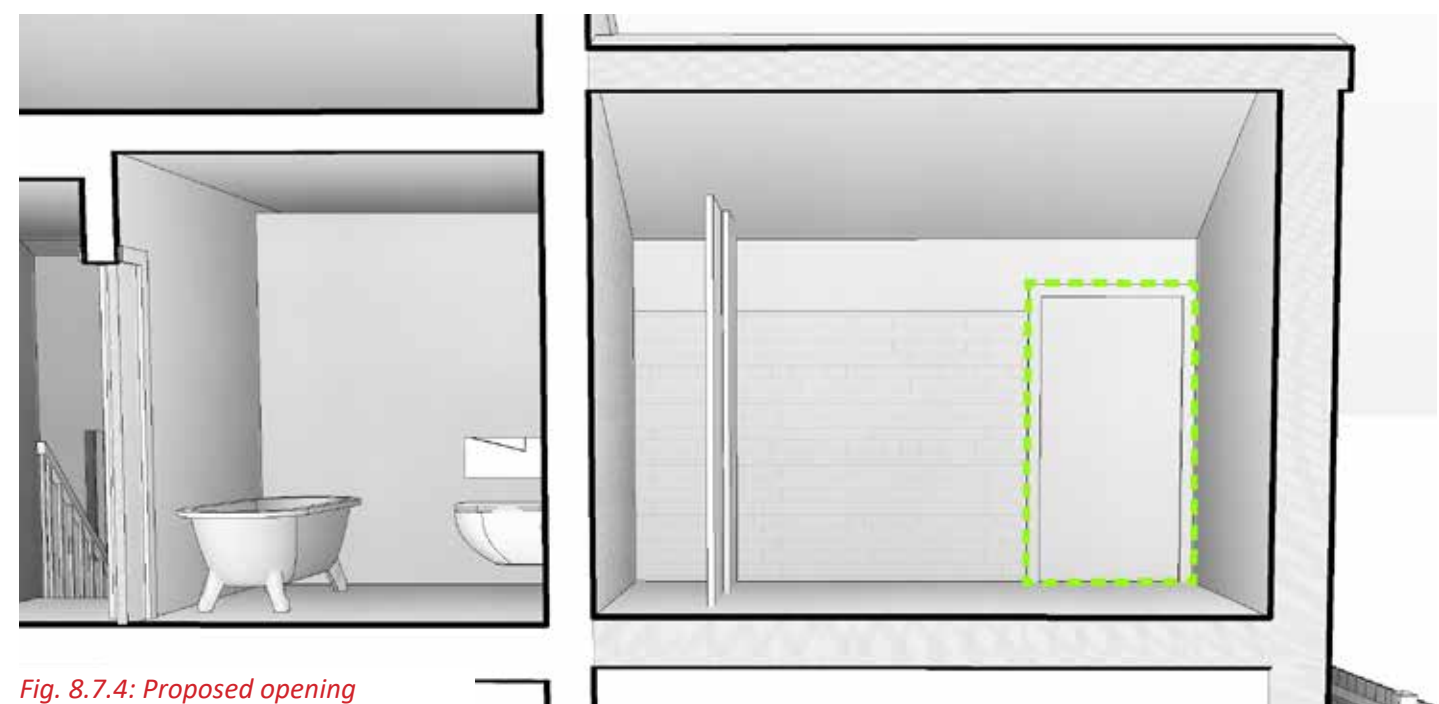
The addition of a lightweight extension above the existing dairy space, housing an en-suite and dressing room necessitates a new opening along the east face of the two-storey range (late 19th Century brickwork) - a largely blank elevation, not visible from the front of the property. The skirting in this room evidences modernisation and the removal of historic fabric.

**07.** New opening from rear bedroom to lightweight extension, along Gridline F

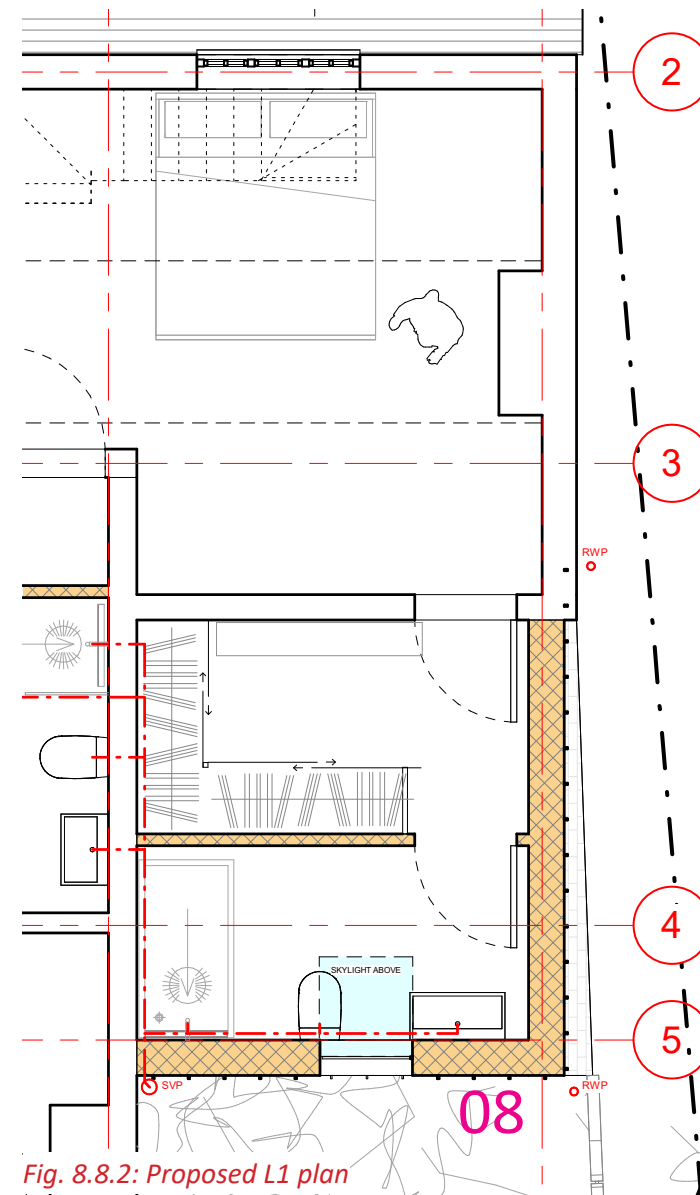
Fig. 8.8.2: Proposed L1 plan

We are proposing a lightweight extension above the existing sunken dairy space. Currently, one bathroom is shared between five bedrooms, which we believe is inadequate for modern family living. We propose an additional bathroom, serving as an en-suite for the master bedroom within the two-storey range. The extension will also house a dressing area for the master bedroom. From the front of the property, the existing dairy is barely visible due to being set back from the primary facade, as well as the abundant mature vegetation to the front, as shown in the photo-matched render opposite (Fig. 8.8.5)

08. Lightweight extension, above dairy

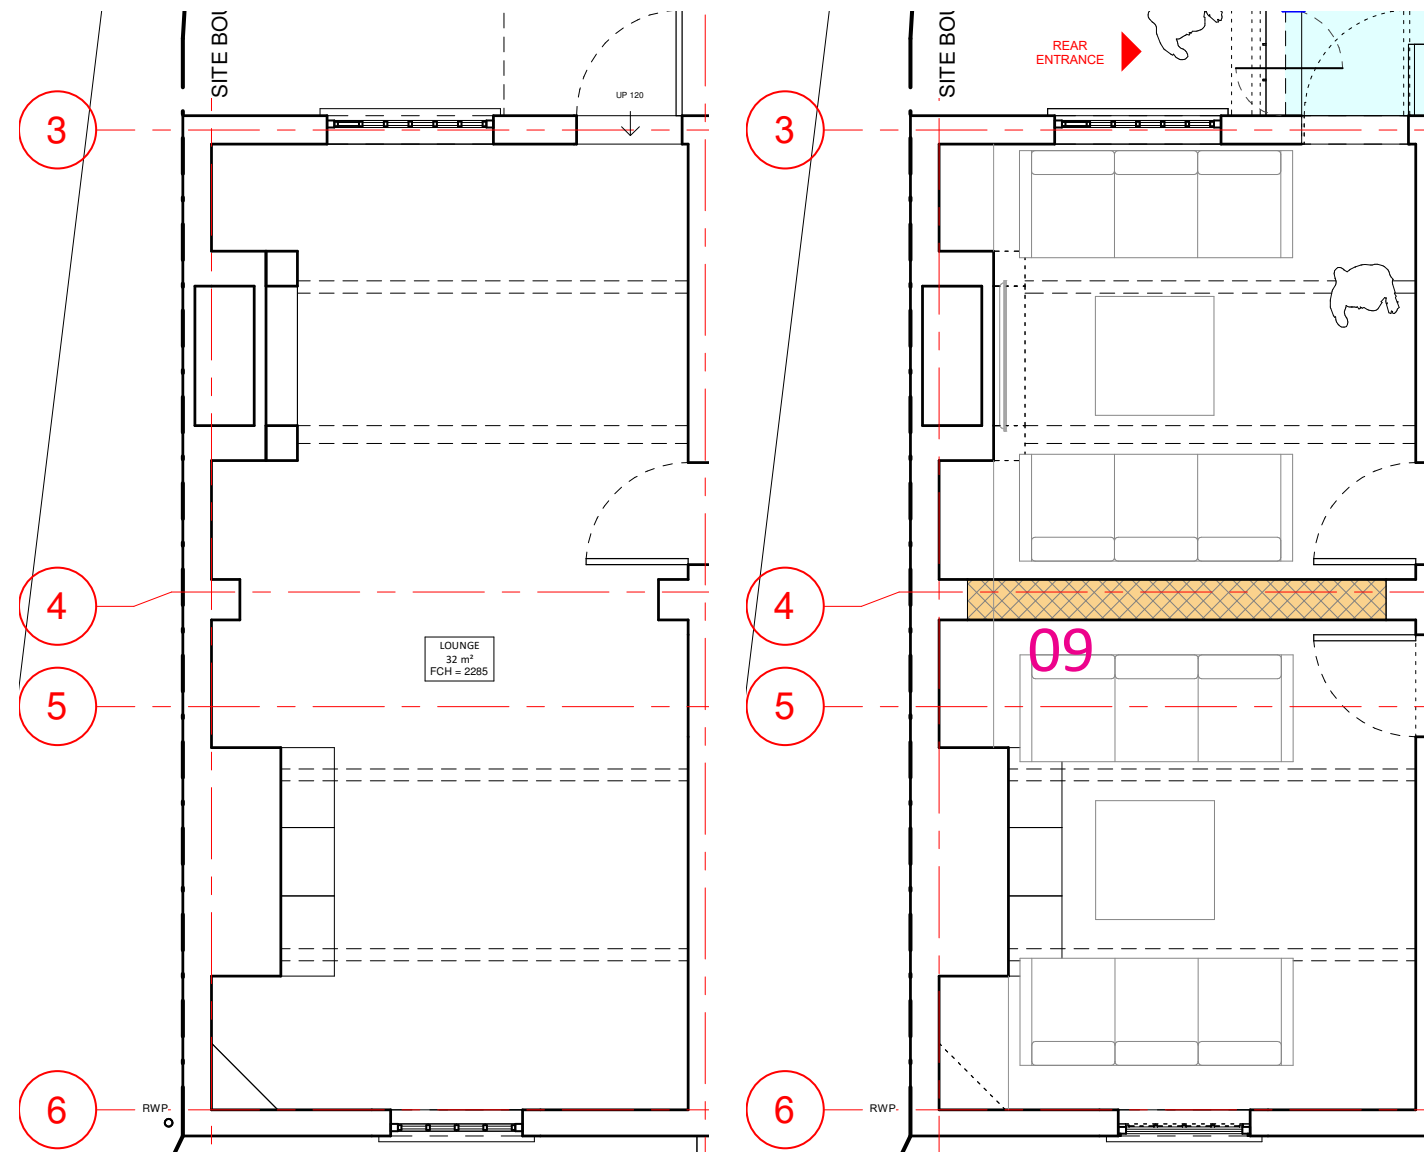
Fig. 8.9.1: Existing L0 plan

Fig. 8.9.2: Proposed L0 plan

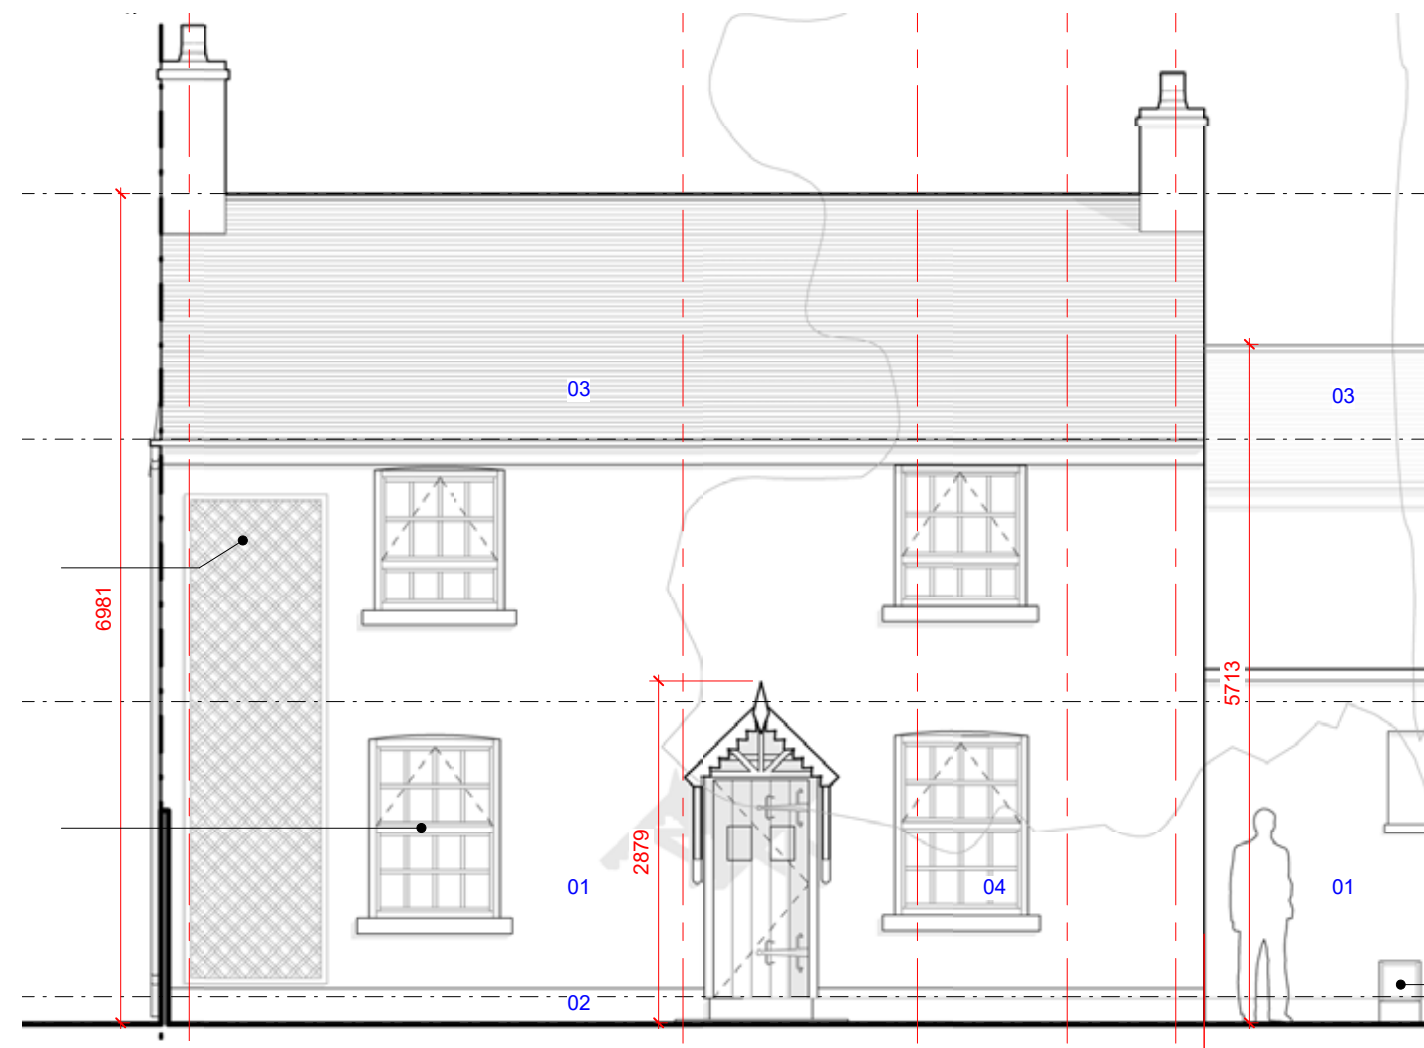
Fig. 8.10.1: Existing front elevation

Historically, eight-over-eight timber sash windows made up the front facade of the building. Casement windows imitating the historic sashes have since been installed, to the detriment of the character of the building and its setting. We are proposing to re-instate traditional eight-over-eight sashes as per the original design.

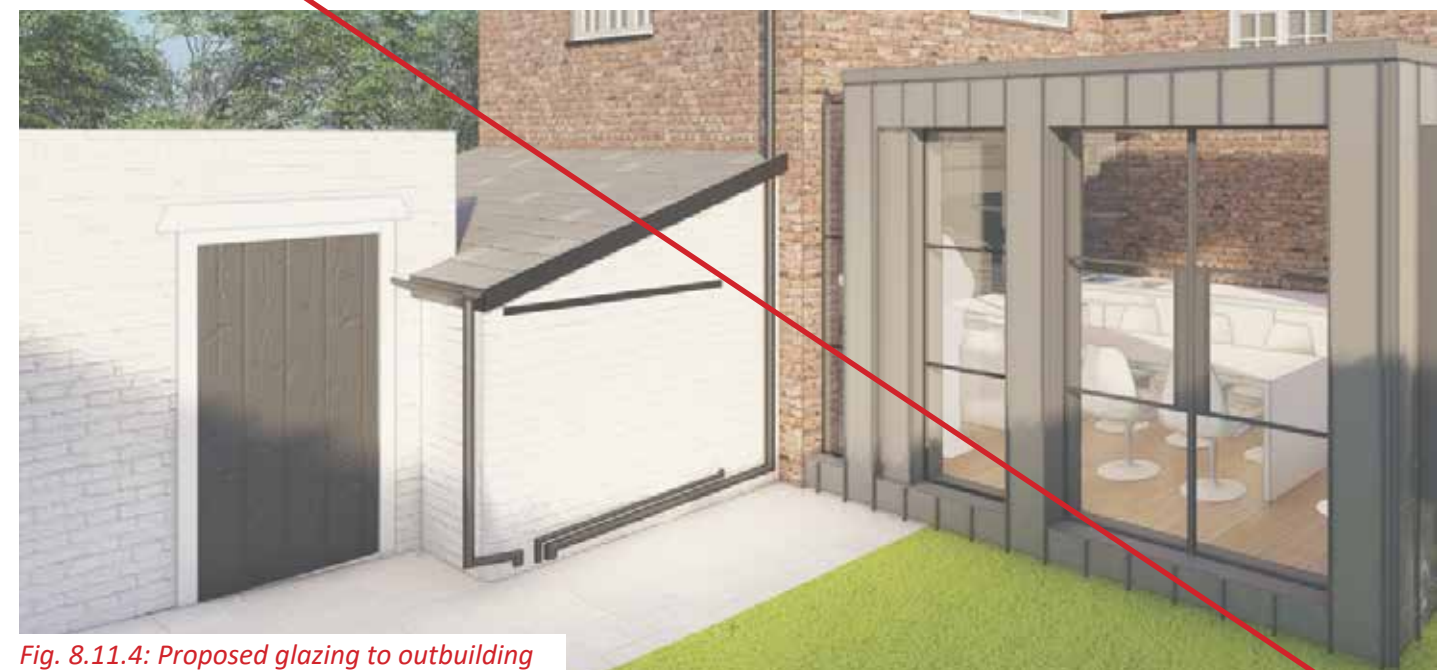
The existing outbuilding is in poor condition. Built in the 20th Century and containing little architectural interest, the components making up the facade are not original to the building. The head height internally within both spaces makes the space into an unuseable wasted space (just 1550mm along the western wall of the utility). Once insulation is included, this space becomes even more impractical. We proposed to bring the lost spaces back into use; removing the roof to the outbuilding and part of the utility, and building a flat roof limited to the height of the existing utility ridge. We also propose to work with the existing openings, with the existing door opening being retained, and the historic existing external door to the kitchen to be re-used within this existing opening. We also proposed to lower the sill of the small window, and insert a new conservation-style skylight to the new roof.

Fig. 8.11.4: Proposed glazing to outbuilding

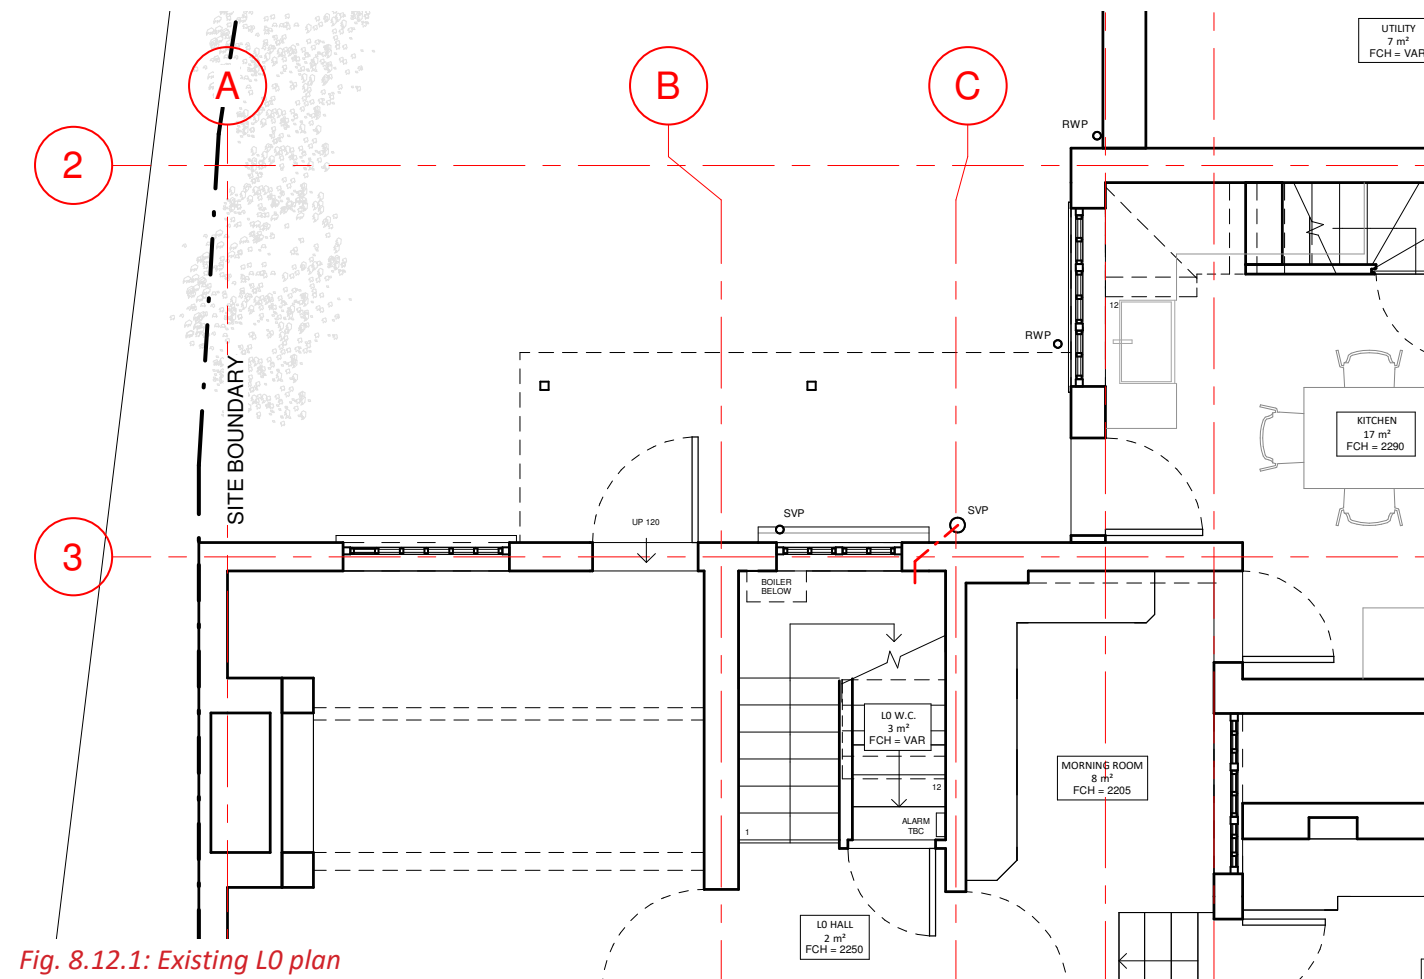
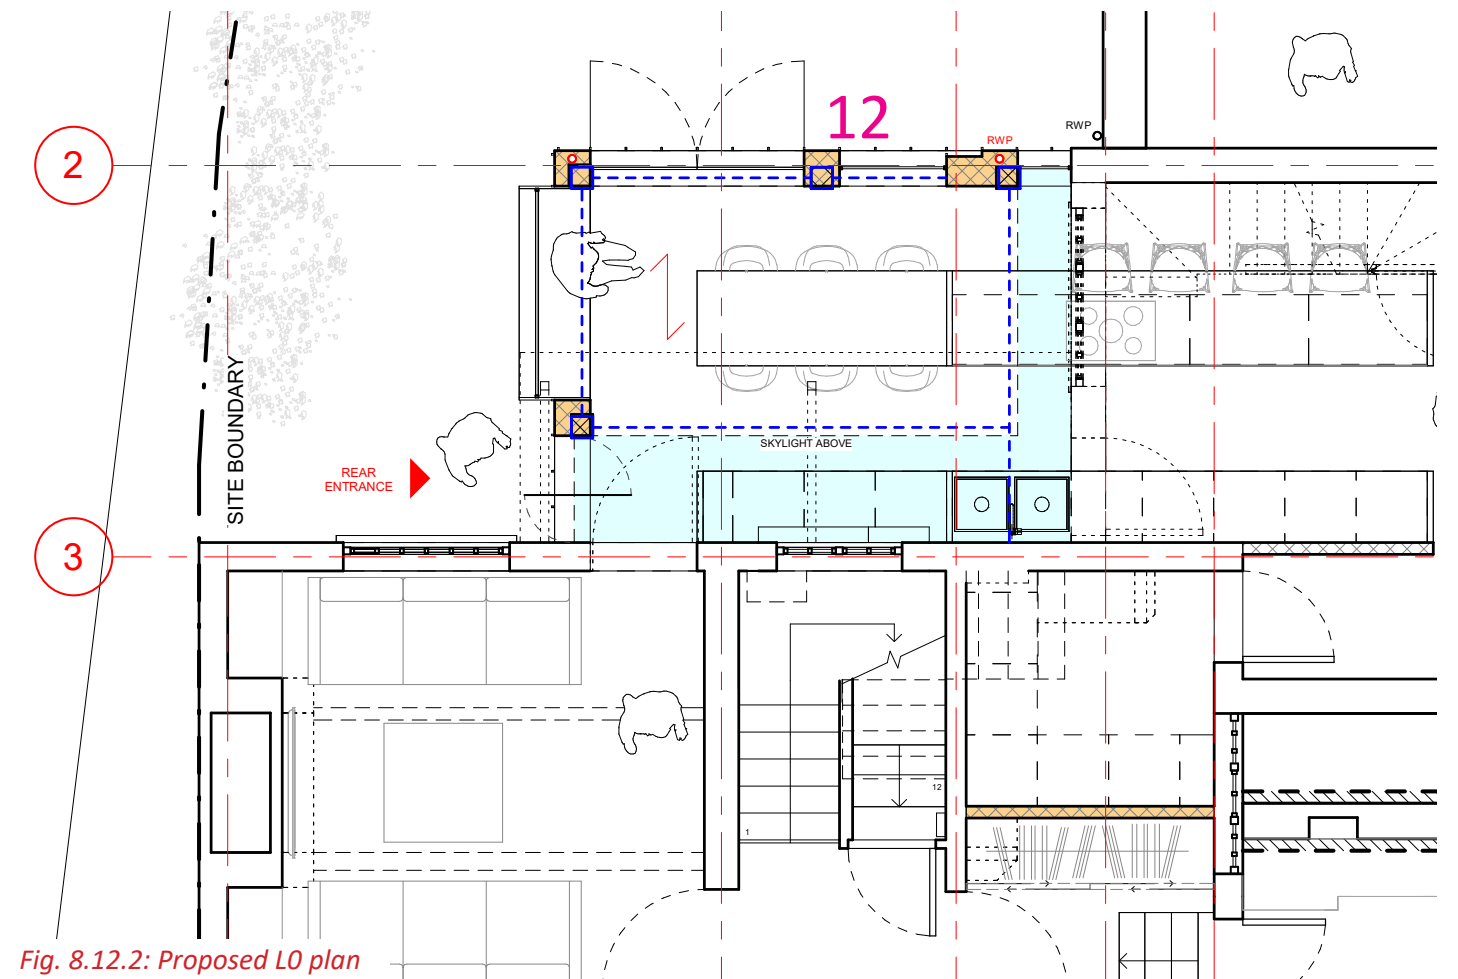
Fig. 8.12.1: Existing L0 plan

Fig. 8.12.2: Proposed L0 plan

The existing kitchen in the two-storey range to the rear is dark, with no connection to the living spaces within the original farmhouse. We propose a glazed extension, minimal both in scale and aesthetic, extending the space to the south. This will fill the kitchen with light while unifying the ground floor plan, linking the kitchen/diner to the living spaces. The extension touches the historic building fabric lightly through use of a wrap-around glazed rooflight, and maintains views of the existing brick through plentiful glazing, impacting minimally on the existing building.

In its scale, the extension has been limited vertically to the underside of the window at the landing of the existing stair, and has not been brought any further out from the farmhouse than the existing two-storey range. It is also one bay (internal chambers within original farmhouse) in width, meaning the historic scale and rhythm of the plan is maintained.

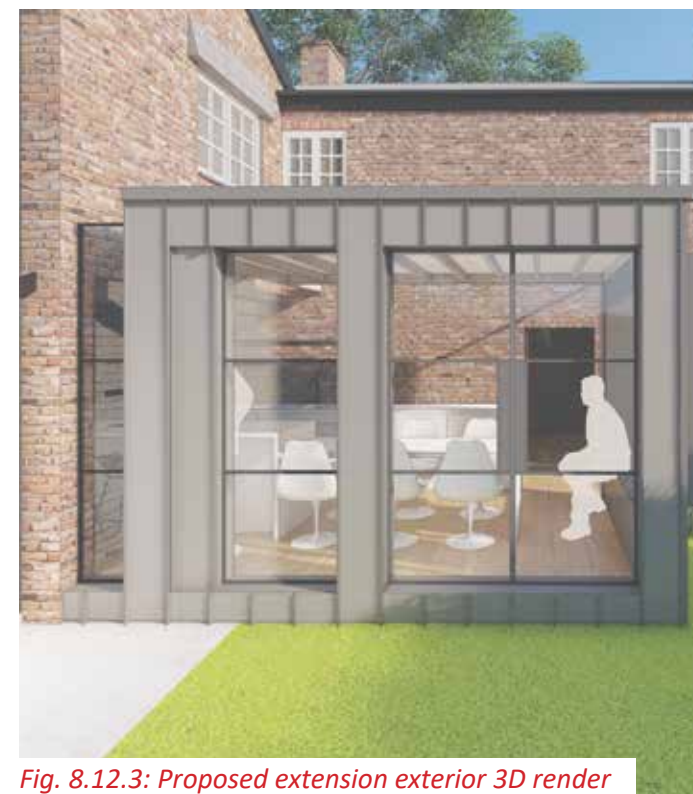
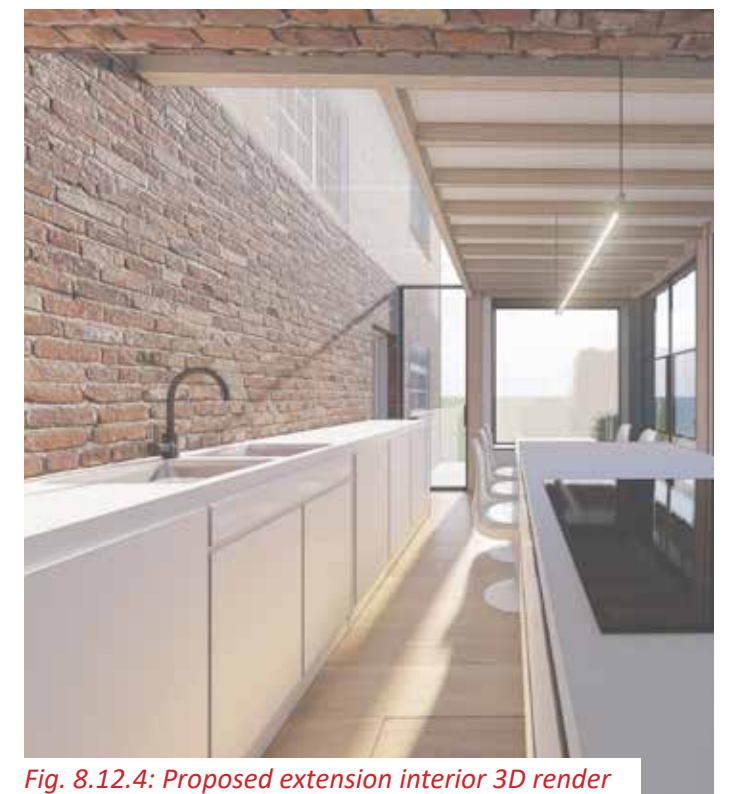
Fig. 8.12.3: Proposed extension exterior 3D render

Fig. 8.12.4: Proposed extension interior 3D render

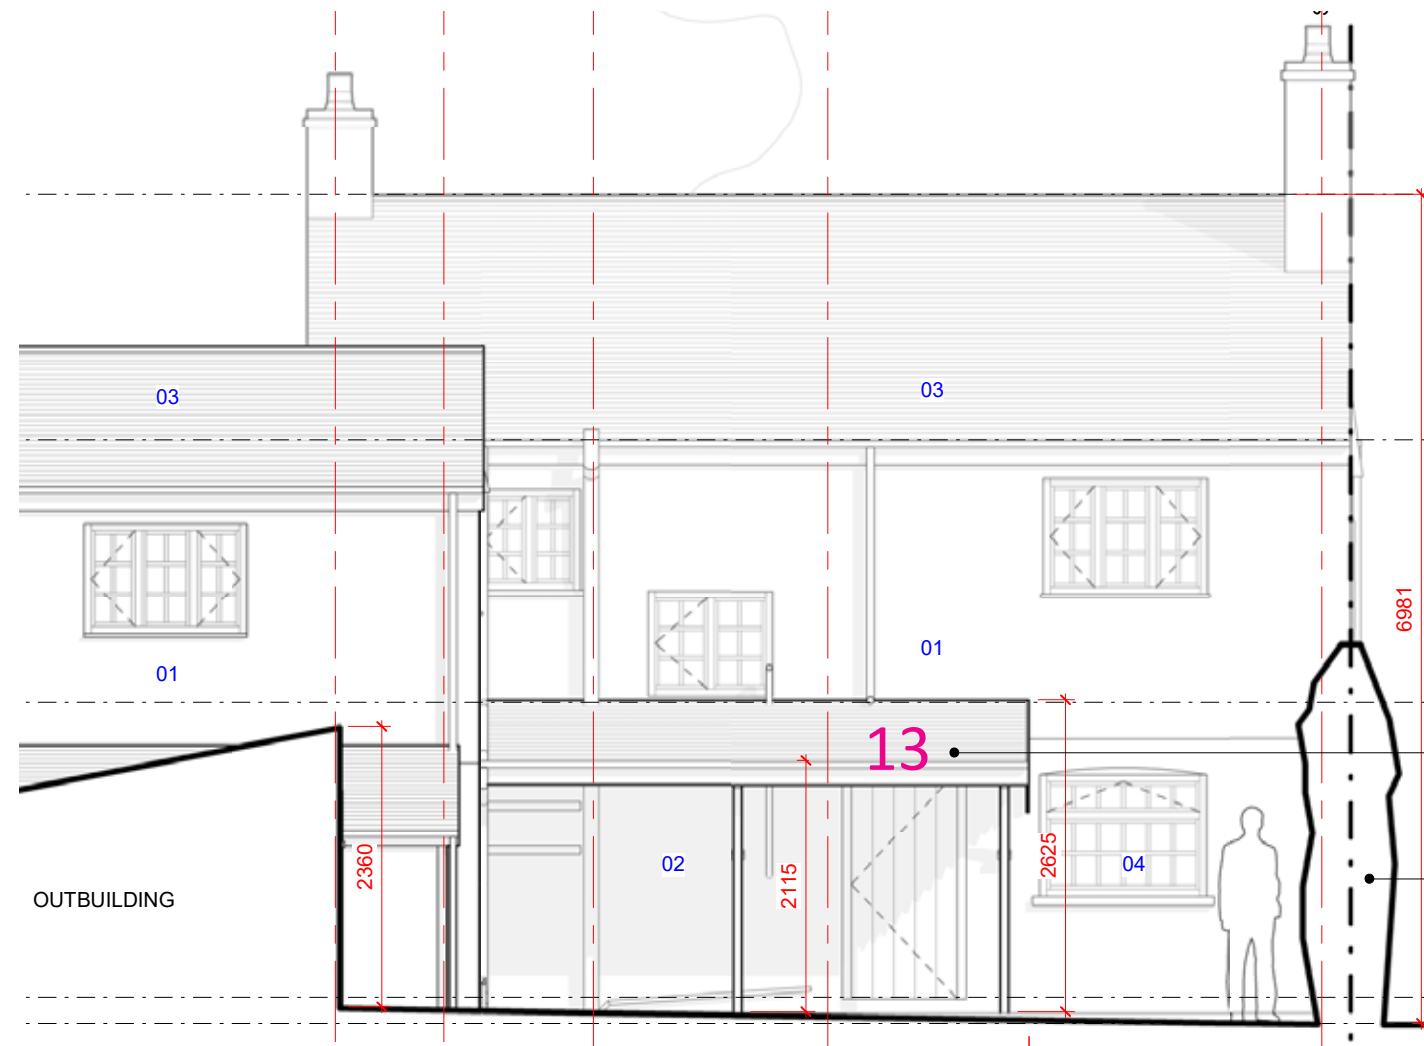
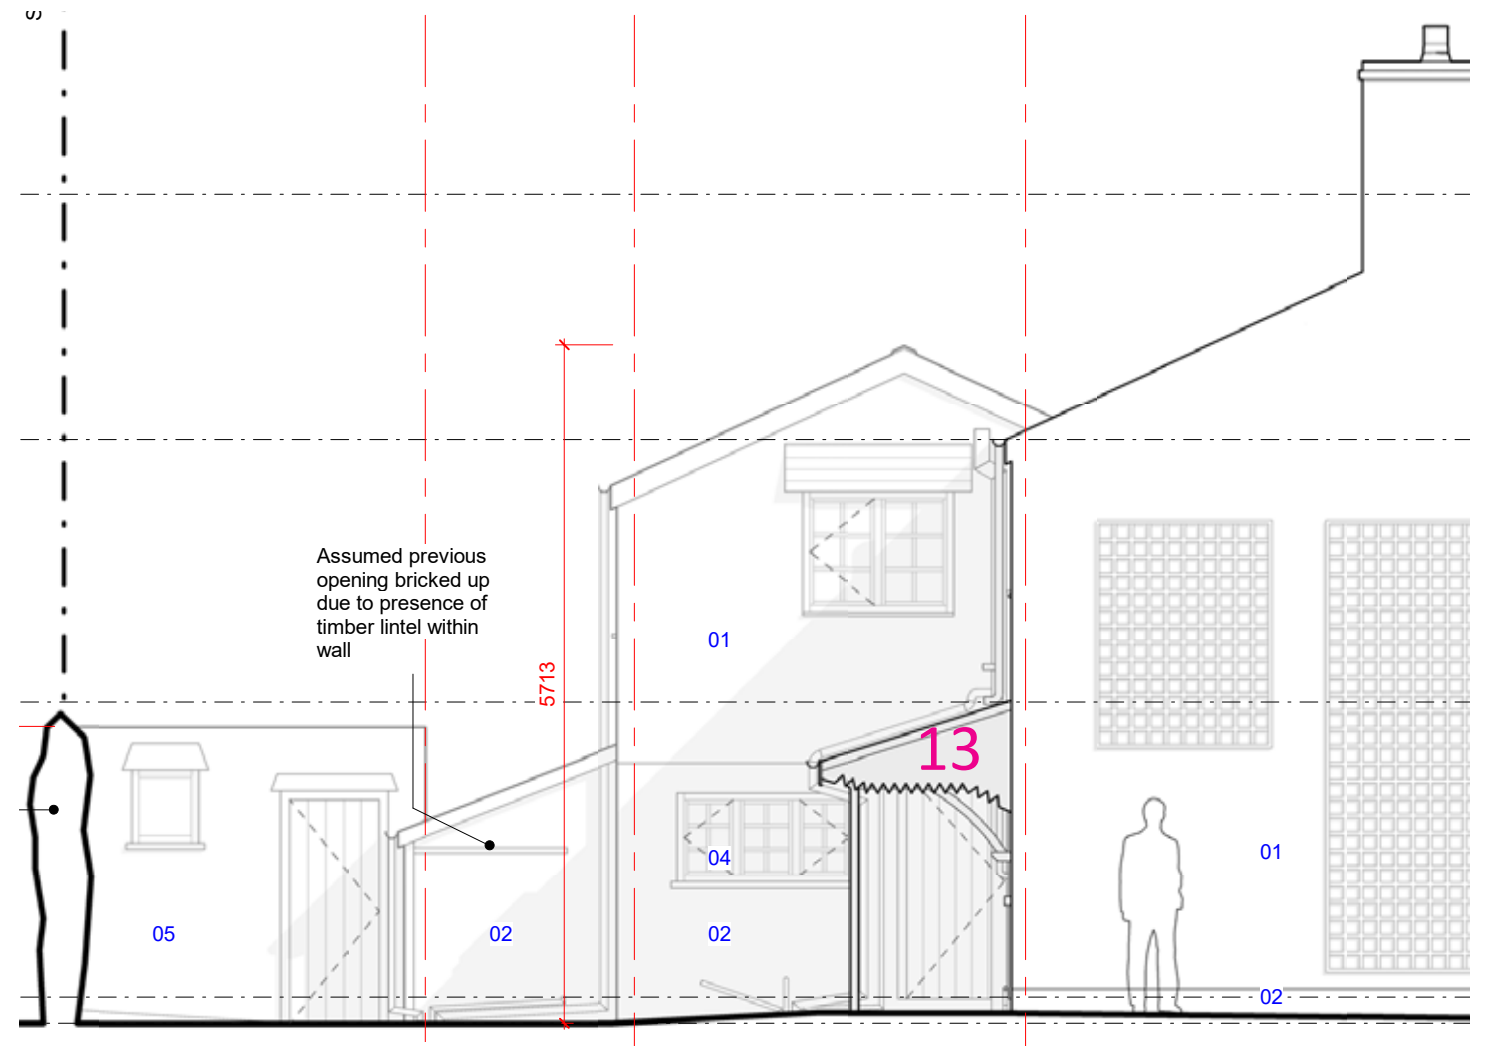
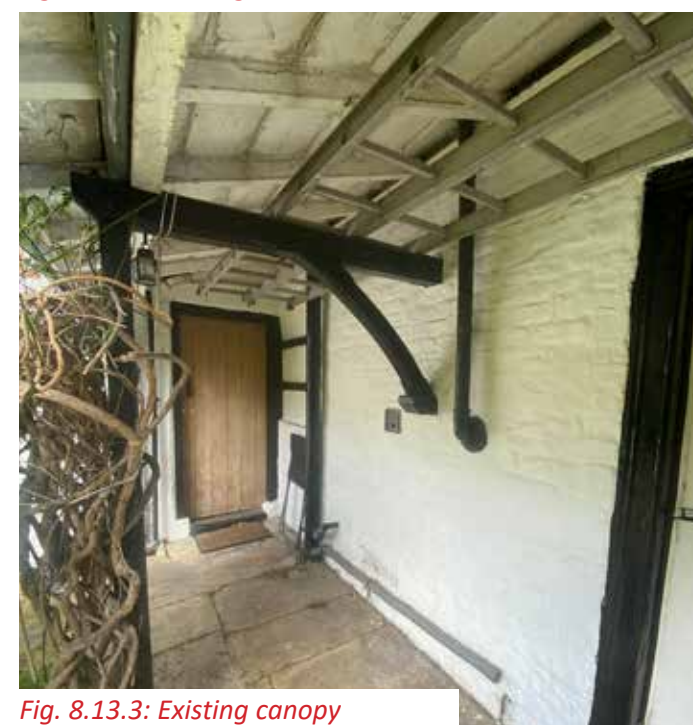
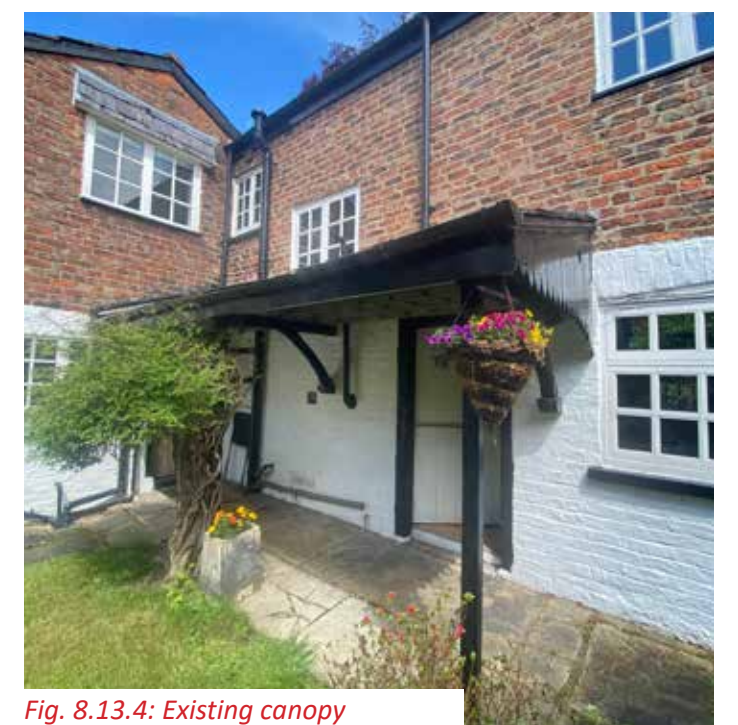
Fig. 8.13.1: Existing rear elevation

An external lean-to slate canopy, supported by timber posts and brackets, added later in the 19th Century, would historically have been used as an external store to keep dairy products out of direct sunlight. Due to its location and scale, we do not consider it viable to retain the canopy. The canopy is unfortunately too shallow and the height too low, to convert it into a habitable internal space. After extensive investigation, we concluded that relocating the canopy would simply dilute its relationship to the building.

Fig. 8.13.2: Existing side elevation

Fig. 8.13.3: Existing canopy

Fig. 8.13.4: Existing canopy
