# 10 Chorlton Green\_ Grade II Listed, Formerly Higginbottom Farmhouse

# Executive Summary

The purpose of this document is to demonstrate how our proposals to modify this Grade II listed farmhouse to a usable, comfortable family dwelling, whilst preserving and enhancing character of existing building. Our proposals include connecting the ground floor living accommodation by inserting a lightweight glazed extension, omitting a second staircase from the kitchen, and adding a second bathroom to serve the five existing bedrooms. We have developed our proposals in consultation with Dave Morris, formerly of the local planning authority, and Jenny Wetton, of JW Conservation.

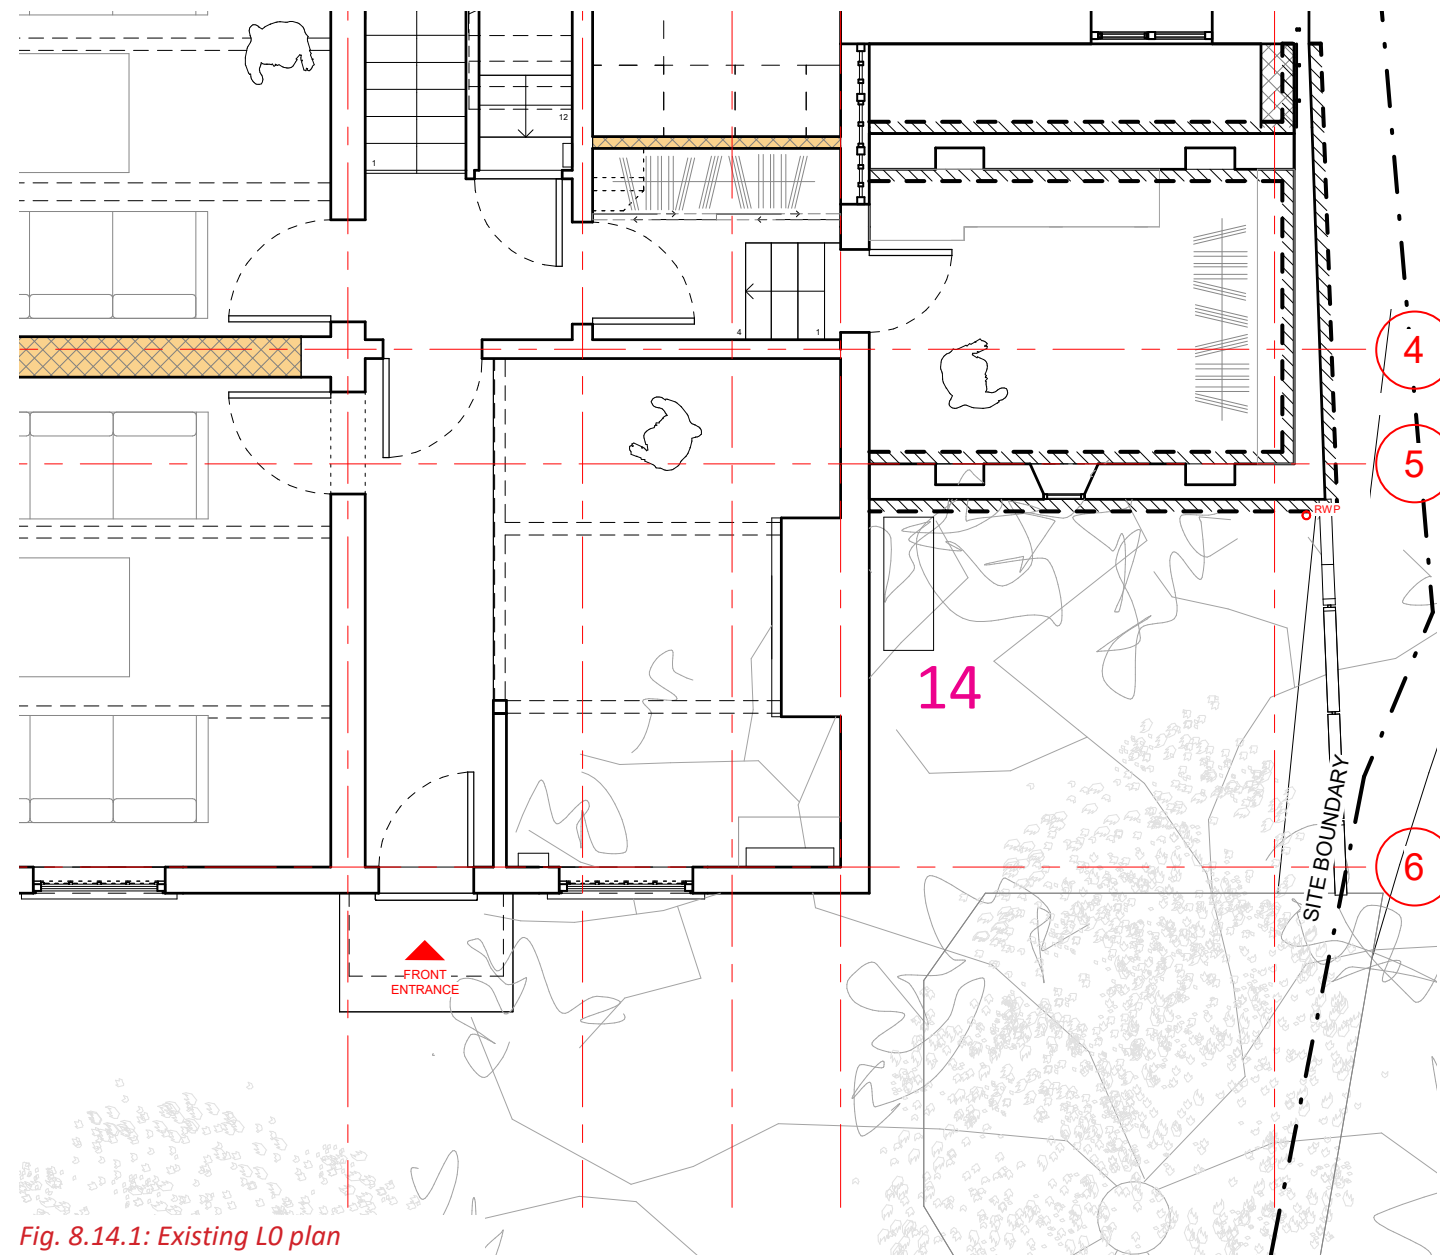
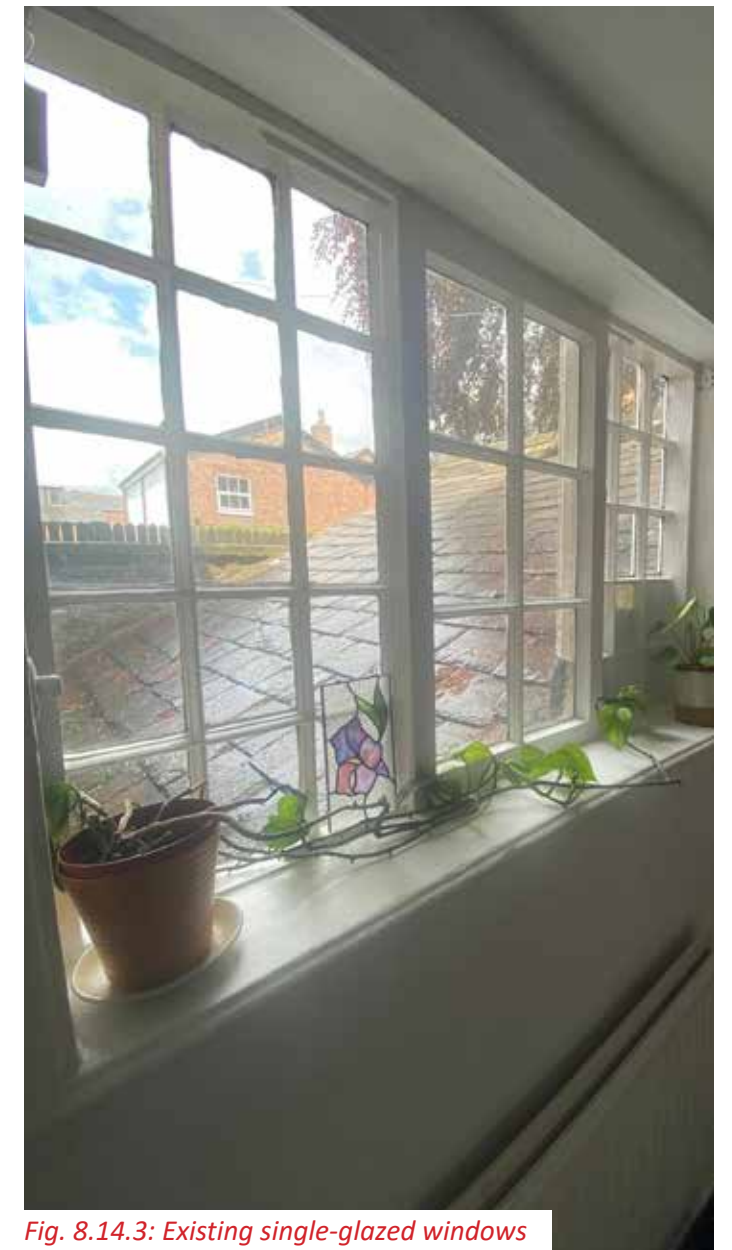
Fig. 8.14.1: Existing LO plan

Fig. 8.14.2: Existing inadequate radiators

Fig. 8.14.3: Existing single-glazed windows

The house is currently cold and inefficient. To bring the house into the 21st Century, and meet standards for thermal comfort and renewable energy, we are proposing to install an air source heat pump (ASHP) to heat the house.

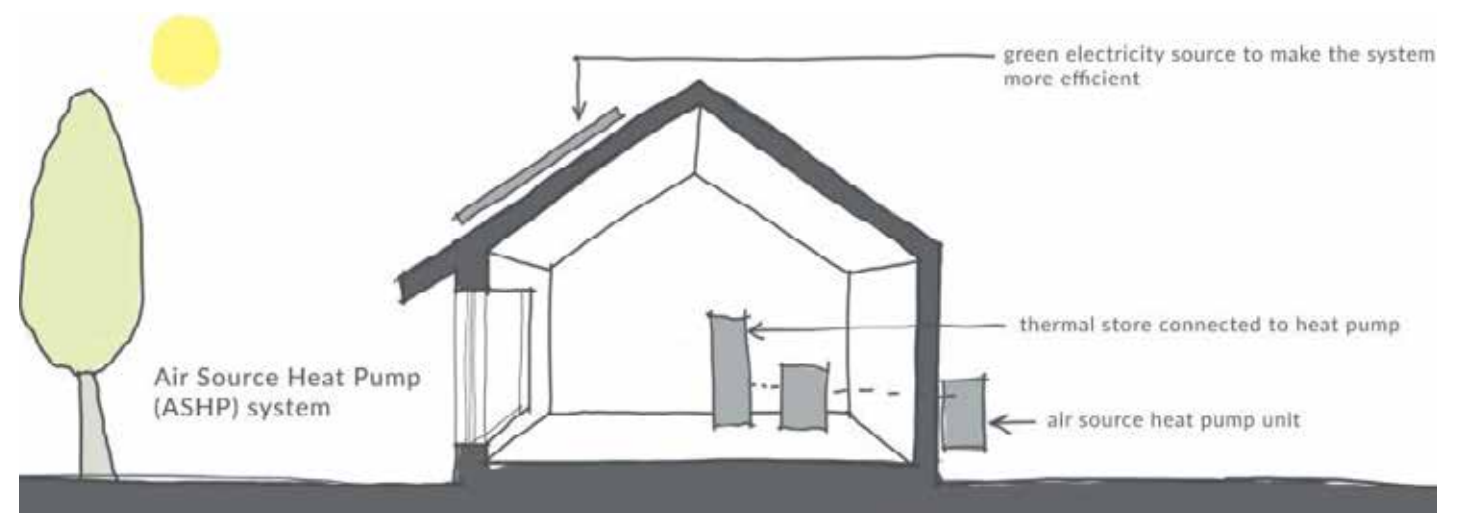
Fig. 8.14.4: Air source heat pump (ASHP)

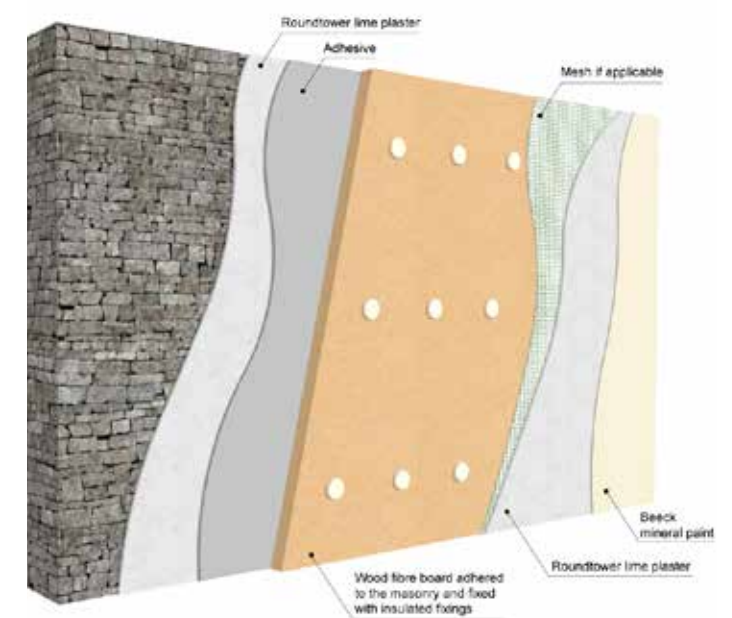
The exterior walls of the property are made up of solid masonry. In order to keep the building breathable and provide adequate ventilation while upgrading thermal performance, we are proposing to internally line all walls with insulated lime render plaster. Visually, this will match the existing plaster to the interiors, while allowing for more breathability and reducing heat loss.

Fig. 8.16.3: Proposed insulated lime render plaster

Fig. 8.16.4: Proposed insulated lime render plaster

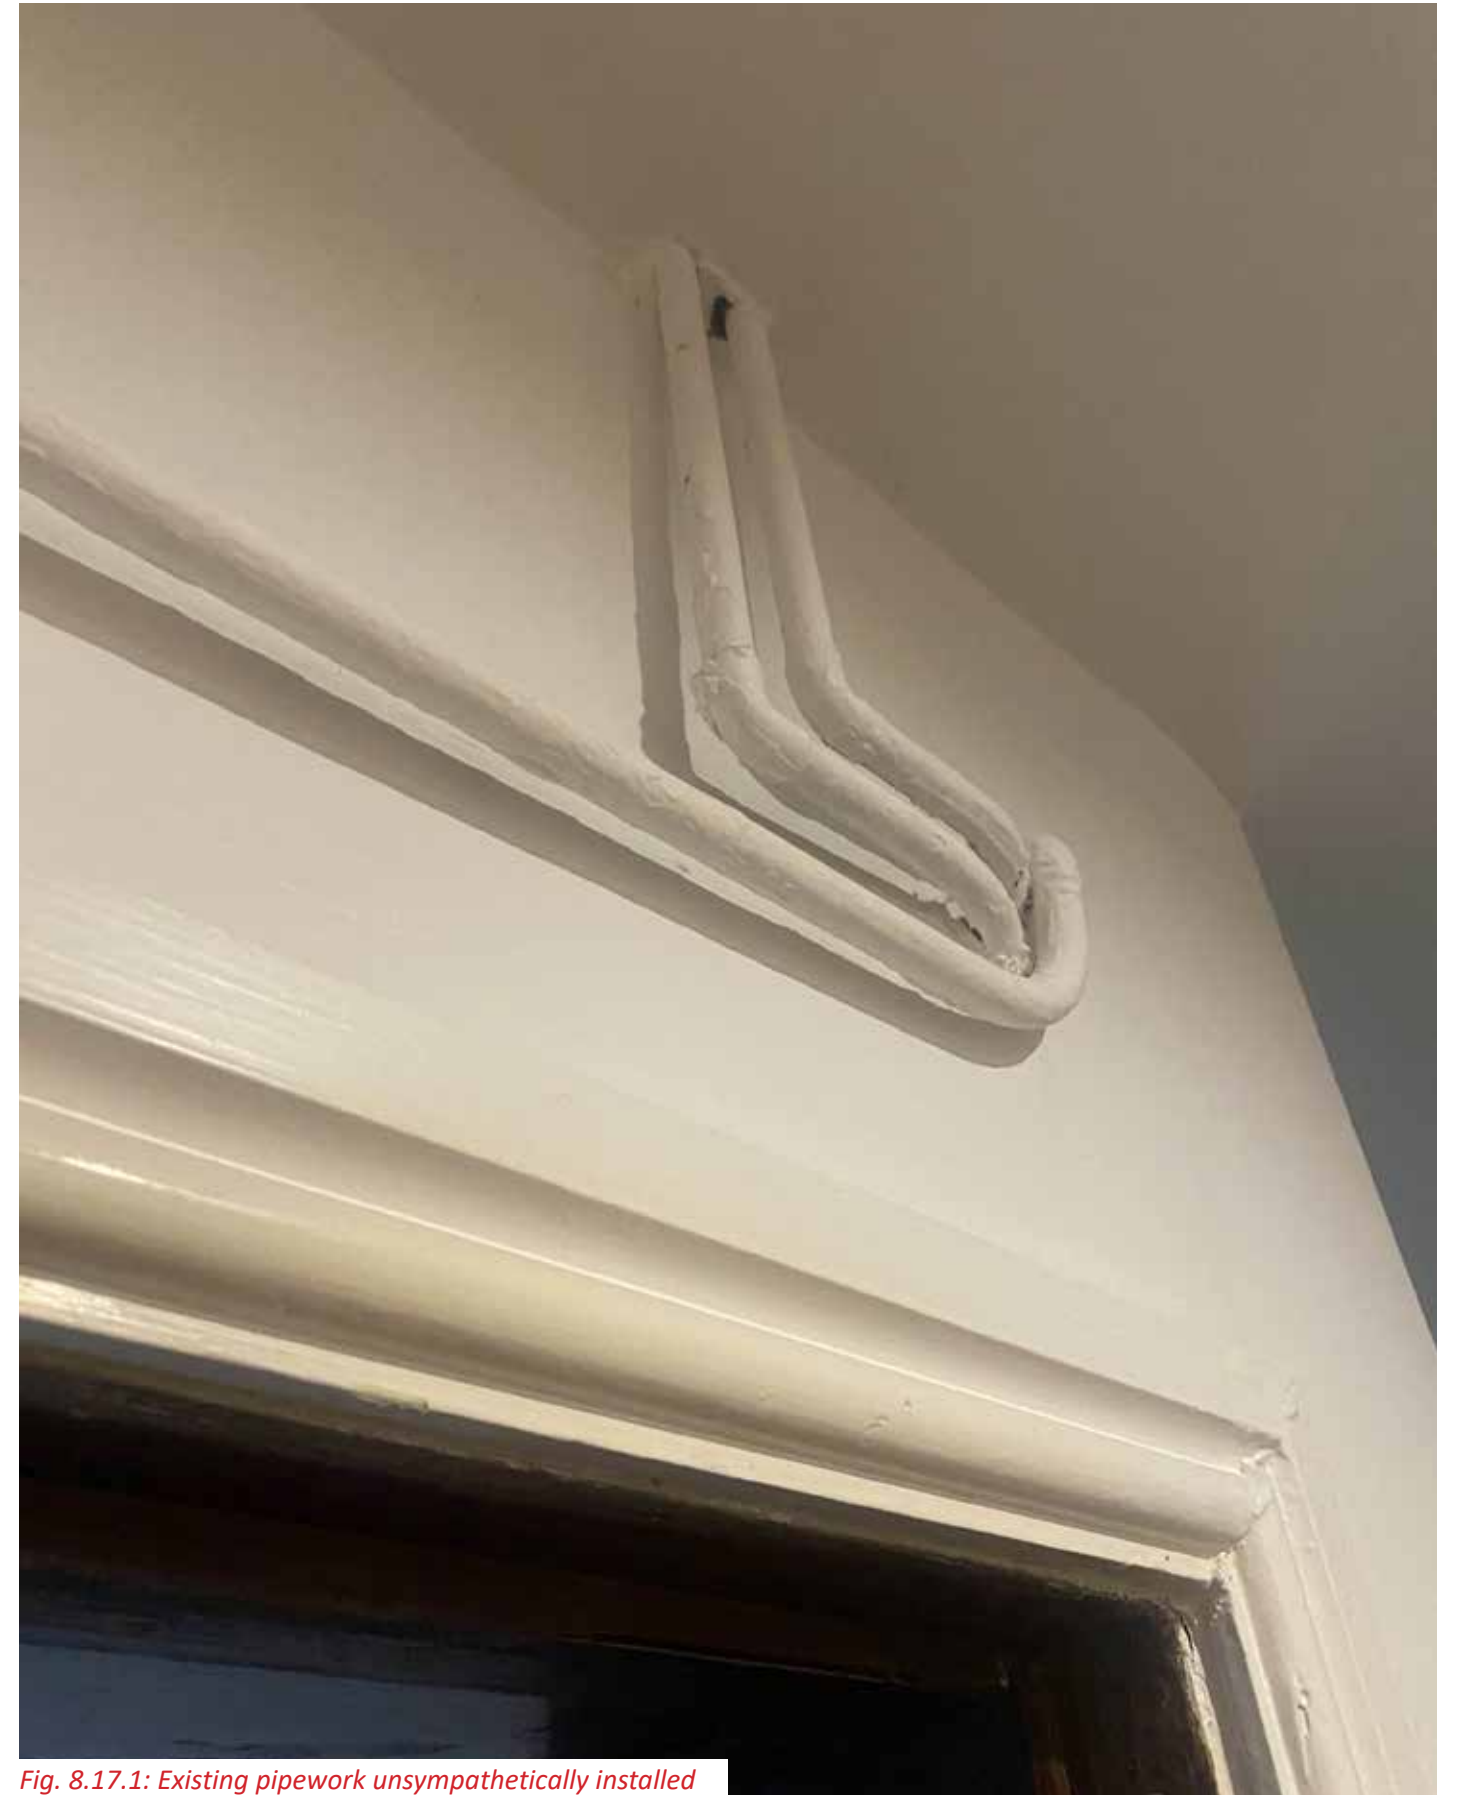
*Pipework has at some point been messily and unsympathetically installed within the historic building fabric. Exposed pipes have been hammered into original walls, not only detracting from the aesthetic but also harming the historic building fabric. We propose to remove all this visible and redundant pipework, replacing it with a more sympathetic solution that isn't visible.*

*Fig. 8.17.1: Existing pipework unsympathetically installed*

| Ref. | Intervention | Description / Significance | Location | Benefit | Notes |
|---|---|---|---|---|---|
| 17 | Omit and replace all old pipework from historic building fabric | Current pipework unsympathetically installed, causing damage to walls. Replacement pipework will not be visible. | | Public | Unsympathetic / not original to building currently. |

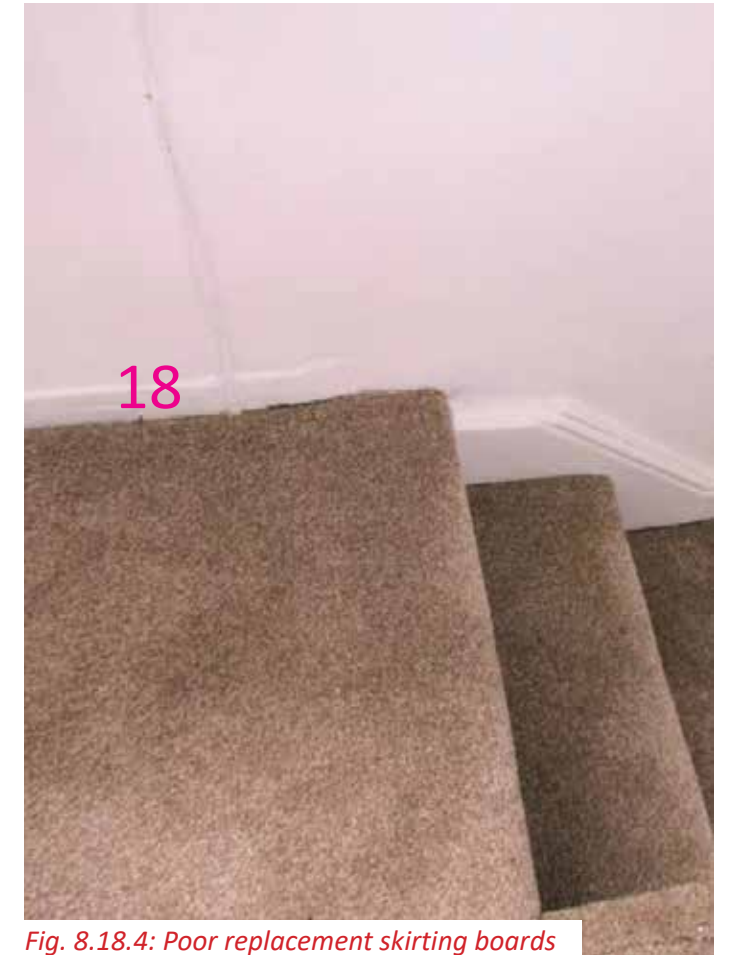
Fig. 8.18.1: Original skirting boards

Fig. 8.18.2: Poor replacement skirting boards

Fig. 8.18.3: Poor replacement skirting boards

Fig. 8.18.4: Poor replacement skirting boards

Throughout the house, there is a mix of historic, original skirting and modern, poorly fitted alternatives. We propose to strip all the modern replacement joinery and skirting, replacing them with alternatives in the style of the original building.

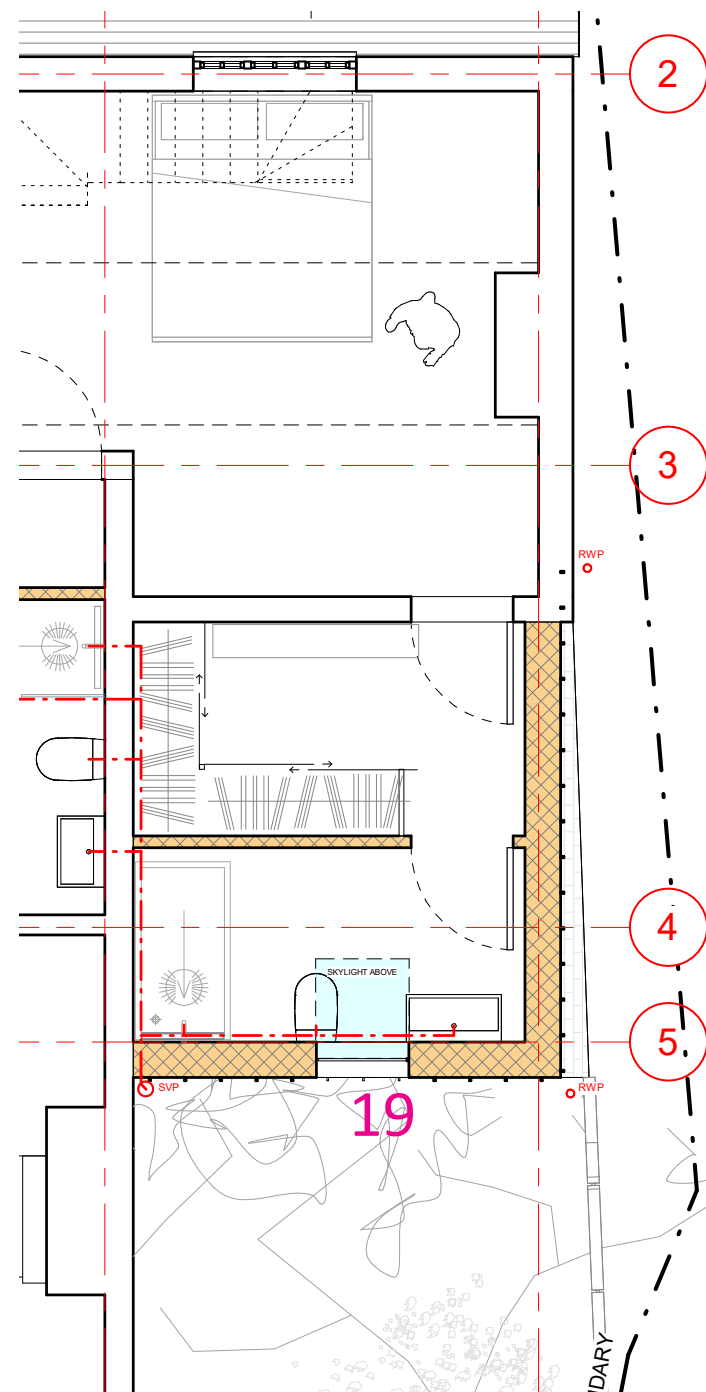
Fig. 8.19.1: Proposed L1 plan

Fig. 8.19.2: Proposed front elevation

After consultation with the planning officer, we propose to add a small up-and-over eaves window to the front of the first-floor extension over the dairy. The window is aligned with the existing opening below, and the sill height is aligned with the existing openings along the primary facade of the farmhouse.

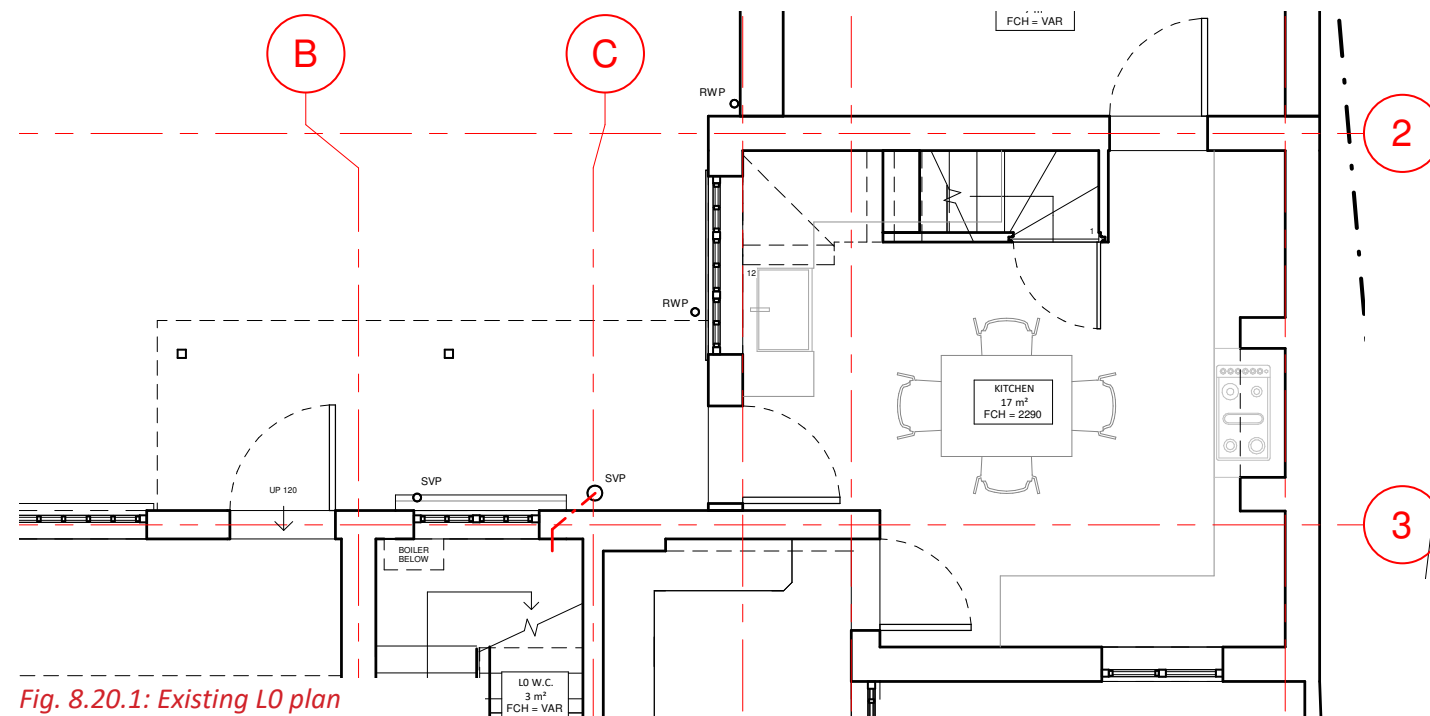
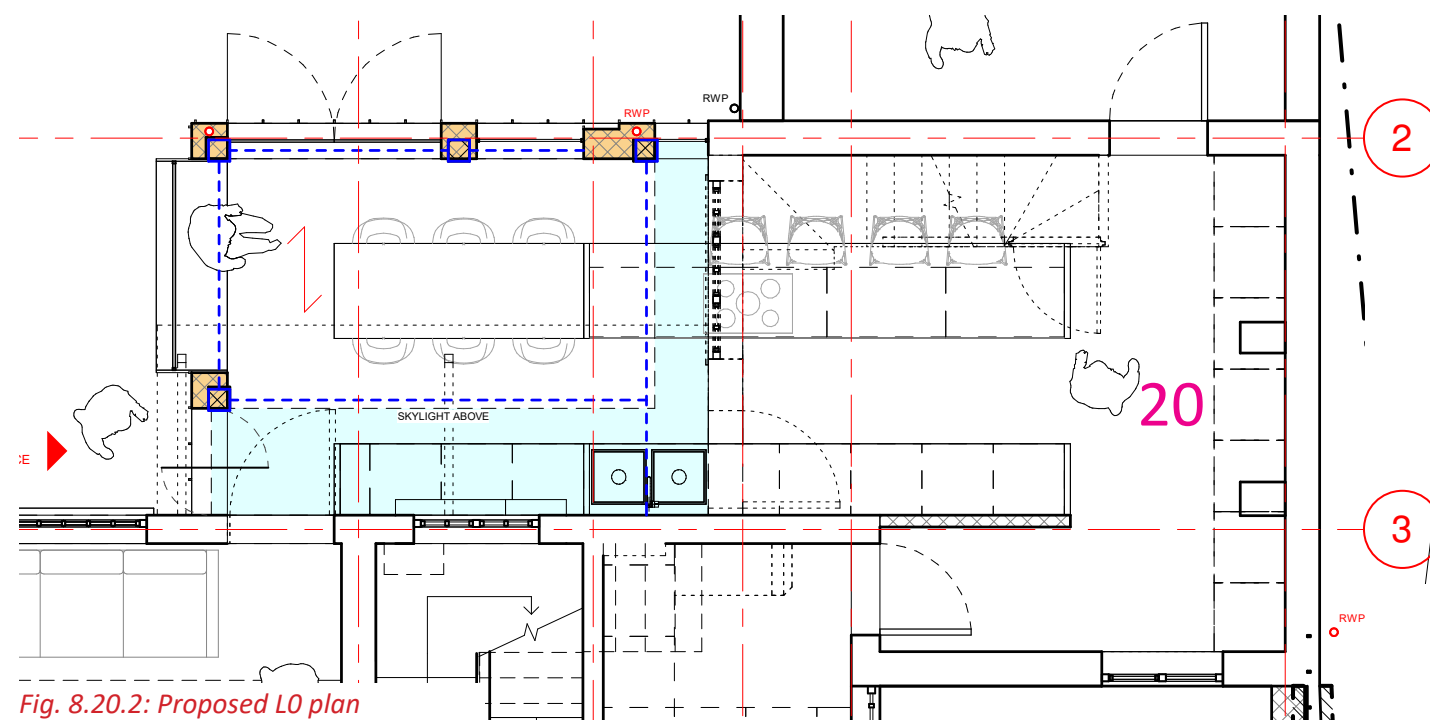
Fig. 8.20.1: Existing L0 plan

Fig. 8.20.2: Proposed L0 plan

An existing chimney breast located in the kitchen appears to have been opened up, with just the surround retained, which now houses a range cooker. It has however been tiled over, and lost its character as a result. We propose to keep the fireplace with kitchen units built around it. We plan to strip the current tiles and plaster, either exposing the original brick or plastering over it using insulated lime render plaster.

Fig. 8.20.3: Existing chimney breast

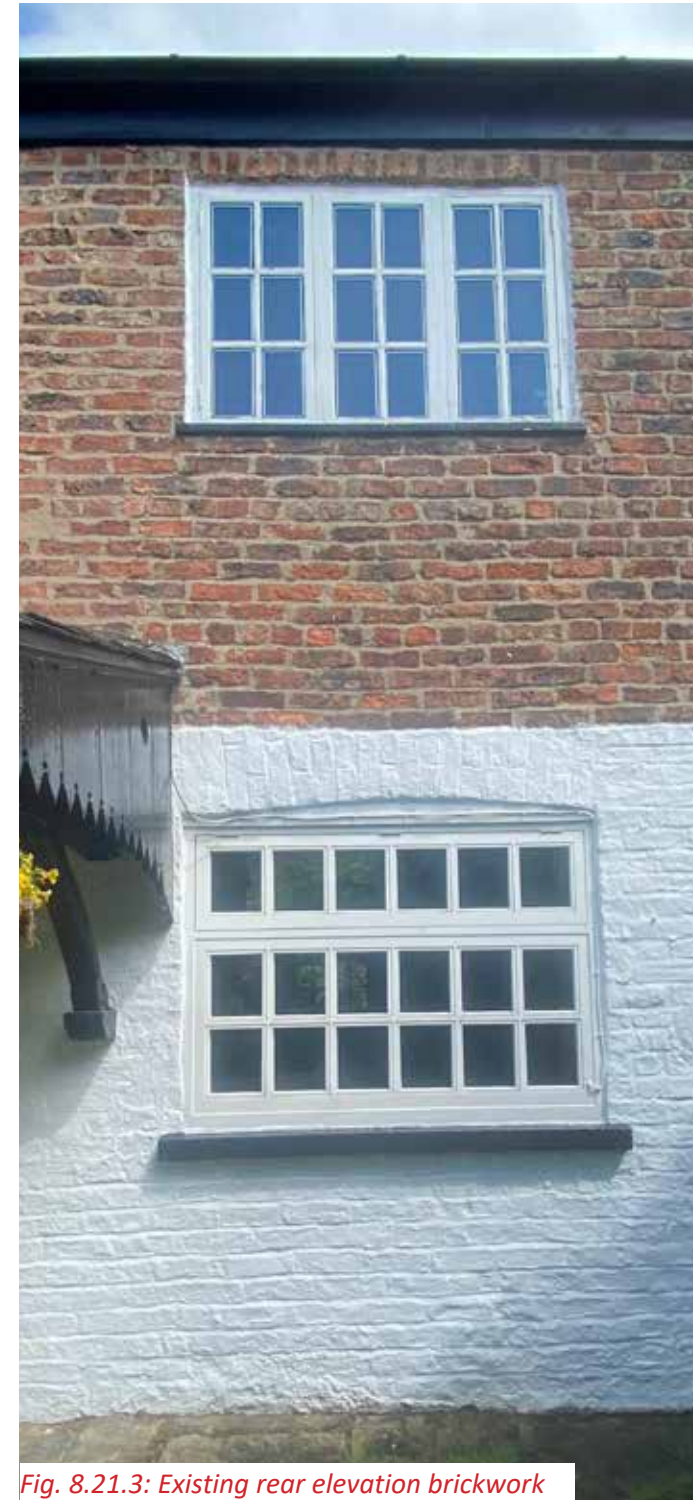
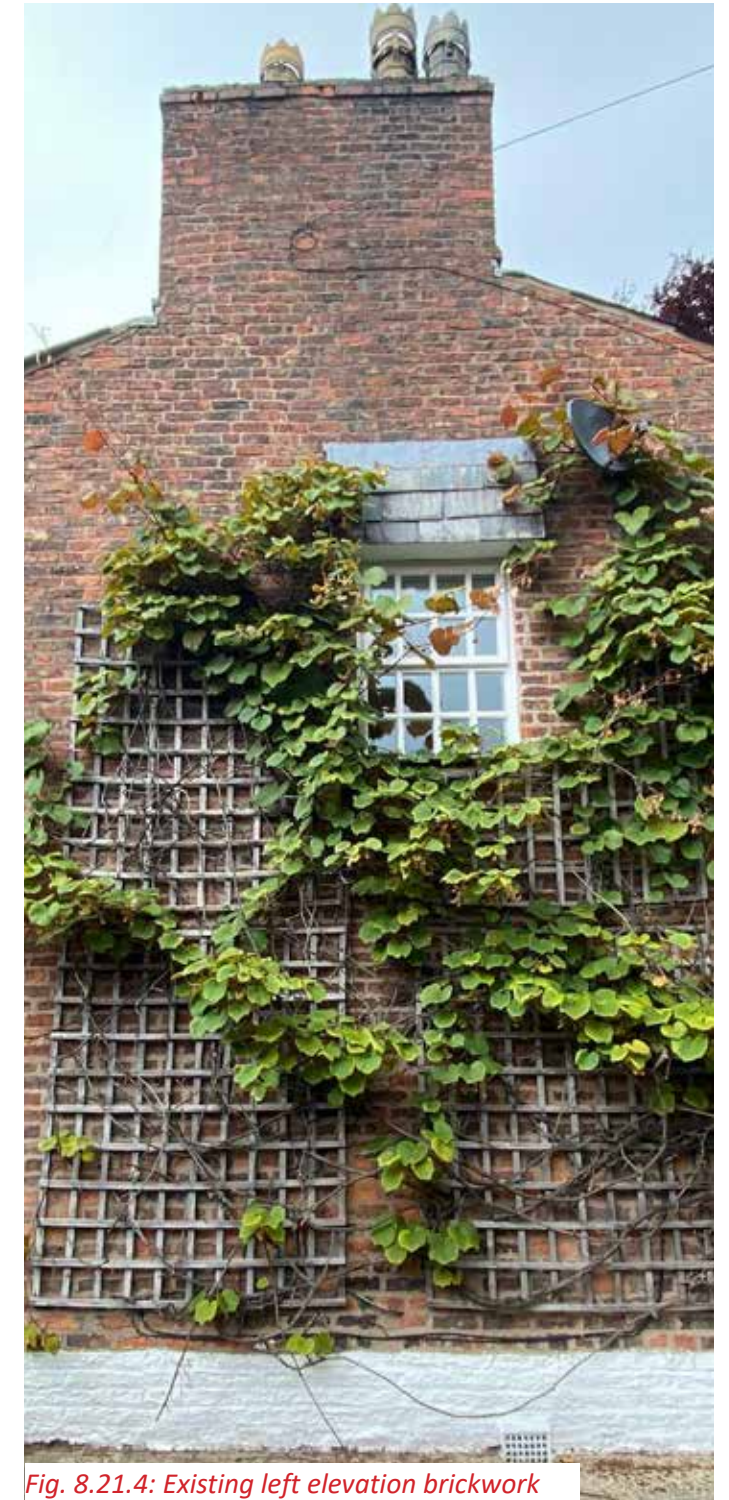
Fig. 8.21.1: Existing front elevation brickwork

Fig. 8.21.2: Existing right elevation brickwork

Fig. 8.21.3: Existing rear elevation brickwork

Fig. 8.21.4: Existing left elevation brickwork

Most of the brickwork is in a poor condition, which is detrimental to the character of the building. We propose the re-pointing of all brickwork in poor condition with lime mortar to improve the aesthetic of the exterior. We also propose to carefully remove the paintwork from the exterior of the building, allowing the brick to breathe.

| Ref. | Intervention | Description / Significance | Location | Benefit | Notes |
|---|---|---|---|---|---|
| 21 | Repoint all brickwork in poor condition using lime mortar | | All external walls | Public | More attractive exterior. Future-proofing building. |
