# **Land at Bennett Street, Manchester**

## **Archaeological Evaluation Report**

**Report Title:** Land at Bennett Street, Manchester – Archaeological Evaluation Report

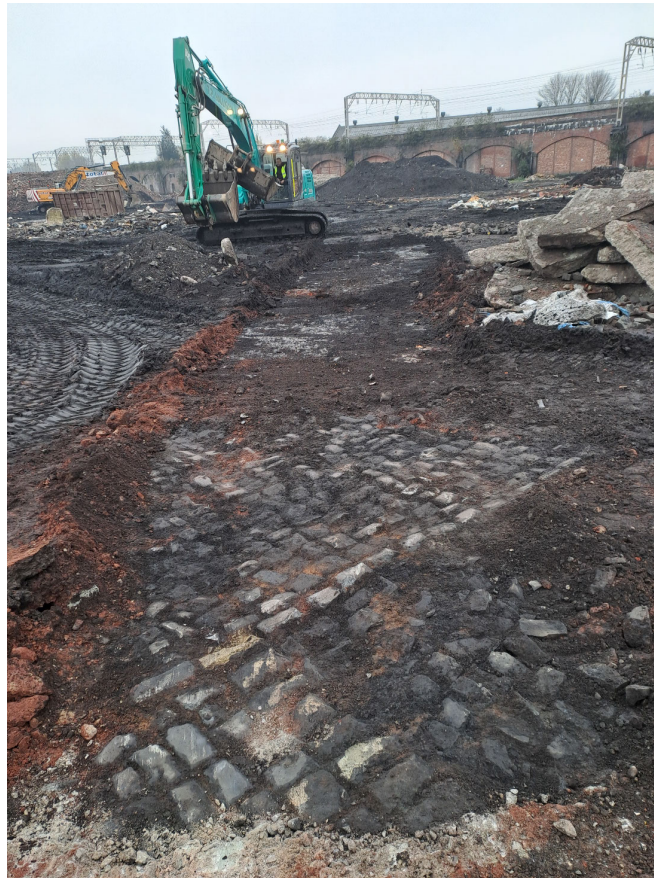
Plate 1 - Limestone setts in situ, overlying the location of Trench 2

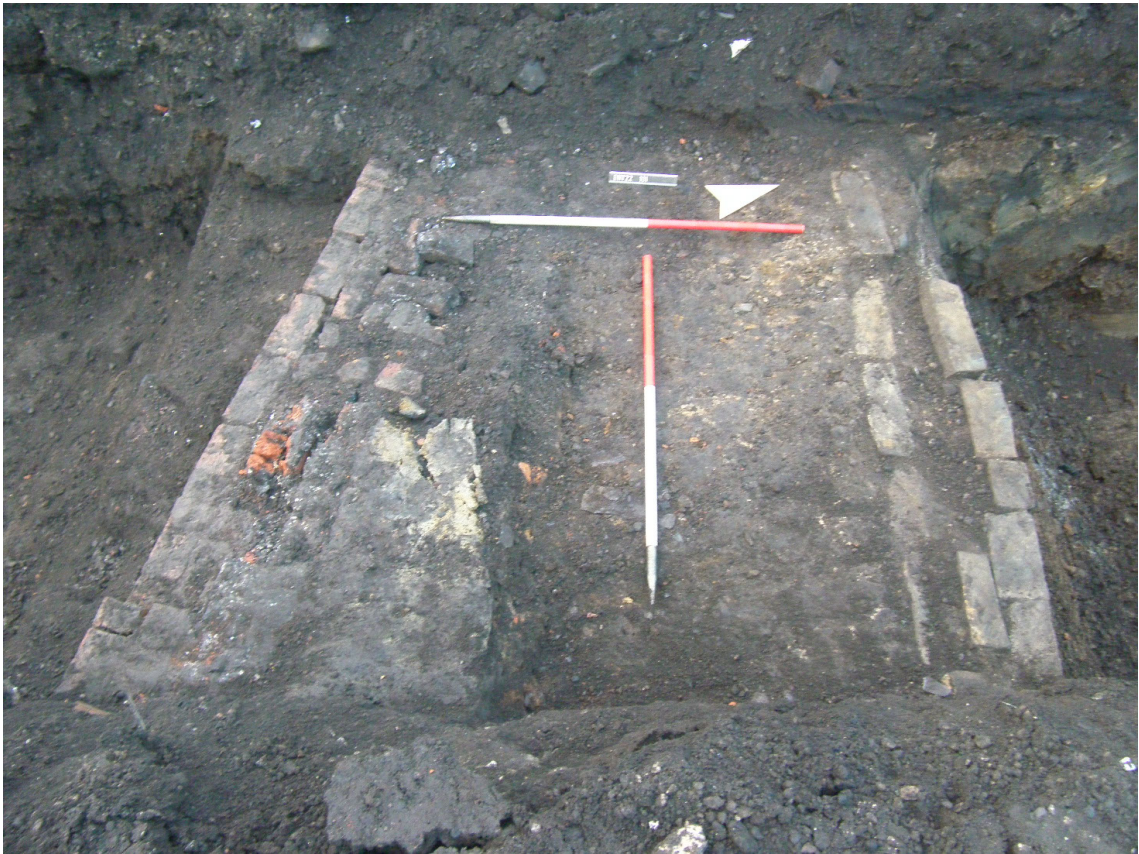
Plate 3 - Trench 1. Wall 101 and limestone setts 118

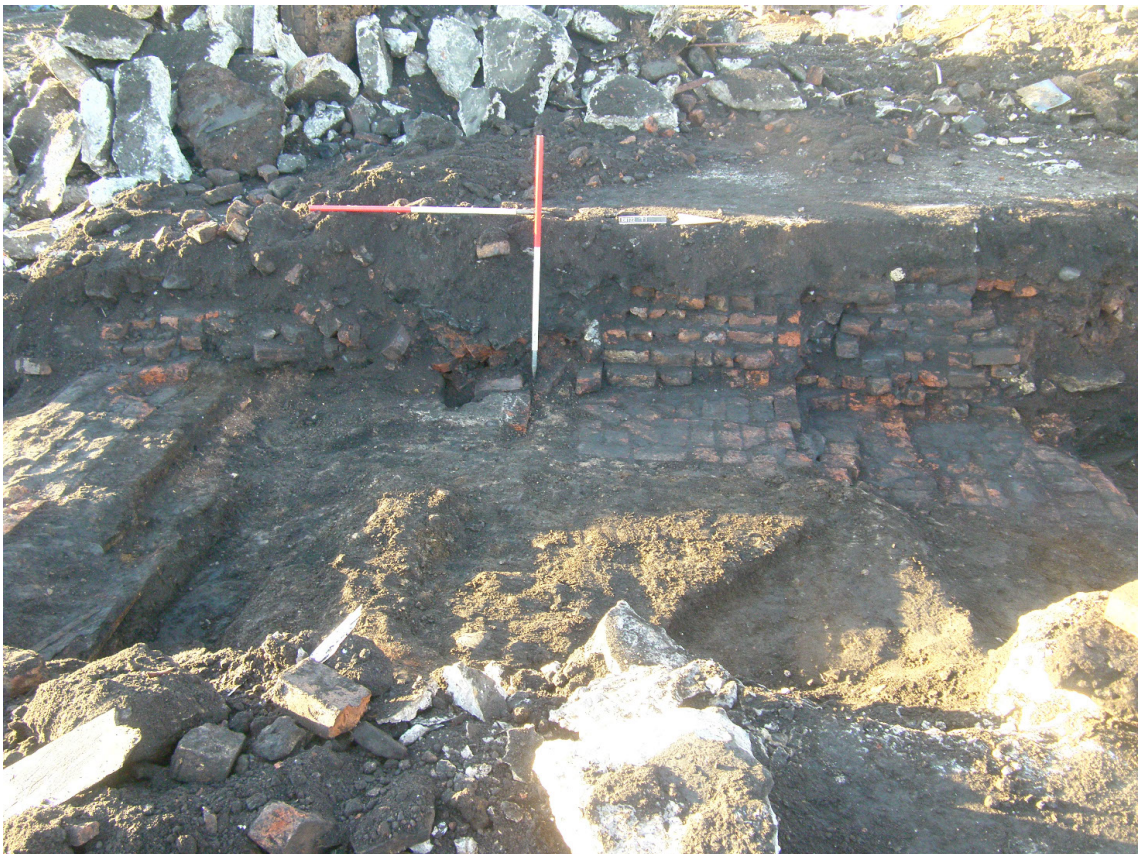
Plate 4 - Trench 1. North-east-facing section showing structure 102

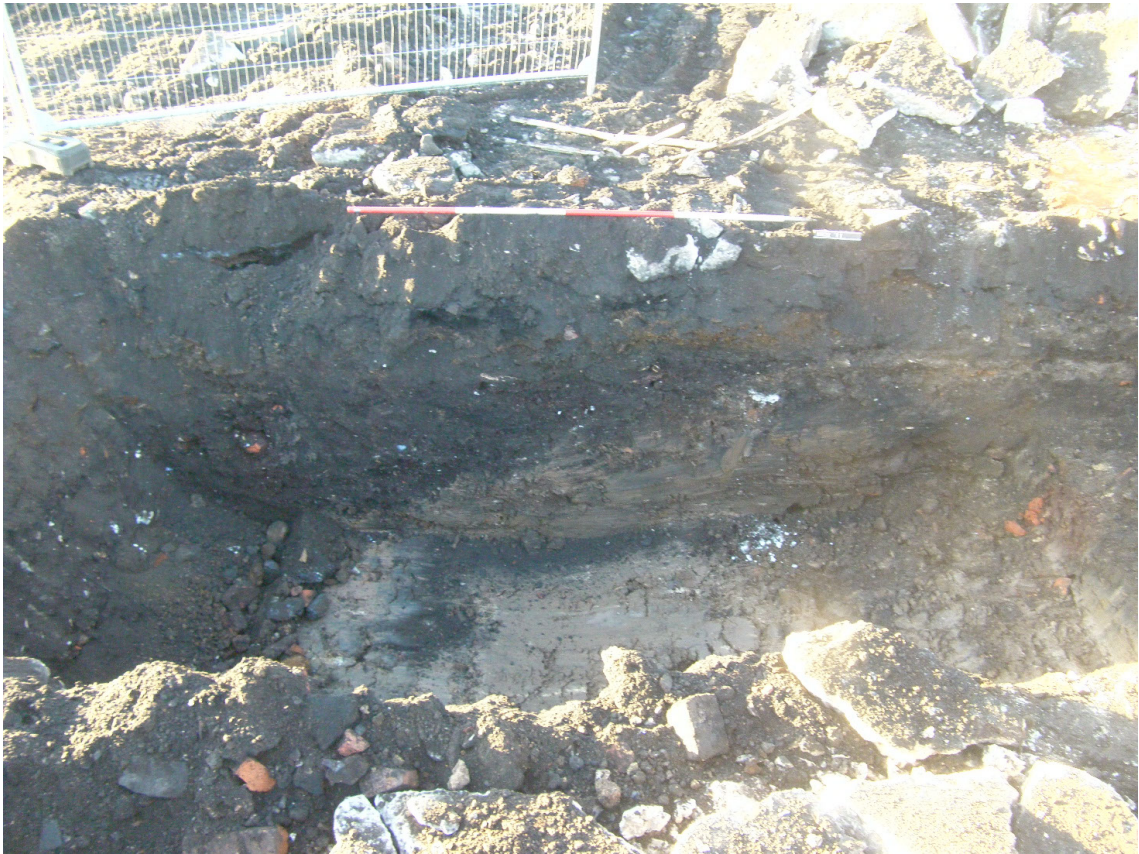
Plate 5 - Trench 1. North-east-facing section of pit 120

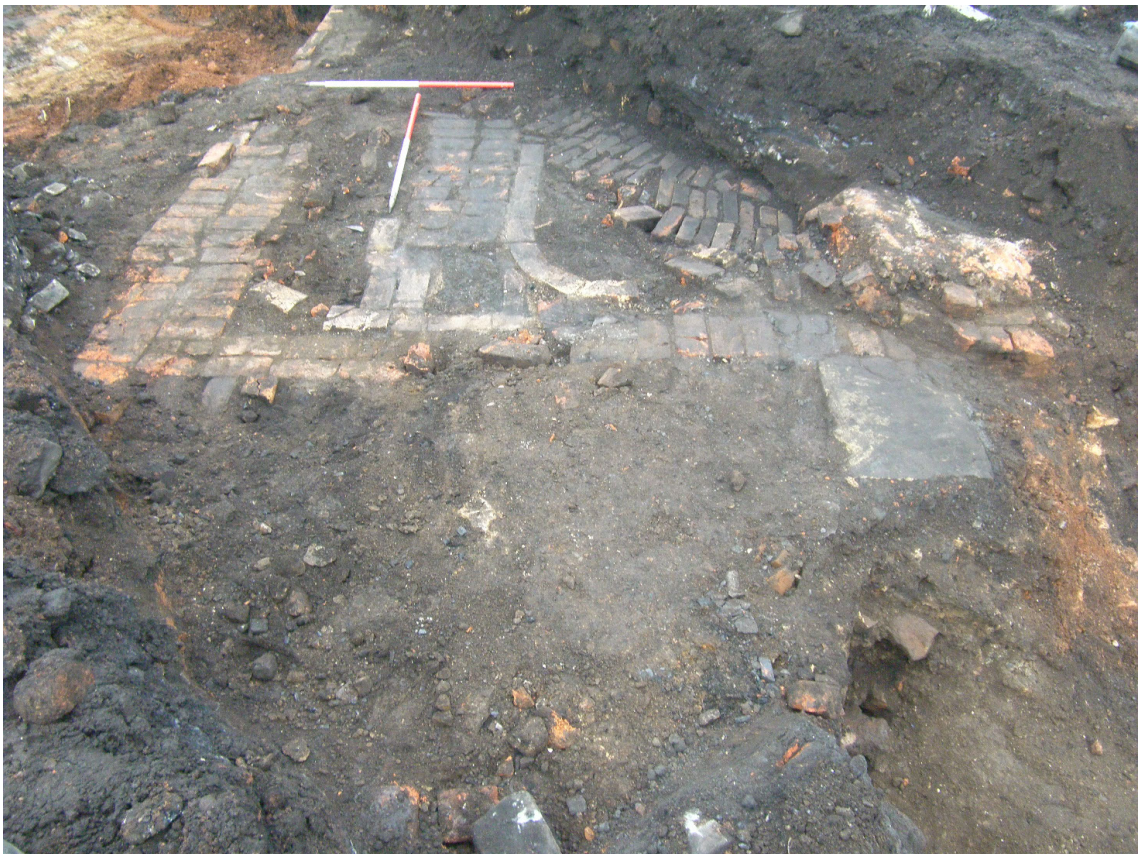
Plate 6 - Trench 2. Overview of brick structure 201, looking south-west

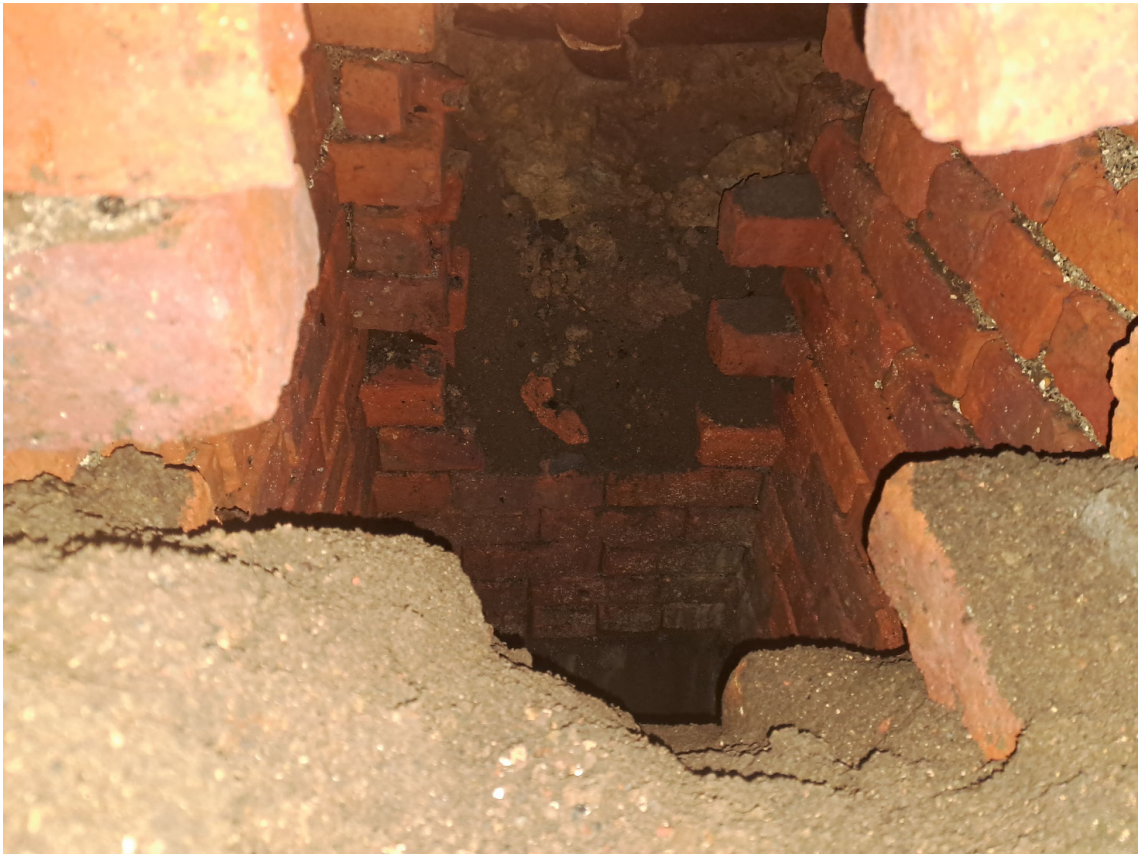
Plate 7 - Trench 2. Brick chute below platform 201

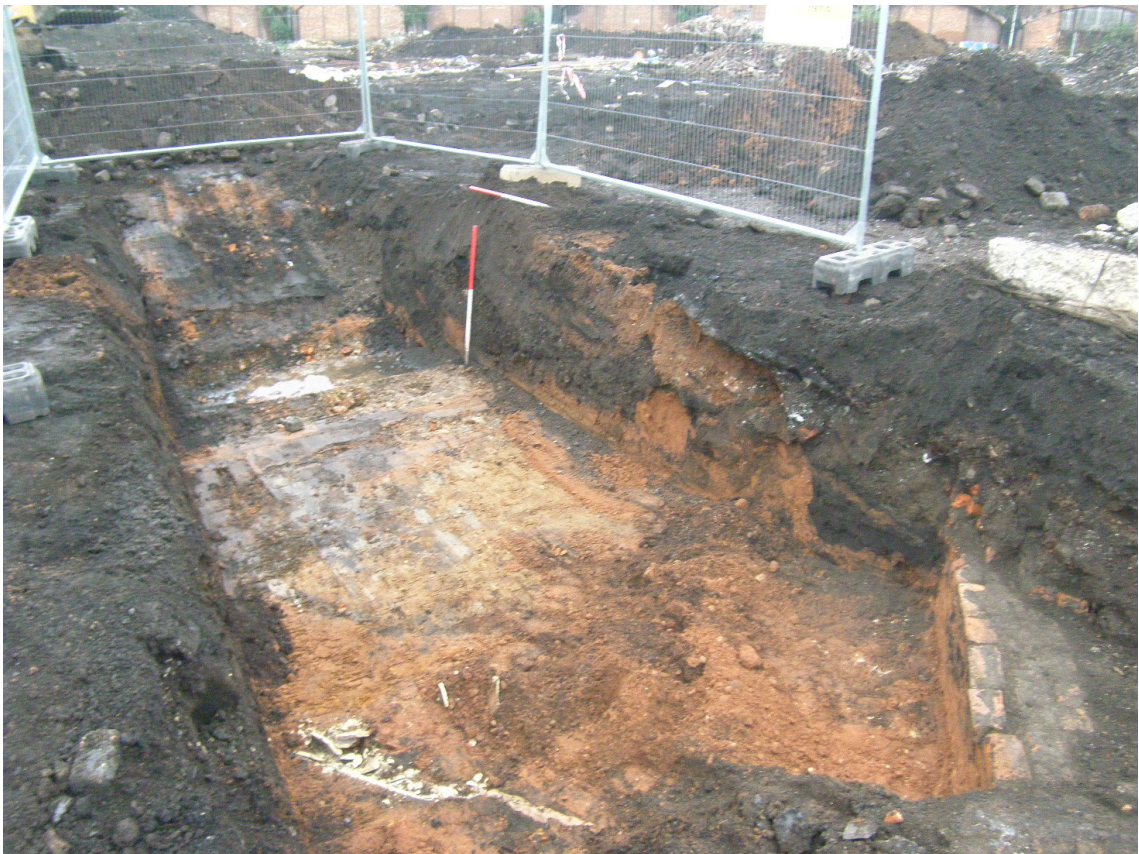
Plate 8 - Trench 2. Casting sand 208, to the south of platform 201

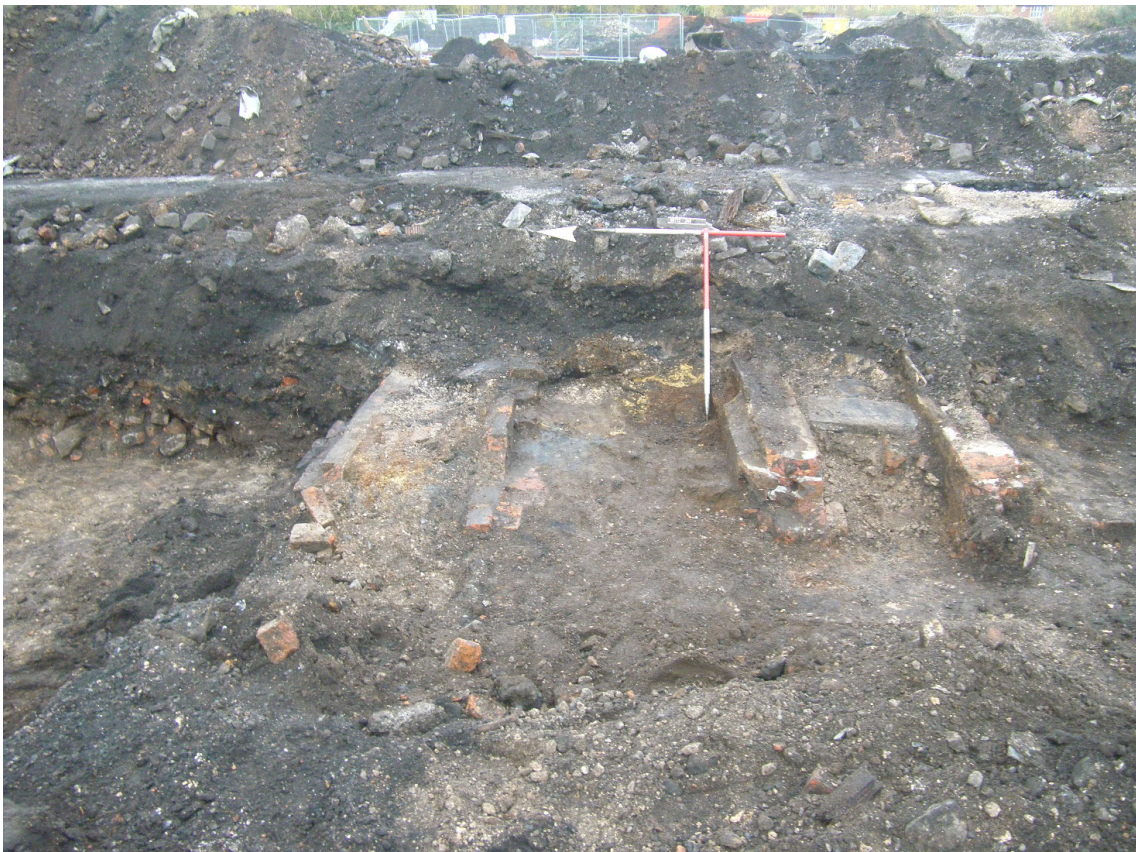
Plate 10 - Trench 3. Brick bays within structure 301

- 4.4.4 Structure **301** was 5m wide and was separated into three irregularly spaced bays defined by brick walls (Plate 10). Removal of the rubble within the northern bay revealed a loose, reddish brown sandy deposit containing degraded wood, corroded iron and slag (**314**).

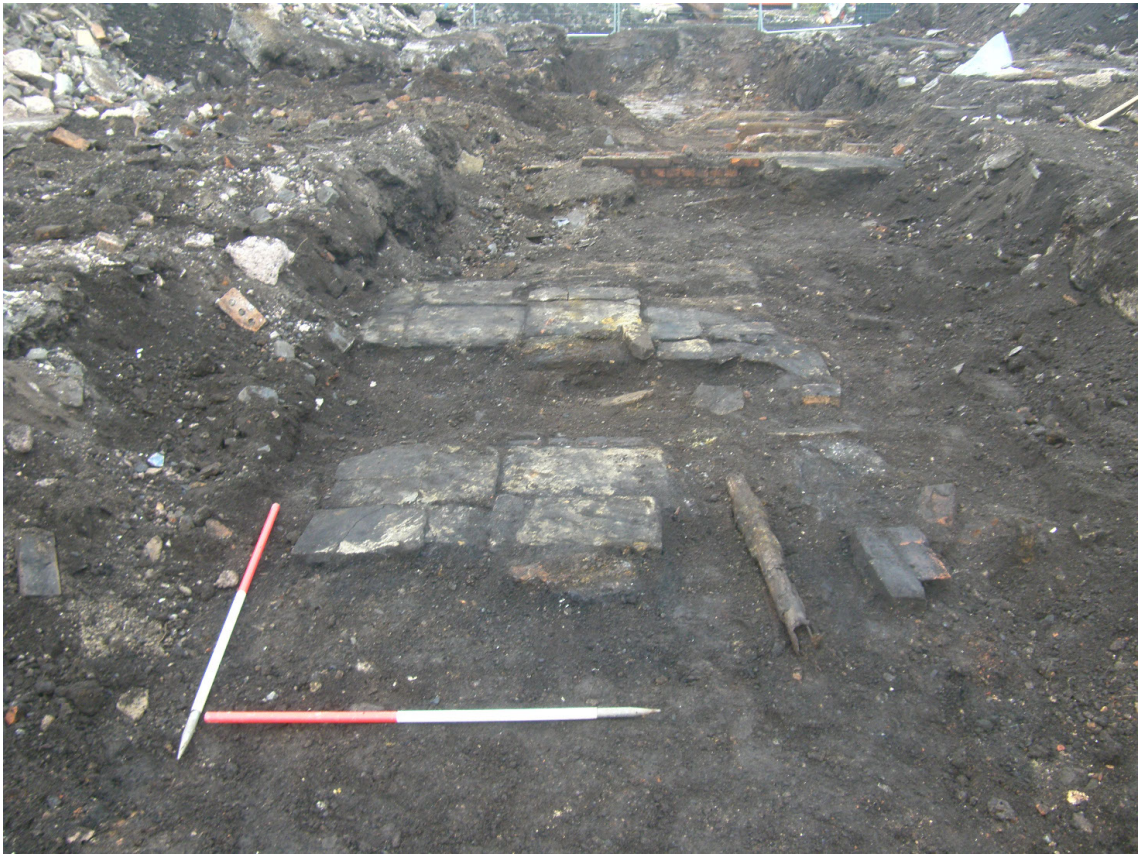
Plate 11 - Trench 3. Flagstone floor 303 and pipe trench 315, looking north-west

- 4.4.5 To the south of structure **301** was a heavily disturbed flagstone surface (**303**); one flagstone retained an iron fitting and had a heavy concentration of metallurgical waste adhering to it (Plate 11). A central area within **303** was devoid of flagstones and was potentially the location of metal processing equipment. A linear trench extending from this void to the south-east (**315**) contained a corroded length of iron pipe in situ, with a further length of iron pipe protruding upwards from the rubble to the east.

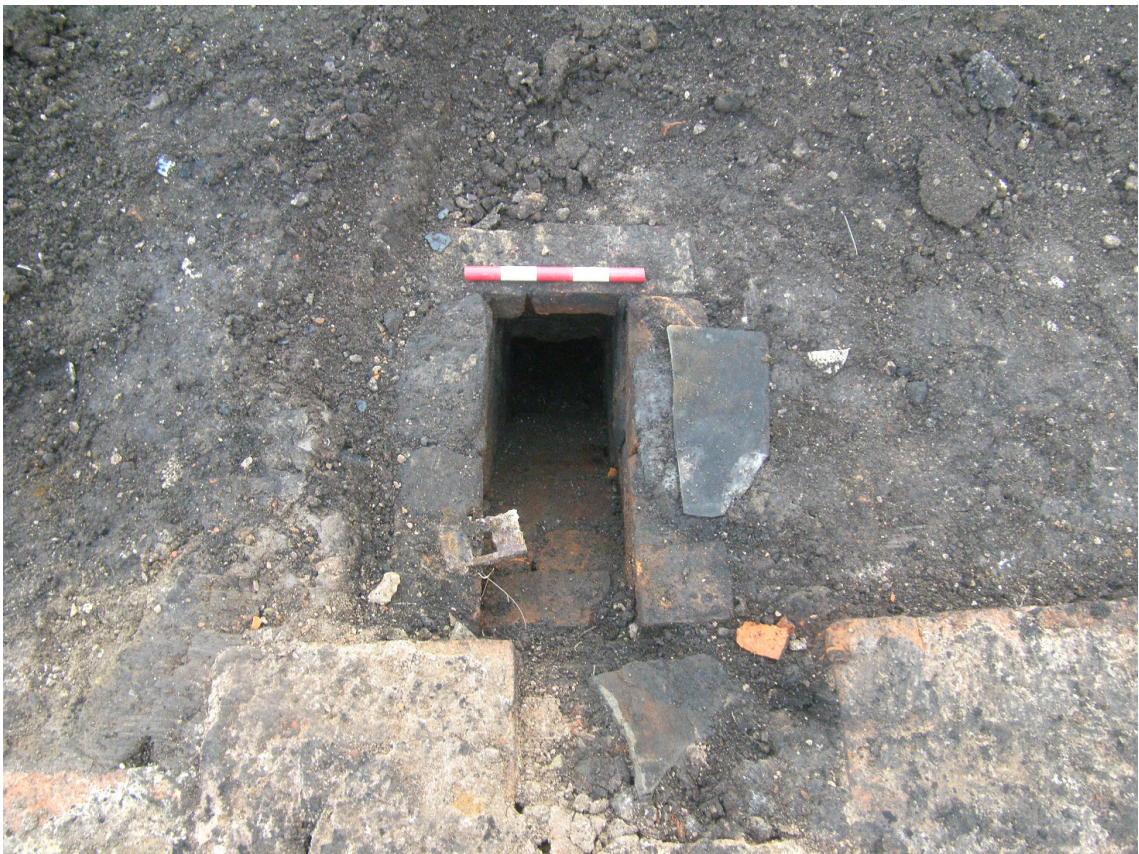
Plate 12 - Trench 3. Brick chute 317

- 4.4.6 On a parallel south-east alignment to pipe trench **315**, and c.2m to the west, was a brick footing (**302**), potentially for a wall, that continued over a span of 10m and beyond the south-east limit of Trench 1. A brick chute (**317**) measuring 0.4m by 0.6m adjoined the south-west face of **302** and retained an iron hinge that indicated it was originally covered by a hatch (Plate 12). Along the north-east face of **302** was a square cut (**310**) 2m wide that had been filled by orange sand (**311**). A

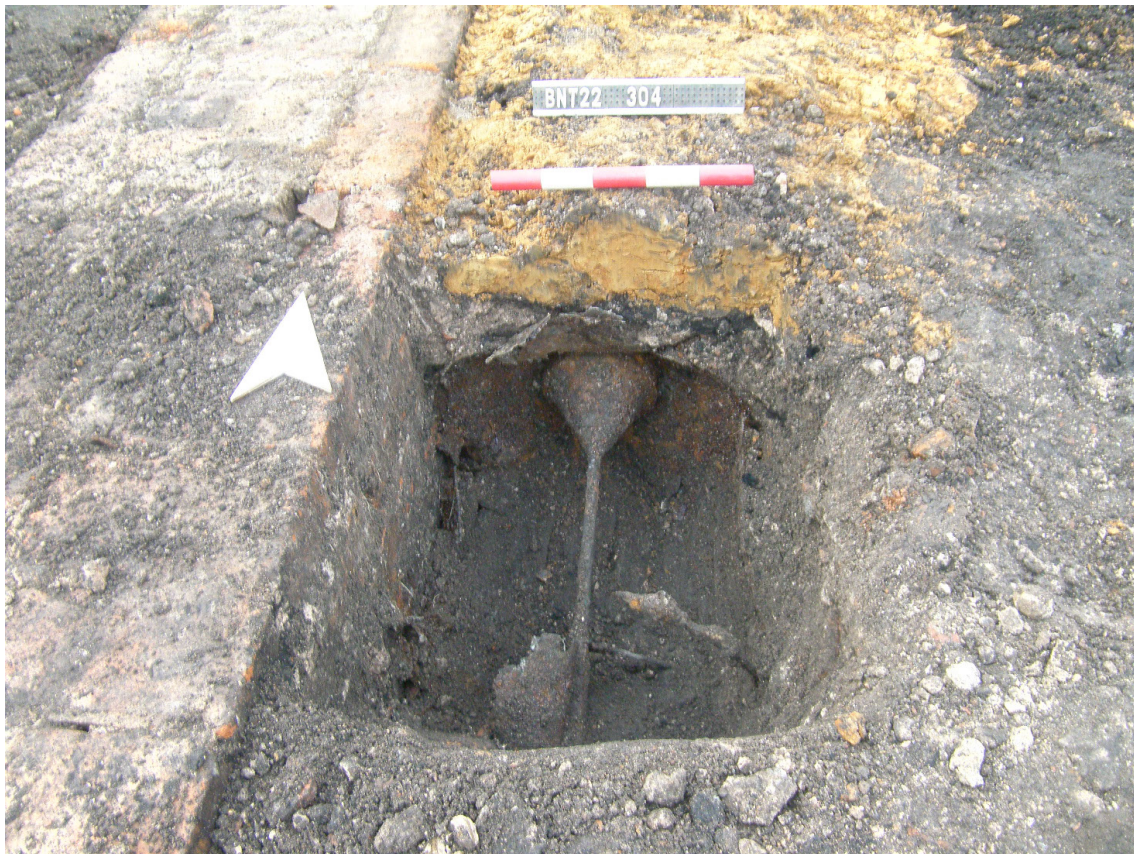
Plate 13 - Trench 3. In situ machinery 304, within cut 310

sondage excavated within cut **310** revealed a corroded iron cylinder (**304**) that appeared to be an element of machinery deliberately situated alongside brick footing **302** (Plate 13). It is possible that cut **310** contains further mechanical elements relating to **304** and to specific manufacturing processes that were being undertaken within the area of the foundry covered by Trench 1.

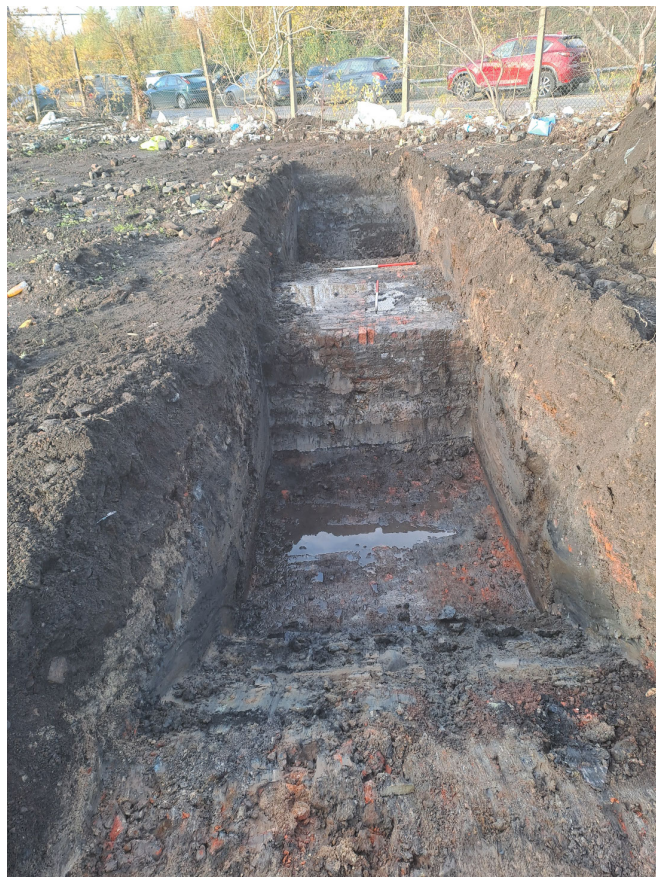
Plate 14 - Trench 4. Upstanding remains of weighing station and burnt horizon 403

- 4.5.3 A 1.2m-thick deposit of sand, clay and rubble (**402**) was removed from around the weighing station by machine and showed it to survive to a height of over 1m (Plate 14). Clay layer (**402**) had accumulated above a 0.2m-thick horizon of ash and burnt brick (**403**), which potentially marked the ground surface contemporary with the weighing station at a depth of 1.8m below the modern ground surface. The natural alluvial clay (**404**) was recorded below deposit **403** at a depth of 2m.

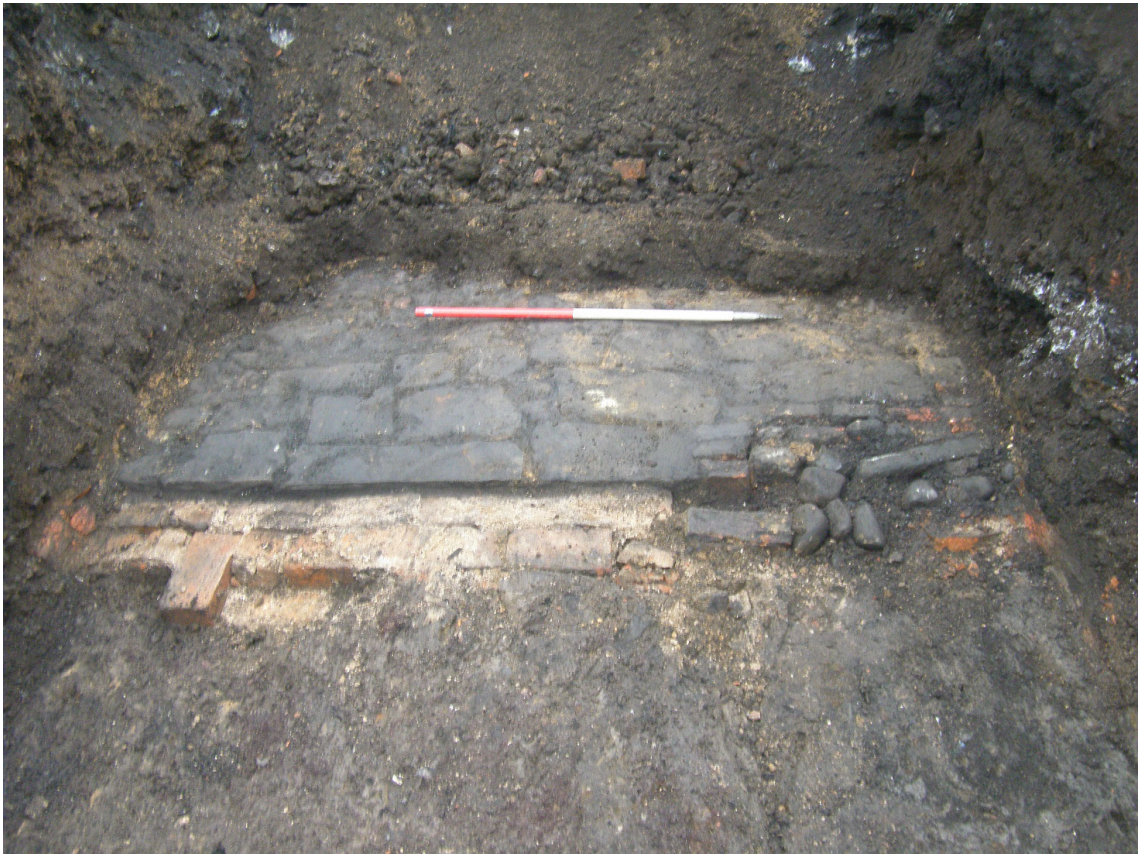
Plate 15 - Trench 5. Flagstone floor 501, looking north

- 4.6.1 Trench 5 measured 20m by 3m and was orientated north to south across Burgess Villa, as shown on the 1848 Ordnance Survey map.
- 4.6.2 Removal of 0.4m of modern overburden (**500**), 0.7m of tarmac (**509**) at the north end of the trench and a trench-wide demolition horizon (**508**) up to 1m thick, revealed the footings of a building likely belonging to Burgess Villa.
- 4.6.3 At the north end of the trench was a flagstone floor (**501**), extending 2m into the trench from the northern edge (Plate 15). Its southern limit was edged by two rows of brick, with a cobbled area at

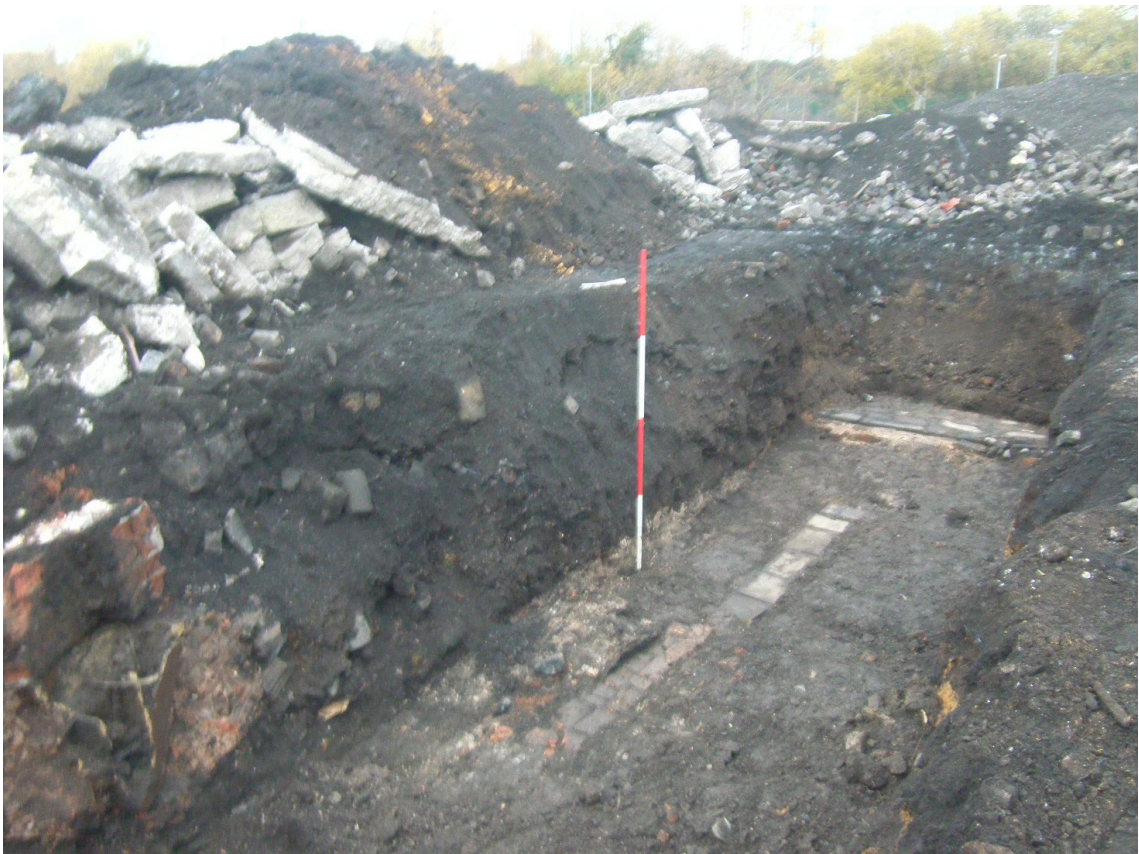
Plate 16 - Trench 5. Wall footing 502 and mortar deposit 511, looking north-west

- 4.6.4 Extending southwards from floor **501** was a wall footing (**502**) of sandstone slabs with two surviving courses of brickwork (Plate 16). Wall **502** appeared to define a room to the west, denoted by crushed brick and mortar (**511**) that probably would have been a foundation layer for a flagstone floor, like **501** to the north. A 2m-wide break between floor surface **501** and wall **502** plausibly related to a second doorway.

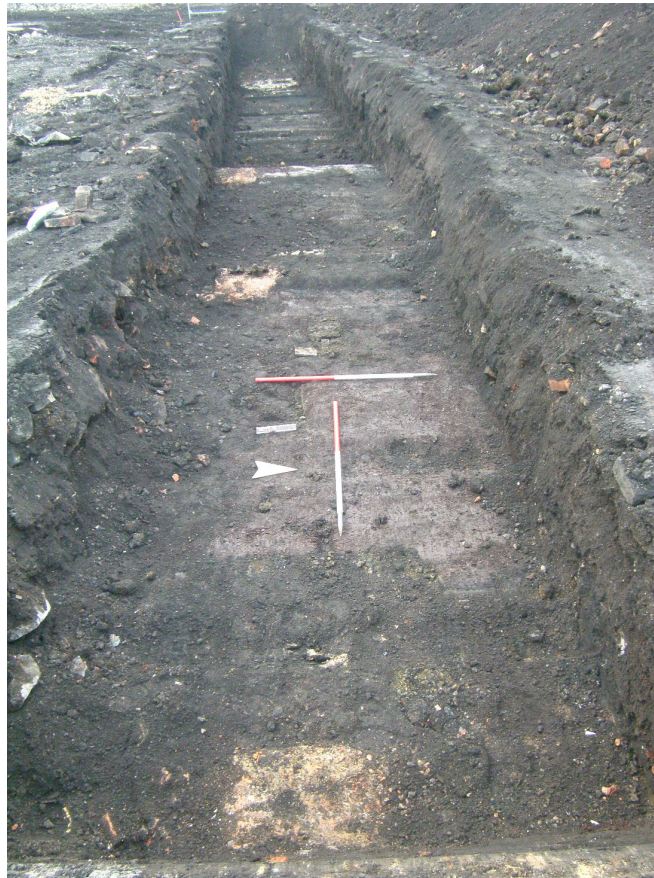
Plate 17 - Trench 6. Cinder surface 607, showing concrete pads set within cut 604

- 4.7.2 Removal of a 0.8m-thick horizon of demolition rubble (**600**) revealed a compacted surface of purple cinders (**607**) at the east end of the trench. An irregular east to west cut (**604**) had been made through surface **607** into which had been set three irregularly spaced square concrete pads (**601**, **602**, **603**, Plate 17). The pads each measured 0.6m by 0.6m with a thickness of 0.3m and were set within a black deposit of cinders (**608**) that contained domestic refuse and elements of a leather shoe. The location of the concrete pads strongly suggest they belonged to the earliest phase of the Hyde Road stadium and probably supported a superstructure that was largely wooden, no remains of which were identified.

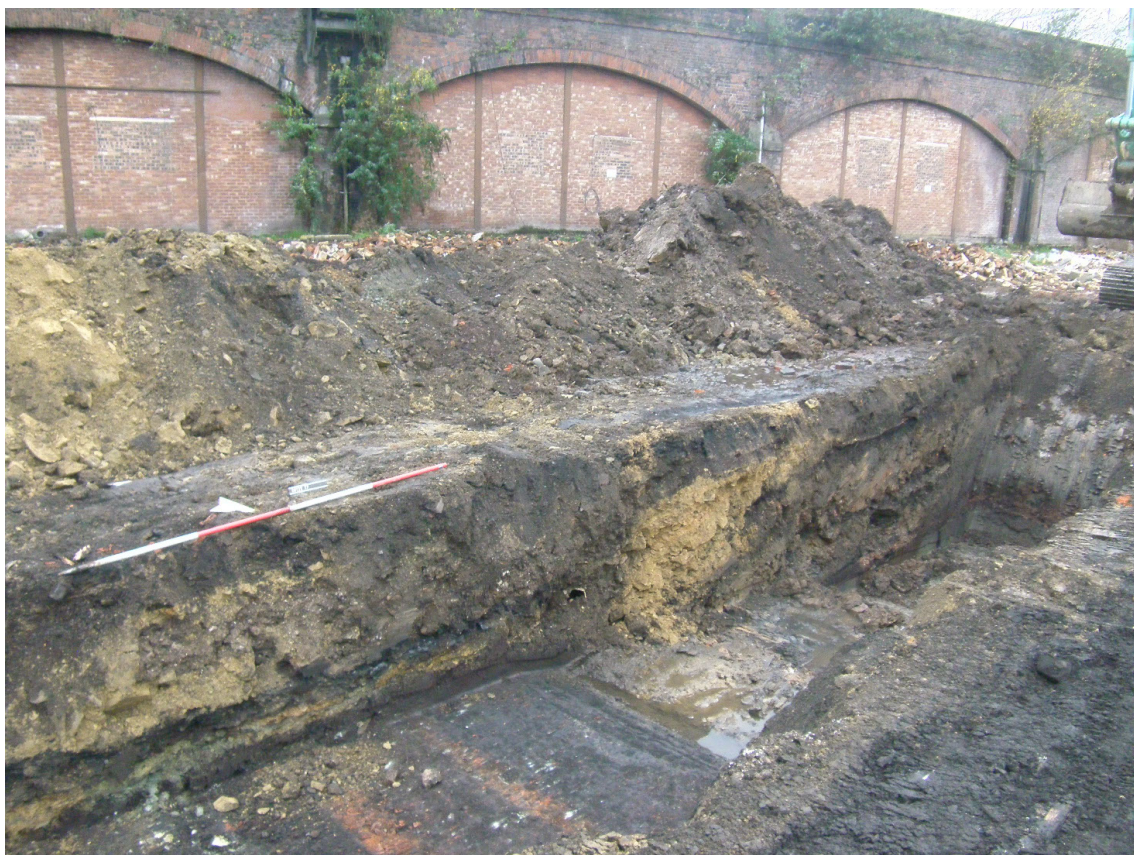
Plate 18 - Trench 7. North-east-facing section showing loose sand deposit 708, sleeper 704, cinder surface 706, potential wall footing 707, clay bank 703 and burnt horizon 702

- 4.8.2 Removal of 0.4m of modern overburden (**700**) revealed a disturbed section of railway sidings at the north-west end of the trench, comprising a 0.2m-thick cinder bedding deposit (**704**) within which survived a single wooden sleeper (Plate 18).

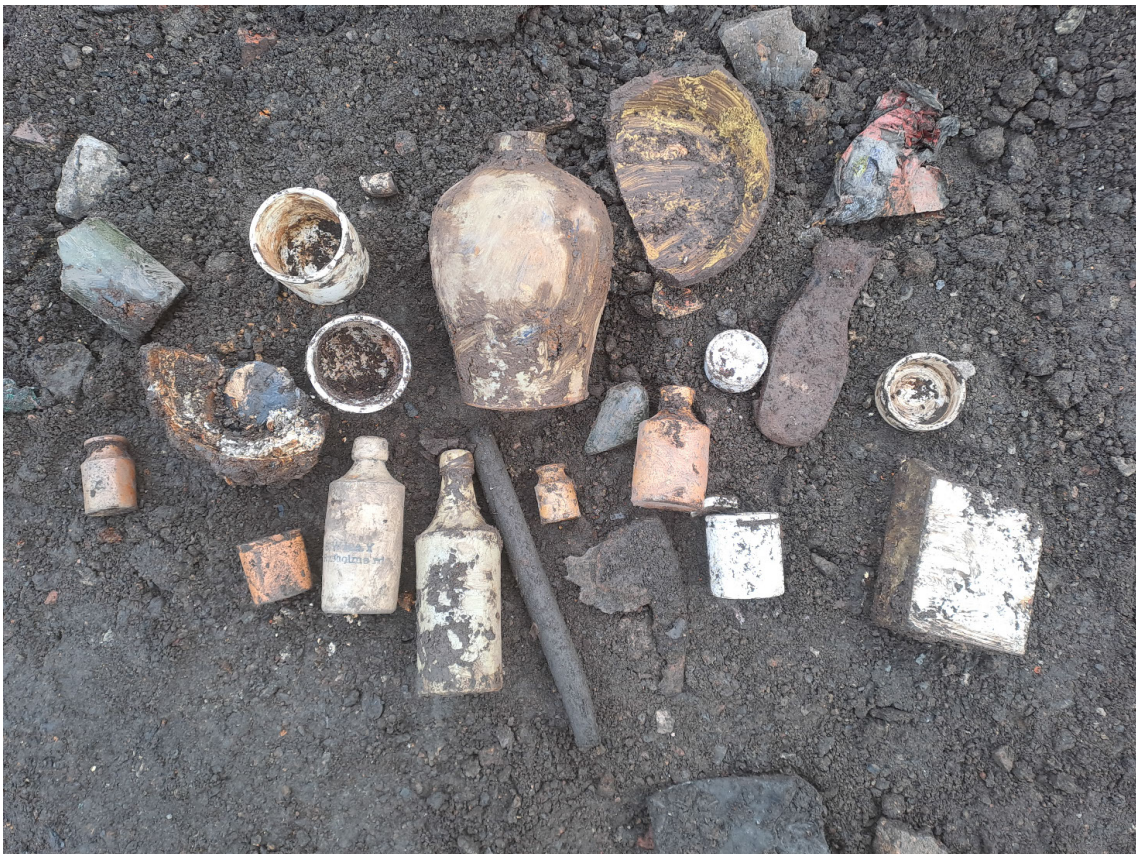
Plate 20 - Trench 8. Assemblage of finds recovered from midden deposit 801

dating from the 19th and early 20th centuries (Plate 19, Plate 20).
