# Appendix C

## SECONDARY GLAZING

| PROJECT: | 196 DEANSGATE, MANCHESTER | | |

Fabric Repairs: Method Statement (rev B)

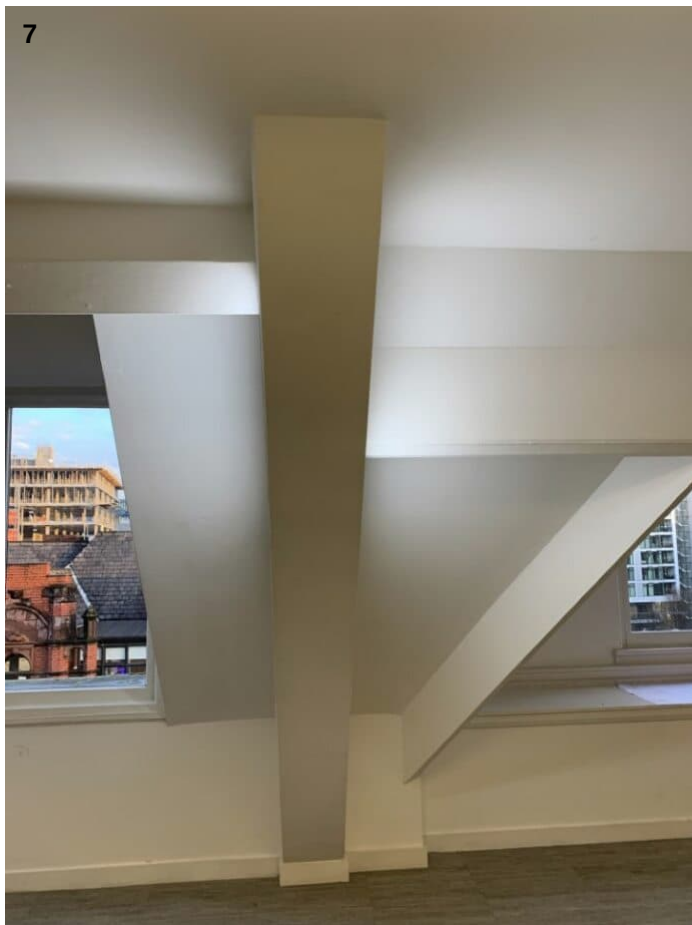
7

Timber beams to mansard roof
