| PROJECT: | 196 DEANSGATE, MANCHESTER | | |
| DRAWING TITLE: | 1ST FLOOR EXISTING WINDOWS ELEVS | | |

## 1.0 Fabric Repairs Method Statement

196 Deansgate is a Grade II listed building of historic importance. The following Fabric Repair Method Statement has been produced to support the accompanying Heritage Partnership Agreement (HPA).

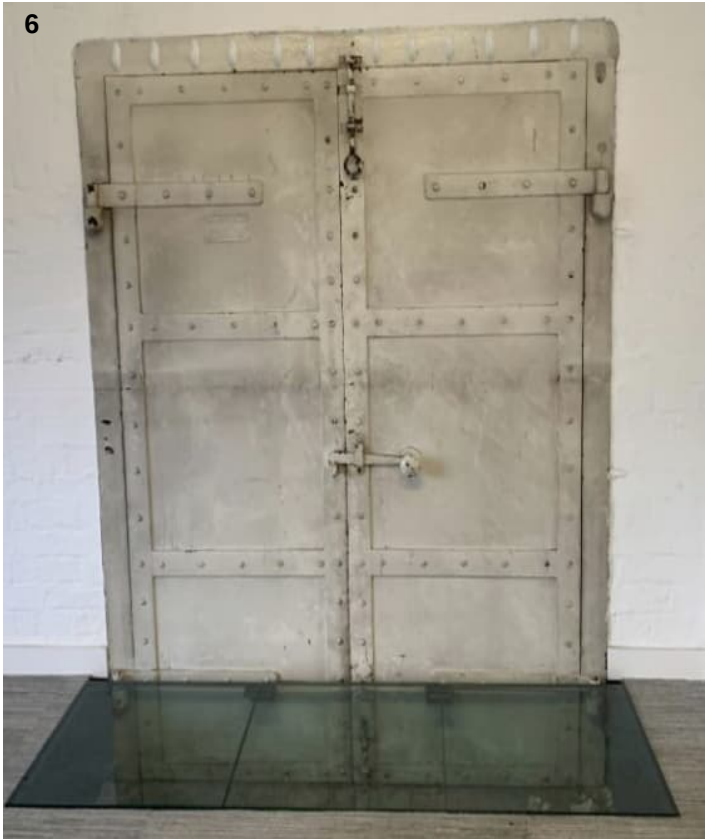
6

Goods lift

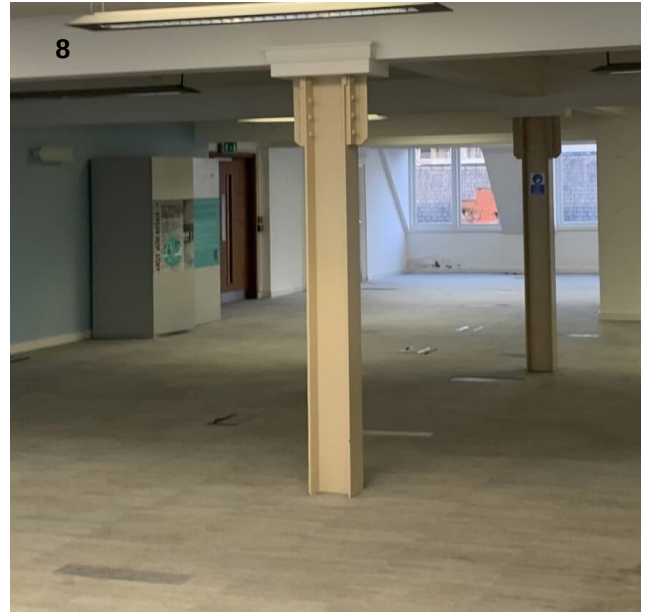
8

Steel column

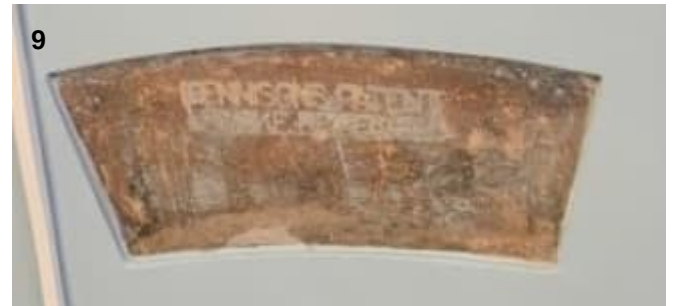
9

Exposed brick arch of a fireplace

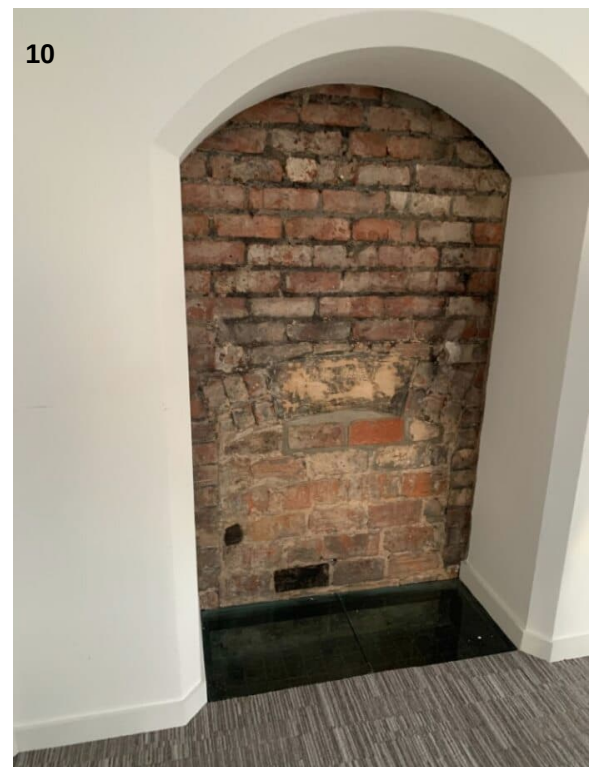
10

Exposed brick of a fireplace
