# 4.5 Cycle Facilities

# 4.6 Bloom Street - Roof Extension

## 5.0 Heritage Proposal

# 5.1 Significant Heritage Items

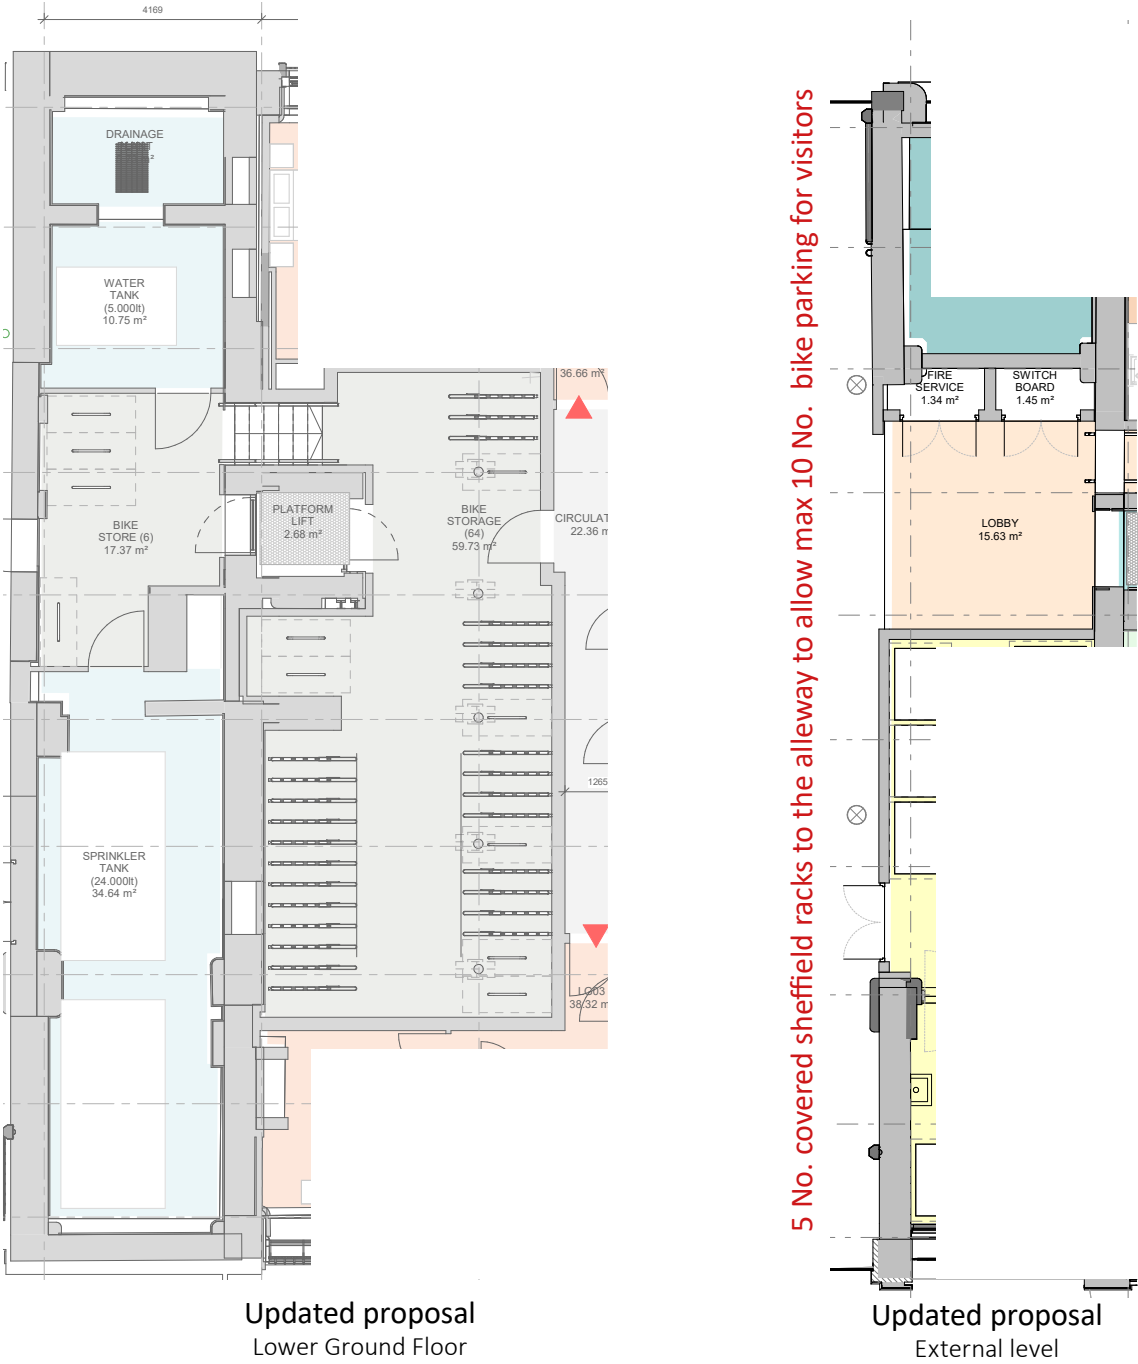
PROPOSED BIKE STORE

The current proposal permits one bike parking space per apartment, for a total of 80. Of these, 76 are located in the lower ground floor and basement, both accessible via the platform lift. Further 4 spaces, secured through 2 sheffield racks, are located in the alleyway for visitors or temporary parking.

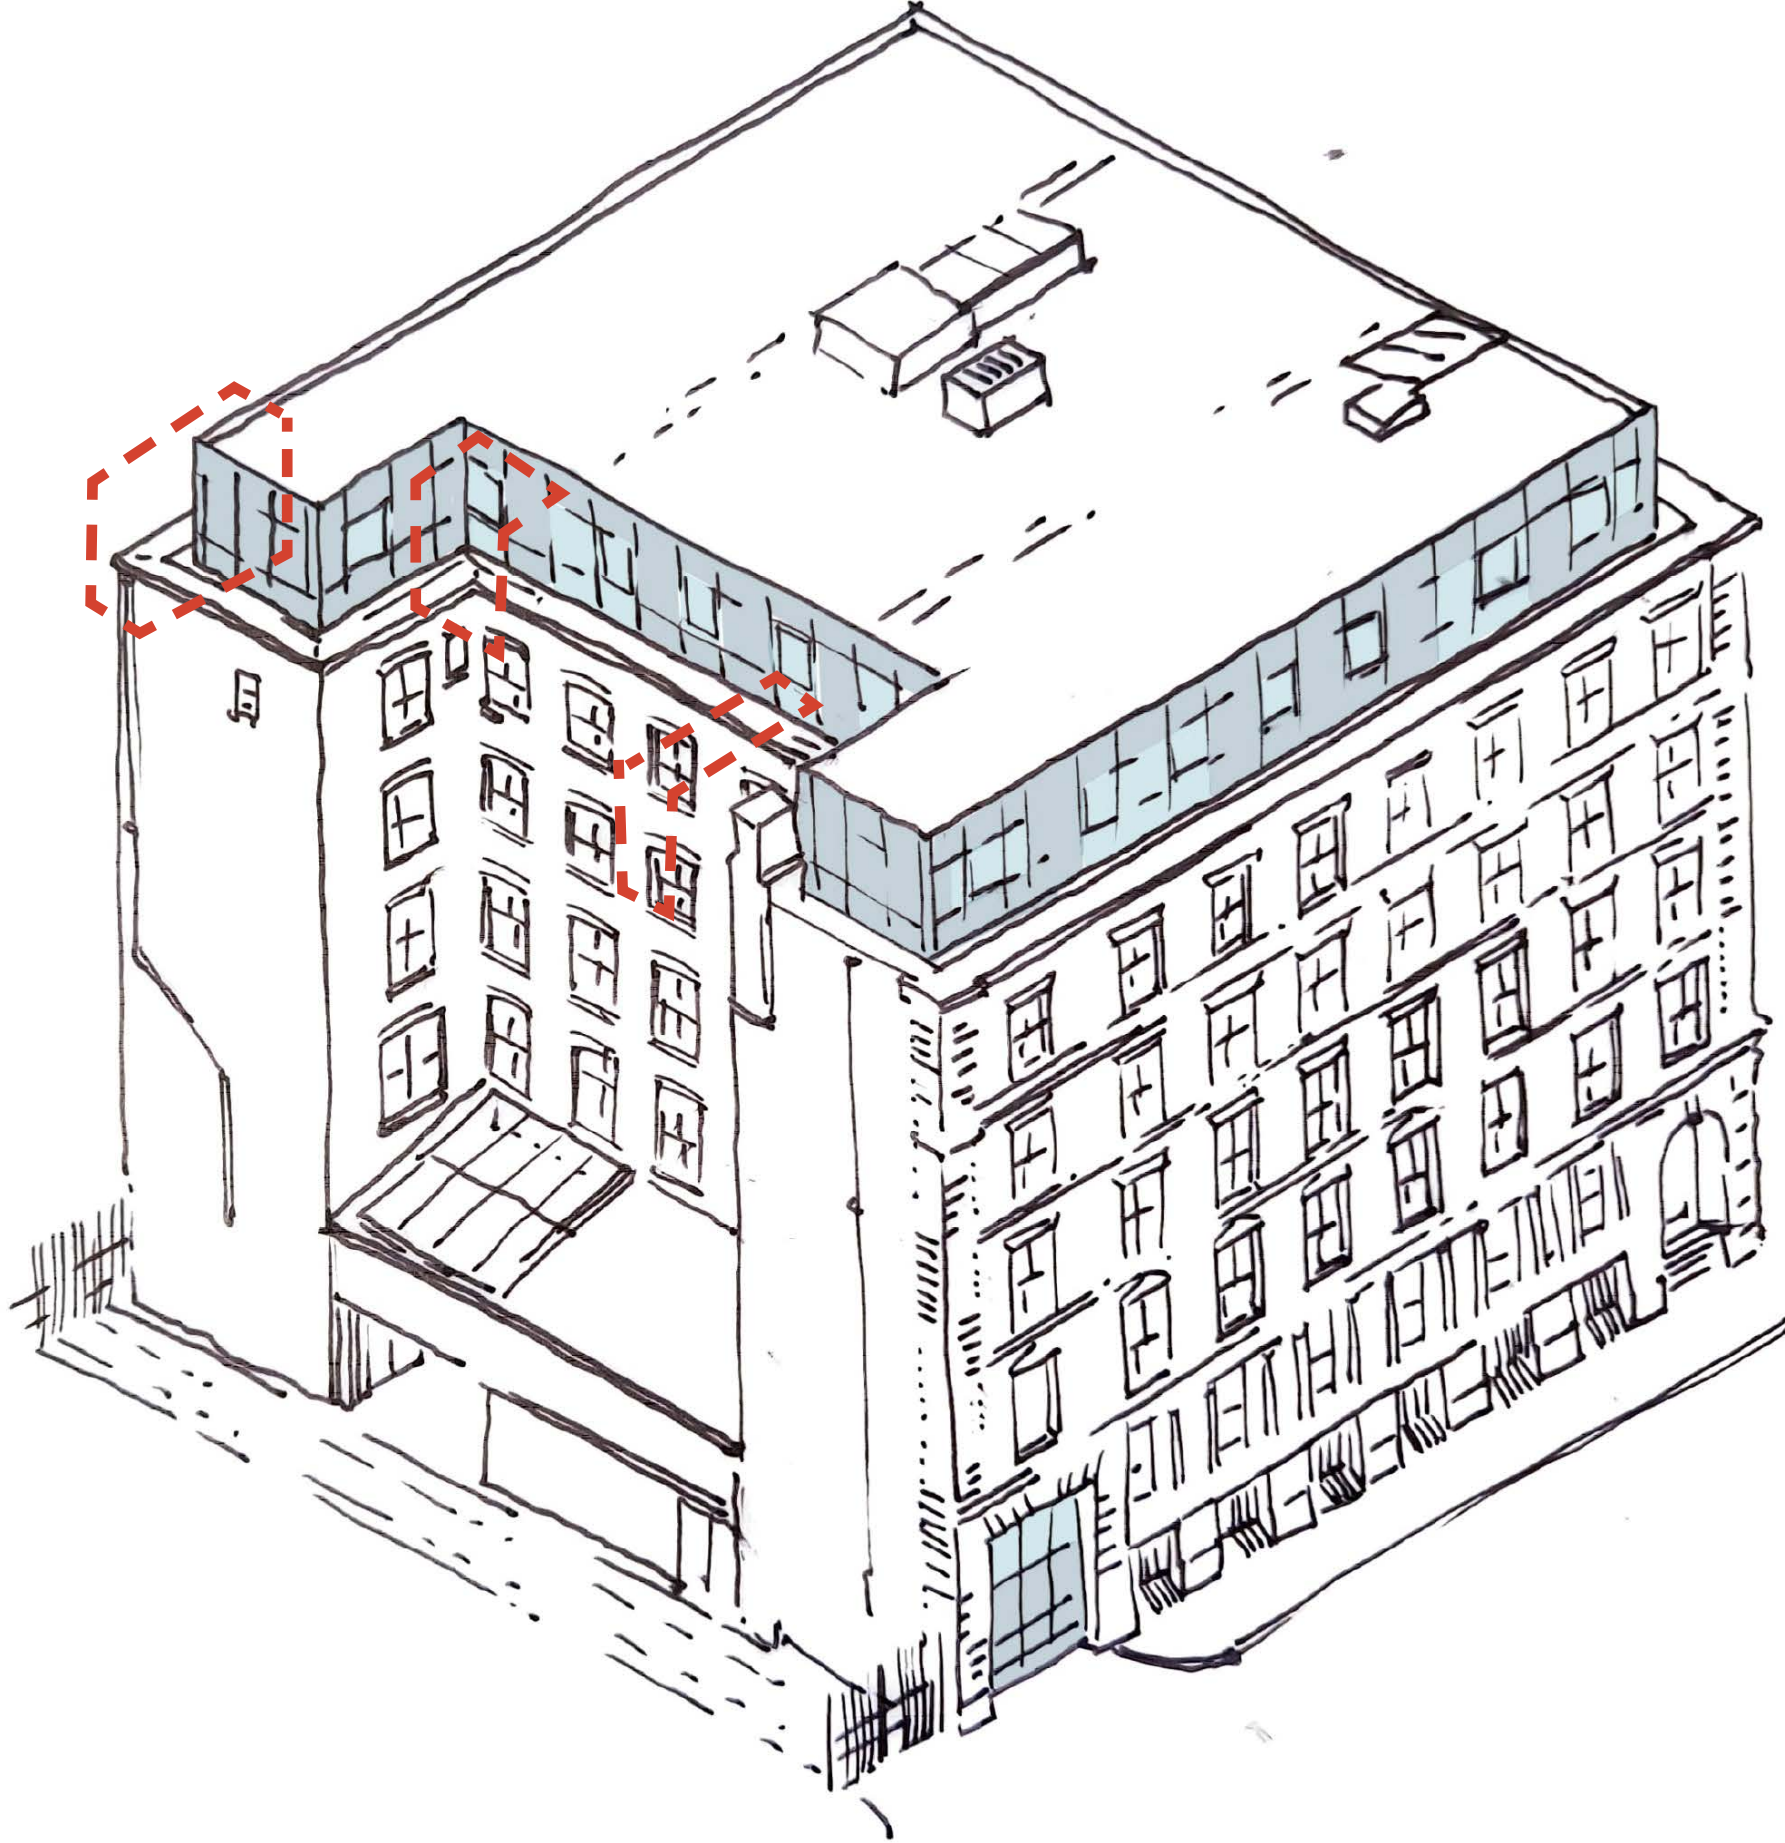
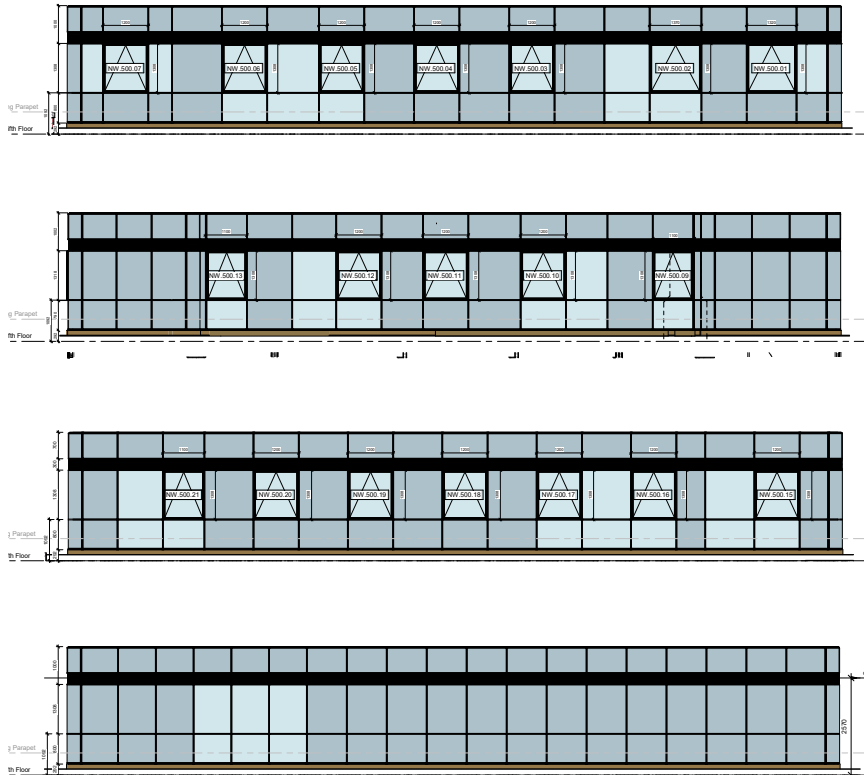
Approved balconies now proposed to be removed

The previously approved scheme included a glazed extension atop the existing building, which is proposed to be retained. The proposal also incorporated three small balconies on the alleyway elevation. However, these balconies were found to be too small for practical use and detrimental to the layout of the adjacent apartments.

As part of the scheme review, it is now proposed to remove these balconies and reconfigure the space of the apartments. The overall aesthetic remains largely unchanged, with the only alteration being the removal of vertical glazed fins, resulting in a sleek glazed box that subtly enhances the existing structure.

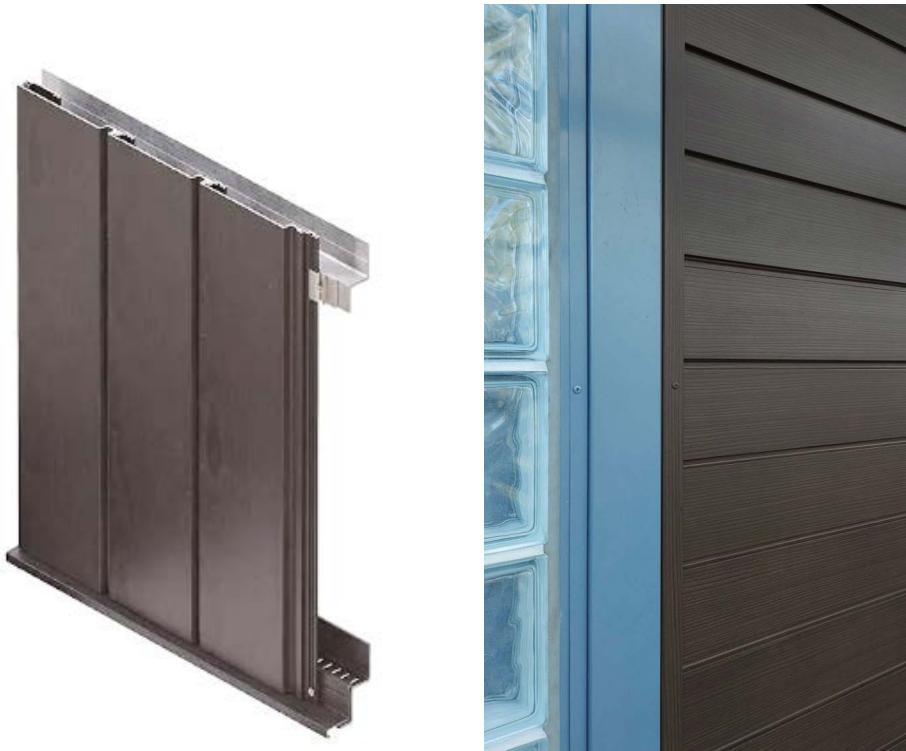
The alleyway elevation of Mindel House features a hoist opening that requires infilling. Historical photographs indicate the presence of solid infill panels, but after demolition, a glazed timber double door was discovered closing the opening. These doors are too damaged for reuse and are missing on most floors. However, they serve as a design reference for new Juliette balconies opening to living spaces on each floor. The proposed doors will be constructed from timber, extending from floor to ceiling (with height varying by floor), and incorporating micro double glazing to mitigate heat loss.

The infill height will be consistent across all levels and will be filled with horizontal planks, inspired by similar features in the vicinity, such as Jacksons Warehouse on Tariff Street. This building was refurbished under previous fire regulations, which permitted timber horizontal planks. Due to current regulations, A2-rated aluminum cladding that simulates timber, such as Vulcan VulcaLap Rainscreen Plank, is proposed for this project.

The timber Juliette doors and infill panels will be of the same color, and the required balustrade will feature a minimalistic design, painted black.

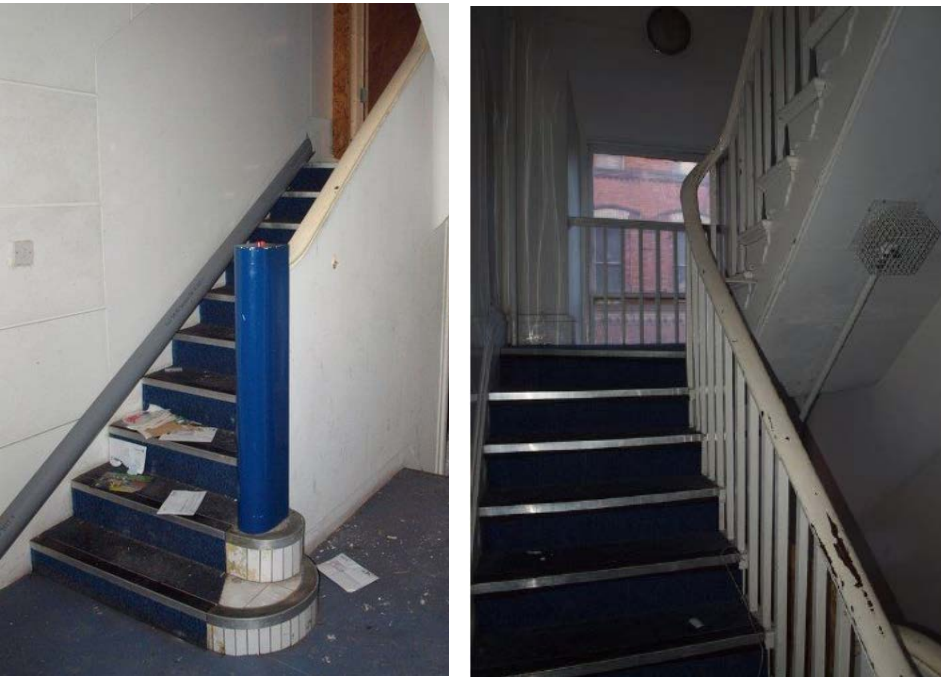
- Main Staircase

The timber stair extending from the ground to the fourth floor is the main and only escape stair. It is proposed to be repaired where necessary, with the lath and plaster ceiling reinstated where missing.

Balustrades might need structural reinforcement which will be concealed.

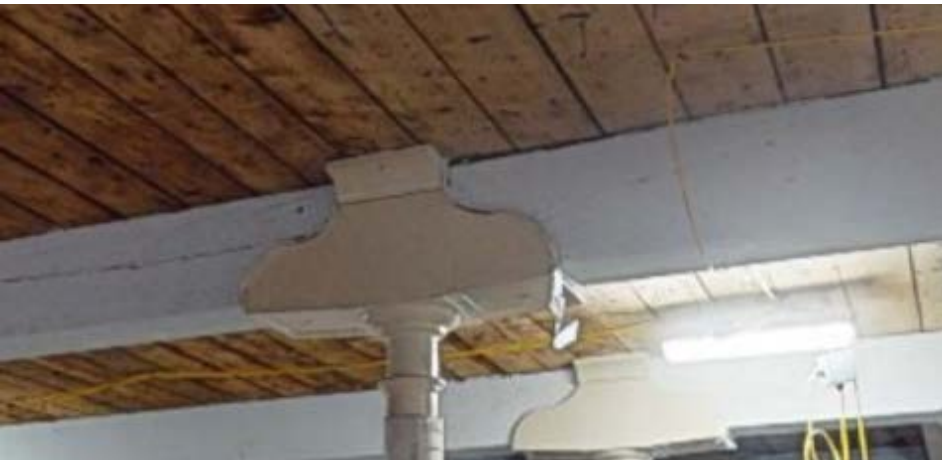
- Cast iron columns, capitals and timber beams

Cast iron columns and capitals to be left exposed, intumescent painted to ensure adequate fire performances, and finished in cream colour as per what has been found to be the original colour.

Timber beams are proposed to be left exposed. According to previous Fire Strategy, most of them have now received intumescent paint. The new fire strategy doesn't account for the existing beams to be intumescent painted therefore it is proposed the following:

- Application will be completed for those areas left unfinished where within the same room (Gridline M7 from Upper Ground to level 3)
- Beams will be left with their natural colour where treatment has not been applied (Lower Ground floor)

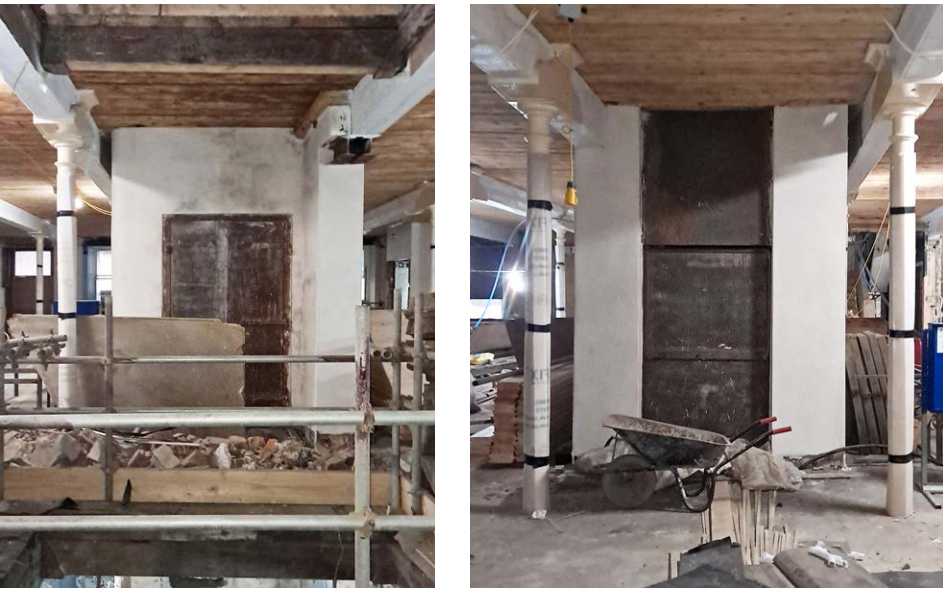
- Metal shaft doors

Except at the lower ground level, the central masonry hoist is accessed via metal doors and shutters.

Double metal doors, situated within a wall separating different plant rooms, will remain in place but will require fire-rated lining to both sides to meet resistance requirements between plant rooms.

The current location of the vertical shutters compromises the use of the plant room. Therefore, they will be refurbished, redecorated, and relocated along the corridor, fixed to the masonry wall. Due to the weight of these elements, support fixtures will be provided for both the masonry wall and the floor.

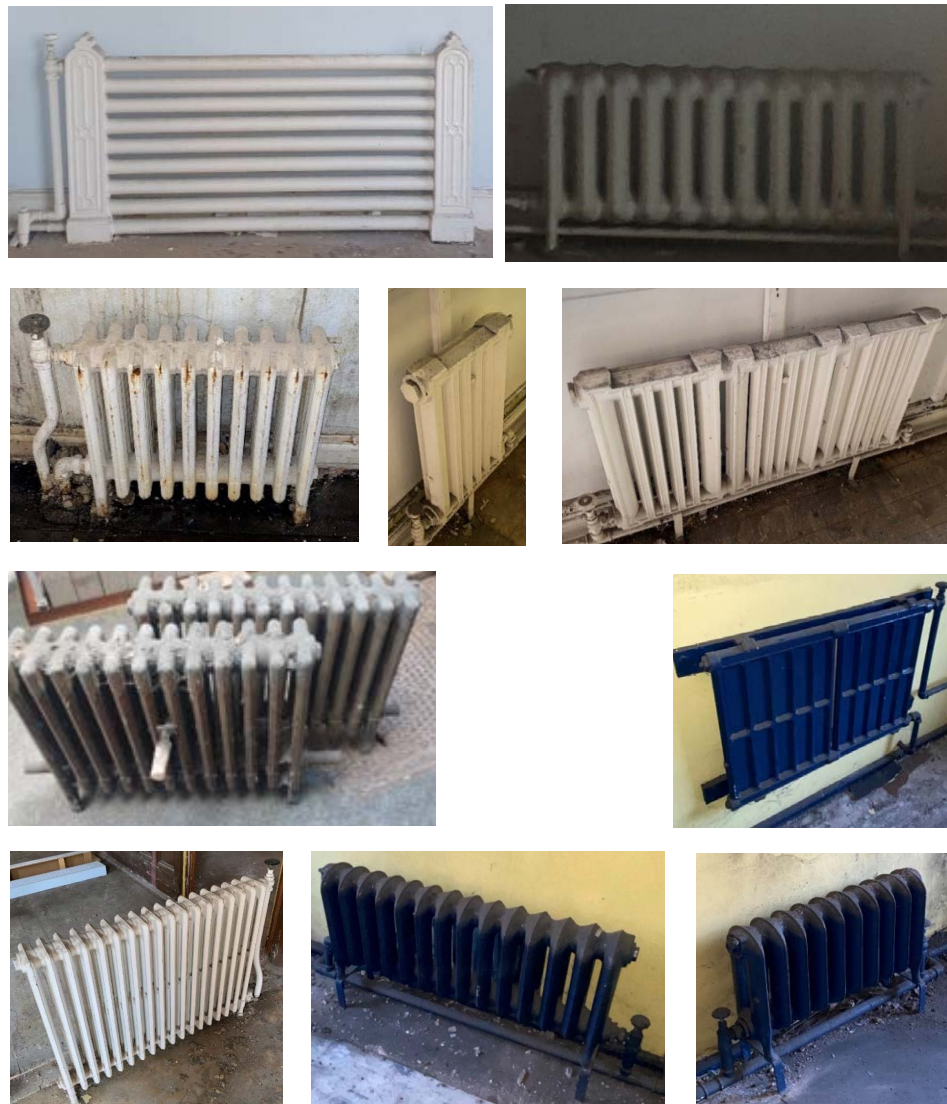
- Radiators

There are 11 historic radiators in total, all originally found in Mindel House. It is proposed to relocate all of them within this building, typically in the stair lobby or along the corridor, depending on the available space.

All radiators are proposed to be refurbished and repainted, with the color to be determined in line with the internal color scheme. For practical reasons, they are not proposed to be connected to the heating system, but will be retained as features for their heritage value. Fixing methods vary depending on the model, but they are usually fixed both to the back wall and the floor.

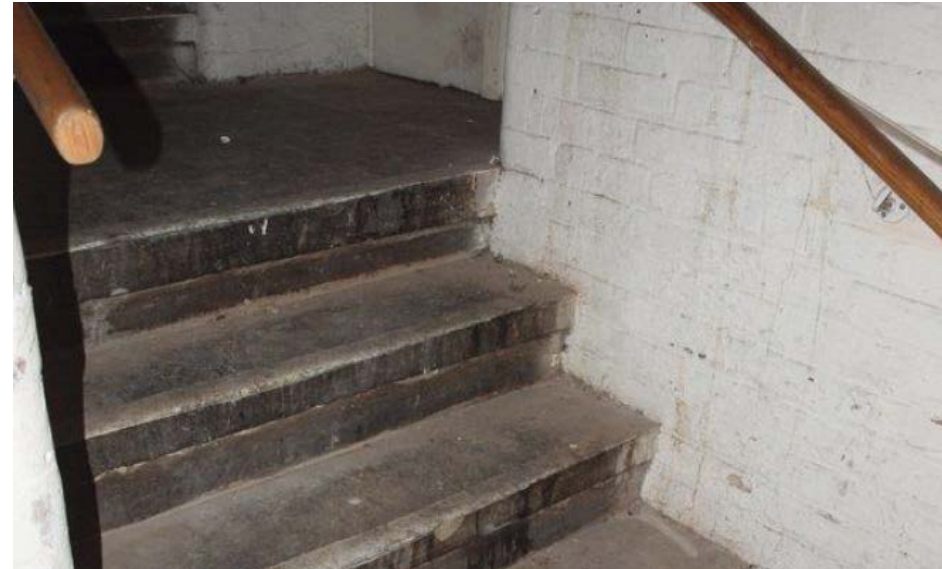
- Rear Staircase

The rear concrete stair is intended solely for access between the ground and lower ground floors, as well as for emergency egress at the external level. The upper levels are designated for maintenance purposes only.

The concrete stairs will be cleaned and stair nosing will be created by colouring the area with textured light grey paint. The masonry wall will be cleaned and redecorated as needed. Existing handrails will be retained, and missing ones will be replaced with matching designs.

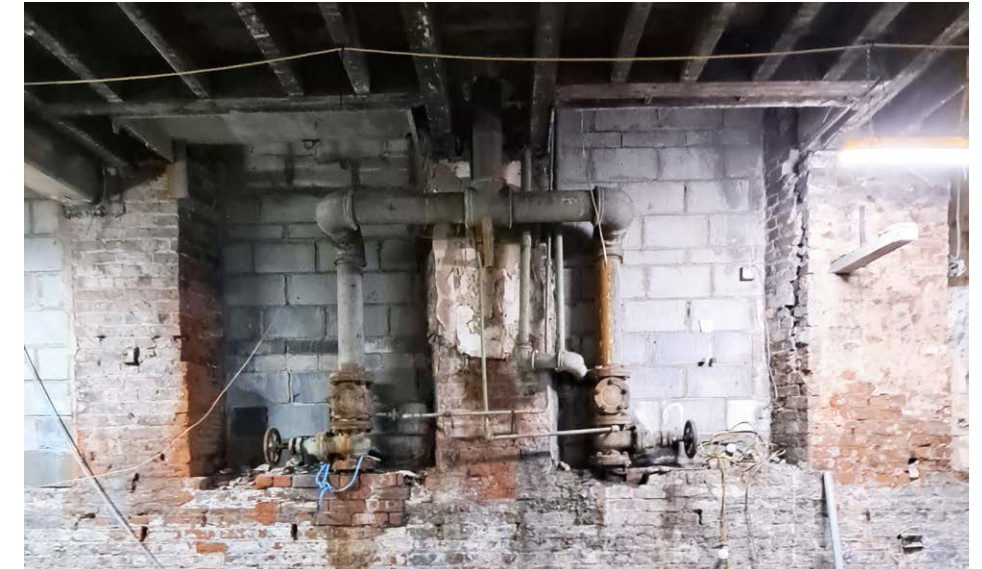
- Sprinkler valves + pipes

Currently located within apartment No. LG01 and in front of two windows, this item is proposed to be relocated in the corridor near the entrance to the floor, within a specially created recess to house it. It will need to be carefully dismantled with a cut to the ceiling level required.

It is proposed to be cleaned, repaired and repainted. Then relocated within the recess with exactly the same configuration. Wall pattressing and fixing brackets will be required.

A heritage plaque, explaining history, use, original location and relocation process will be fixed next to the item.

The communal pipes and valves are proposed to be retained, refurbished, and relocated as a feature. However, it has been observed that smaller elements of the system, such as the distribution pipes, have mostly been removed from the site, with only a small portion remaining. Those elements are in poor condition and are situated in locations that do not align with the fire strategy. Therefore, they are now proposed to be removed.

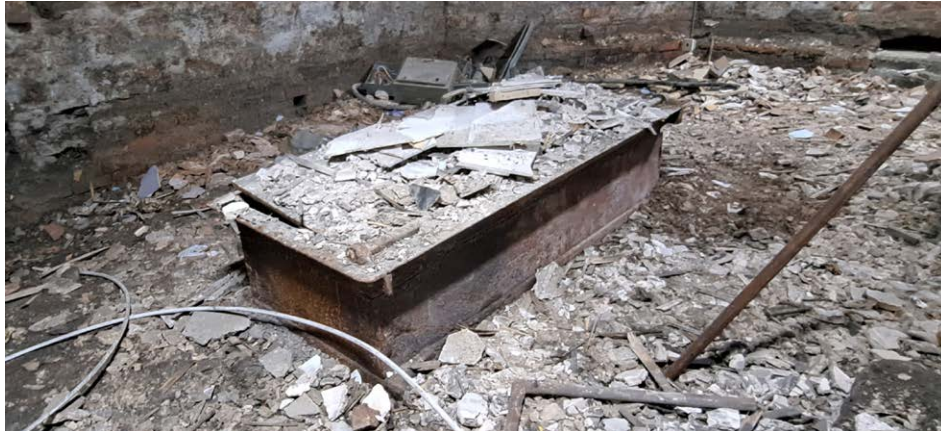
- Safe door

The element is currently on the floor after the wall that hosted it was demolished. It is proposed to be cleaned, treated for rust, and redecorated.

To facilitate its retention and relocation along the corridor, its thickness will be reduced to a maximum of 350mm. With health and safety in mind, it will be placed in a corridor that is used solely for access to one apartment.

The element will be securely fixed to the lift block wall shaft with brackets, and additional pedestals will be installed on the floor to help distribute the weight.

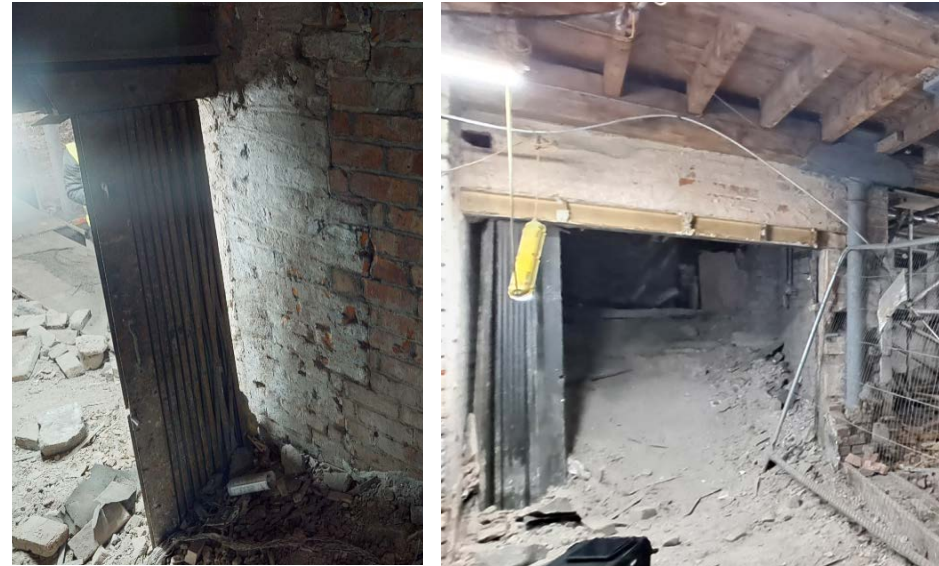
- Concertina door + scissor gate

Both elements are proposed to be removed from their original location to make space for a platform lift. They will be sanded, cleaned, and hung fixed open on the corridor walls near their original location.

Pattressing will be required for both elements.

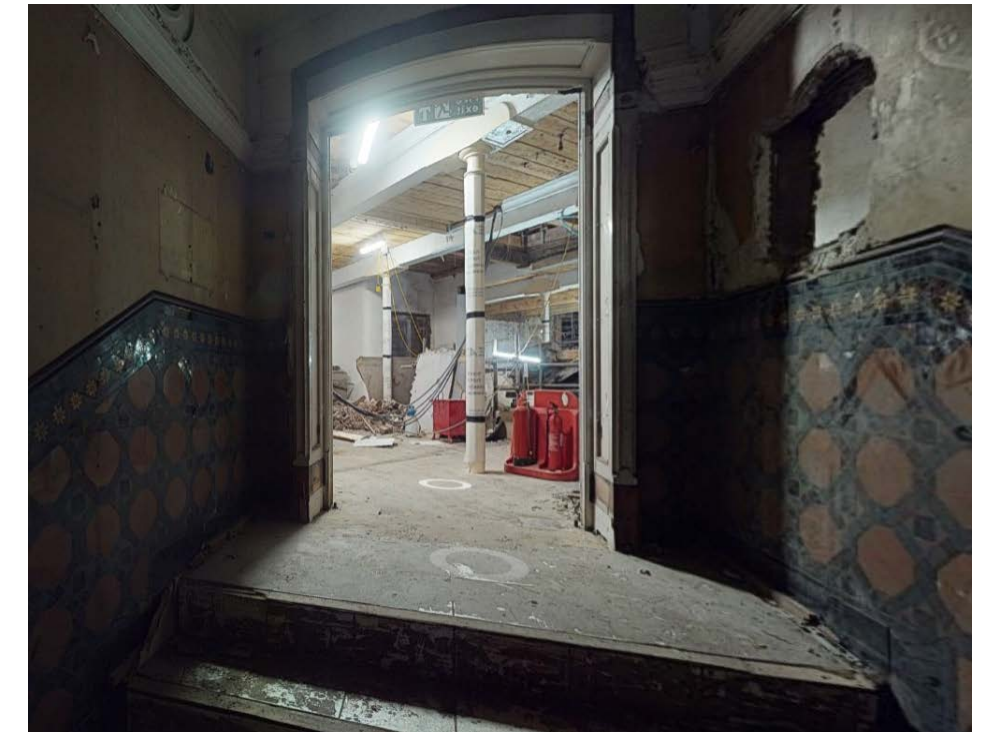
- Main entrance

The entrance requires a comprehensive refurbishment. The main door needs to be repaired, sanded, and redecorated in the same color as the existing one. The ironmongery should be upgraded, and security features integrated.

A new secondary internal door will be installed, fully glazed with the top following an arched architrave, and the frame will be colored RAL 7022.

Decorative timber panels will be retained, repaired, and redecorated. Lath and plaster walls will be repaired where damaged, and the half-height tile decoration will be refurbished with missing tiles replaced where possible. The wall color will be determined as part of the overall color scheme concept.

Plaster decorations and moldings will be repaired where cracked and repainted in white.

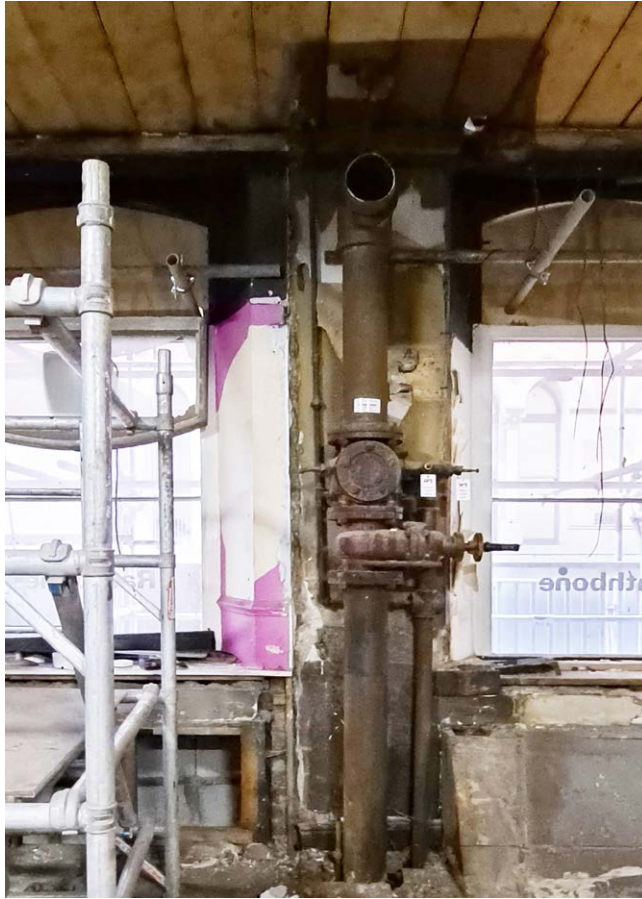
- *Sprinkler valves+pipes*

Currently located within apartment No. UG01, this item is proposed to be relocated to the entrance lobby. It will need to be carefully dismantled, including a cut to floor level.

The item will be cleaned, repaired, and repainted. While the preference is to avoid enclosing it in a glazed box, this may be necessary if, after refurbishment, the metal parts remain too sharp.

Wall pattressing and fixing brackets will be required. Additionally, a heritage plaque explaining the item's history, use, original location, and relocation process will be installed next to it.

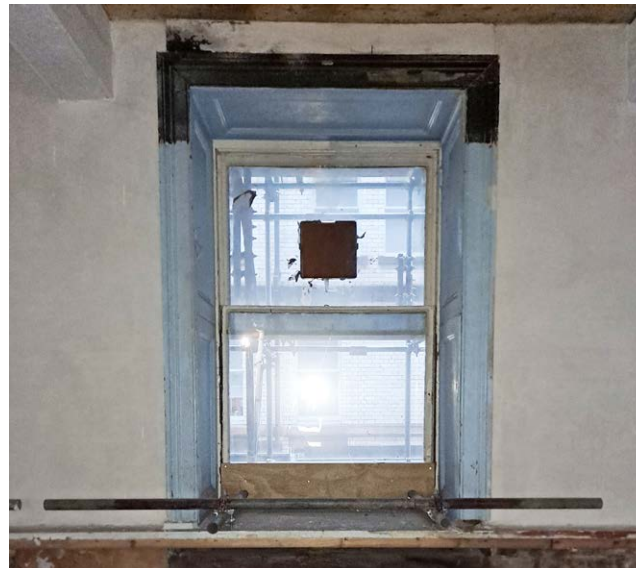
- *Window timber surrounding*

Present only on Richmond Street, these elements are proposed to be dismantled, refurbished, repainted, and then reinstalled in their original location. Secondary glazing will be fixed and sealed against the timber panels, with timber pattresses added behind the panels for support.

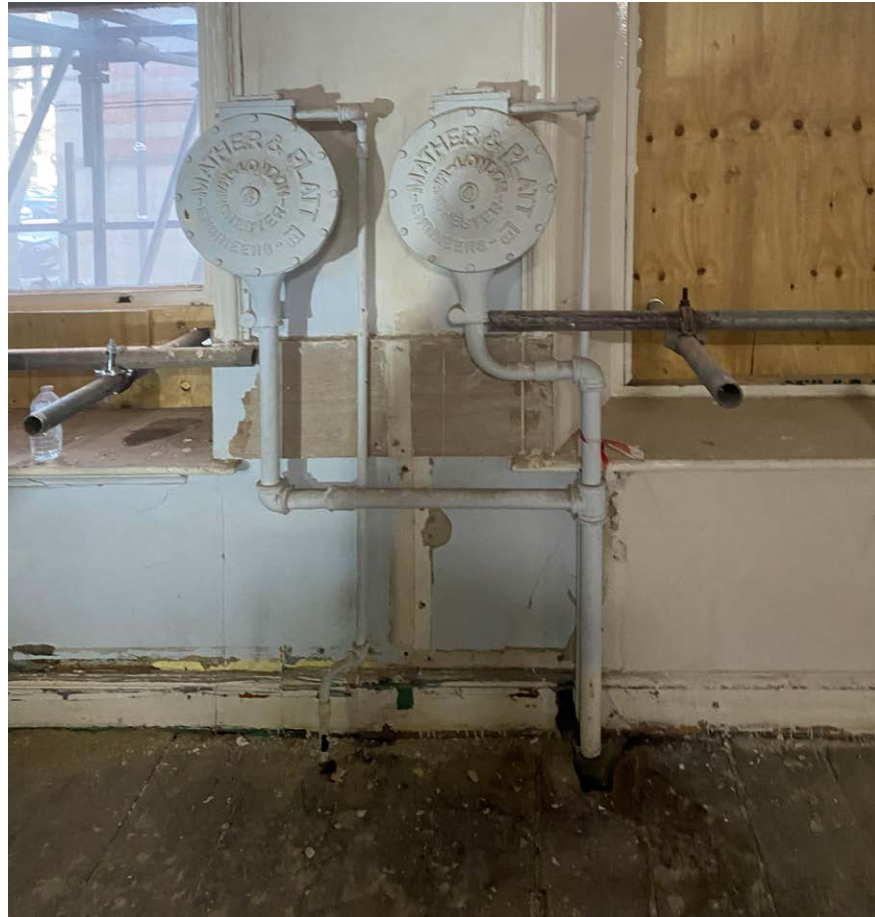
- Rorary alarm gong

To be cut from floor, refurbished, repainted and relocated within circulation area near Hoist shutter.

To be securely fixed back to wall with pattressing required.

The preference would be for it to not being enclosed in a glazed box, however it might be required if after the refurbishment, the metal parts will be retained too sharp.

A heritage plaque explaining history, use, original location and relocation process to be fixed next to the item.

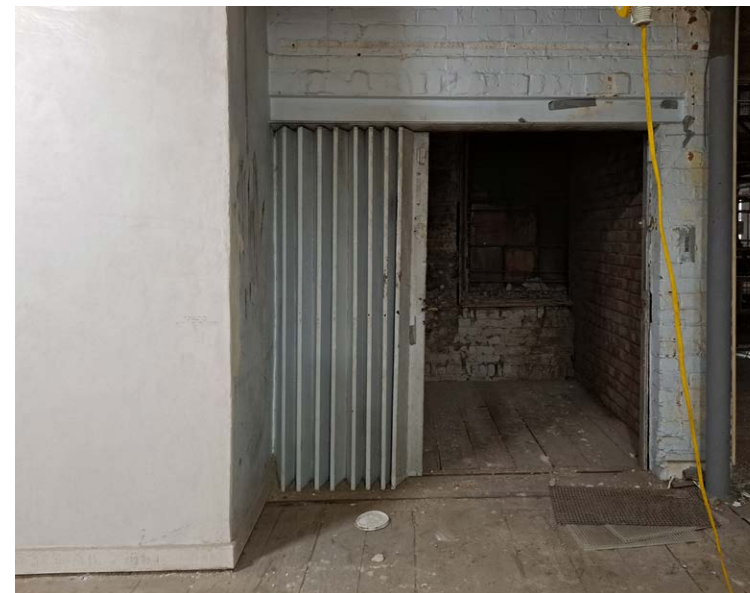
- Concertina doors + scissor gate

Concertina Door to be left in place and fixed to top and floor to open position.

Lintel to be lifted 300mm to allow min 2100mm clear height between new floor finish and concertina steel beam. Base track to be left in place. Old paint to be removed.

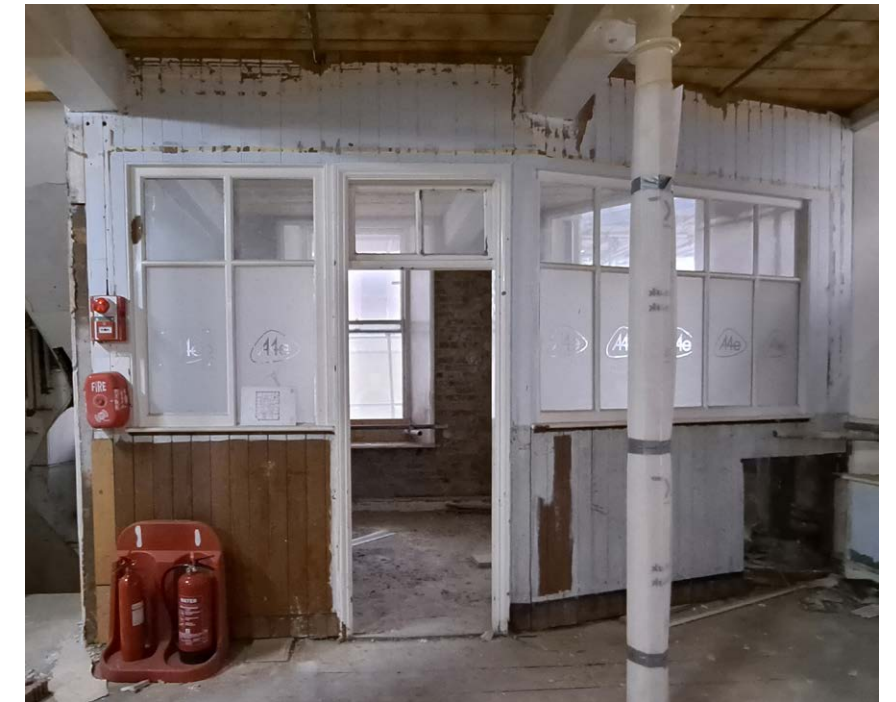
- Timber and glass screen

The partition is to be refurbished and repainted, with glass replaced where necessary, and a new door fitted. To allow sufficient headroom for the door after the new floor is raised, the door overpanel will need to be removed. It is proposed that the overpanel be fixed above the door as a heritage item. The base of the partition will need to be cut to accommodate the installation of the floor fire compartment system.

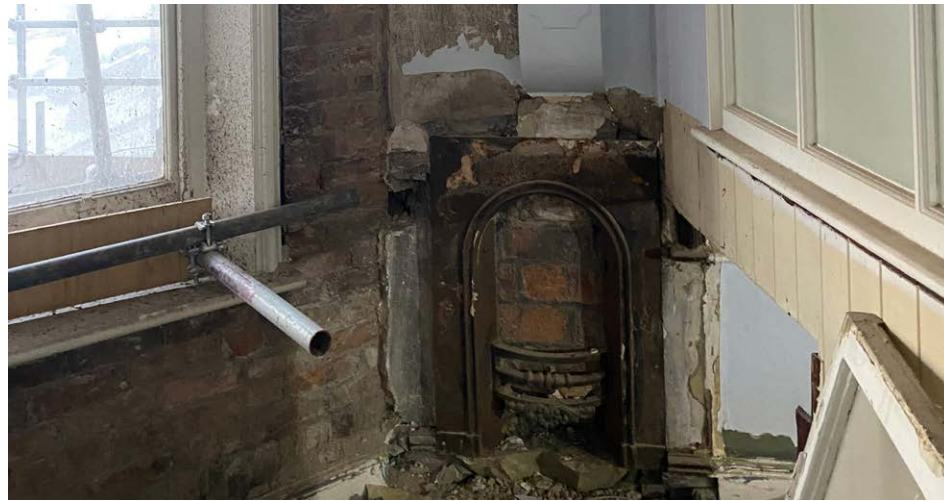
- *Fireplace*

Rust treatment required. To be repaired, redecorated and put back in place as heritage item. To be lifted above new floor level.

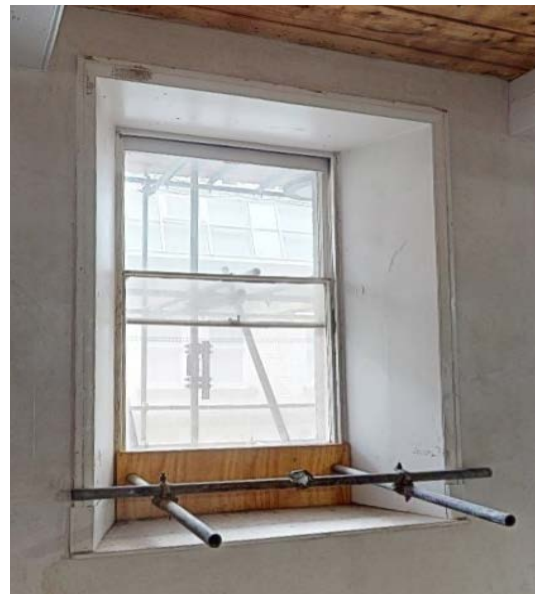
- *Window reveal*

To be refurbished, repainted white and located back in place. Secondary glazing to be fixed and sealed against timber panels with timber pattress added behind panels to support those elements.

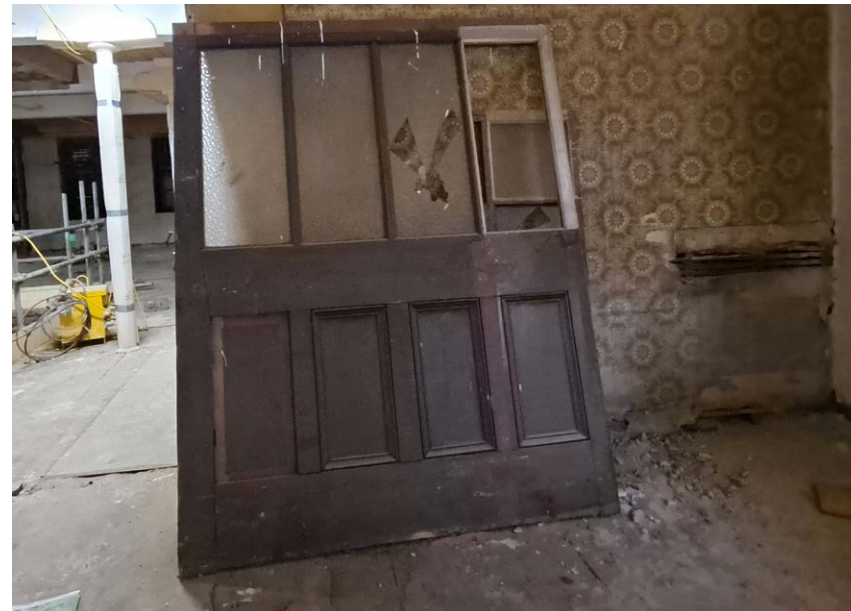
- *Timber panel*

Glazed timber panel to be repaired and relocated within corridor as heritage feature. Glass to be replaced with same type where damaged, timber to be repainted. To be hung to the wall through brackets. Pattressing required.

Previously, it was noted that there were missing timber panels in Mindel House, identified in the approved proposal to be preserved as heritage features within corridors.

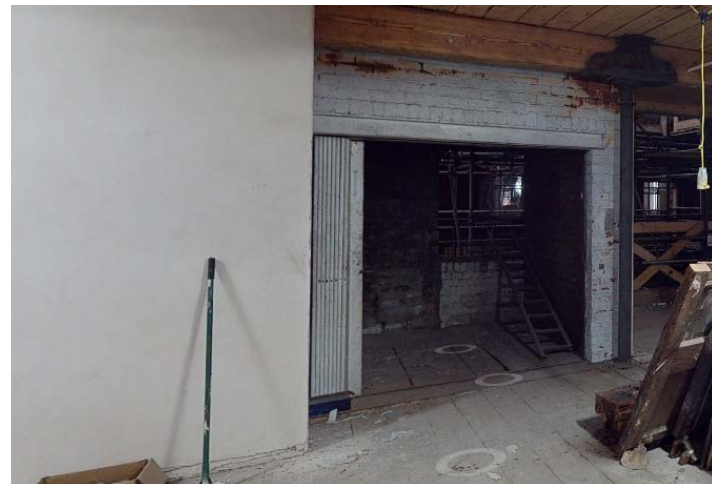
- *Concertina doors + scissor gate*

Concertina Door to be left in place and fixed to top and floor to open position.

Lintel to be lifted 300mm to allow min 2100mm clear height between new floor finish and concertina steel beam. Base track to be left in place. Old paint to be removed.

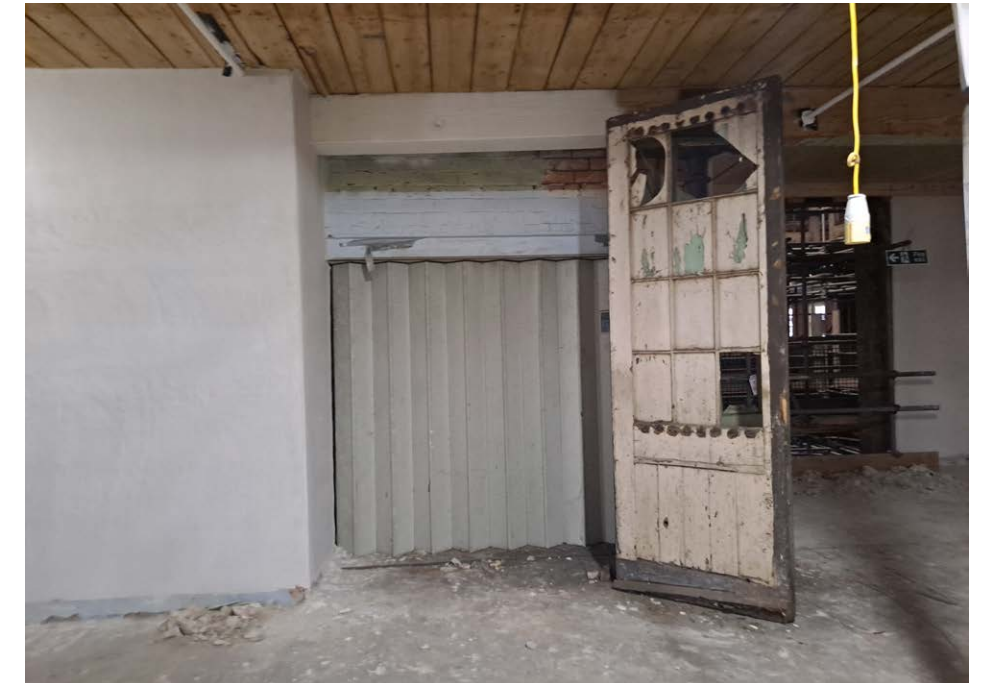
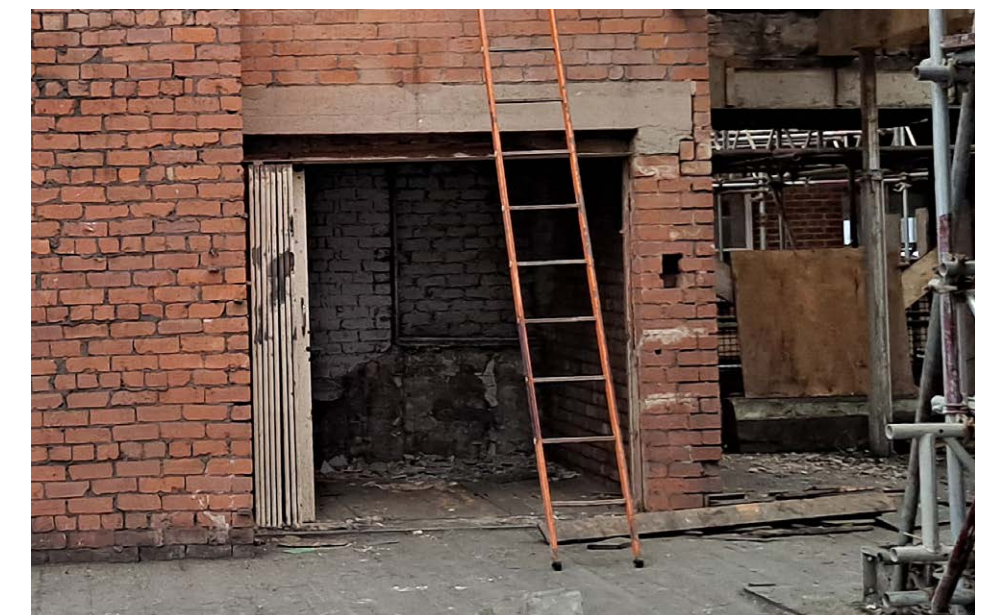
- *Concertina doors + scissor gate*

Concertina Door to be left in place and fixed to top and floor to open position.

Lintel to be lifted 300mm to allow min 2100mm clear height between new floor finish and concertina steel beam. Base track to be left in place. Old paint to be removed.

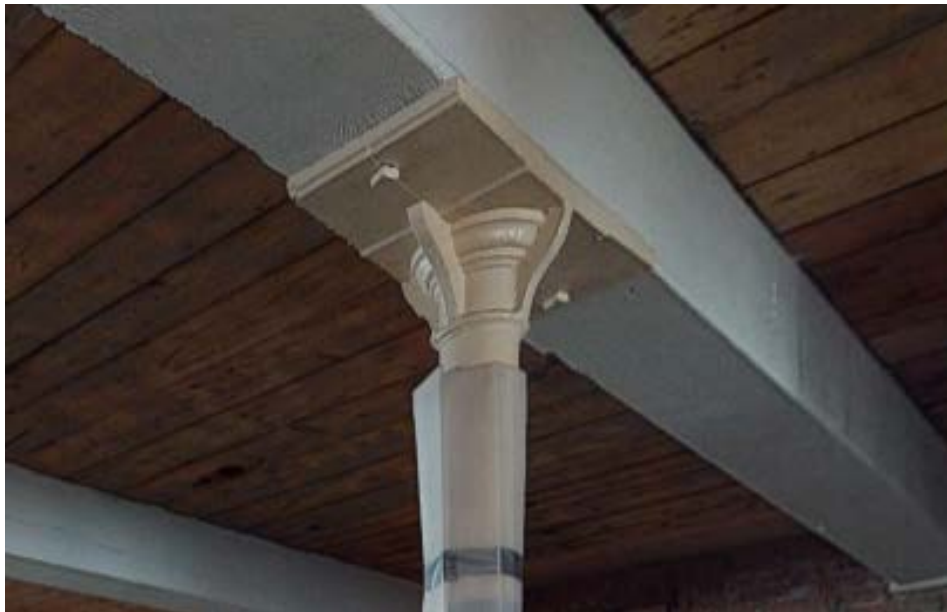
- Cast iron columns, capitals and timber beams

Cast iron columns and capitals to be left exposed, intumescent painted to ensure adequate fire performances, and finished in cream colour as per what has been found to be the original colour.

Timber beams are proposed to be left exposed. According to previous Fire Strategy, most of them have now received intumescent paint. The new fire strategy doesn't account for the existing beams to be intumescent painted therefore it is proposed the following:

- Application will be completed for those areas left unfinished (Localised areas at Level 3)
- Beams will be left with their natural colour where treatment has not been applied (Lower Ground floor)

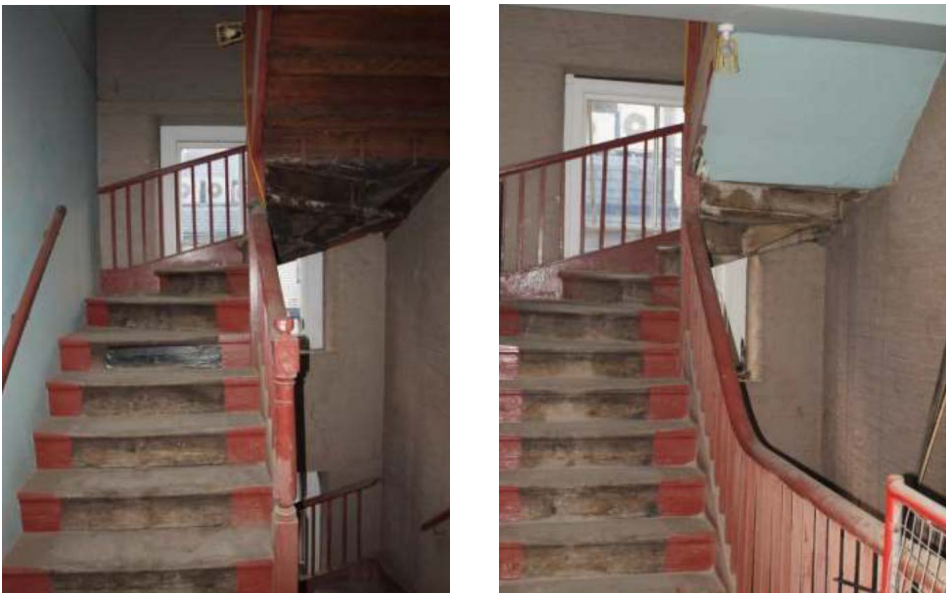
- Rear staircase (Level 1 to 4)

Timber stair extending from level 1 to 4 proposed to be retained as heritage item only. Not usable by residents but accessible via a service ladder for cleaning and maintenance only. Other than cleaning, no additional intervention is proposed for this item.

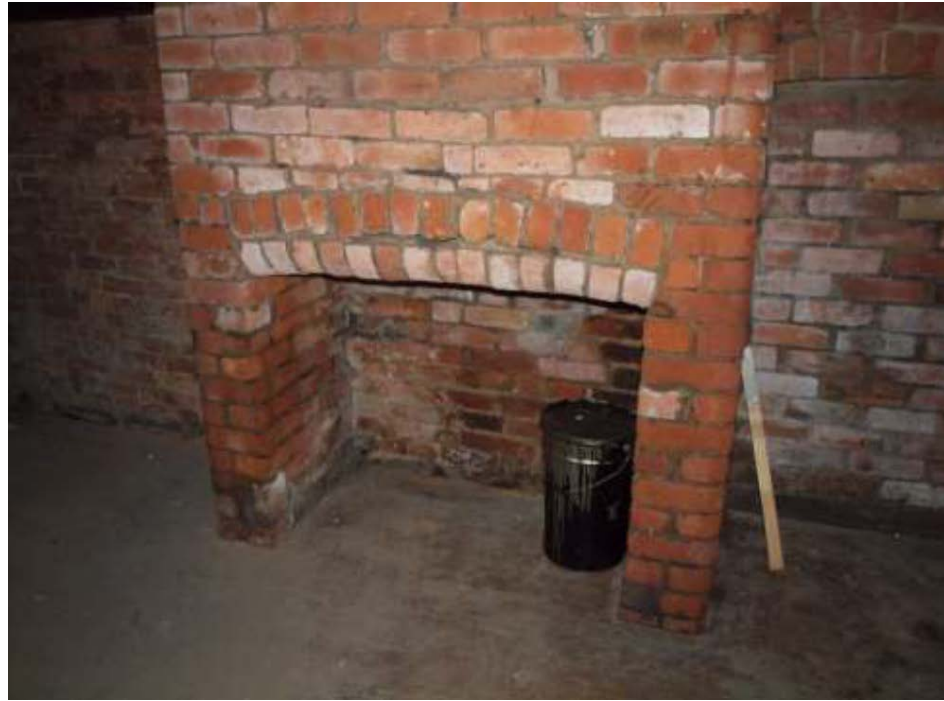
- Feature fireplace

Fireplace to be retained as feature with exposed brickwork. To allow exposure it is required to be partially reconstructed after required tanking system is installed behind.
