# 4.5 Cycle Facilities

# 4.6 Bloom Street - Roof Extension

## 5.0 Heritage Proposal

# 5.1 Significant Heritage Items

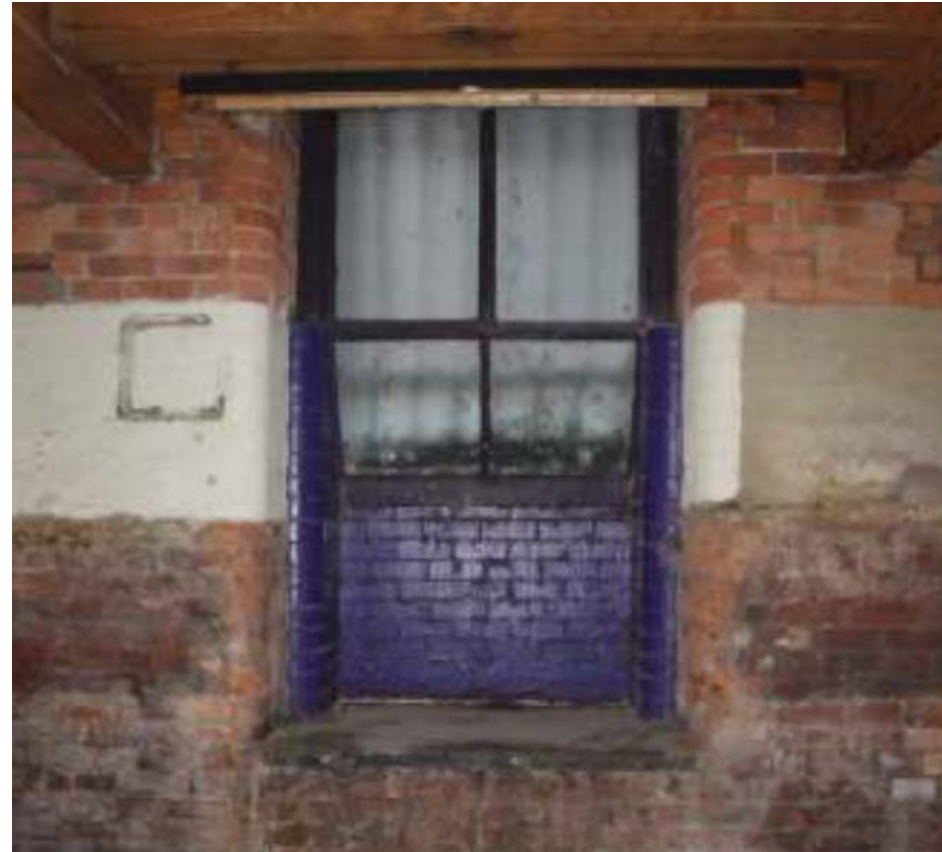
- Overhanging Window

The metal frame is proposed to be retained or reproduced identically if found to be excessively damaged. Currently, there are four existing windows whose conditions will be assessed by a specialist. Additionally, two extra windows need to be reinstated at openings currently used as doors. Reconstruction of the window surroundings may be necessary in those locations.

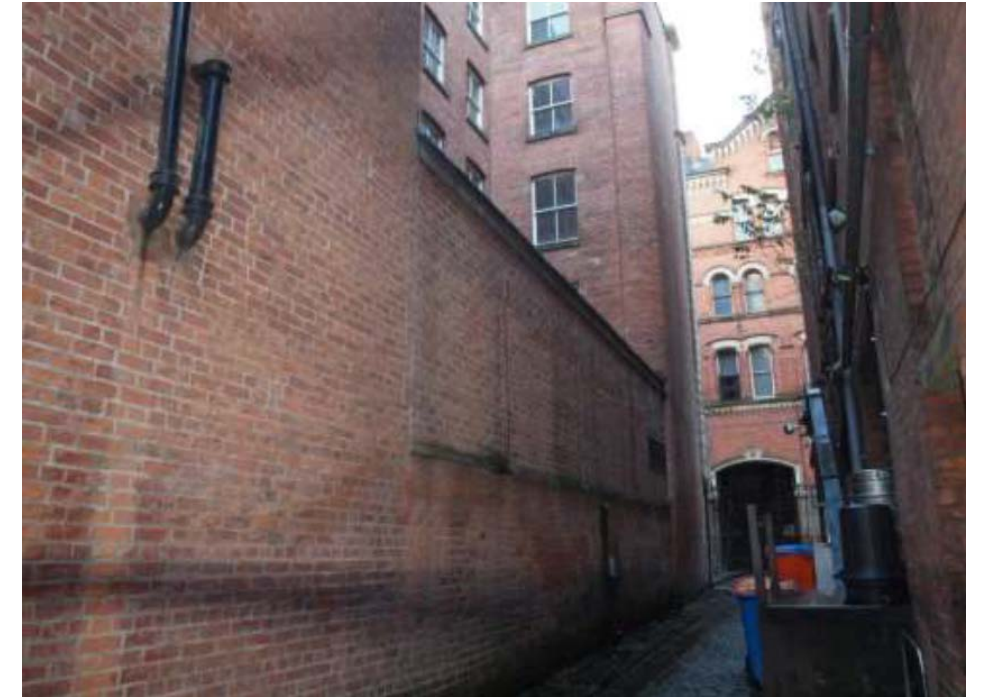
- Annex wall

Brickwall currently demolished, proposed to be reconstructed with reclaimed bricks externally and blockwork internally to provide strength and help with the use of reclaimed bricks to the outside course. The annex is used to house accessible access to the building and the bin store.

Refer to Alleyway drawings for more details.

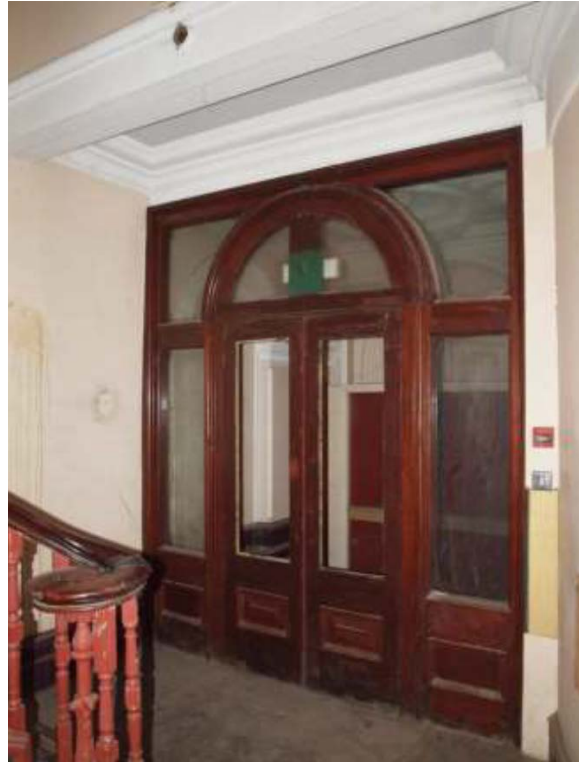
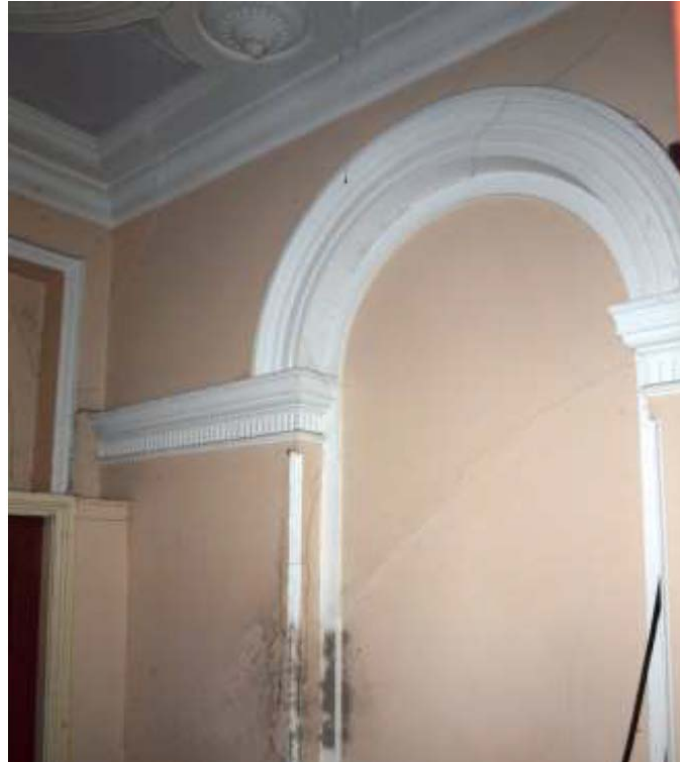
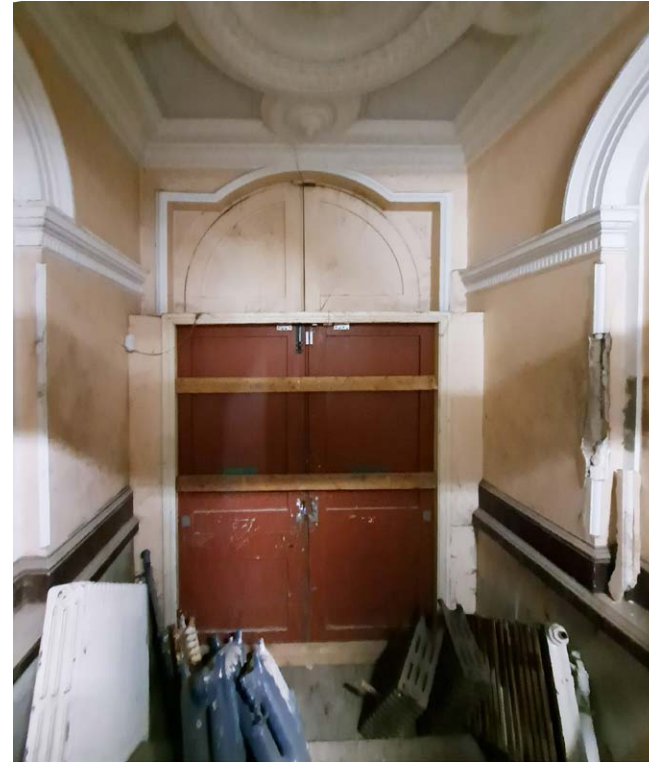
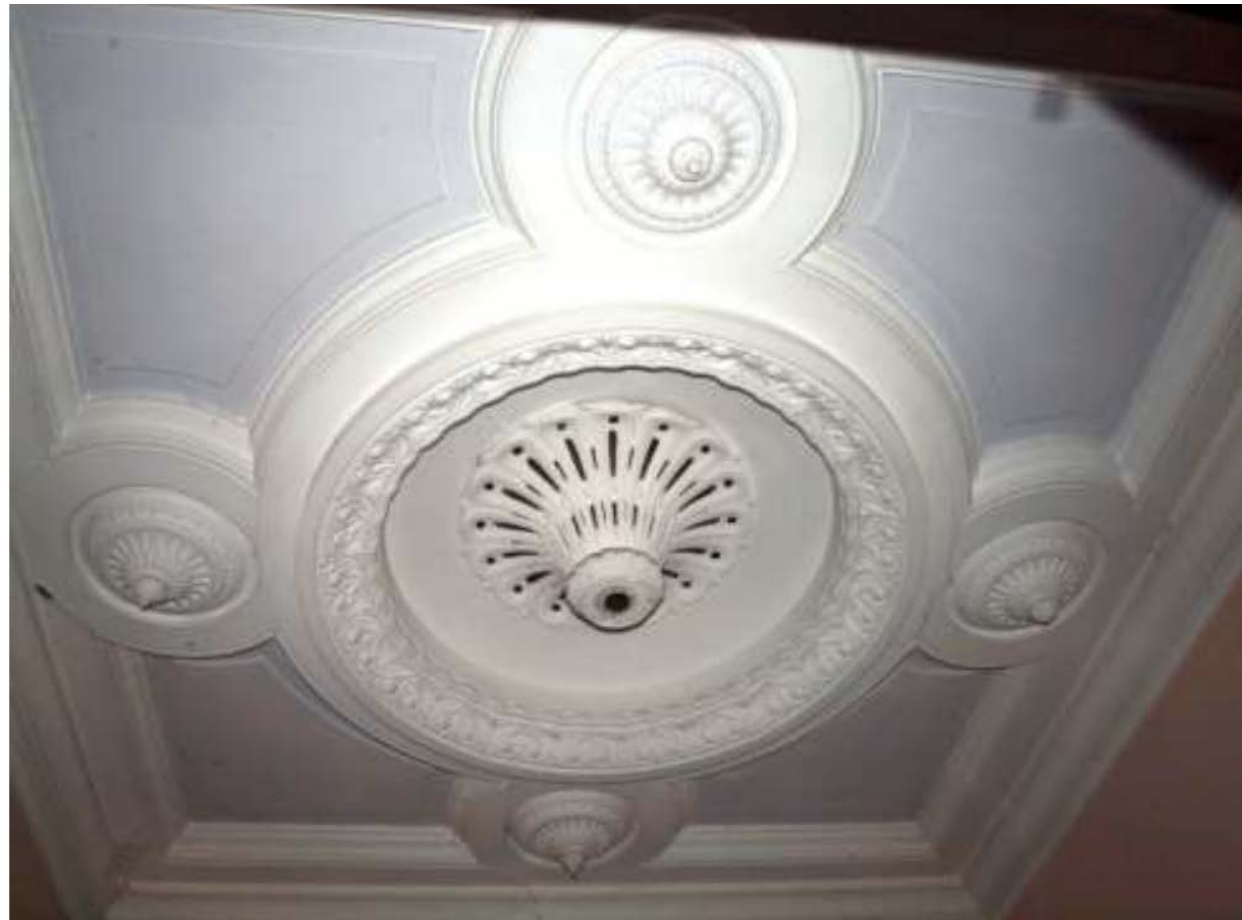
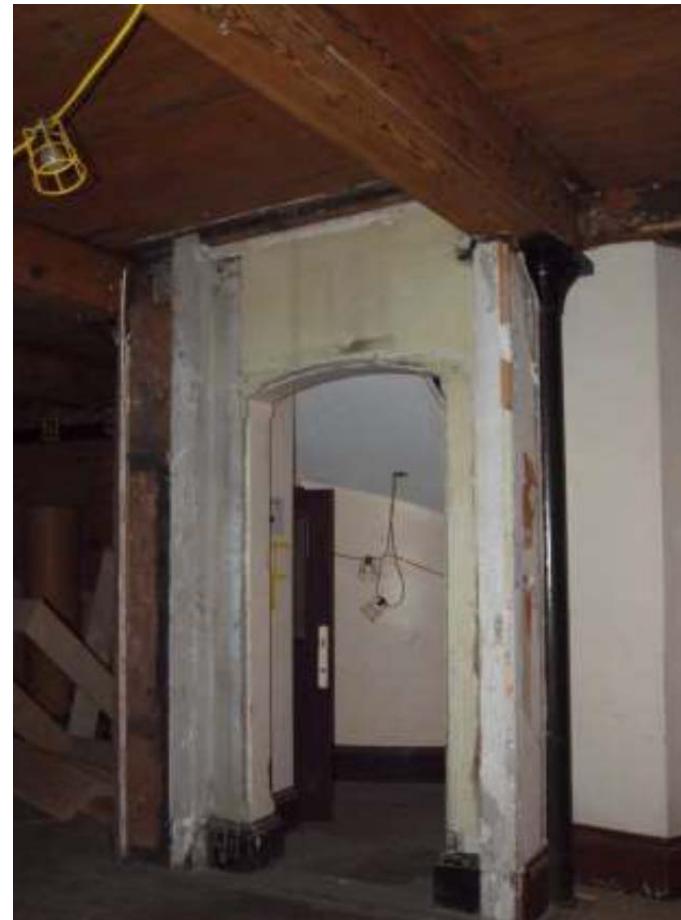
- *Entrance + Lobby*

The entrance requires a comprehensive refurbishment.

The main door will be repaired, sanded, and redecorated to match the existing color. Ironmongery will be upgraded, and security features integrated.

The glazed internal timber door will be repaired, sanded, and repainted. The opening swing and hinges will be reversed to allow outward opening for escape purposes. Ironmongery will also be upgraded.

Lath and plaster walls will be locally repaired and replastered where necessary.

Plaster roses and decorations will be repaired where cracks are present and redecorated.

The decorative arch above the door will be retained and repaired. A new glazed door with an overpanel will be constructed following the shape of the arch.

The entrance requires a comprehensive refurbishment. The main door needs to be repaired, sanded, and redecorated in the same color as the existing one. The ironmongery should be upgraded, and security features integrated.

Decorative timber panels will be retained, repaired, and redecorated. Lath and plaster walls will be repaired where damaged, and the half-height tile decoration will be refurbished with missing tiles replaced where possible. The wall color will be determined as part of the overall color scheme concept.

Plaster decorations and moldings will be repaired where cracked and repainted in white.

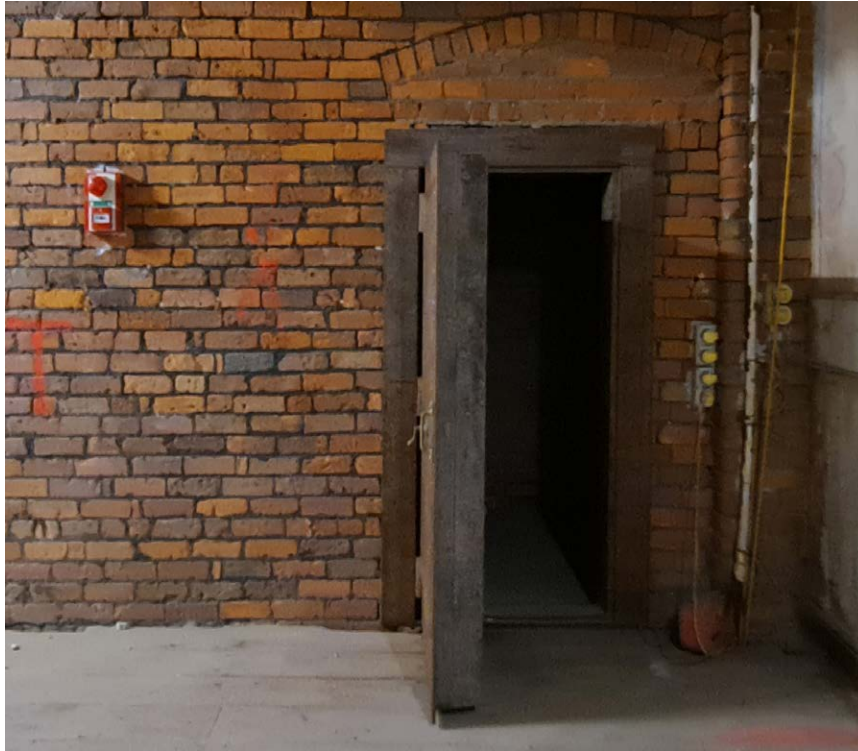
- Safe door + surrounding wall

Safe door to be refurbished as follows:  
Treated for rust and then repainted in anthracite grey.  
To be left in place but lifted in line with the new raised floor level.  
Heavy-duty support required underneath to spread the load.  
It will be located within a wet room; therefore, the paint is required to be moisture-resistant.

The surrounding brick wall is proposed to be partially demolished for a length of approximately 2300mm. This is to help with the use of space that otherwise would be left unutilized.

- *Level 1 Safe door wall partial demolition*

Safedoor brickwall is proposed to be partially demolished to help with the space planning of the apartment. Demolition is approx. 2300mm in length. It is not structural, however in its inner side it has a thick layer of concrete inserted to ensure security required for the previous function. The safe door is proposed to be refurbished and left in place.

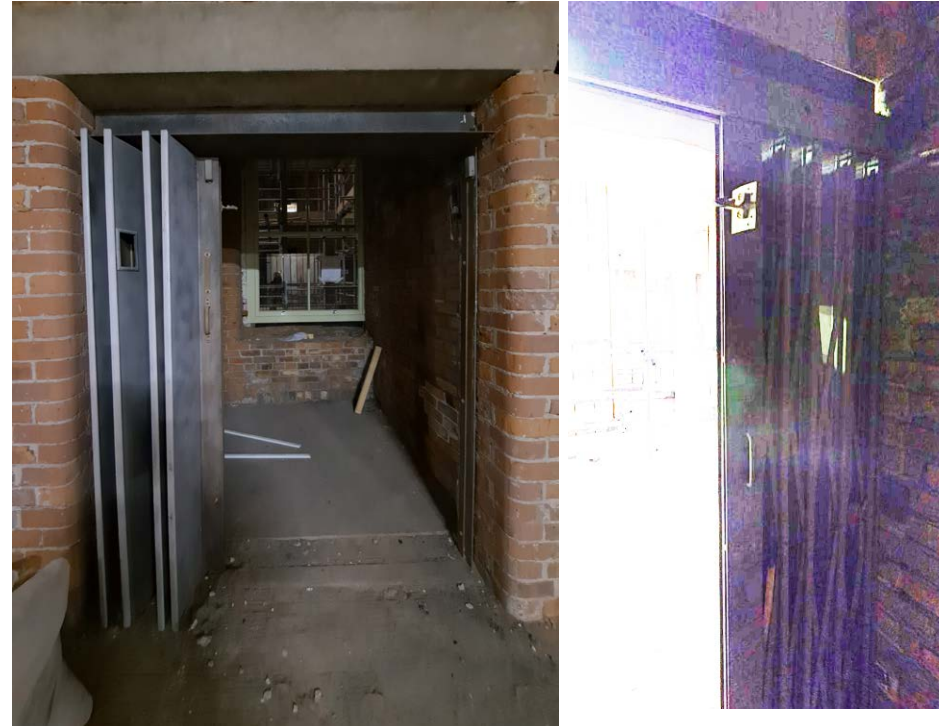
- Concertina door + scissors gate

Concertina Door and scissors gate to be left in place and fixed to top and floor to open position.

Lintel to be lifted 300mm to allow min 2100mm clear height between new floor finish and concertina steel beam. Base track to be left in place. If still present, old paint to be removed.

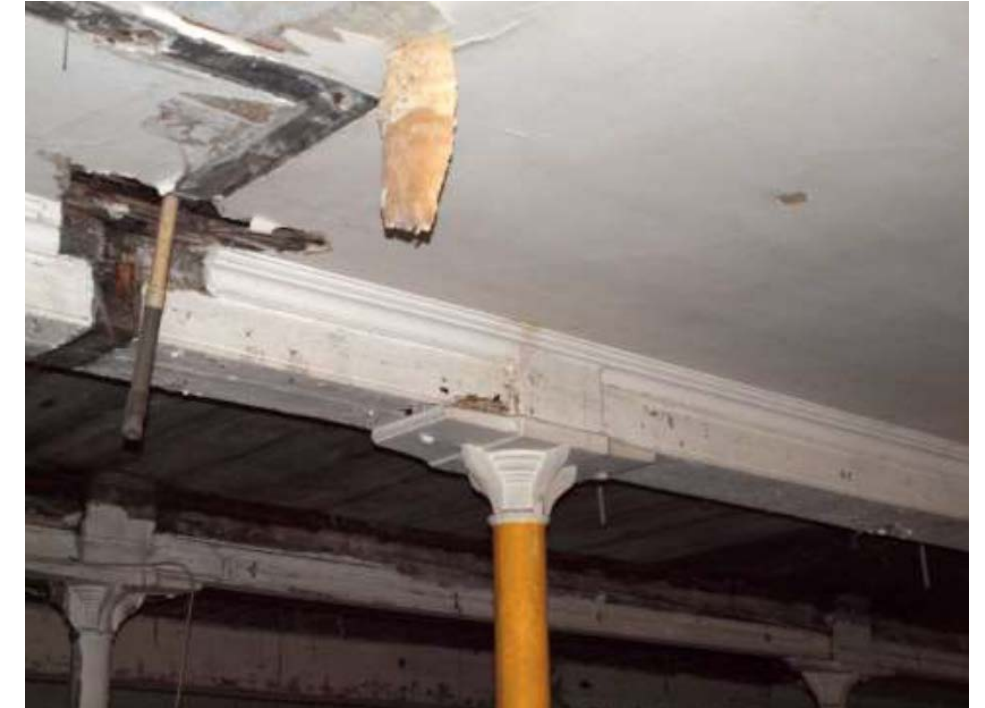
- Cornicing

Various locations mostly at level 1.

They are proposed to be boxed in when clashing with partitions, and for aesthetic reasons, when inside a room, to be reconstructed for continuity up to the next partition.

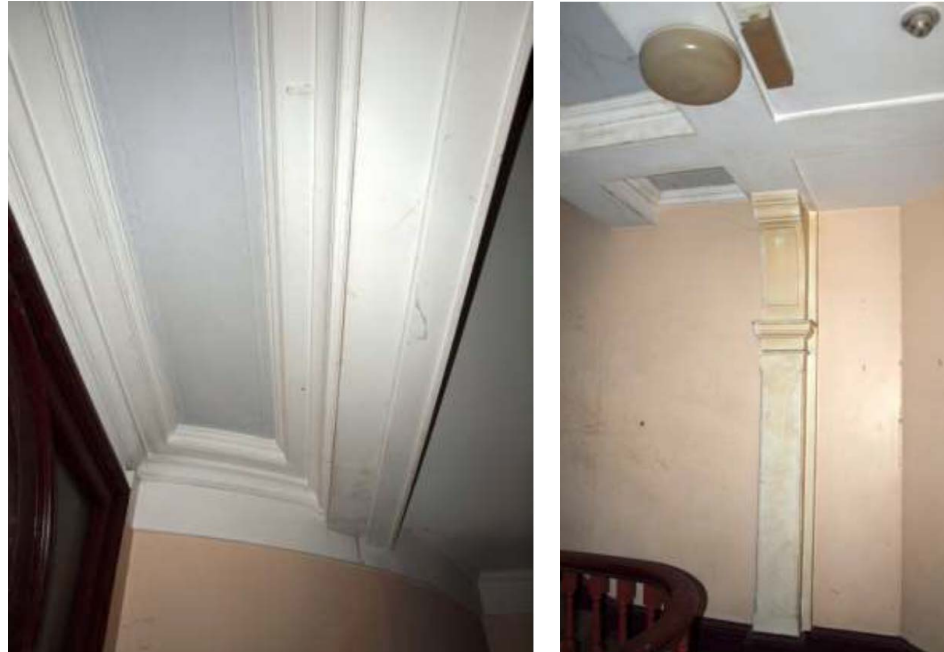
- *Stair lobby*

Lath and plaster wall to be locally repaired and replastered where required.

Plaster pillar and decorations to be repaired where cracks are present and redecorated.

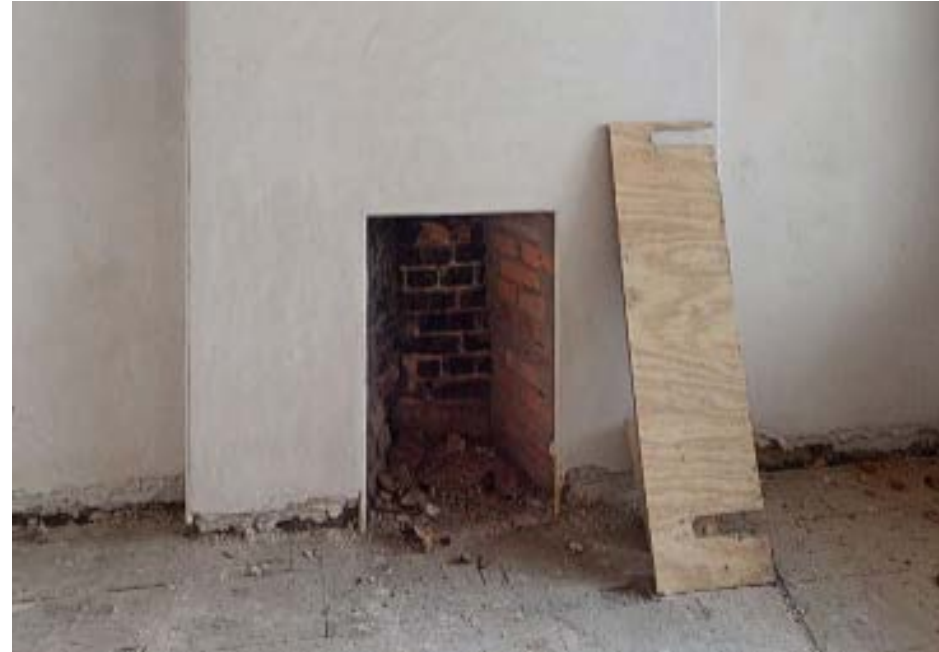
- *Fireplace*

Fireplace opening to be refurbished and retained as a feature. Top to be blocked off.

Work has been carried on site, however further investigations on the new plaster is required to confirm that works have been carried to a satisfactory standard.

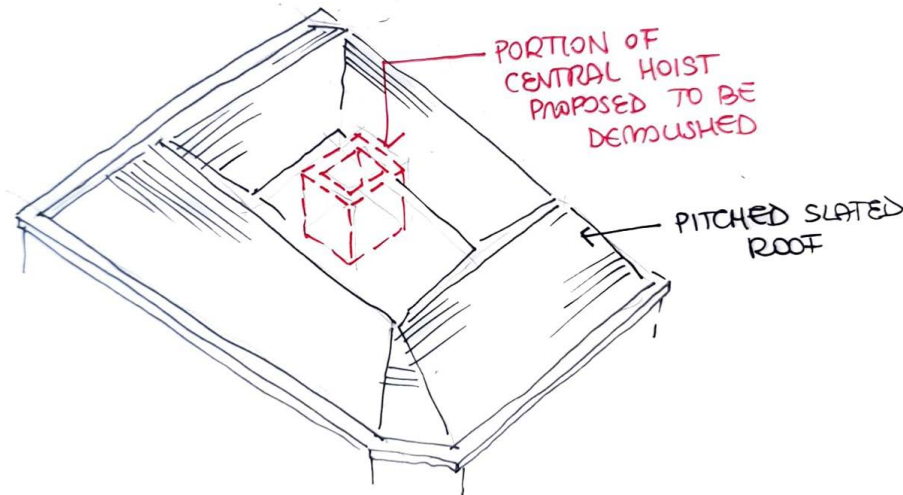
- Central lift hoist

To help with the location of required plants within the central flat roof area, the portion of the masonry hoist extending above roof level is proposed to be demolished. The cut is proposed to be done just below roof level.

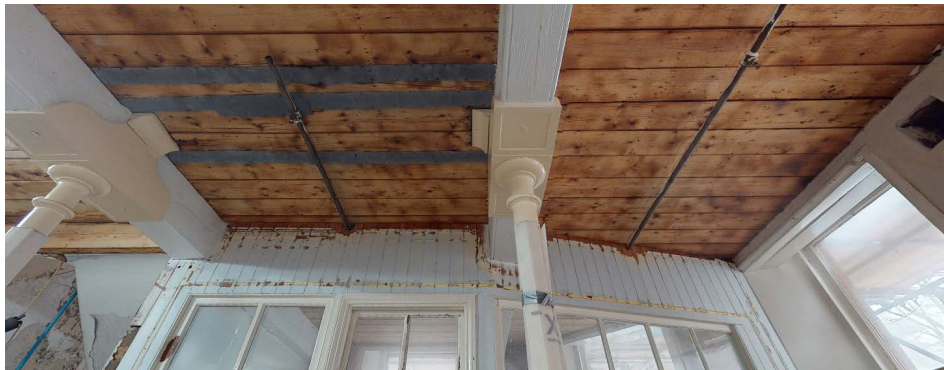
- Old sprinkler system

The communal pipes and valves are proposed to be retained, refurbished, and relocated as a feature. However, it has been observed that smaller elements of the system, such as the distribution pipes, have mostly been removed from the site, with only a small portion remaining. Those elements are in poor condition and are situated in locations that do not align with the fire strategy. Therefore, they are now proposed to be removed.

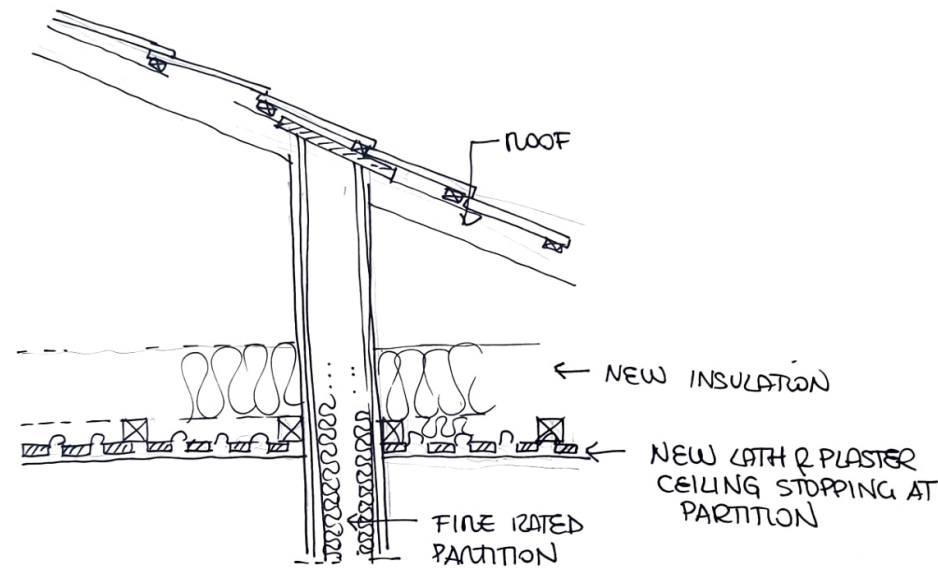
- 4th floor lath&plaster ceiling

The old lath&plaster ceiling at level 4 has now been removed, but is proposed to be reinstated as part of the proposal.

To comply with fire compartment requirements, fire-rated partitions will be constructed up to the roof level, and lath and plaster ceilings will extend between these walls.

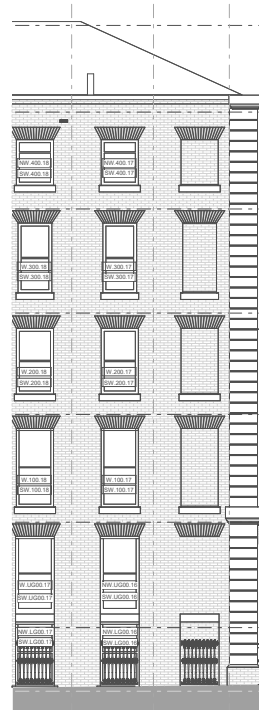
- Blind windows on Richmond St.

The line of blind windows on gridline M1, originally intended to be reopened, is now proposed to remain bricked off.

It has been determined that the bricked infill was part of the original design. Since there is no requirement for glazing in the proposed scheme, it is proposed to leave the windows as they currently exist.

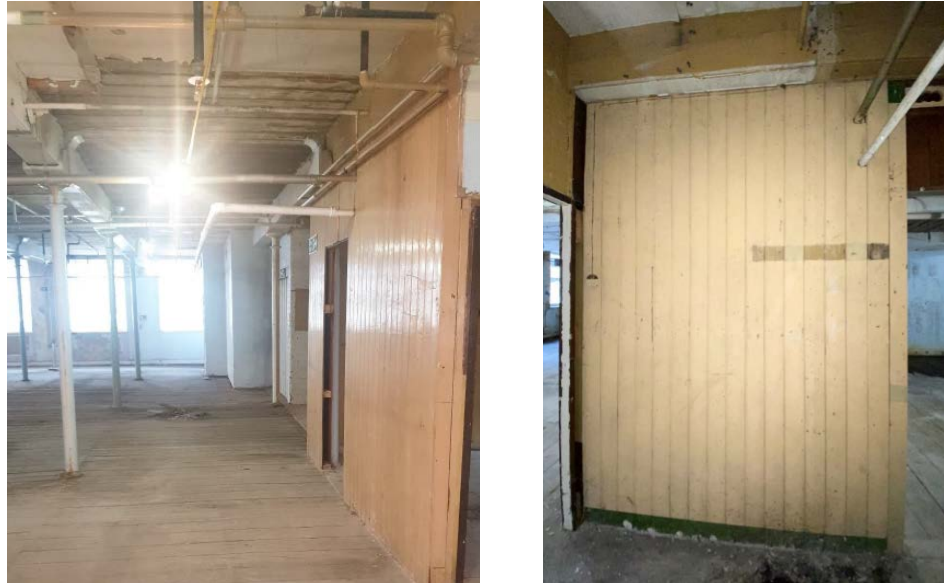
- *Timber panels (lost)*

Previously, it was noted that there were missing timber panels in Mindel House, identified in the approved proposal to be preserved as heritage features within corridors.

Upon reviewing heritage records, it has become evident that the timber elements indicated in the drawings were originally part of timber partitions, as depicted in the photographic records above. Unfortunately, these elements are now lost. However, due to their combustibility, it would not have been feasible to place them along escape corridors as previously proposed.

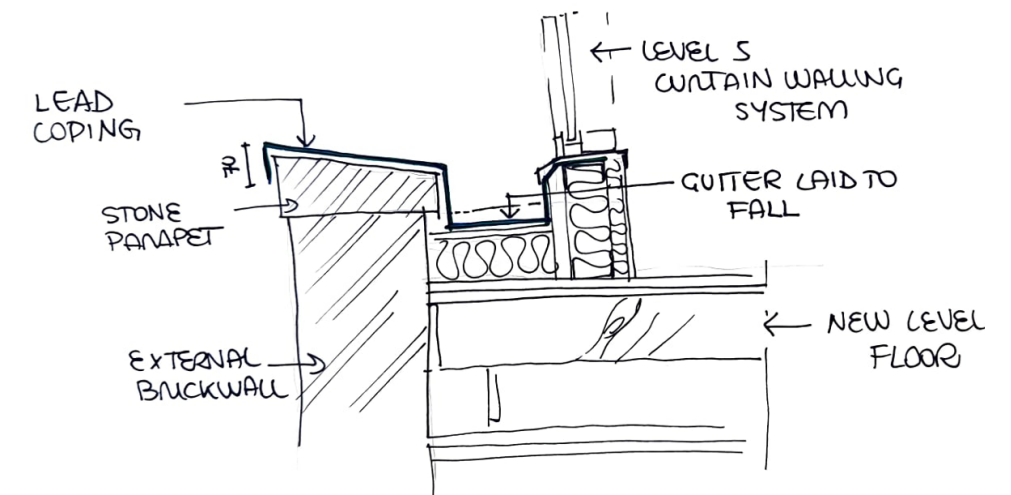
- *Stone parapet lead*

As per Mindel house, the stone parapet is proposed to be dressed with lead flashing to endure weather protection. The detail here is slightly different as it interfaces with a flat surface and the level 5 extension.
