NHS Manchester University

# Withington Hospital Stage 3 Arboricultural Method Statement

2485237

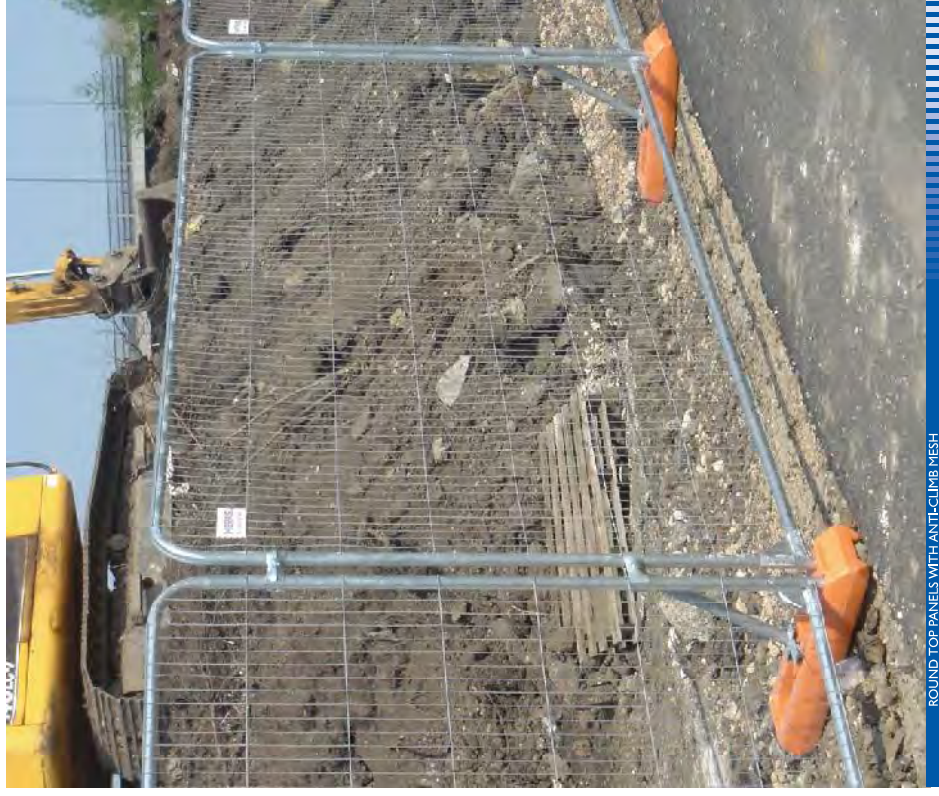
ROUND TOP PANELS WITH ANTI-CLIMB MESH

Our latest solution for securing site perimeters and protecting the public has been phenomenally successful since its launch, and offers the ultimate market leading temporary fencing system.

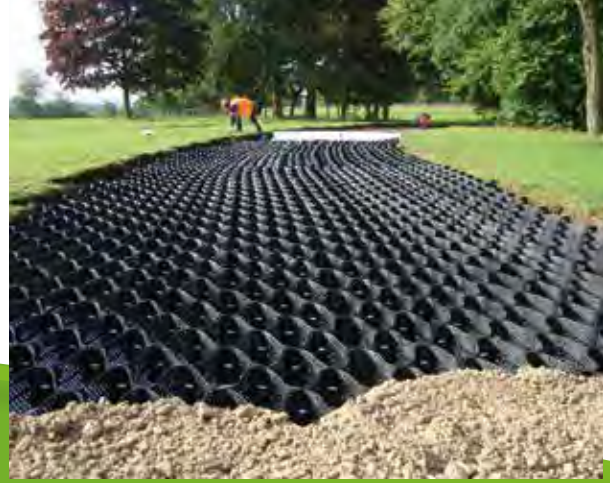
## LOAD DISTRIBUTION

By distributing and bridging applied loads, the GEOWEB® TRP system reduces vertical stresses that are typically applied to the underlying soil and root zone.

The GEOWEB® system is ideally suited for tree root protection applications where weak subsoil or no-dig restrictions exist.

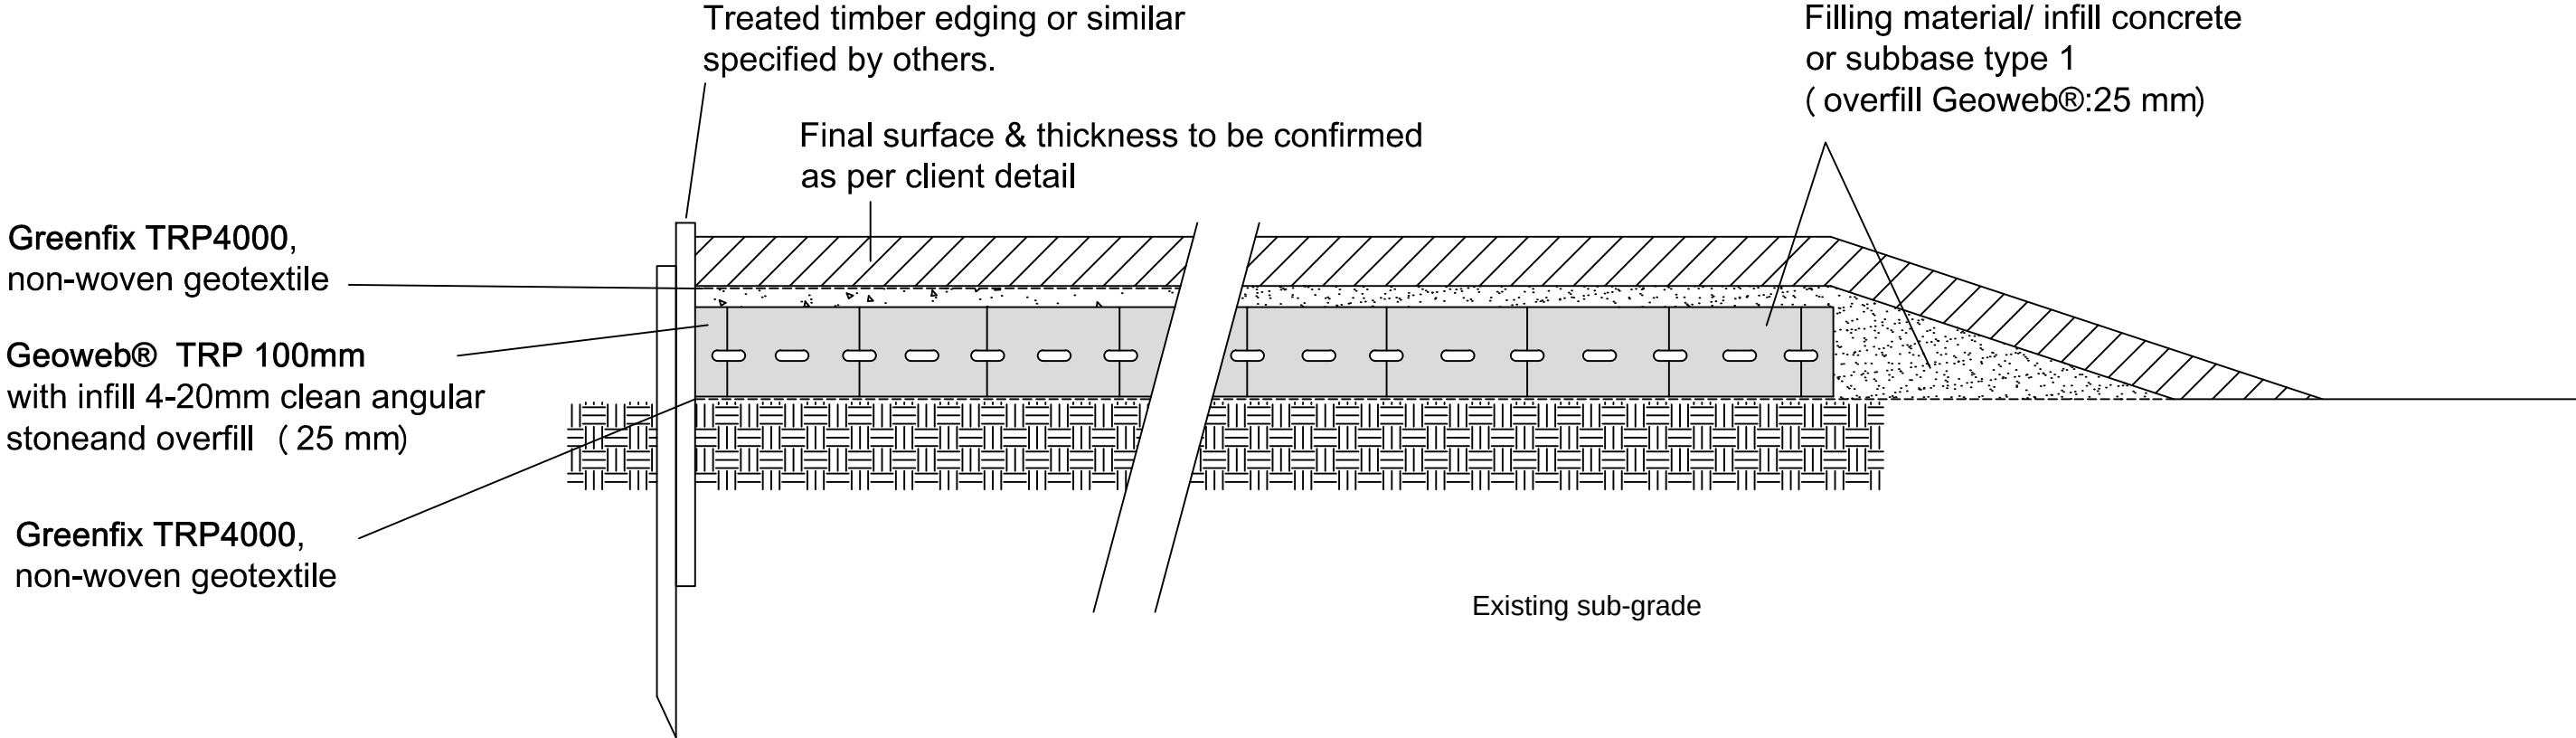
Note: 3 or 4 cells filled with concrete or subbase type 1

Adjacent Geoweb units to be joined with Atra-keys.
