# PICCADILLY WAREHOUSE

Mindel House & Bloom Street

Design and Access Statement Addendum

Section 73/19

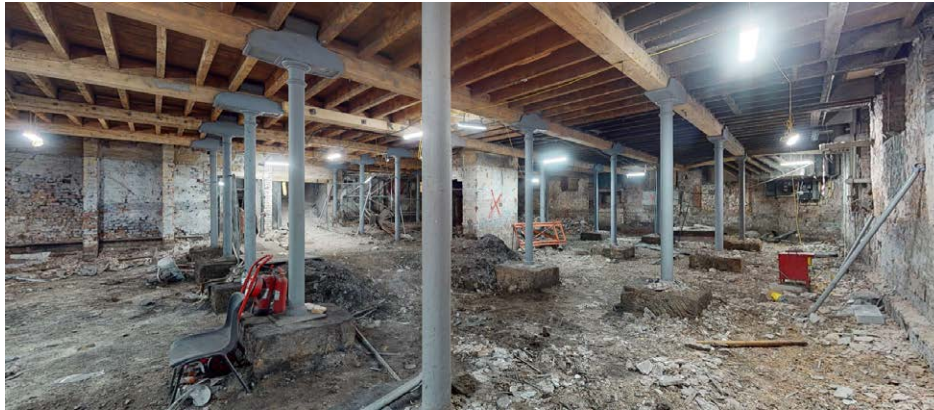
#### Lower Ground floor

- Existing floor removed and to be rebuilt
- Proposed demolition of internal partitions completed
- Brickwalls to be cleaned prior to receive tanking
- Blocked-off windows reopened

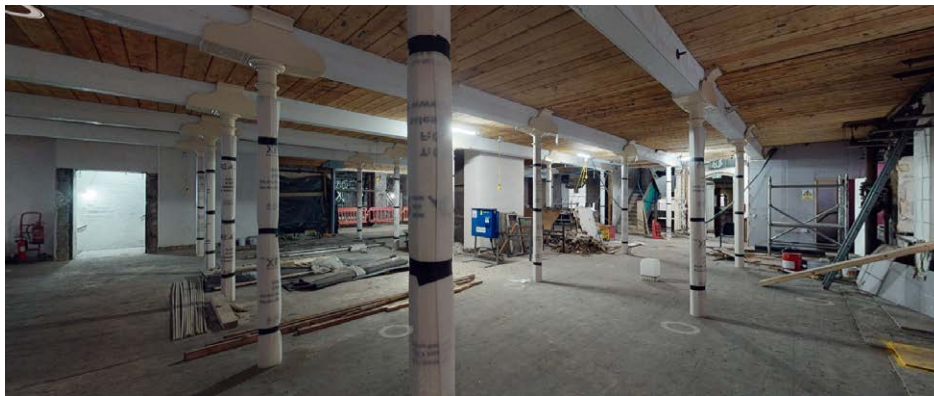
#### Upper Ground Floor

- Windows and their surroundings to be refurbished
- Some plastering repair carried. Localised reopening required to check that remedial works underneath have been carried.
- Plastering to be completed - use of heritage plaster required.
- Columns and beams intumescent painted - work completed
- New windows to alleyway facade to be manufactured and installed.
- Floor replacement work done. Contractor to assess if has been done to a satisfactory standard.

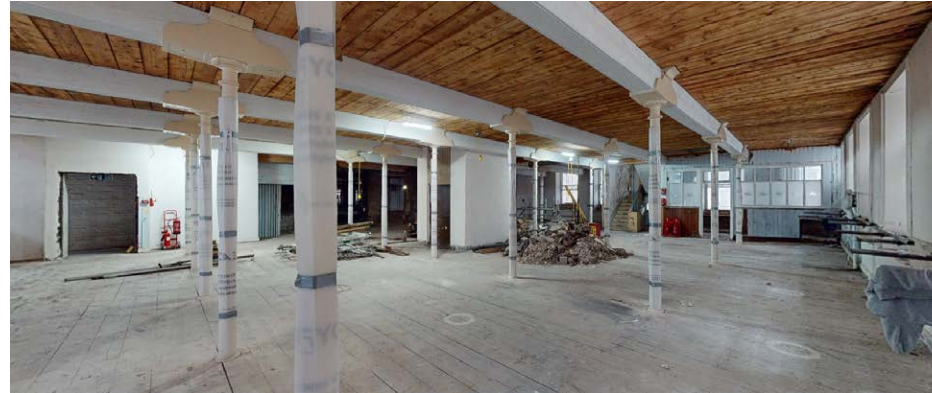
#### First Floor

- Windows and their surroundings to be refurbished
- Most plastering repair carried. Localised reopening required to check that remedial works underneath have been carried out.
- Plastering to be completed - use of heritage plaster required.
- Columns and beams intumescent painted - work completed.
- New windows to alleyway facade to be manufactured and installed.
- Lath&plaster wall wrongly demolished to be reconstructed.
- Floor replacement work done. Contractor to assess if has been done to a satisfactory standard.

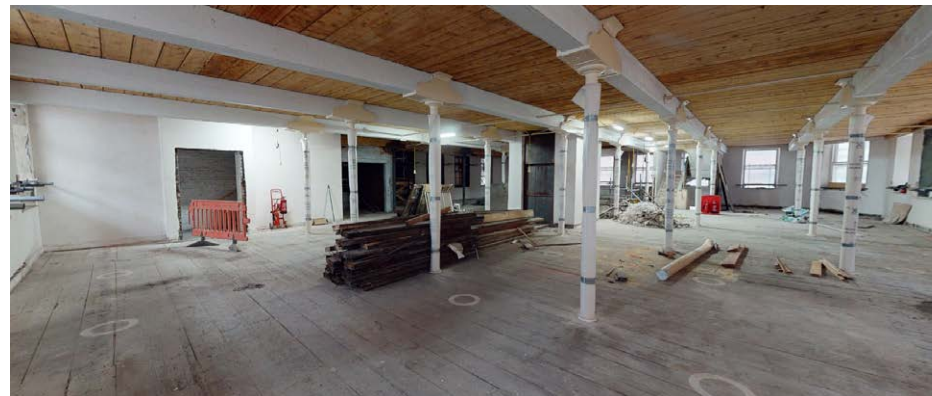
#### Second Floor

- Windows and their surroundings to be refurbished
- Most plastering repair carried. Localised reopening required to check that remedial works underneath have been carried out.
- Plastering to be completed - use of heritage plaster required.
- Columns and beams intumescent painted - work completed.
- New windows to alleyway facade to be manufactured and installed.
- Floor replacement work done. Contractor to assess if has been done to a satisfactory standard.

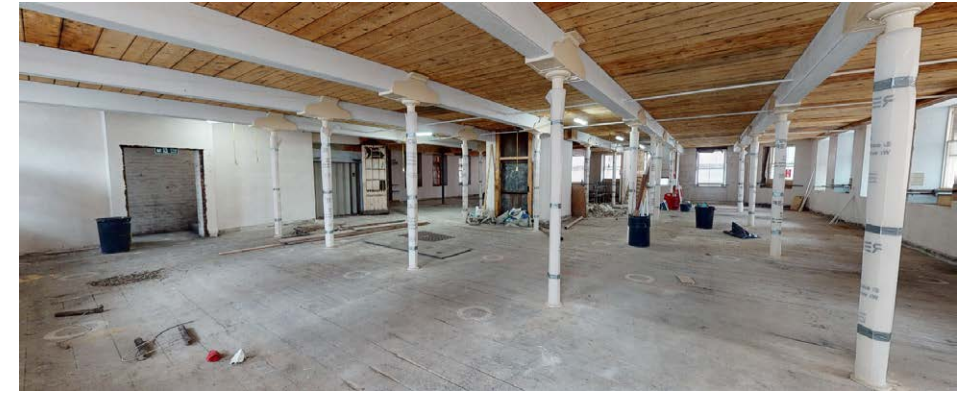
#### Third floor

- Windows and their surroundings to be refurbished
- Most plastering repair carried. Localised reopening required to check that remedial works underneath have been carried out.
- Plastering to be completed - use of heritage plaster required.
- Columns and beams intumescent painted - work completed.
- New windows to alleyway facade to be manufactured and installed.
- Floor replacement work done. Contractor to assess if has been done to a satisfactory standard.

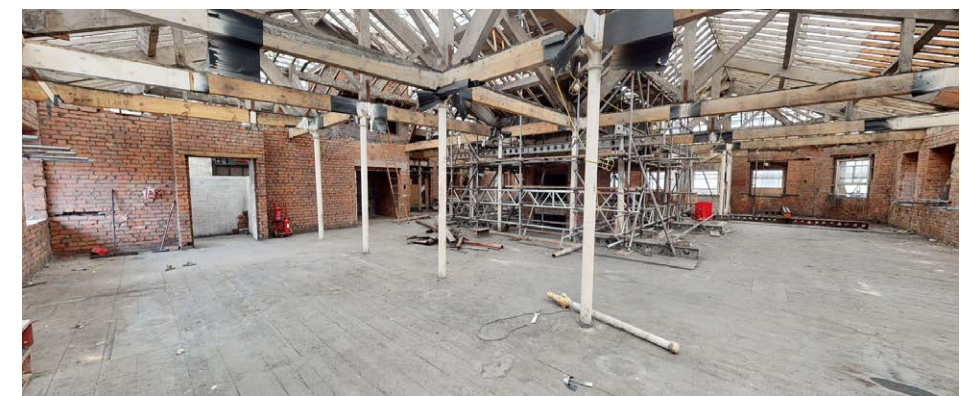
#### Fourth floor + roof

- Roof slates removed. Roof slates to be reinstalled with vapour permeable membrane underneath
- Windows and their surroundings to be refurbished
- All walls to be plastered - use of heritage plaster required.
- Columns and beams to be intumescent painted.
- Lath&plaster ceiling to be reconstructed thoroughout

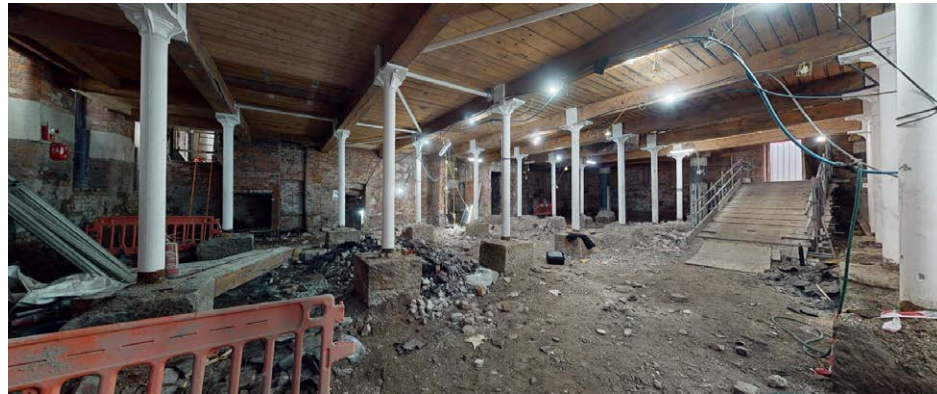
## Lower Ground floor

- Existing floor removed and to be rebuilt
- Proposed demolition of internal partitions completed
- Brickwalls cleaned ready to receive tanking
- Blocked-off windows reopened
- Structural alterations carried out.

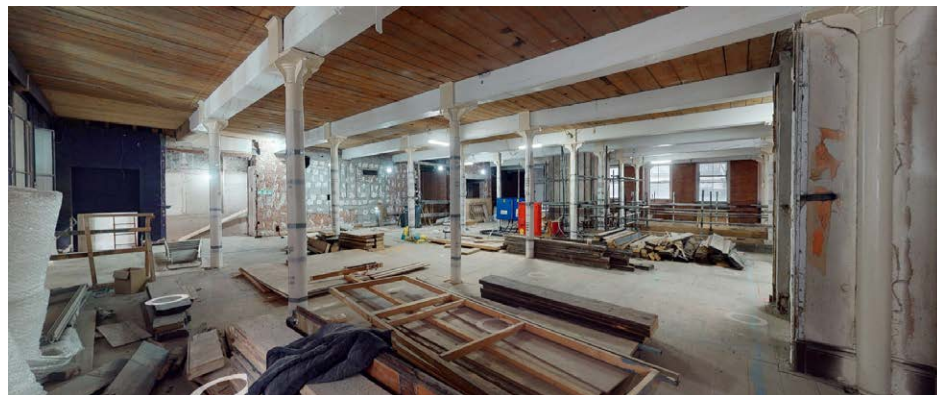
## Upper Ground Floor

- Windows to be refurbished
- Floor infill still required in some areas
- Columns and beams intumescent painted - work completed
- Shaft opening works completed.
- Structural alterations to alleyway to be done

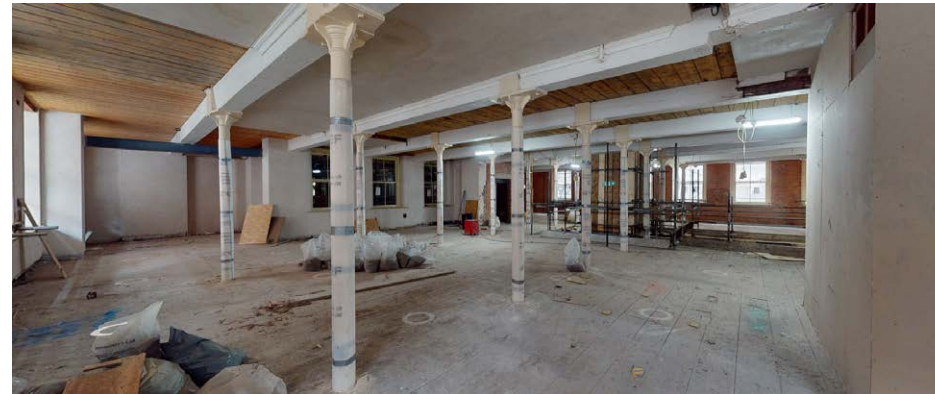
## First Floor

- Windows refurbishment - Aprox. 50% done however fixing method needs to be revised.
- Columns and beams intumescent painted - work completed
- Shaft opening works completed.
- Heritage plastering works complete. Localised reopening required to check that remedial works underneath have been carried out.
- Replacement of steel beam completed
- Brickwork repointing and cleaning completed.
- Structural alteration to safe brickwall to be carried out.

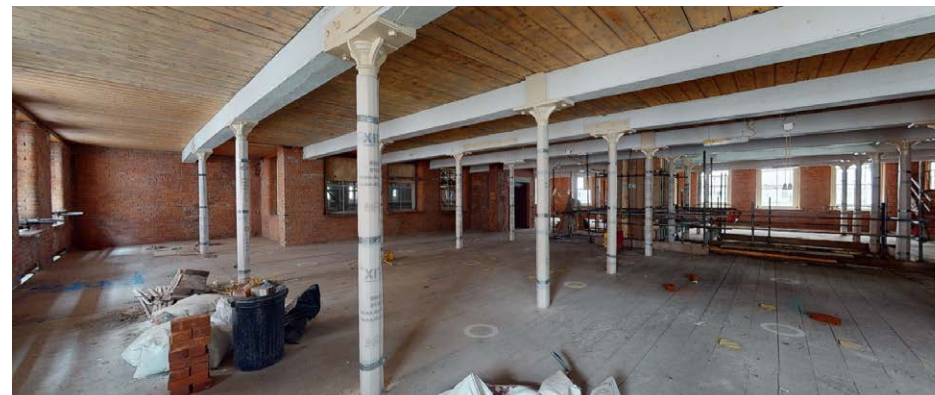
## Second Floor

- Windows refurbishment - Aprox. 50% done however fixing method needs to be revised.
- Columns and beams intumescent painted - work completed
- Shaft opening works completed.
- Brickwork repointing and cleaning completed.

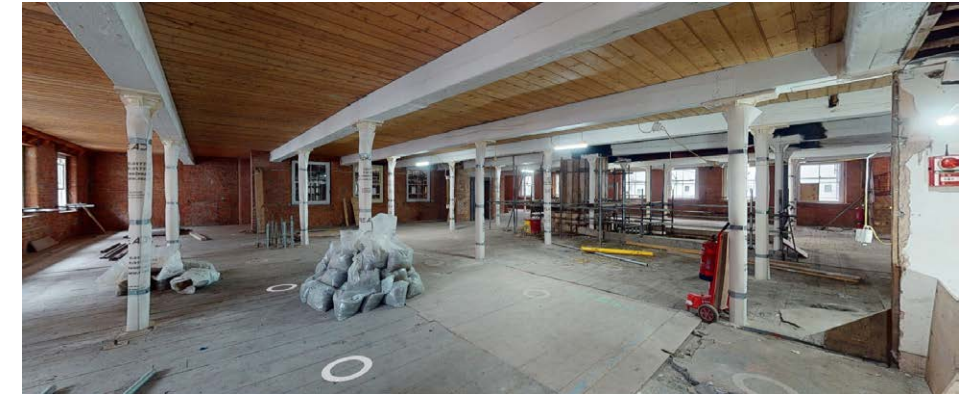
## Third Floor

- Windows refurbishment - Aprox. 50% done however fixing method needs to be revised.
- Columns and beams intumescent painted - work completed
- Shaft opening works completed.
- Brickwork repointing and cleaning completed.

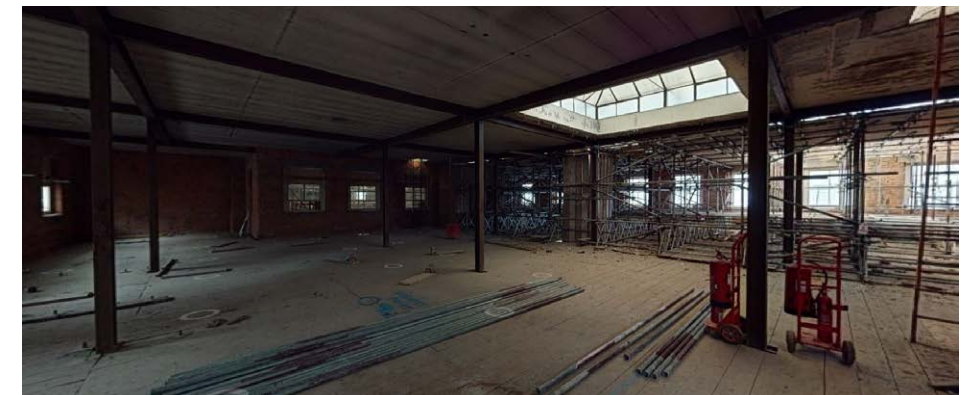
## Fourth Floor

- Windows to be refurbished
- Roof to be fully demolished - work partially done.
- Steel columns to be removed.
- Brickwork repointing and cleaning partially completed.

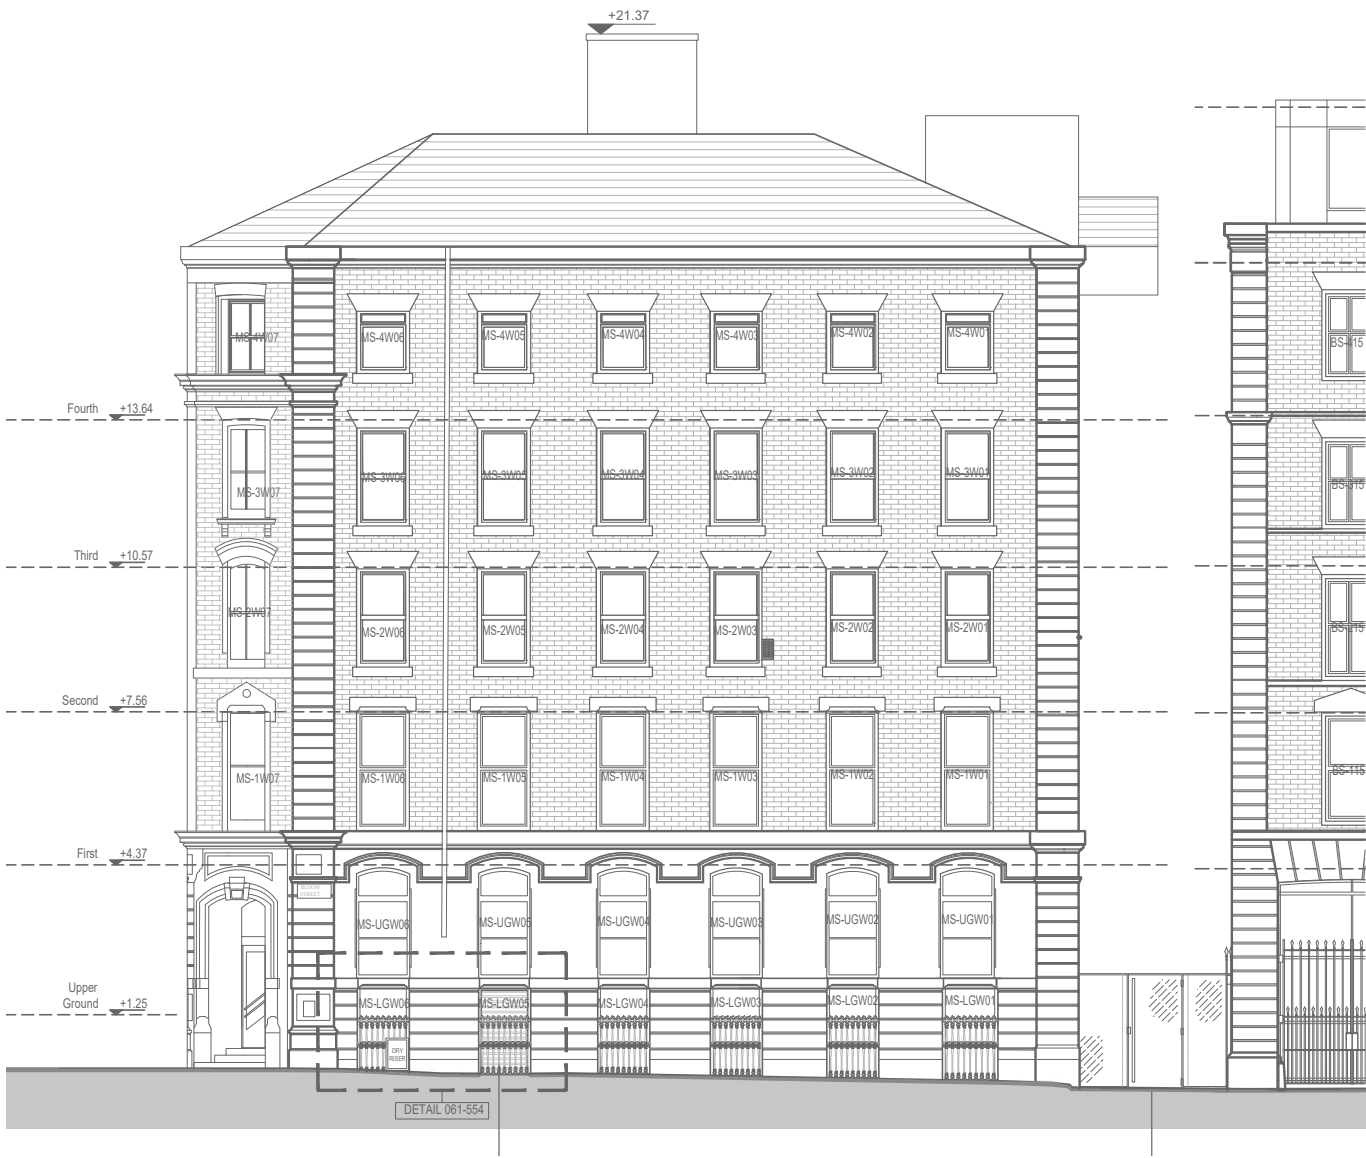
## Mindel House. North West Elevation

**A** Masonry Hoist: Proposed to be cut below central flat roof level to make space for required plants.

**B** Ventilation grills:  
According to the ventilation strategy, MVHR units require supply and extract duct to penetrate the existing facade. New holes are approx. 200x200mm.  
It is therefore proposed to introduce 250x250 cast iron ventilation grills, with the design aligned with grills existing on site.

**B** A.O.V Hatch: Approved location above lobby not functional. Proposed to be relocated above stairs.

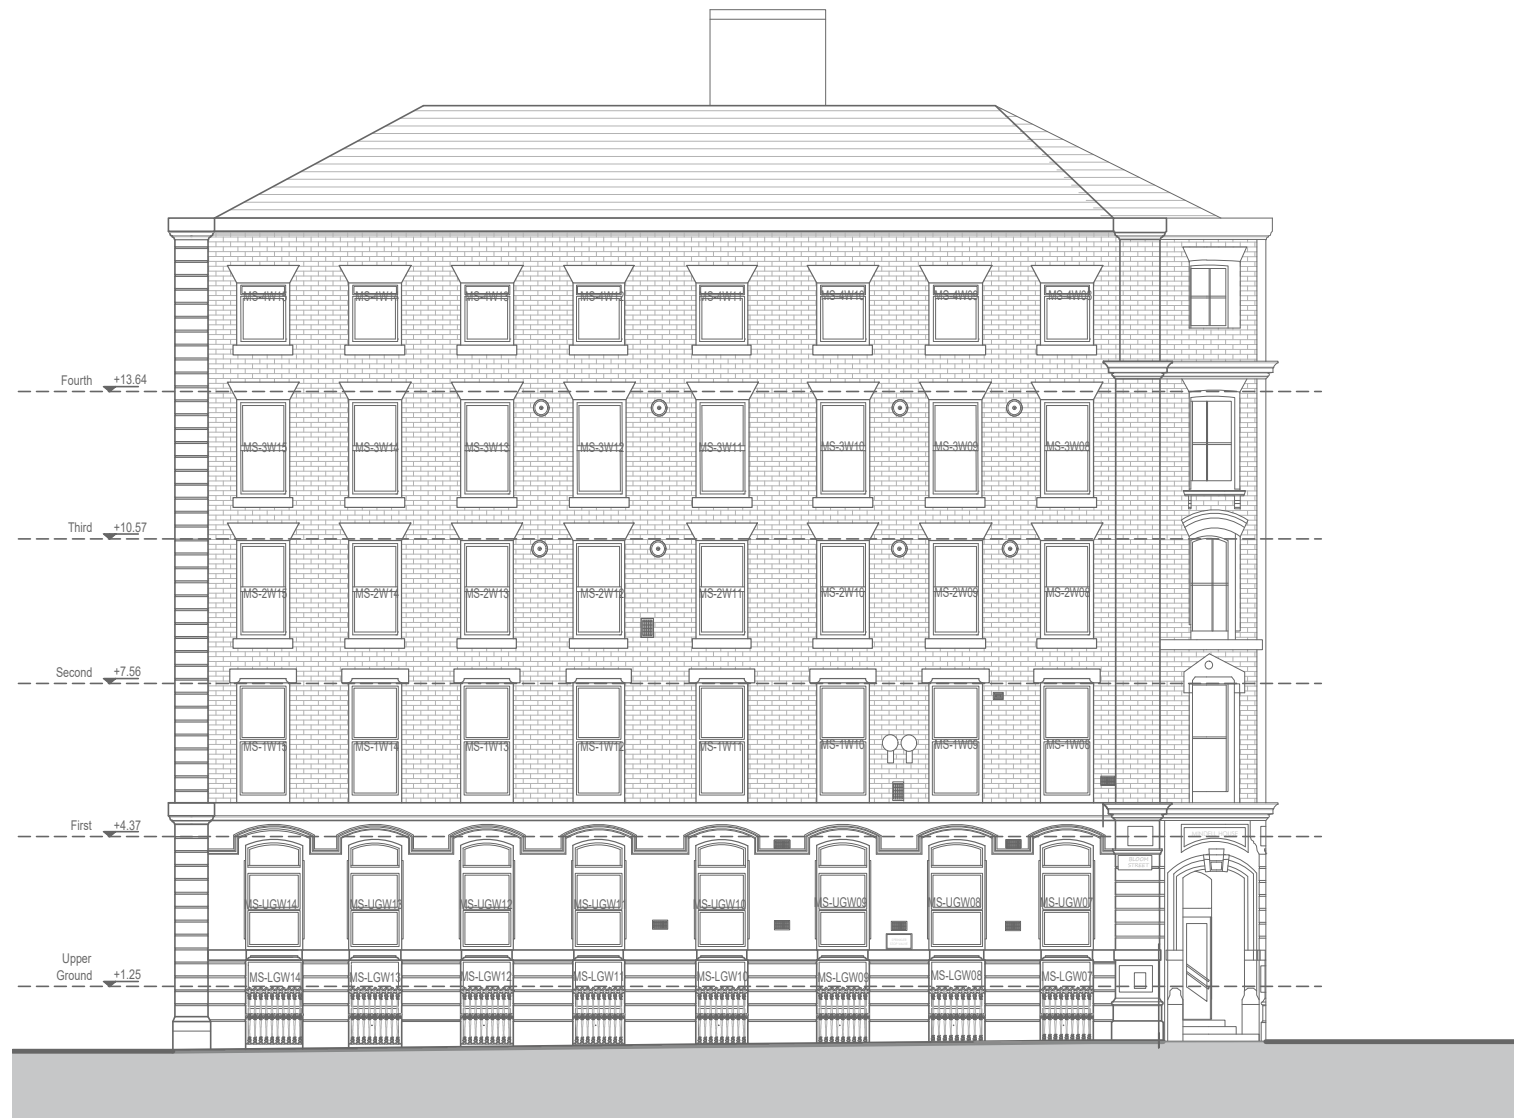
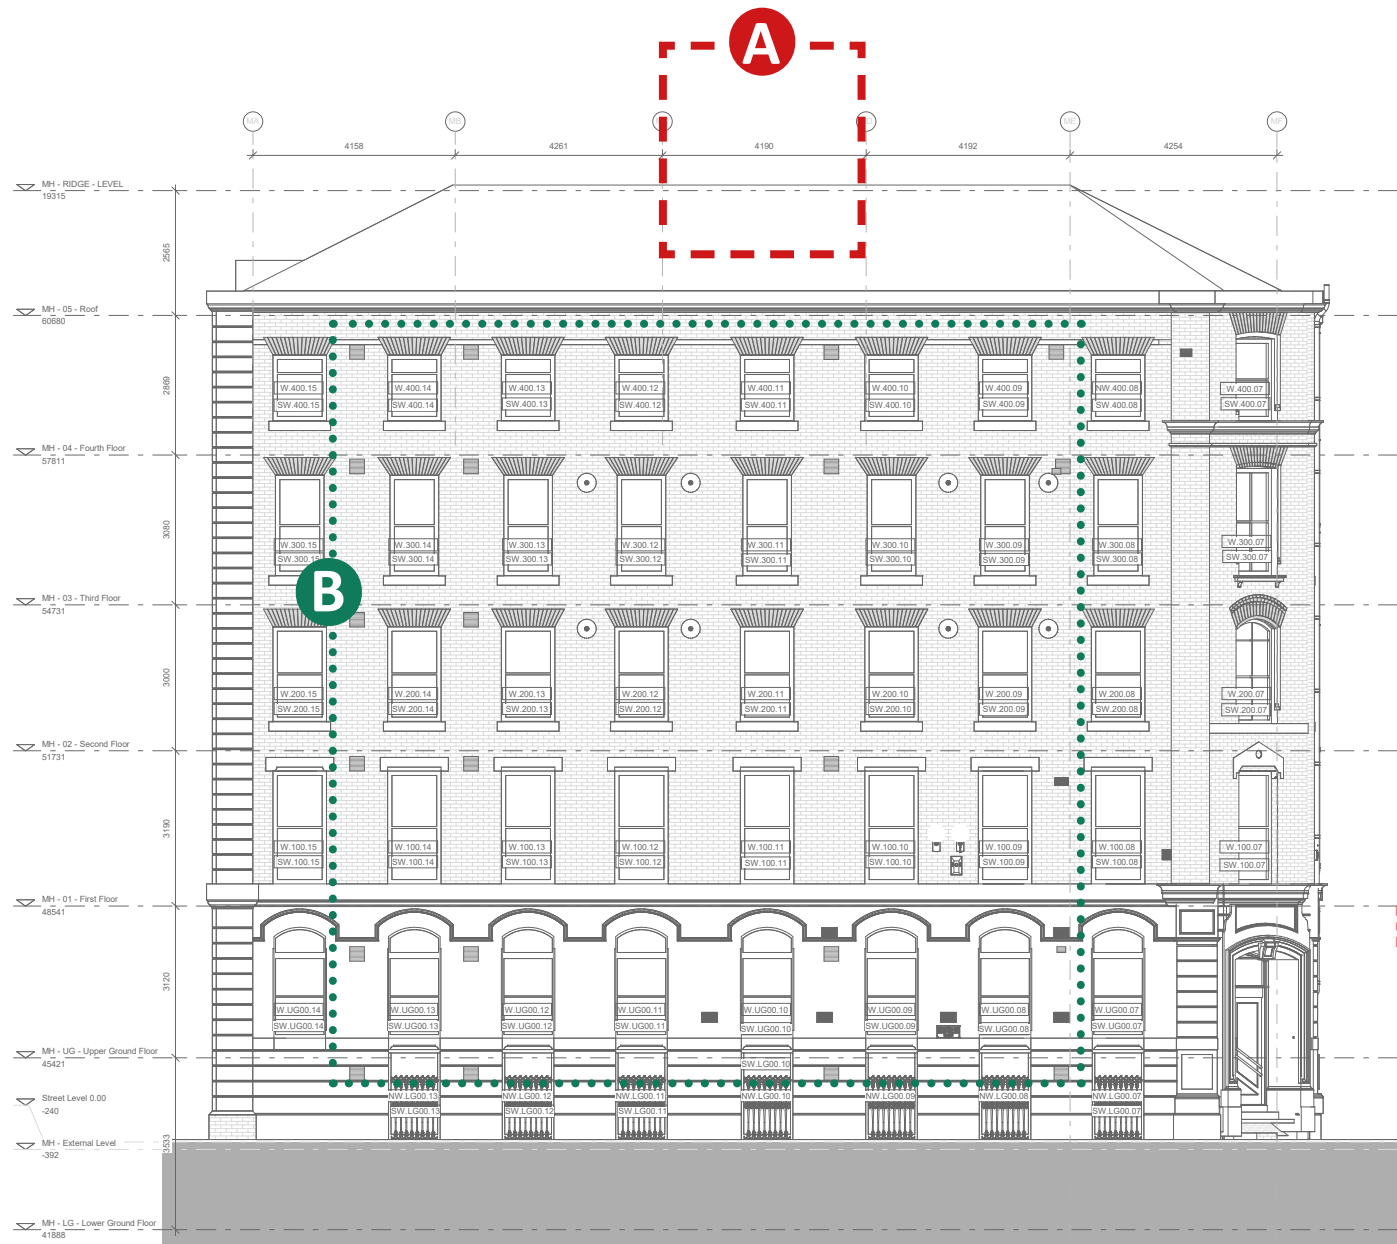
Mindel House. North East Elevation

**A** Masonry Hoist: Proposed to be cut below central flat roof level to make space for required plants.

**B** Ventilation grills:  
According to the ventilation strategy, MVHR units require supply and extract duct to penetrate the existing facade. New holes are approx. 200x200mm.  
It is therefore proposed to introduce 250x250 cast iron ventilation grills, with the design aligned with grills existing on site.

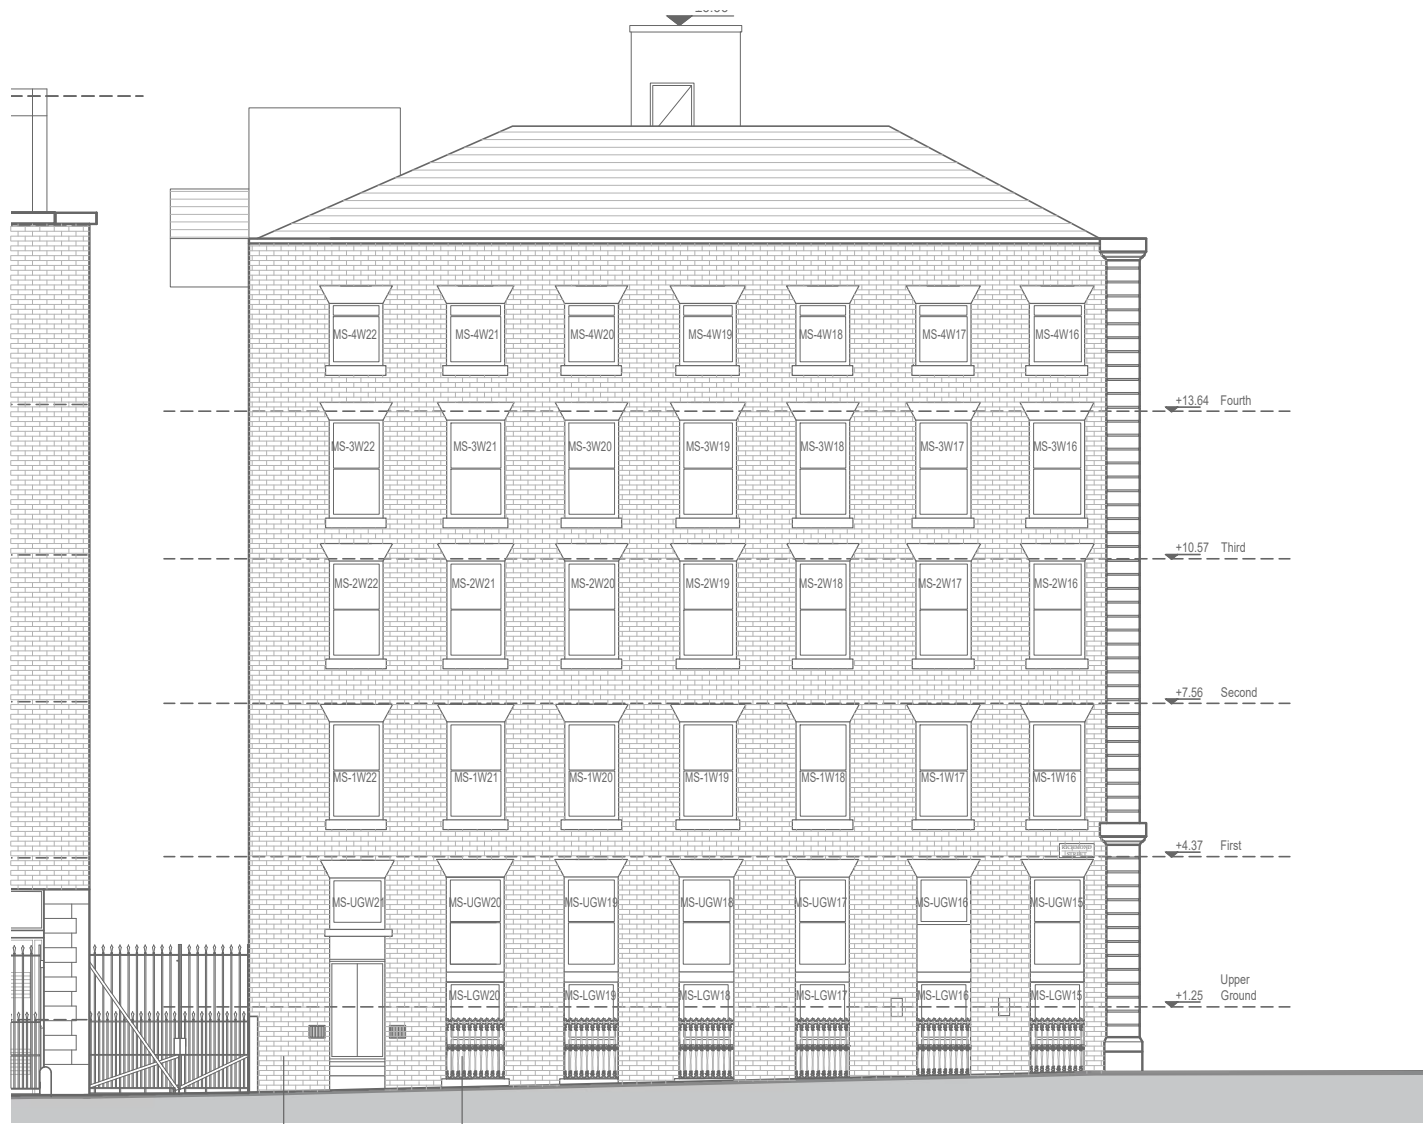
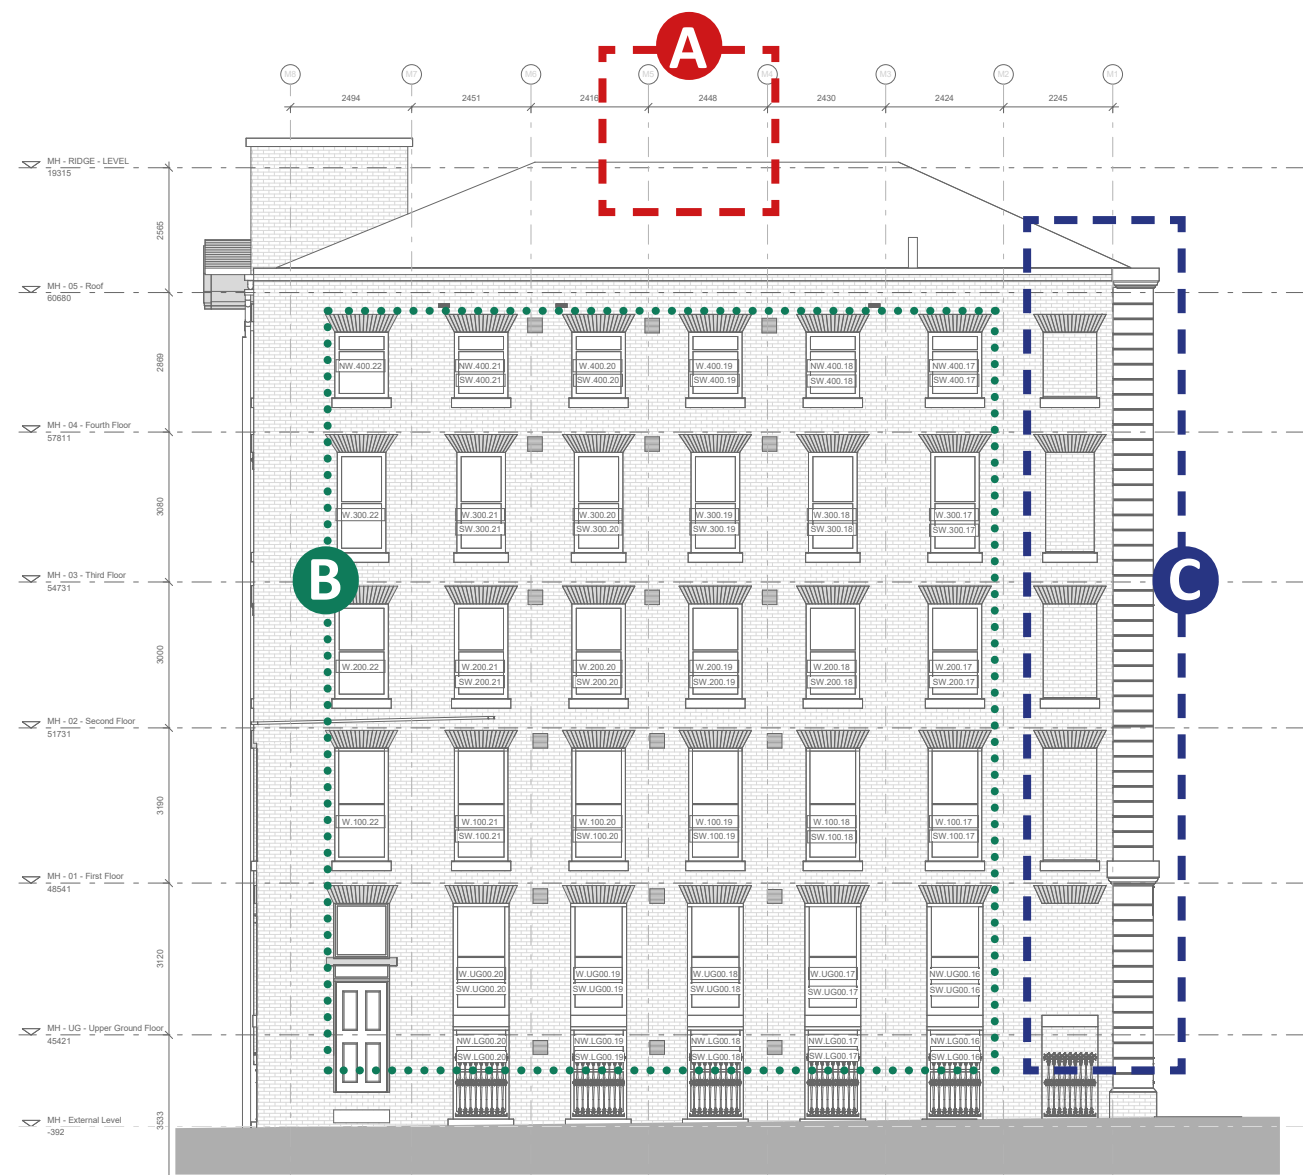
Mindel House. South East Elevation

**A** Masonry Hoist: Proposed to be cut below central flat roof level to make space for required plants.

**B** Ventilation grills: According to the ventilation strategy, MVHR units require supply and extract duct to penetrate the existing facade. New holes are approx. 200x200mm. It is therefore proposed to introduce 250x250 cast iron ventilation grills, with the design aligned with grills existing on site.

**C** Blocked windows: Proposed to be opened in approved scheme, however their brickwork infill appears to be part of original design and therefore is proposed to be kept in place.

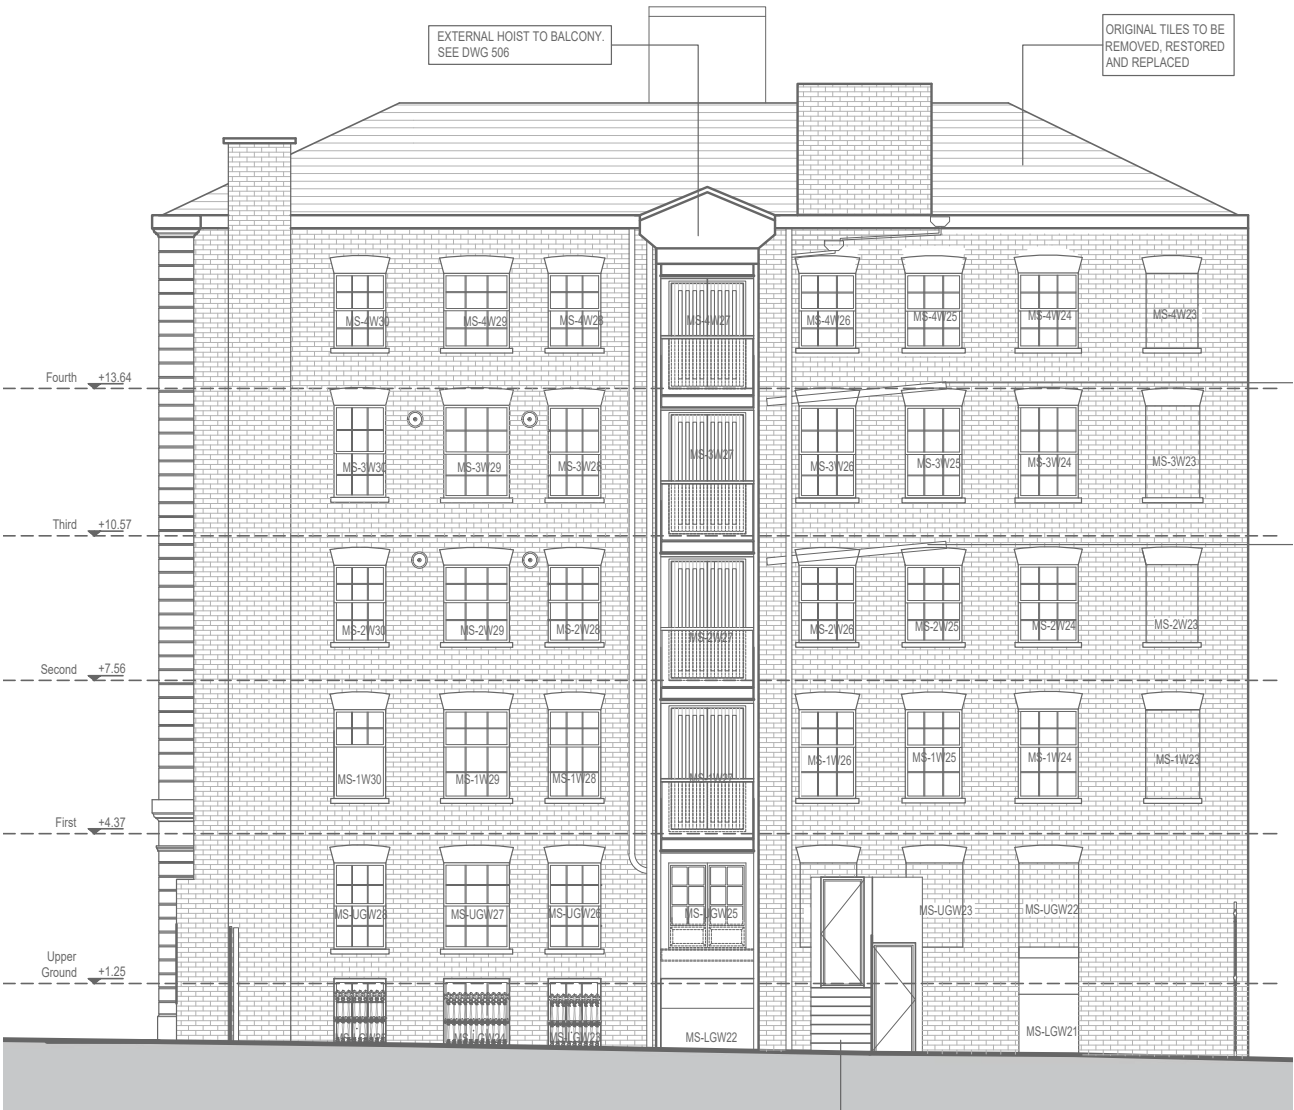
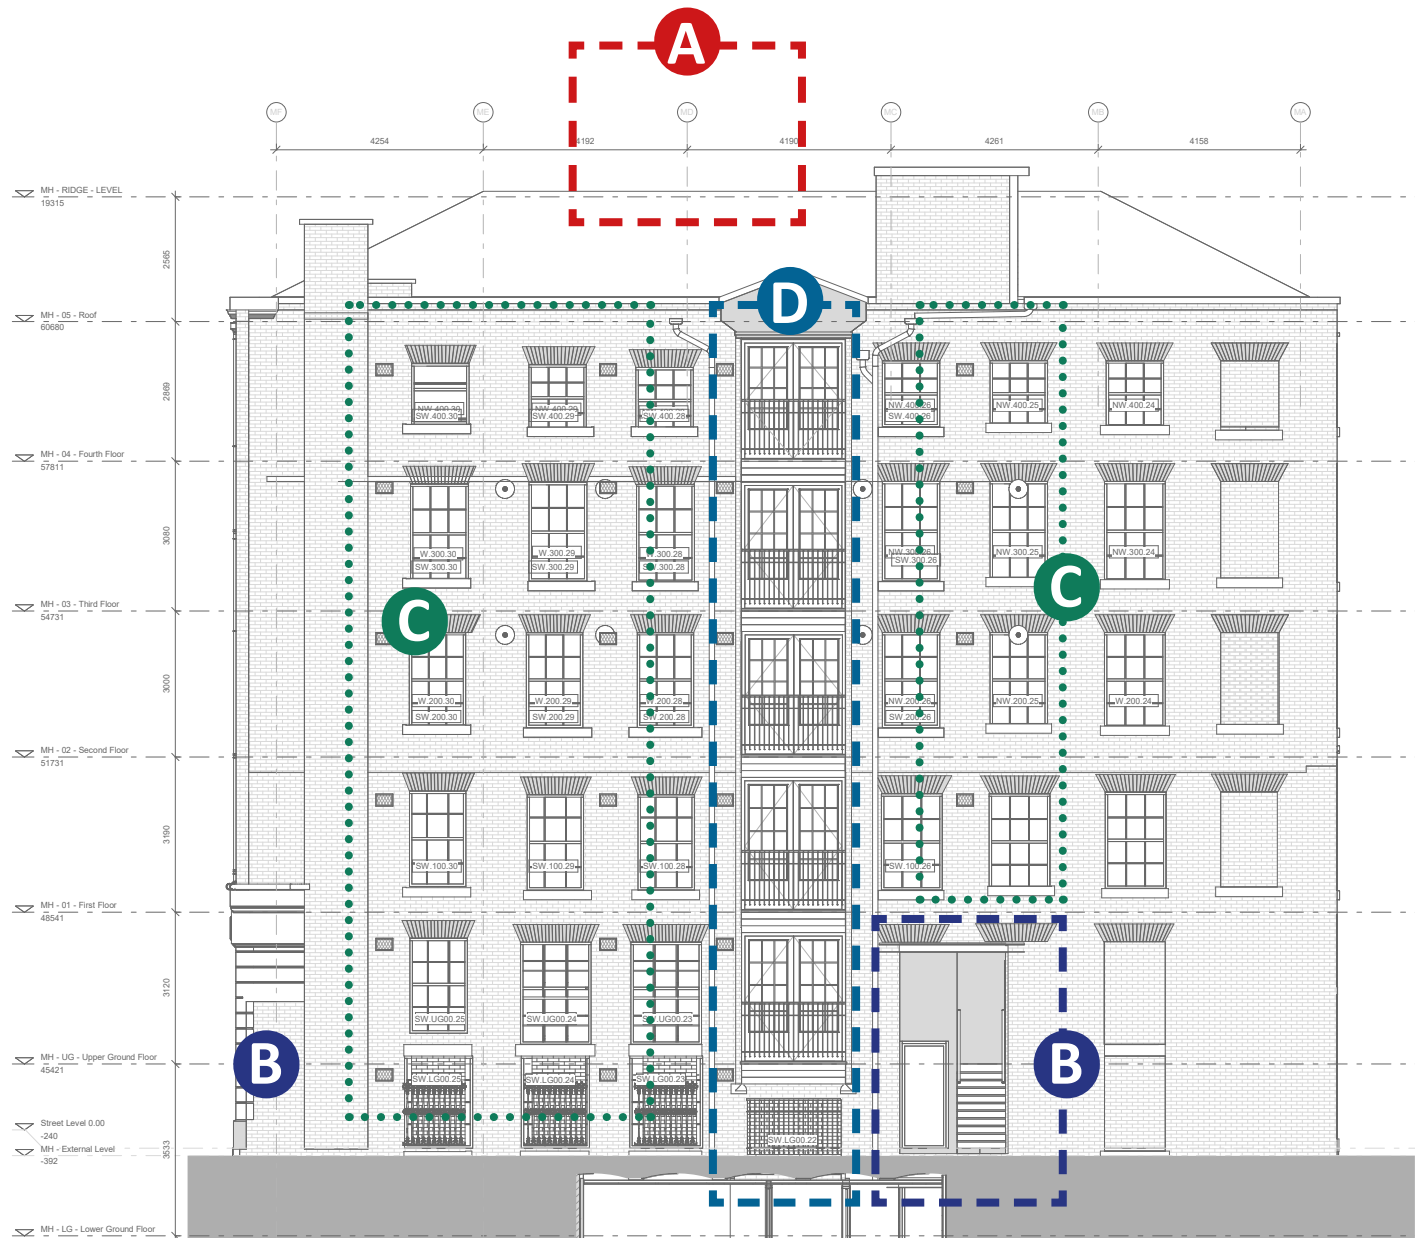
Mindel House. South West Elevation

**A** Masonry Hoist: Proposed to be cut below central flat roof level to make space for required plants.

**B** Alleyway entrance: Design revised to fit area (now surveyed) with finishes for new elements now coordinated with Bloom Street Alleyway entrance.

**C** Ventilation grills: According to the ventilation strategy, MVHR units require supply and extract duct to penetrate the existing facade. New holes are approx. 200x200mm. It is therefore proposed to introduce 250x250 cast iron ventilation grills, with the design aligned with grills existing on site.

**D** Hoist doors: Now following the design of original timber and glazed double doors found in place at level 3 hidden behind solid timber panels. New elements will be in timber with slim double thin glazing. External balustrades required. Minimalist design.

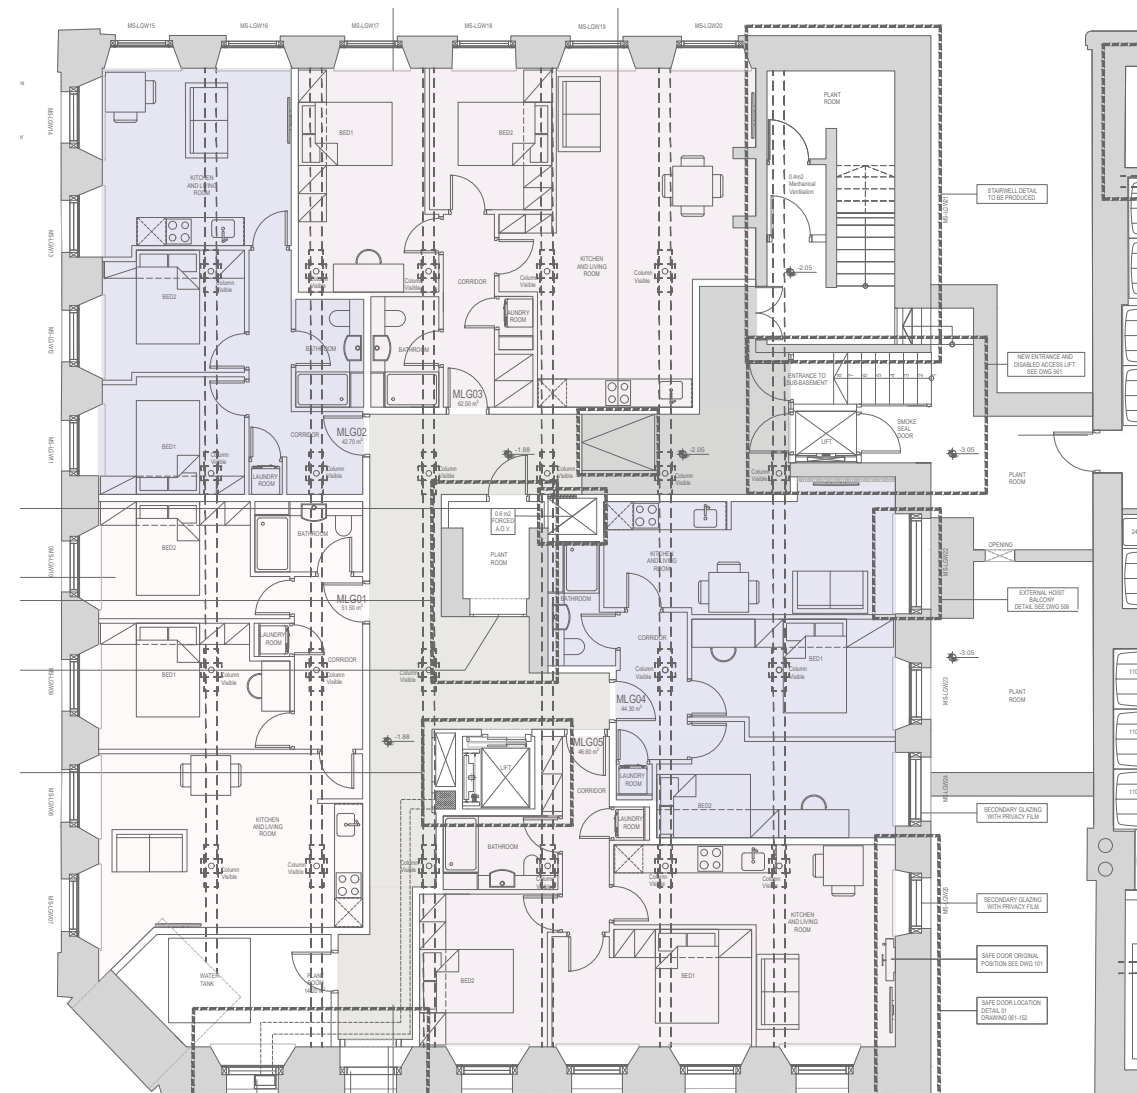
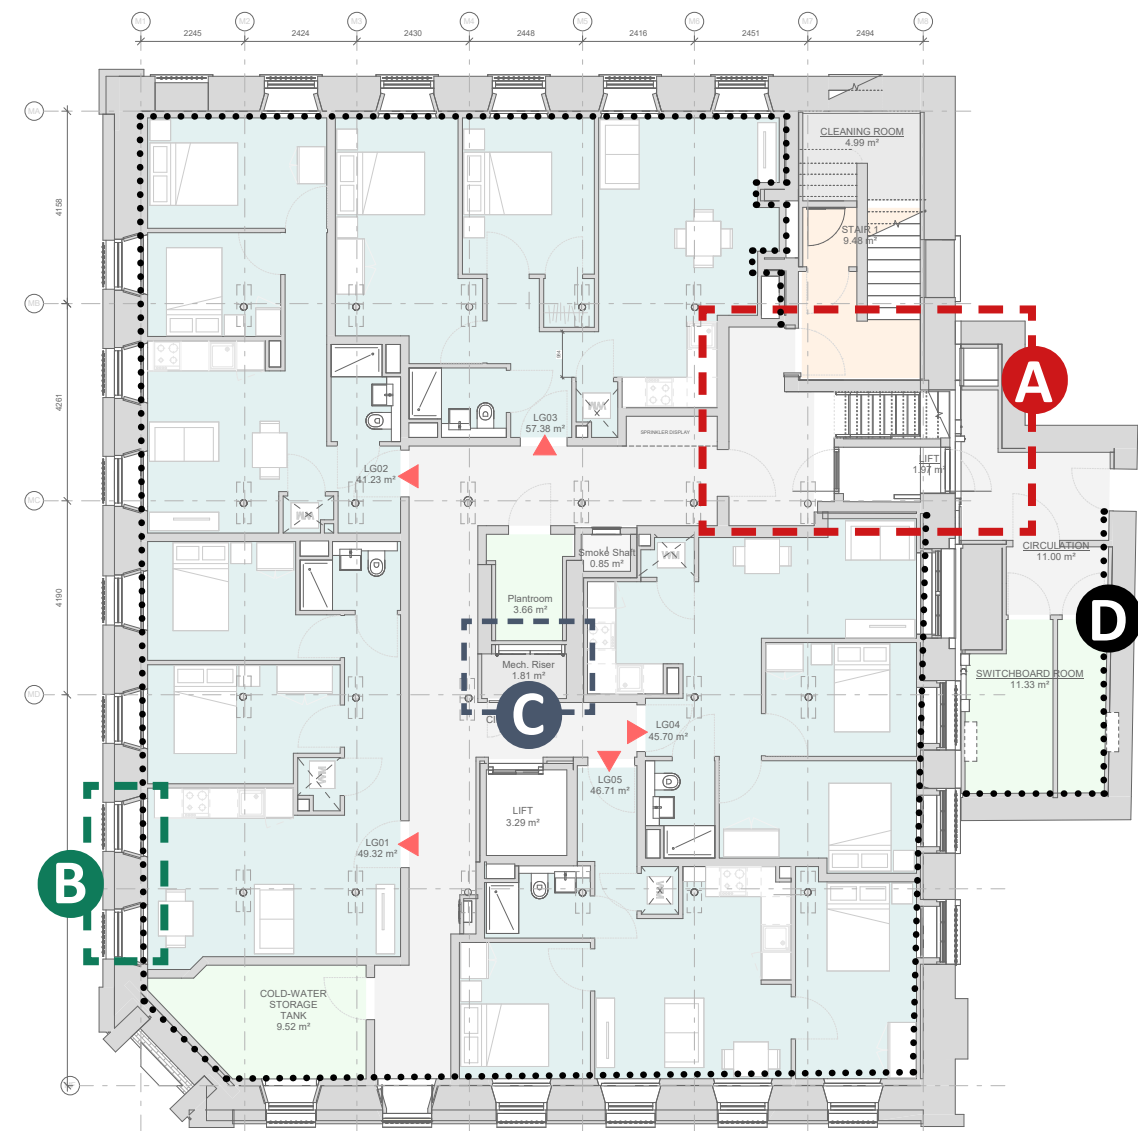
Mindel House. Lower Ground Floor

- Apartment layout: Improved efficiency and open plan arrangement where possible.

- A** Basement entrance: Design revised to fit area (now surveyed)
- B** Historic sprinkler valves+pipes: Now proposed to be refurbished and relocated within communal corridor
- C** Plantroom: Mechanical plant added for functional reasons.
- D** Tanking system

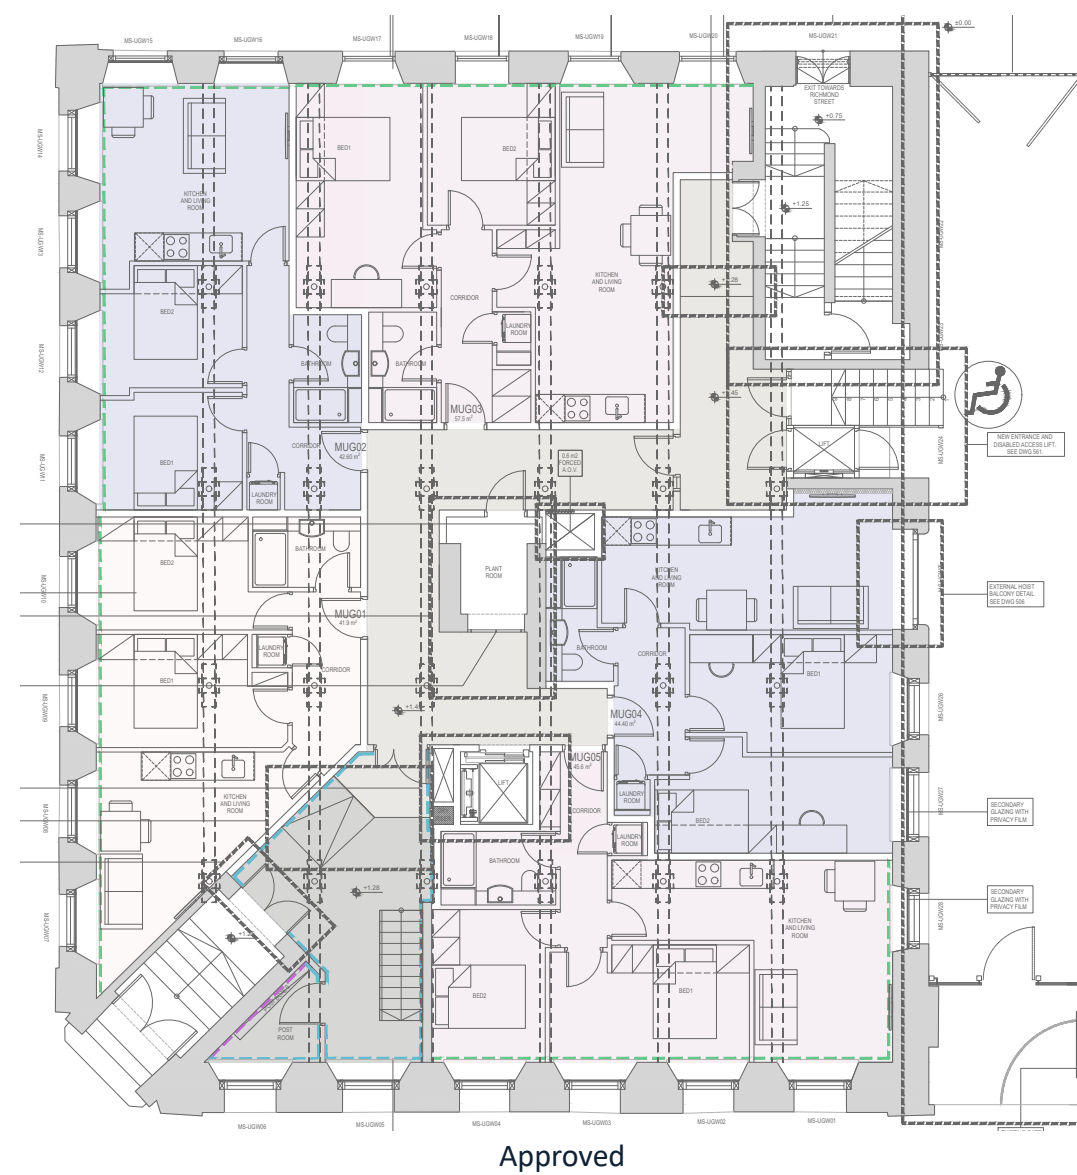
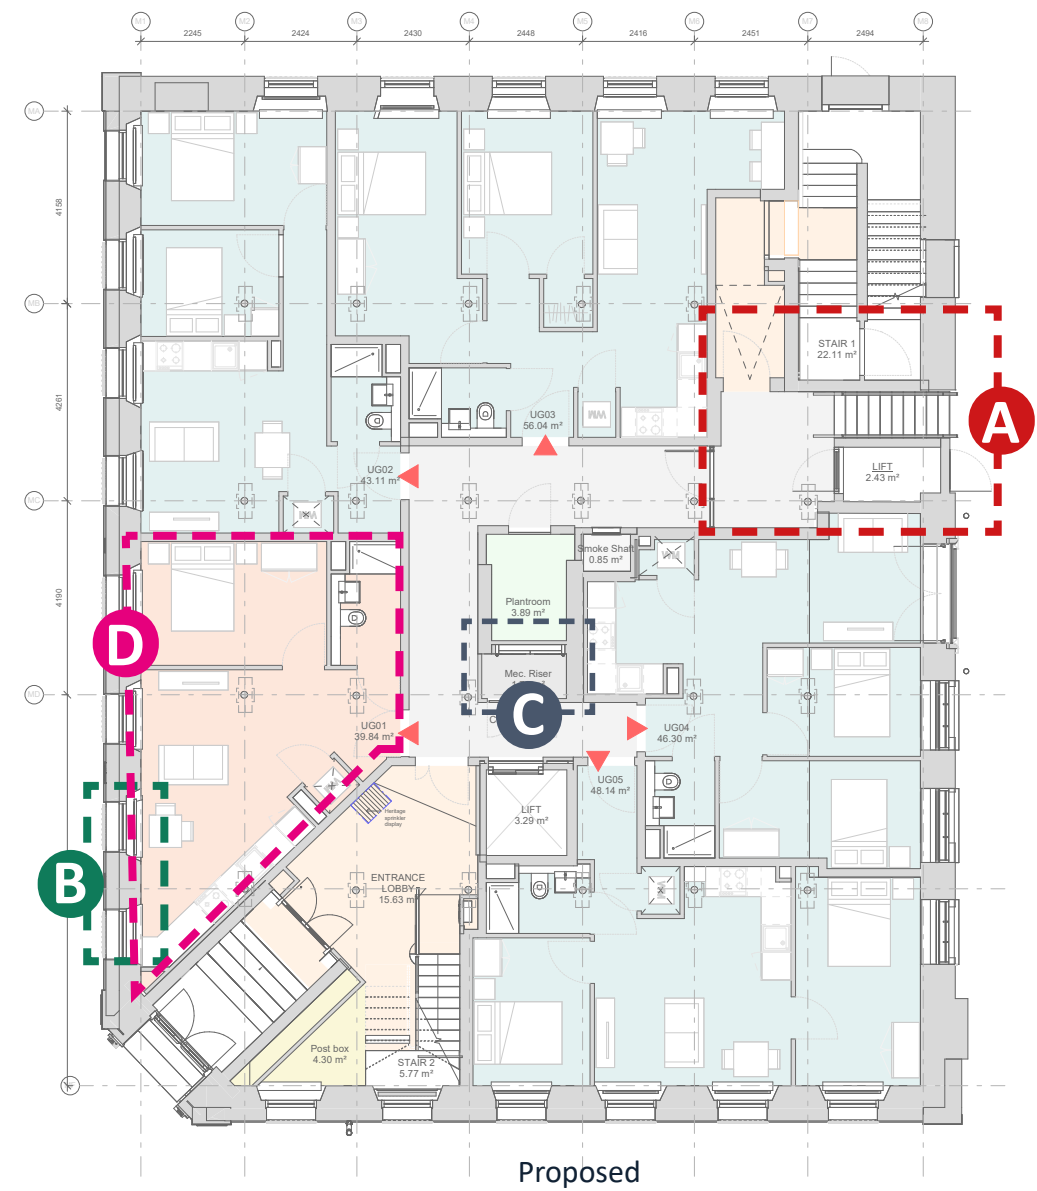
Mindel House. Upper Ground Floor

- Apartment layout: Improved efficiency and open plan arrangement where possible.
- Main stair handrail: to be upgraded to comply with minimum height requirement. Additional top rail required possibly without interfering with original balustrade.

**A** Alleyway entrance: Design revised to fit area (now surveyed) with finishes for new elements now coordinated with Bloom Street Alleyway entrance.

**B** Historic sprinkler valves+pipes: Now proposed to be refurbished and relocated within stair lobby

**C** Plantroom: Mechanical plant added for functional reasons.

**D** Apartment reconfiguration: Approved 2 Bedroom apartment redesigned to 1 Bedroom to provide a suitable kitchen/living space.
