# PICCADILLY WAREHOUSE

Mindel House & Bloom Street

Design and Access Statement Addendum

Section 73/19

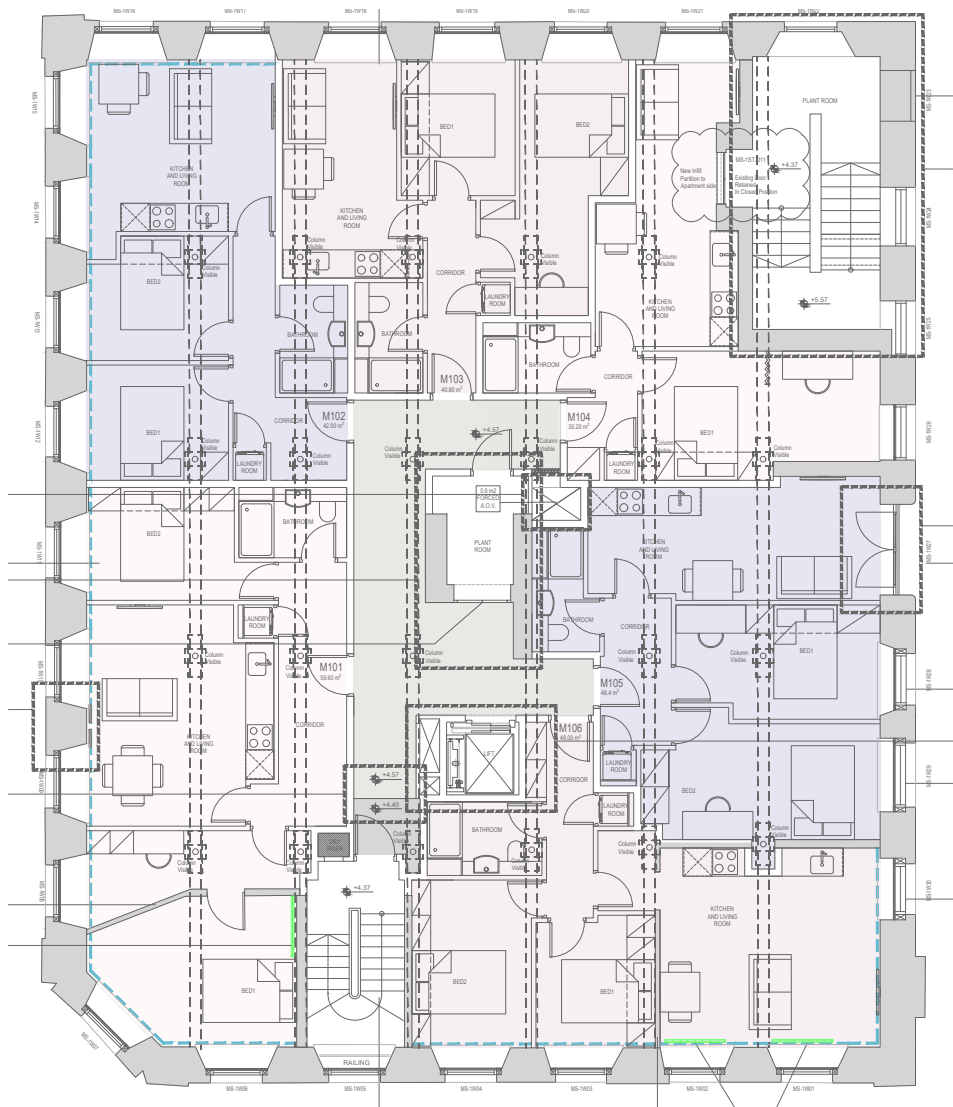
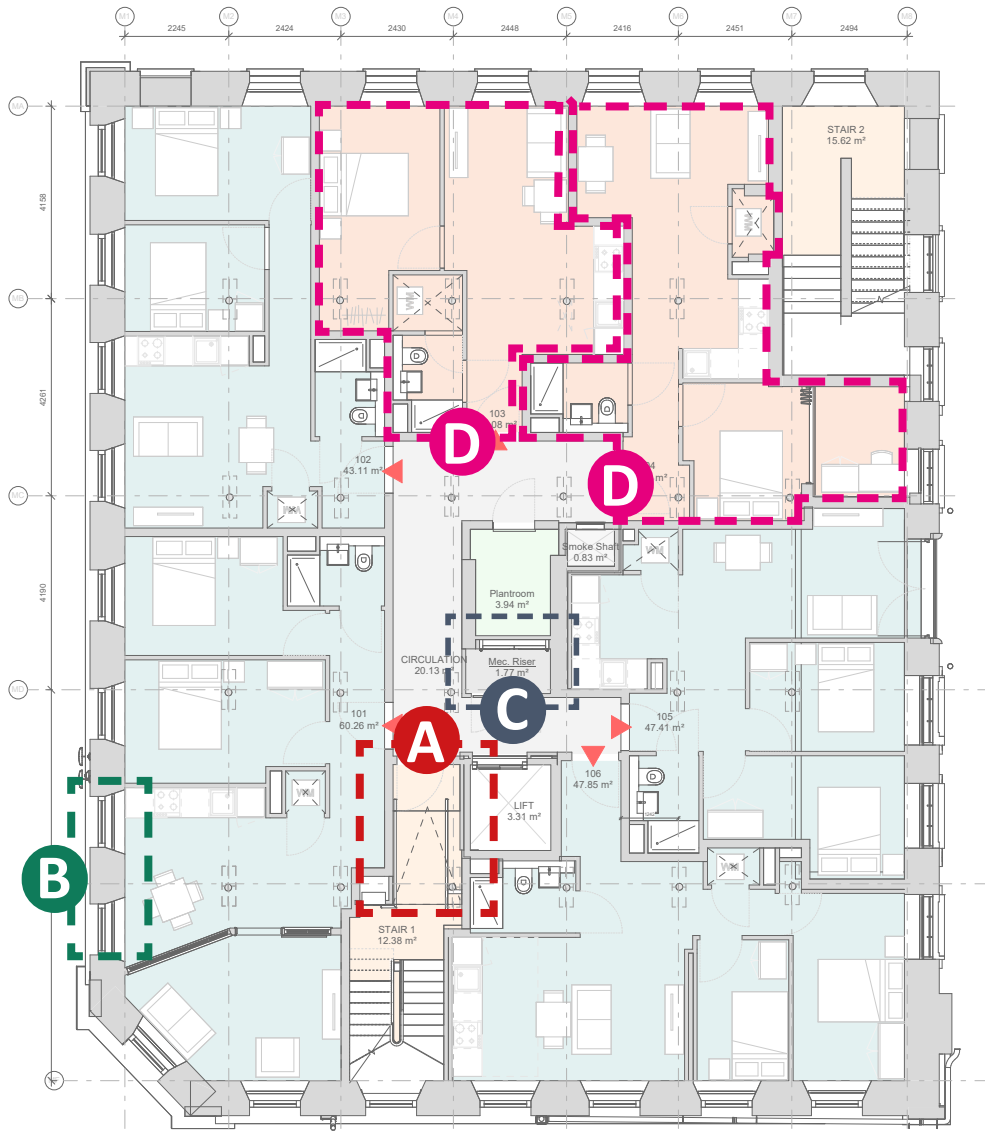
Mindel House. First Floor

- Apartment layout: Improved efficiency and open plan arrangement where possible.
- Main stair handrail: to be upgraded to comply with minimum height requirement. Additional top rail required possibly without interfering with original balustrade.

- A** Stair lobby: Extended to incorporate ramp needed to address the change of level
- B** Historic sprinkler valves+pipes: Now proposed to be refurbished and relocated within stair lobby
- C** Plantroom: Mechanical plant added for functional reasons.

- D** Apartment reconfiguration: The two apartments are redesigned together to provide better accommodation. As a result, one of the apartment has been reduced from 2 Bedrooms to 1.

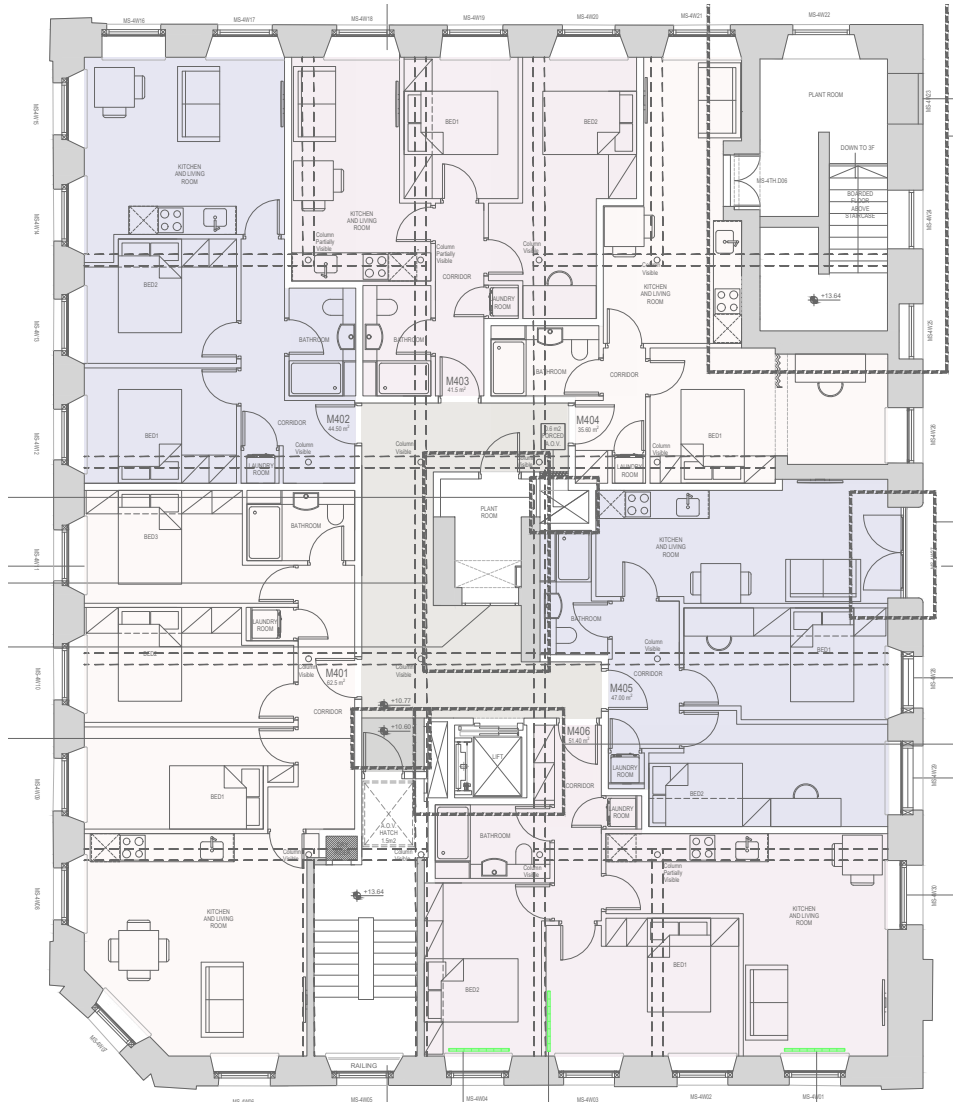
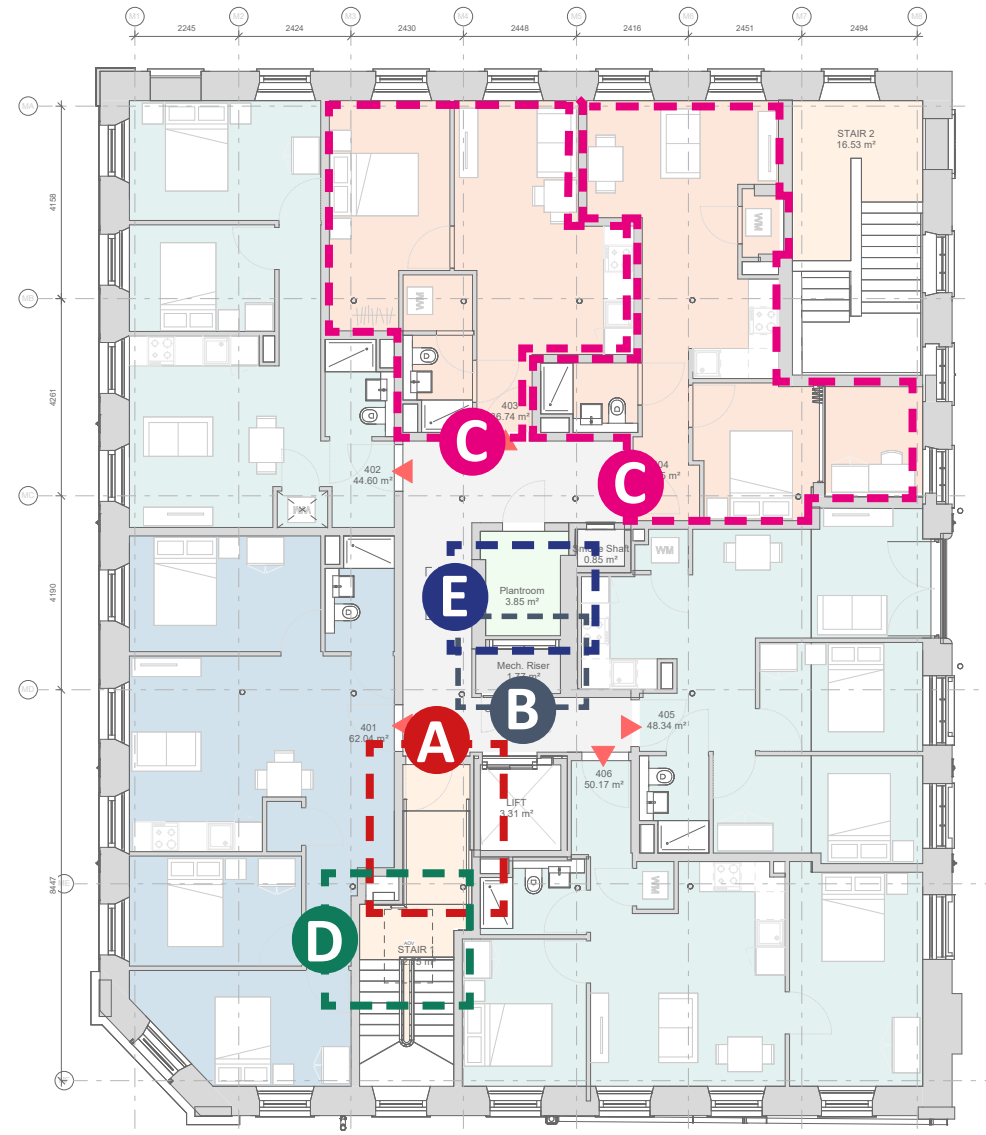
Mindel House. Fourth Floor

- Apartment layout: Improved efficiency and open plan arrangement where possible.
- Main stair handrail: to be upgraded to comply with minimum height requirement. Additional top rail required possibly without interfering with original balustrade.

Stair lobby: Extended to incorporate ramp needed to address the change of level

Plantroom: Mechanical plant added for functional reasons.

Apartment reconfiguration: The two apartments are redesigned together to provide better accommodation. As a result, one of the apartment has been reduced from 2 Bedrooms to 1.

A.O.V Hatch: Approved location above lobby not functional. Proposed to be relocated above stairs.

Masonry Hoist: Proposed to be cut below central flat roof level to make space for required plants.
