Proposed raised **Floor Type 1 - refer to 24006-HFR-BS-XX-DR-A-3010-3011**

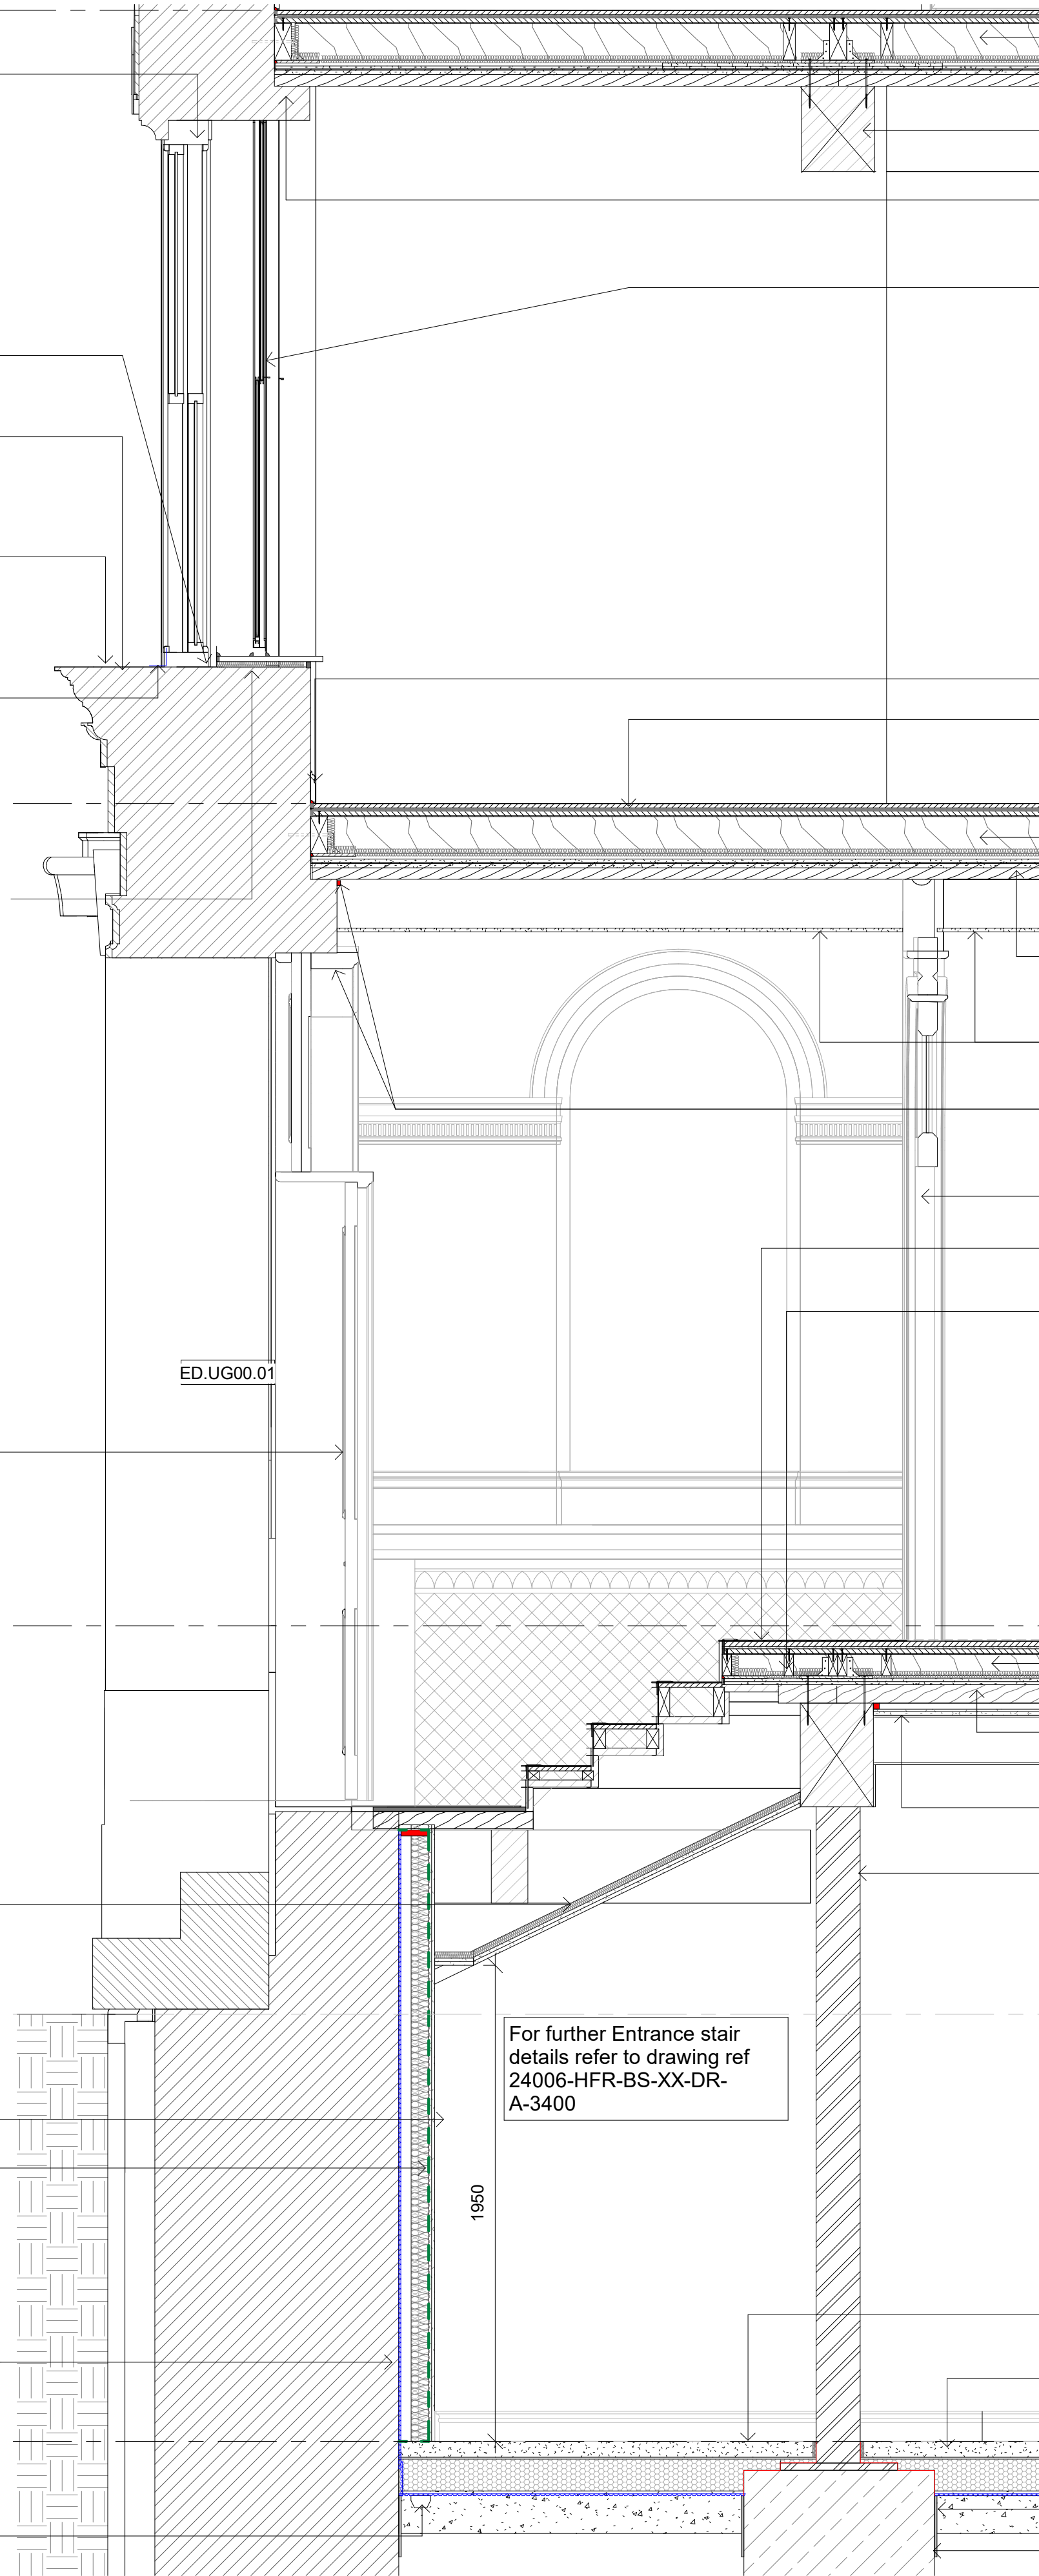
Perimeter drainage channel to Specialist Tanking sub-contractor details and specification. Refer to Civils Engineer drainage strategy drawing for layout design.

Main exposed Timber beams to be painted with 2 coats of dulux trade eggshell paint.

All existing external wall abutment with the new compartment floor build ups are to be filled by a perimeter intumescent mastic fire seal by the fire stopping sub-contractor and is to achieve a fire rating of 60 Minutes.

Secondary glazing unit to be fixed through to existing brickwork reveals. Timber plant piece fixed through dry lining system, with unit fixed after and sealed with Acoustic non-setting mastic, as NBS Clause K10/510 between glazing unit plasterboard/MDF panel to be used to conceal EDPM to existing windows. Proposed timber fixing block at base of secondary glazing to provide base fixing point.  
Where possible, a min 150mm gap must be kept between the existing window and the secondary glazing. The Specialist Secondary Glazing sub-contractor is to determine this following a site inspection for each secondary glazing window.

Internal light abrasive clean to the existing brickwork is to be undertaken in order to remove all paint coatings from internal brickwork, dust, dirt, soiling, staining, surface contaminants etc. All works to minimise dust and prevent damage to face of brickwork, mortar joints etc. Cleaning works to be undertaken by an approved specialist historic masonry cleaning and restoration contractor. All cleaning work to be undertaken in accordance with approved technical recommendations.

Existing 70mm thick timber floorboards to be made good as required and highlighted in the Building Repair Scope of Works. All new timbers should be isolated from direct contact with the masonry using dpm at the timber-masonry interface and ventilated masonry pockets.

Cementitious waterproofing slurry applied to existing, foundation pad stone, metal bearing plate and column. As per tanking specialists details and specifications.
