1 EXTERNAL WALL SECTION - ALLEYWAY.  
1 : 50

2 ALLEYWAY - COMPARTMENT FIFTH FLOOR ABUTMENT DETAIL Copy 1  
1 : 20

3 ALLEYWAY - COMPARTMENT FIRST FLOOR ABUTMENT & WINDOW DETAIL.  
1 : 20

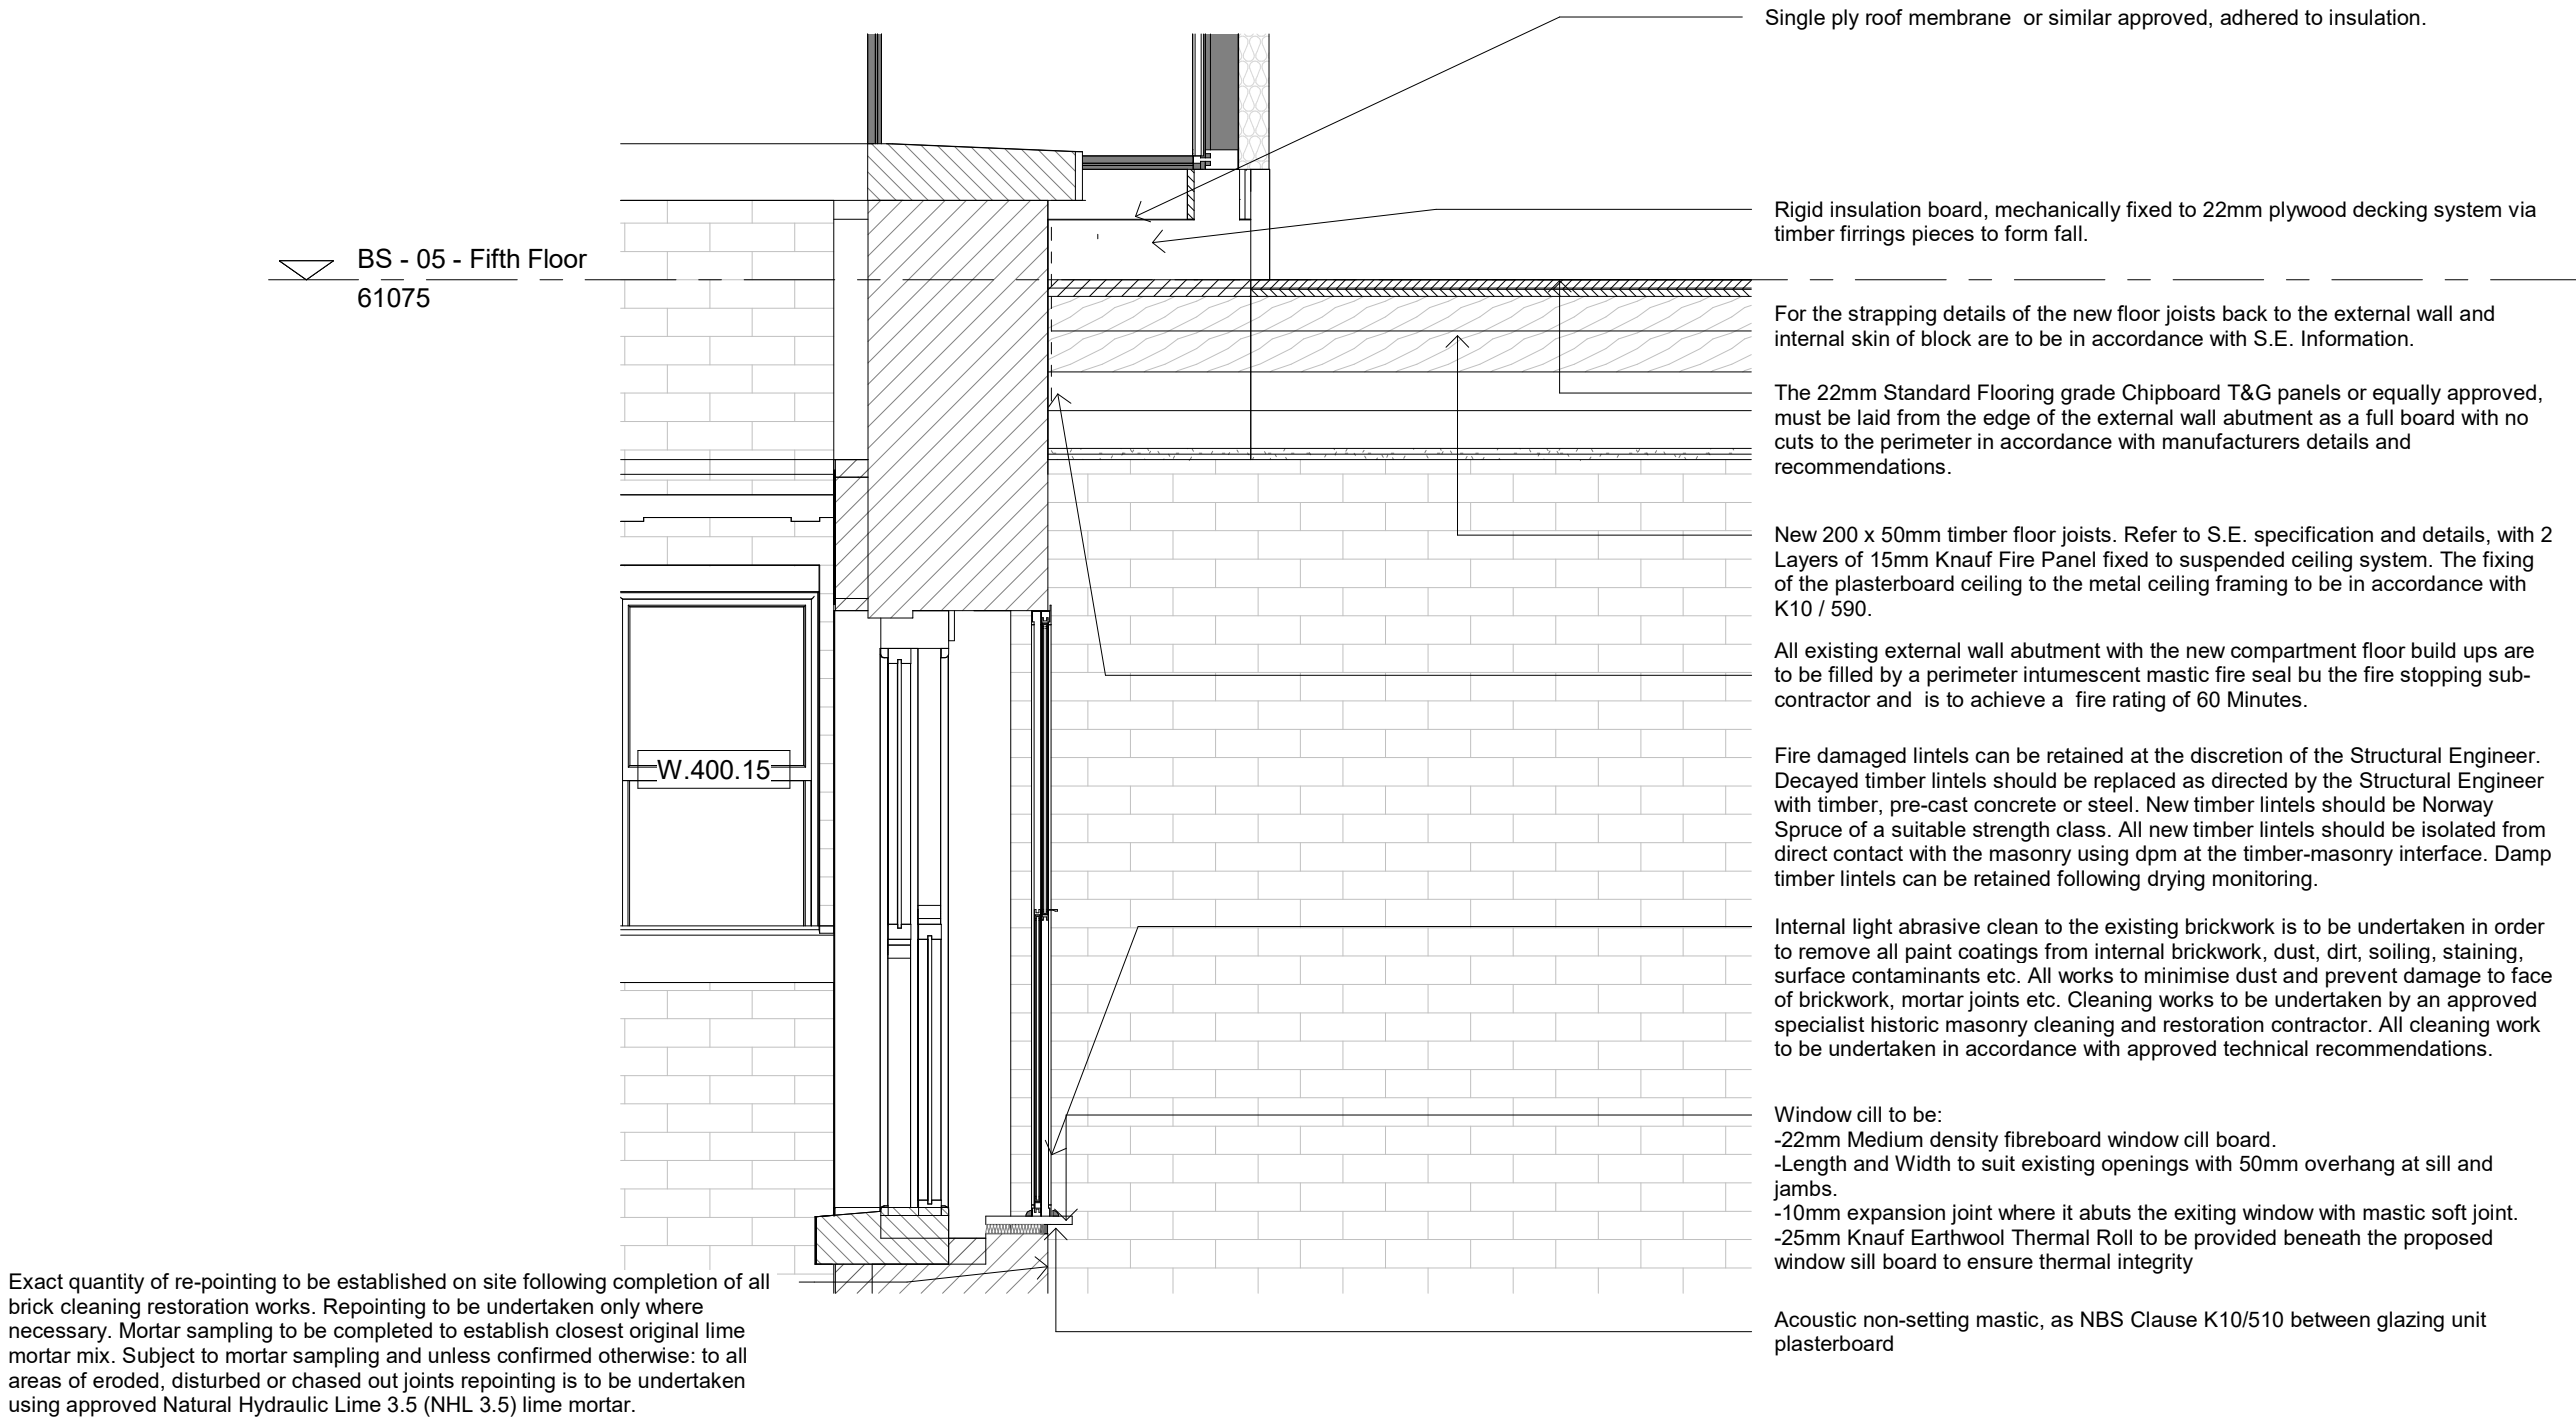
Exact quantity of re-pointing to be established on site following completion of all brick cleaning restoration works. Repointing to be undertaken only where necessary. Mortar sampling to be completed to establish closest original lime mortar mix. Subject to mortar sampling and unless confirmed otherwise, to all areas of eroded, disturbed or chased out joints repointing is to be undertaken using approved Natural Hydraulic Lime 3.5 (NHL 3.5) lime mortar.

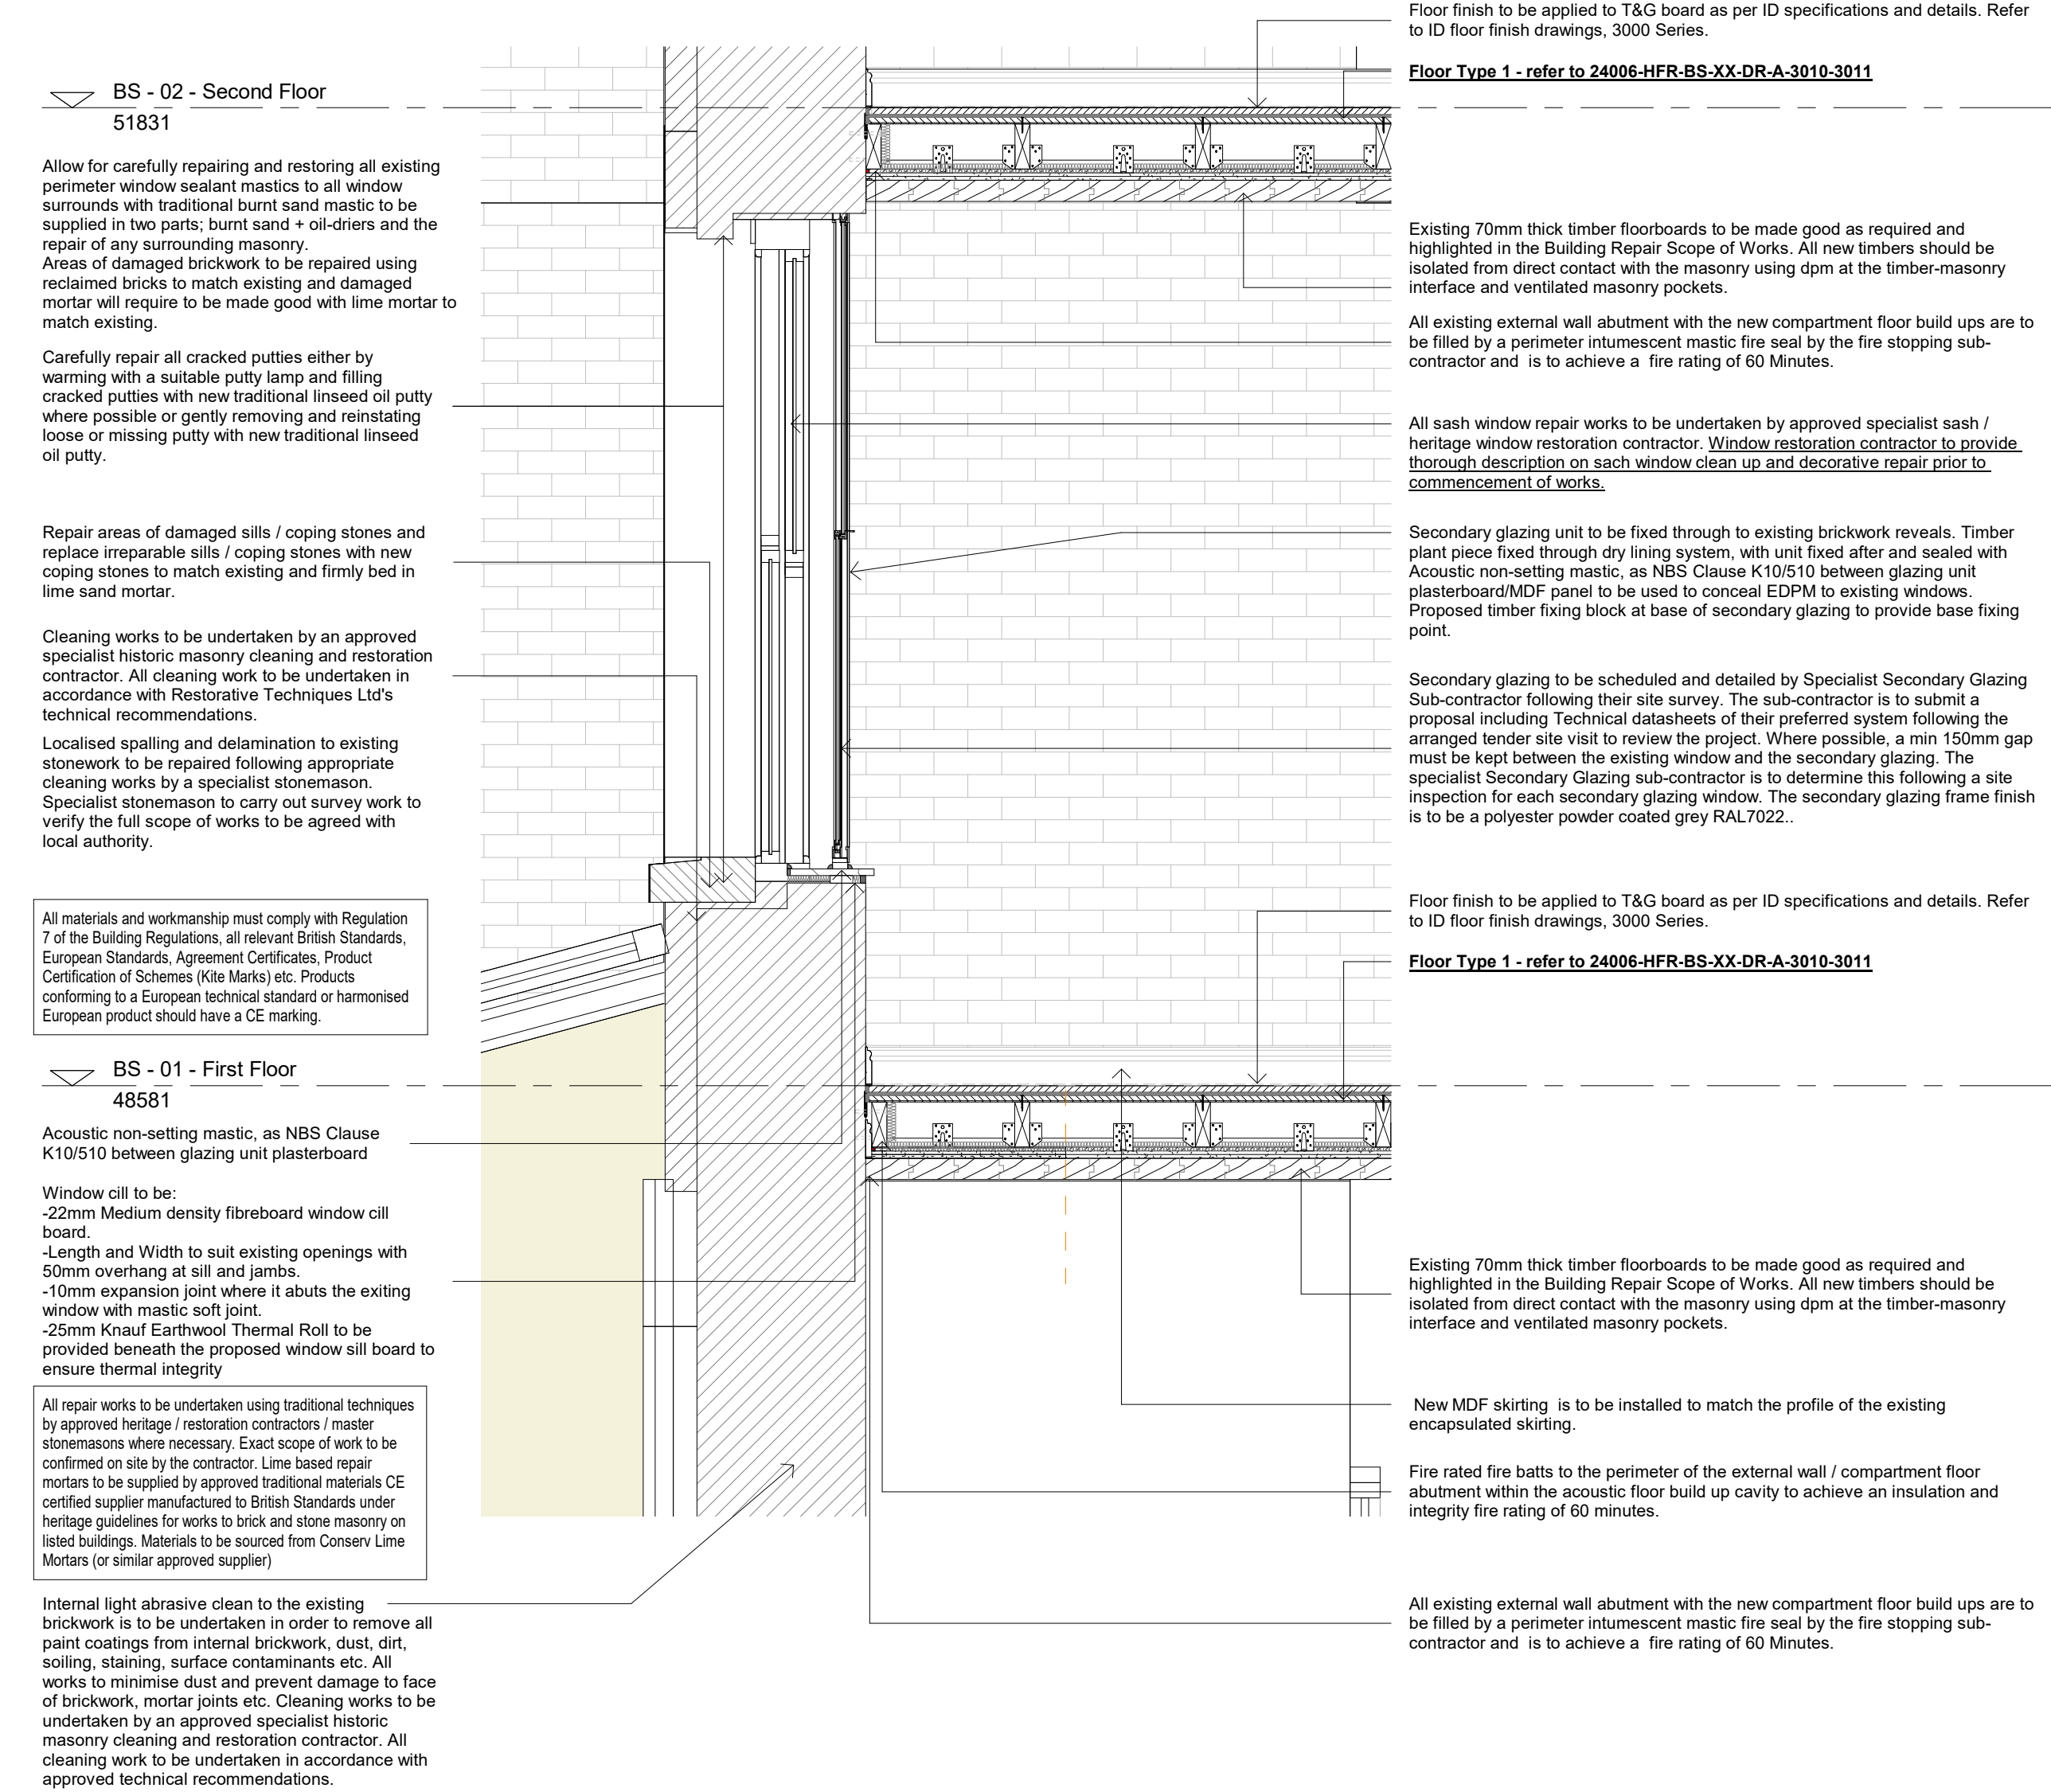
Allow for carefully repairing and restoring all existing perimeter window sealant mastics to all window surrounds with traditional burnt sand mastic to be supplied in two parts; burnt sand + oil-driers and the repair of any surrounding masonry. Areas of damaged brickwork to be repaired using reclaimed bricks to match existing and damaged mortar will require to be made good with lime mortar to match existing.

Carefully repair all cracked putties either by warming with a suitable putty lamp and filling cracked putties with new traditional linseed oil putty where possible or gently removing and reinstating loose or missing putty with new traditional linseed oil putty.

Repair areas of damaged sills / coping stones and replace irreparable sills / coping stones with new coping stones to match existing and firmly bed in lime sand mortar.

Cleaning works to be undertaken by an approved specialist historic masonry cleaning and restoration contractor. All cleaning work to be undertaken in accordance with Restorative Techniques Ltd's technical recommendations.

Localised spalling and delamination to existing stonework to be repaired following appropriate cleaning works by a specialist stonemason. Specialist stonemason to carry out survey work to verify the full scope of works to be agreed with local authority.

All repair works to be undertaken using traditional techniques by approved heritage / restoration contractors / master stonemasons where necessary. Exact scope of work to be confirmed on site by the contractor. Lime based repair mortars to be supplied by approved traditional materials CE certified supplier manufactured to British Standards under heritage guidelines for works to brick and stone masonry on listed buildings. Materials to be sourced from Conserv Limb Mortars (or similar approved supplier)

Internal light abrasive clean to the existing brickwork is to be undertaken in order to remove all paint coatings from internal brickwork, dust, dirt, soiling, staining, surface contaminants etc. All works to minimise dust and prevent damage to face of brickwork, mortar joints etc. Cleaning works to be undertaken by an approved specialist historic masonry cleaning and restoration contractor. All cleaning work to be undertaken in accordance with approved technical recommendations.
